# LAYTON TREE CONSULTING, LLC

## ARBORIST REPORT/TREE PLAN

7621 SE 22<sup>nd</sup> Street  
Mercer Island, WA

**March 30, 2020**

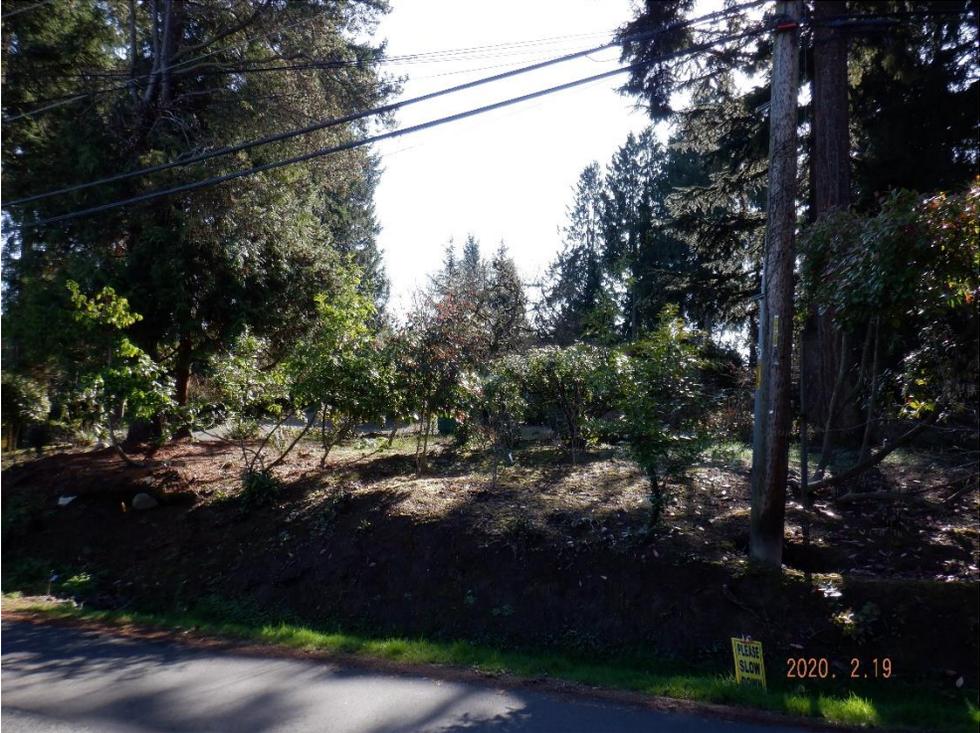
Front of property, Tree #1 on right, Trees #23 and #24 on left

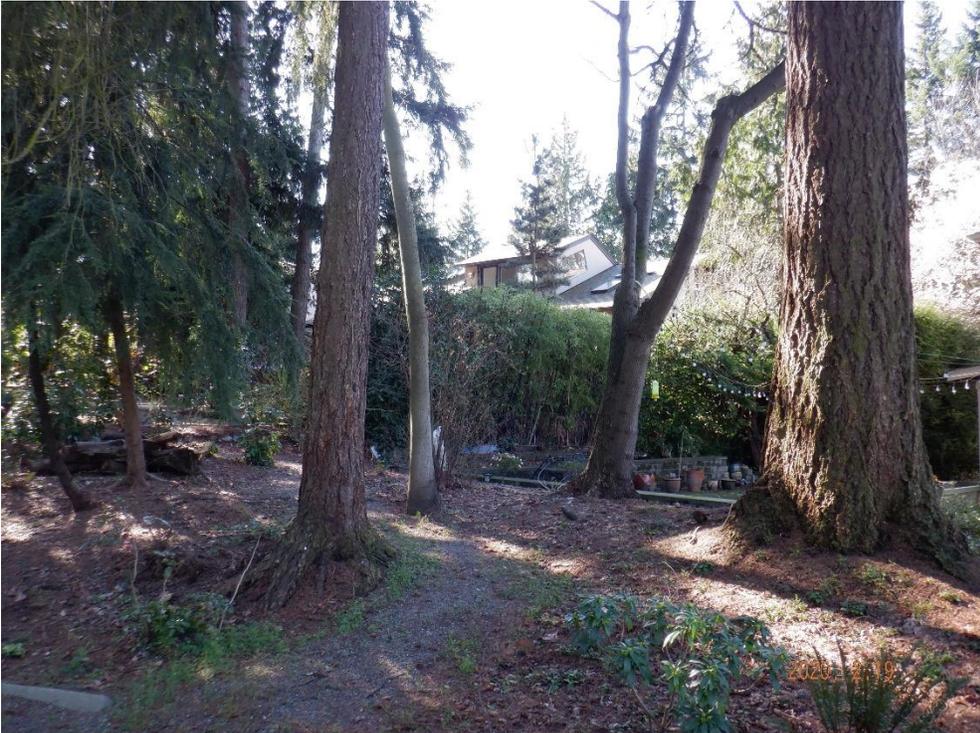
Trees #4, #5, #6 and #7

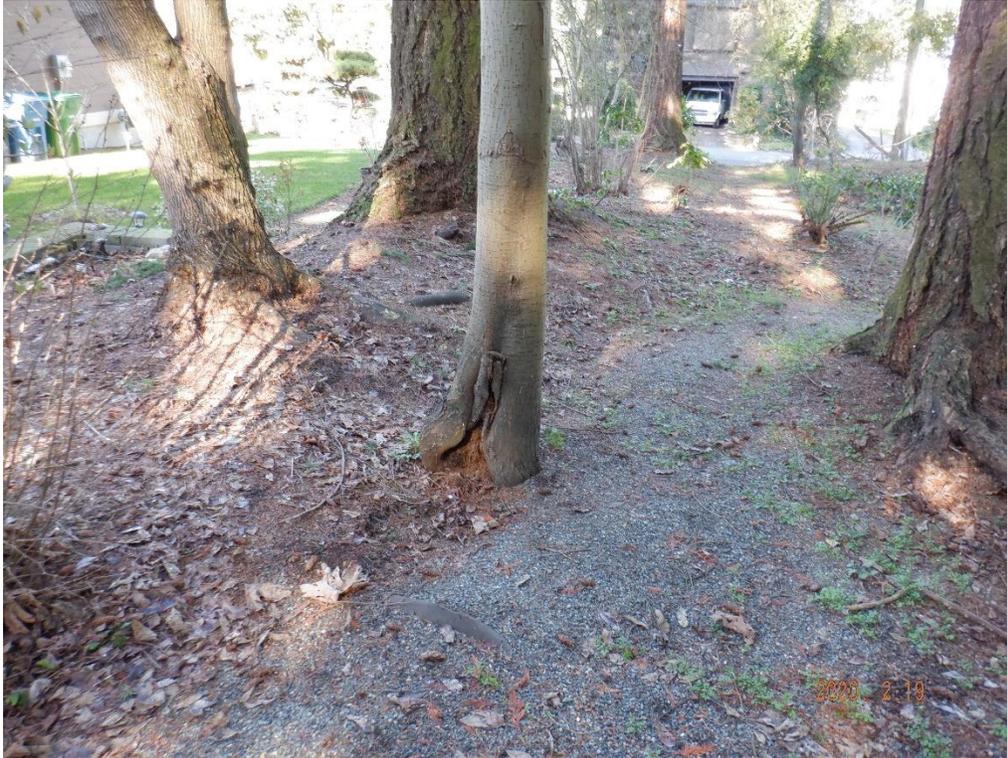
No ‘poor’ condition or high-risk trees were identified on the subject property. With the exception of Tree #7, all assessed trees are in fair to good condition. The attached map indicates the condition of subject trees. Tree #7 is a semi-mature Scouler’s willow. It is suppressed by the larger surrounding trees. There is obvious decay at the root crown. Condition is rated as ‘fair-to-poor’.

Lower trunks of trees on west perimeter, note rot at root crown of Tree #7, Tree 31 and #2 in background

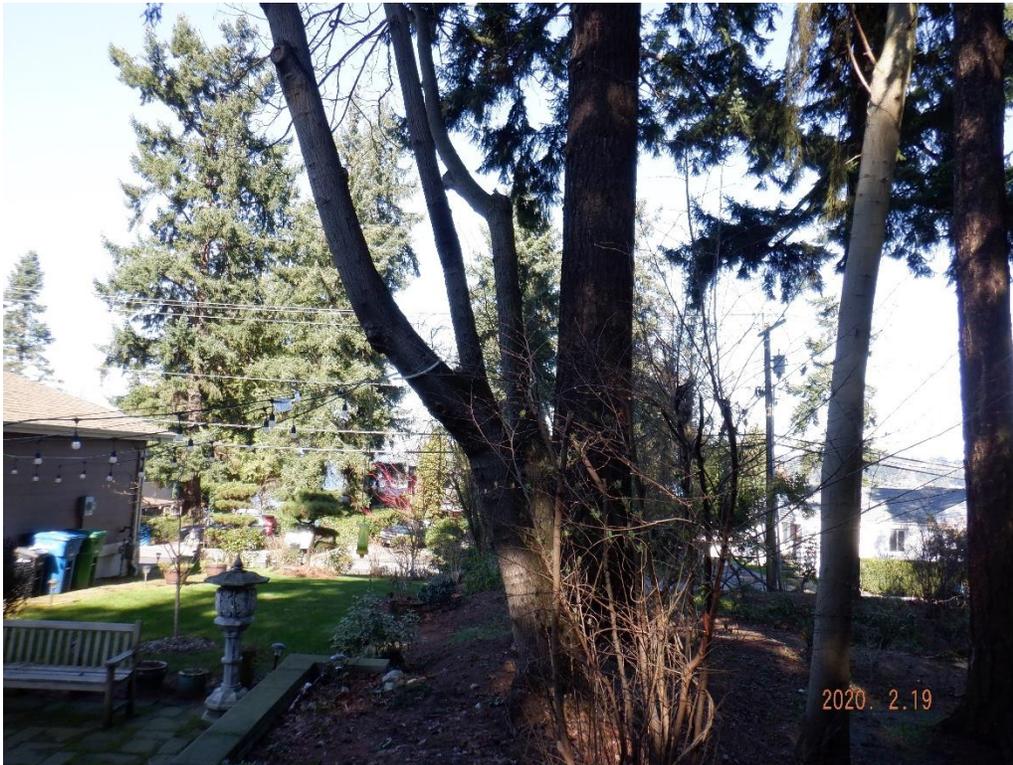
The subject bigleaf maples have developed typical form and structure. Tree #6 is a semi-mature bigleaf maple close to the west property line. It has an asymmetric crown to the west onto the neighboring property. Vigor is fair.

Trees on west perimeter, looking north, Tree #6 (maple) with lean to west towards neighbor

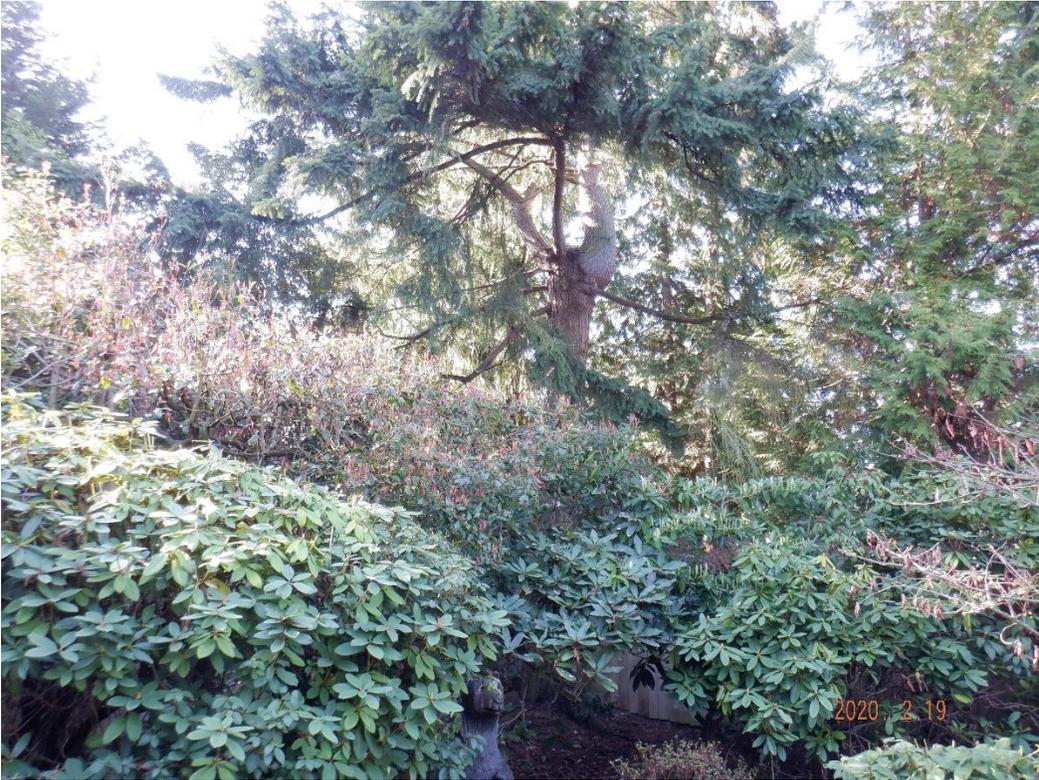
Tree #8 in southwest corner of property

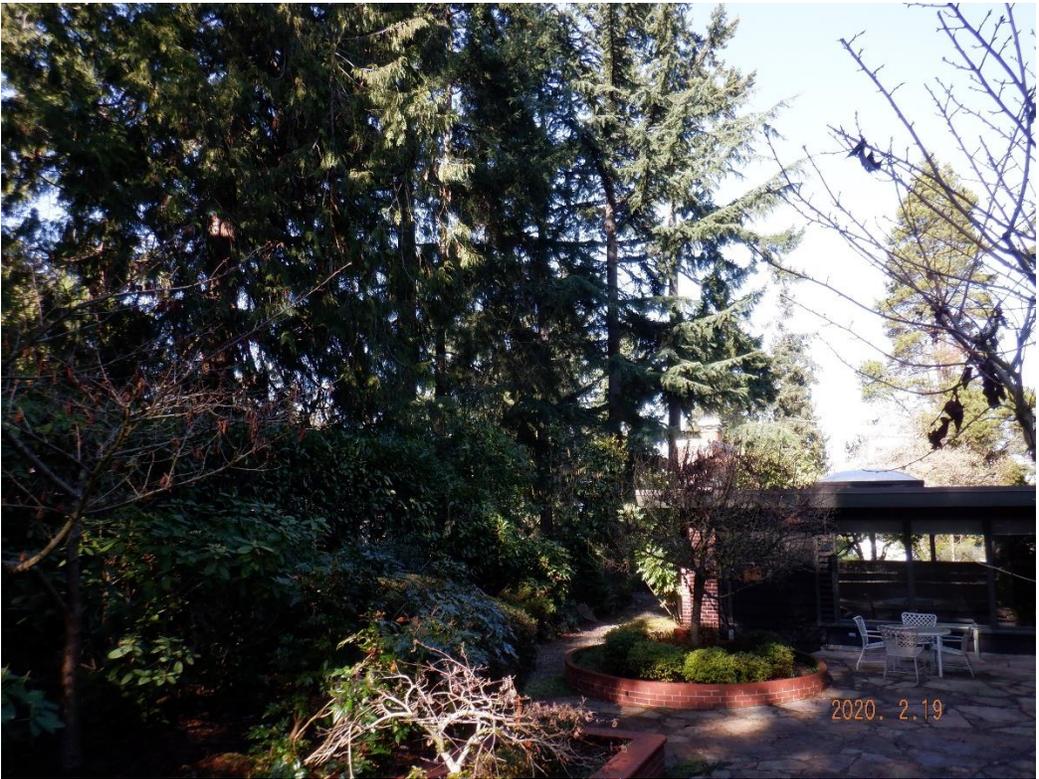
The Western red cedar is of fairly good vigor. Foliage is of normal color and density. The foliage in the upper crown of Tree #101 is a little sparse. The lower trunks are sound and free of any outward indicators of internal stem decay.

Back of property, Trees #101 and #102 on left

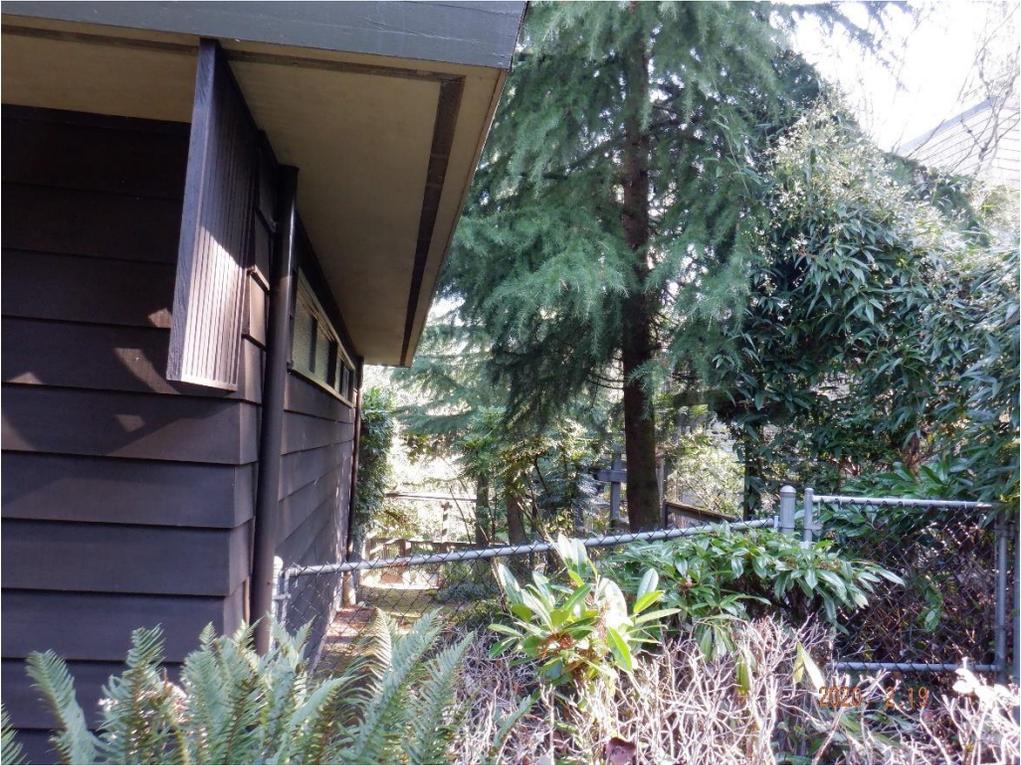
Trees #9, #10 and #11 are young planted Deodar cedar on the south perimeter. All are of good vigor and in good condition.

Trees #9, #10 and #11 on south perimeter

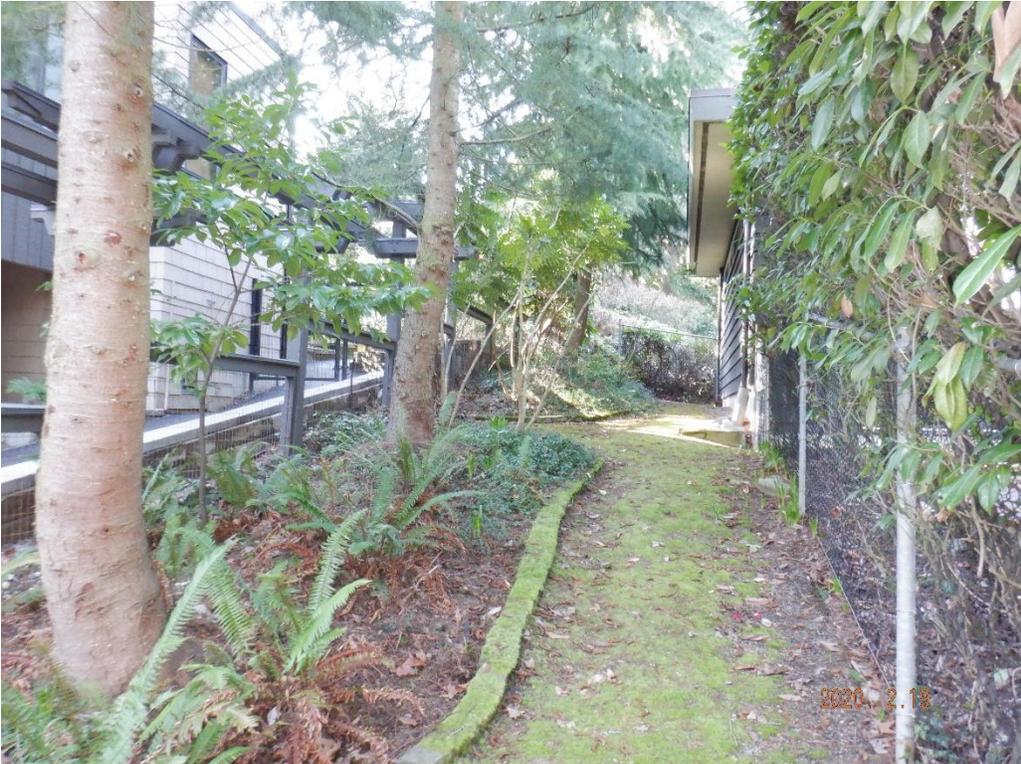
Lower trunks of young Deodar cedar trees

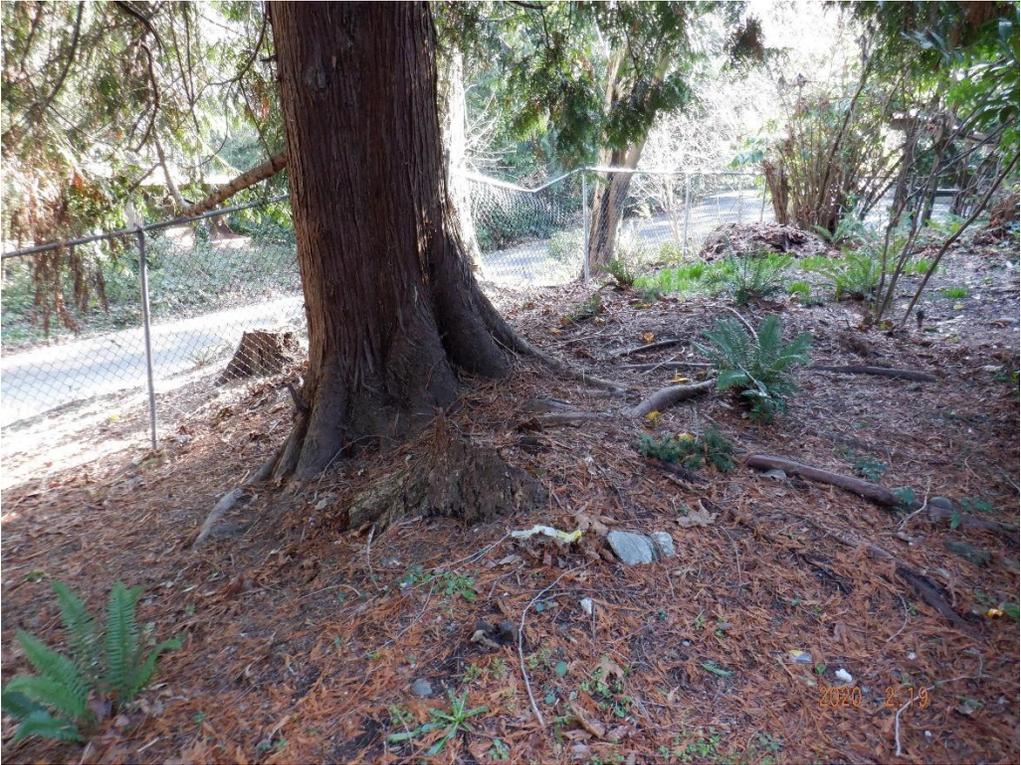
Tree #12 on east perimeter

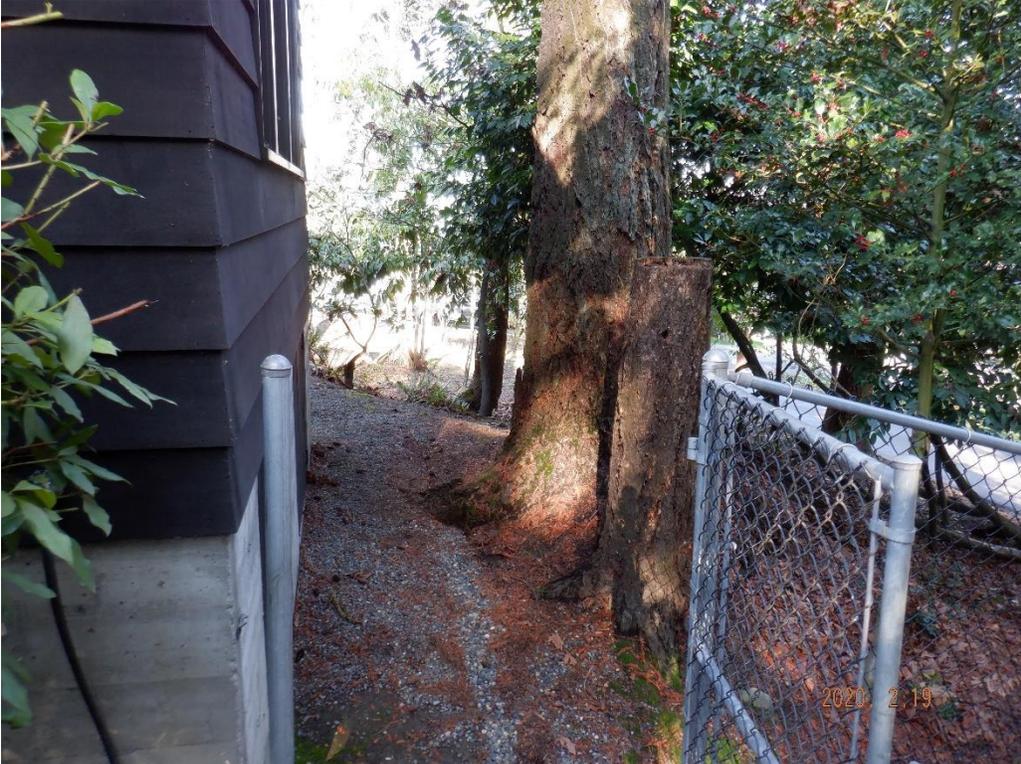
Tree #13 located close to existing structure

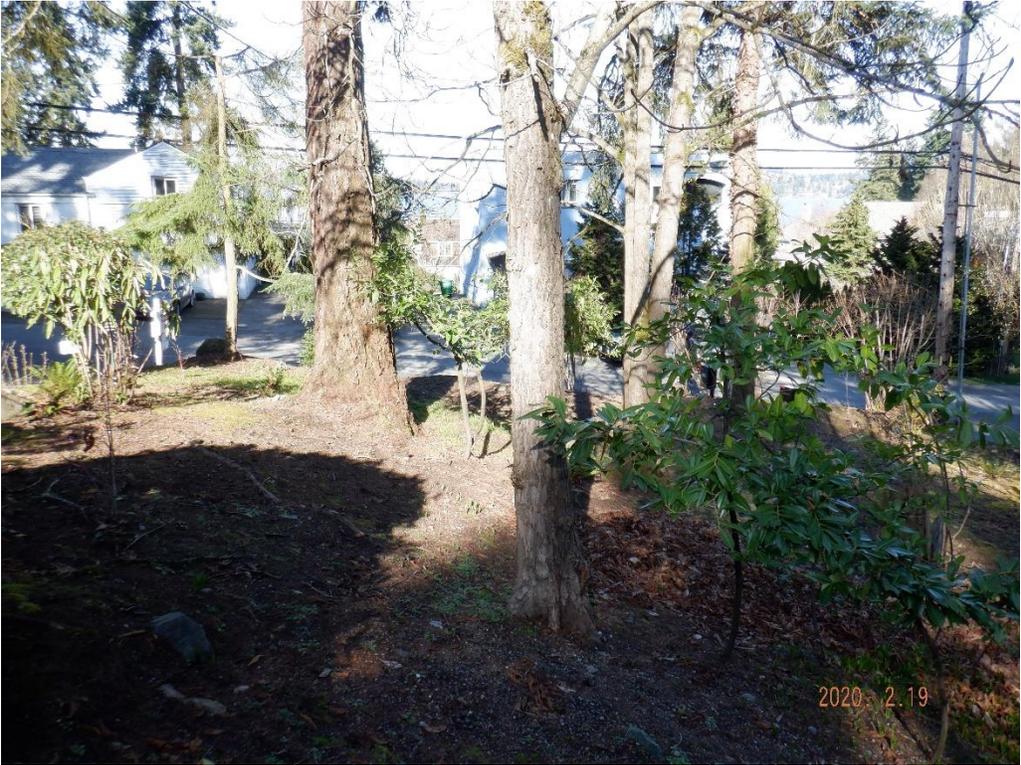
Grouping of trees in northeast portion of property

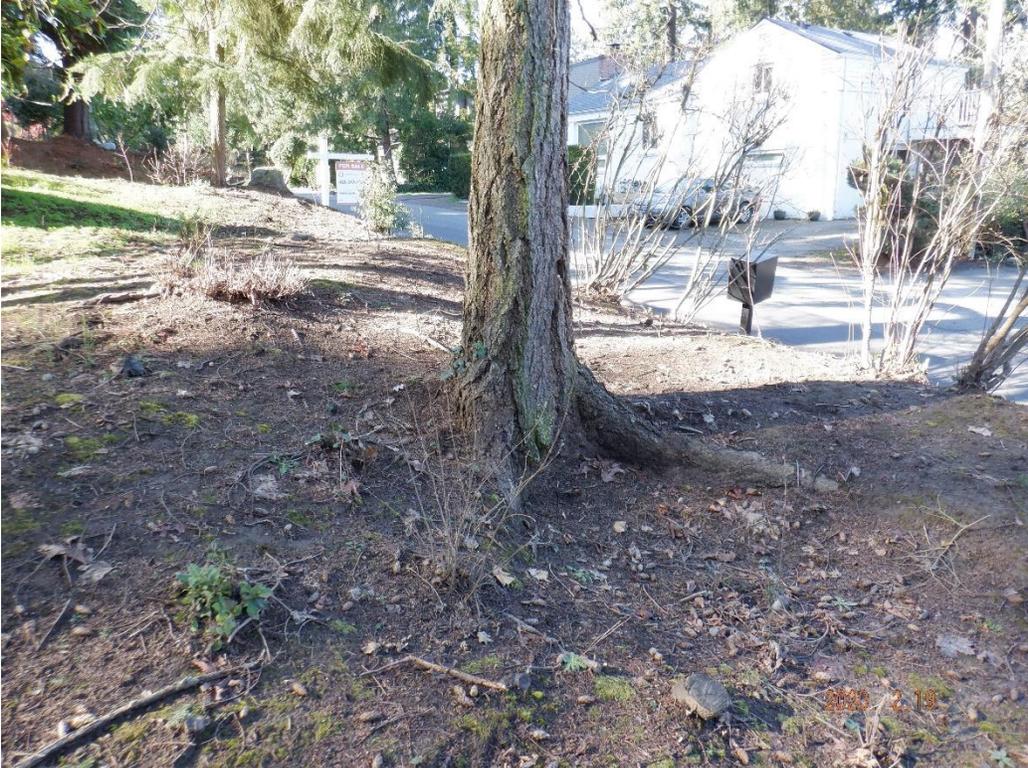
Lower trunk of Tree #21

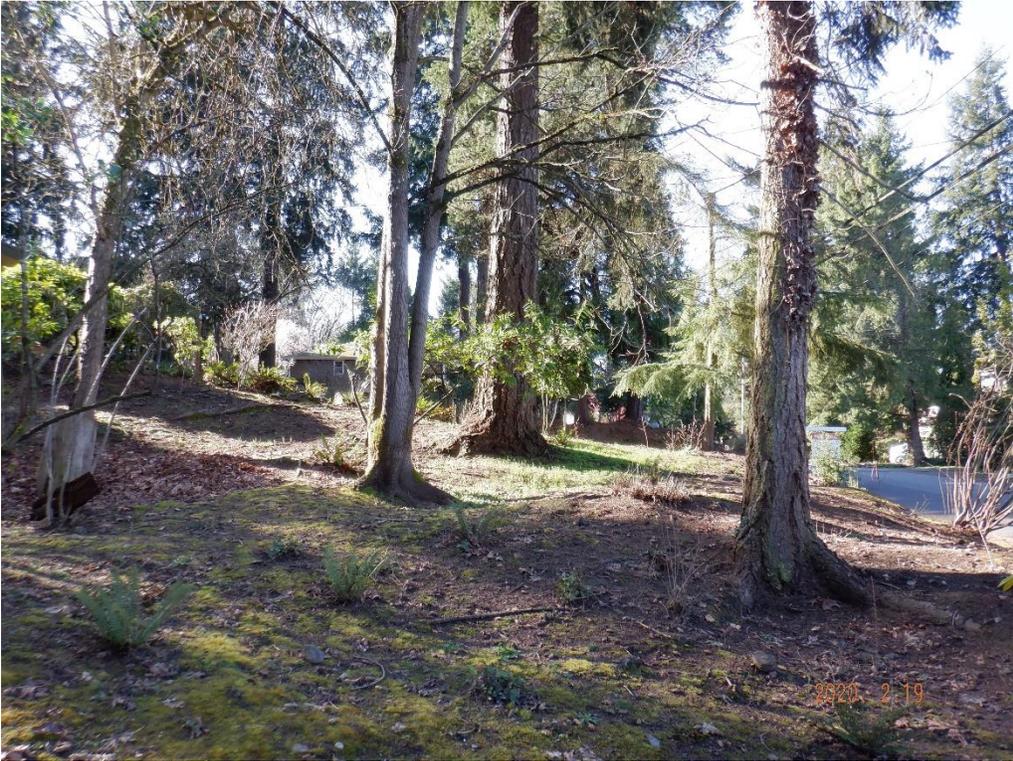
Trees #20, #21 and #22 at front of property

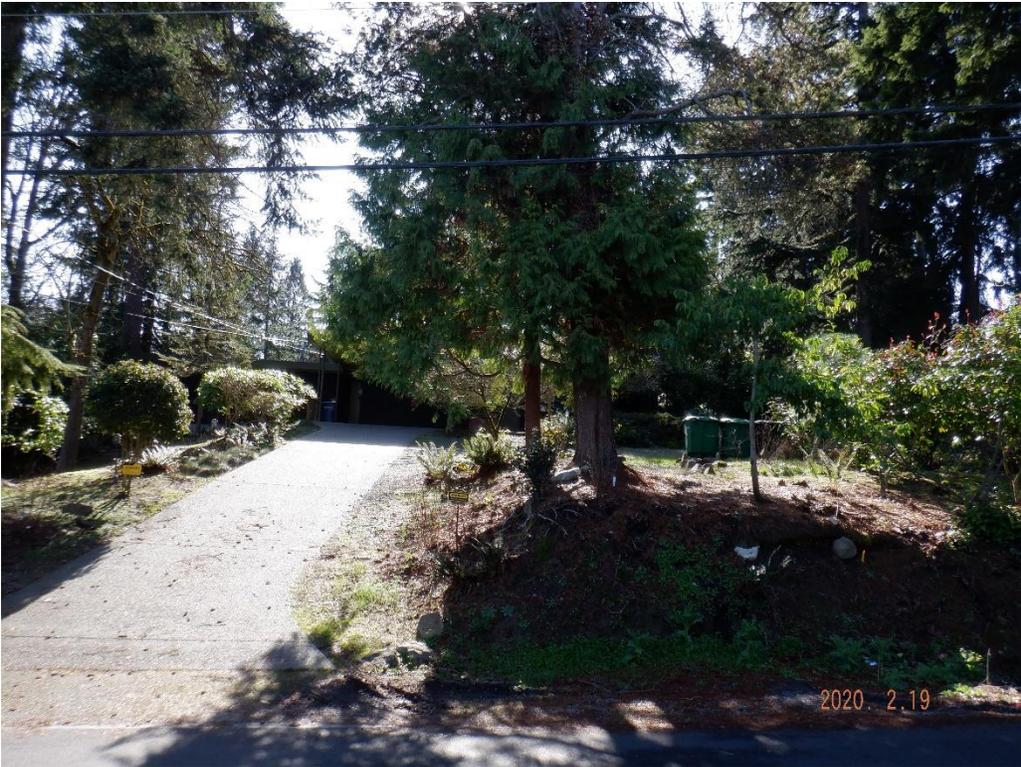
Tree #23 is a mature shore pine at the front of the property. It has multiple forked tops. It has been pruned back in the past for power line clearance.

Trees #23 and #24 at front of property

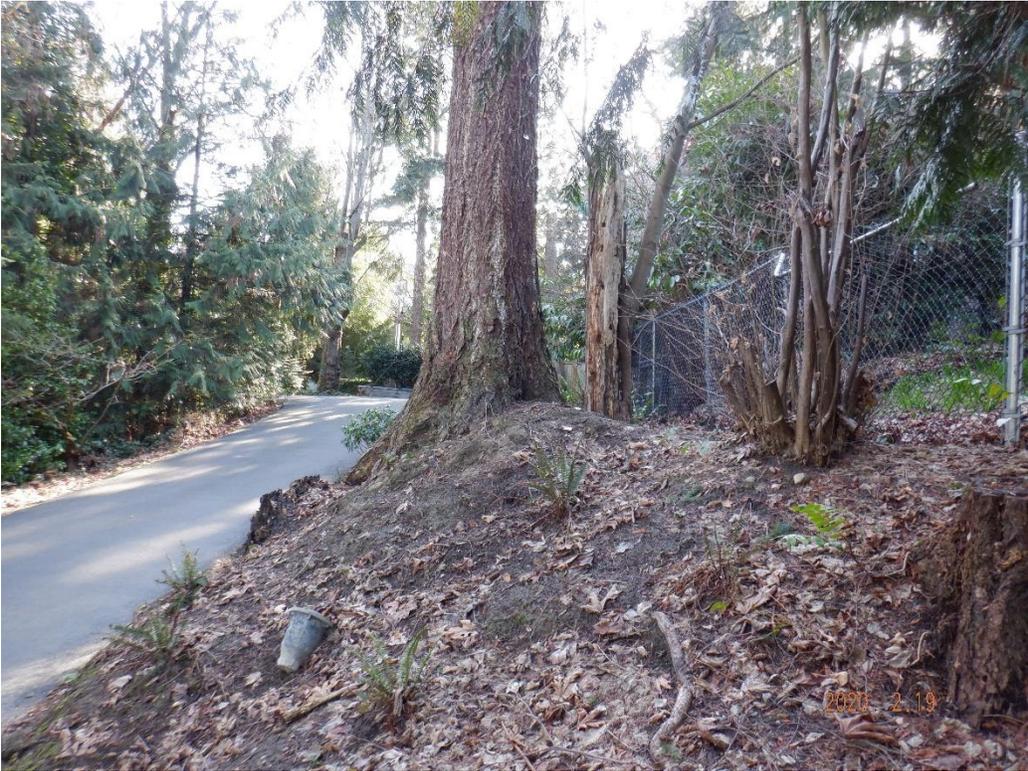
Tree #25 on east property line

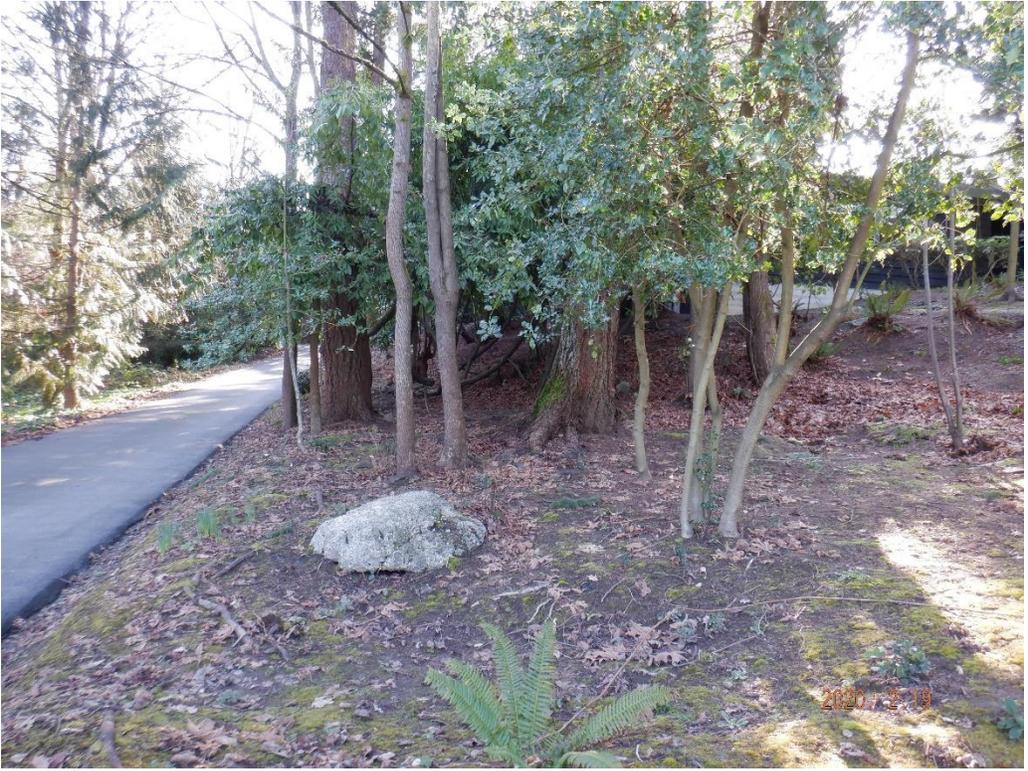
Looking south down east property line
