Preliminary Arborist Report

To: JMK Homes c/o Jed Murphy
Site: 6610 E Mercer Way, Mercer Island, WA
Re: Tree inventory
Date: October 31, 2022
Project Arborist: George White,
ISA Certified Arborist #PN-8908A
ISA Qualified Tree Risk Assessor
Reviewed By: Joseph Sutton-Holcomb
ISA Certified Arborist #PN-8397AM
Municipal Specialist, ISA Qualified Tree Risk Assessor
Referenced Documents: Topographic Survey (Pace Engineers, 6.6.2018)
Koneru Building Permit (Pace Engineers, Revised 5.11.2022)
Attached: Table of Trees
Tree Site Map

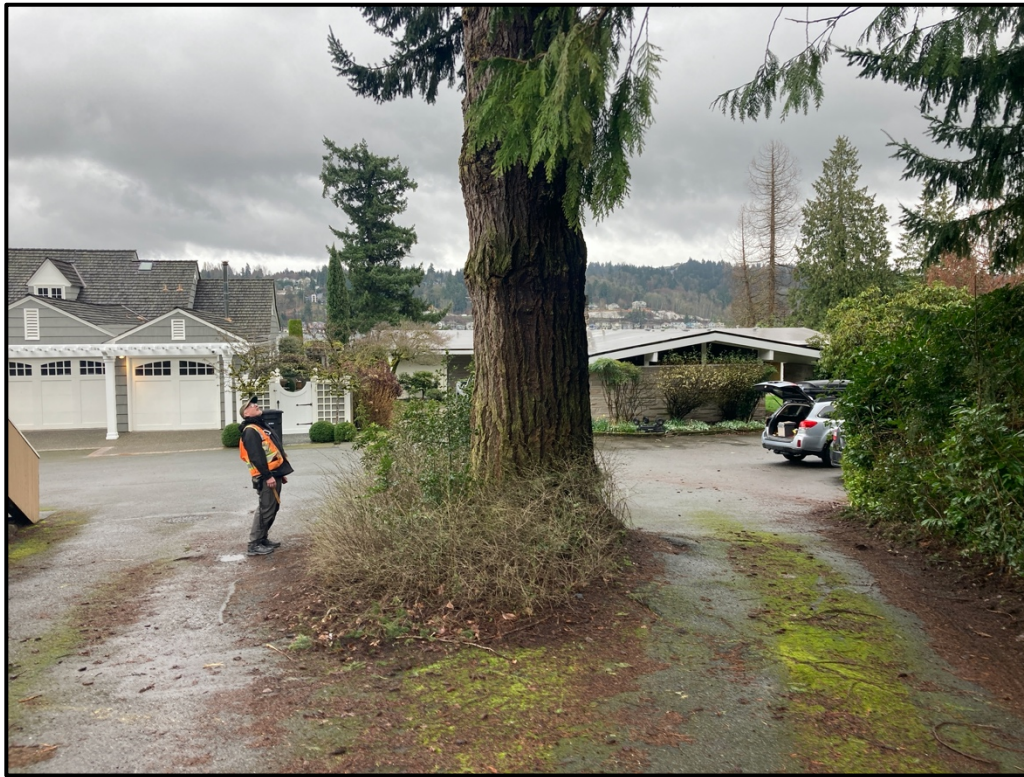
Tree 573 is an exceptional Douglas-fir (*Pseudotsuga menziesii*) that is located in the middle of the driveway easement in the northwest corner of the property. (See photo 1.) This tree is currently proposed for removal. This tree conflicts with the construction of a driveway that would allow for emergency vehicle egress. It also conflicts with plans to install a required fire hydrant and accompanying 6" water line. Therefore, retention of this tree would result in an "unavoidable hazardous situation" as described in MICC 19.10.060.3. if the driveway and fire hydrant are installed at the proposed locations. Therefore, this tree is exempt from the restriction on the removal of exceptional trees.

Photograph 1. Tree 573, An exceptional Douglas-fir in the NW corner of the lot. This tree conflicts with required driveway improvements and new fire-hydrant.

The stump of tree 573 should be ground in place, not ripped out to avoid root damage to adjacent trees. Six replacement trees will be required for this tree in accordance with the standards outlined in MICC 19.10.070.

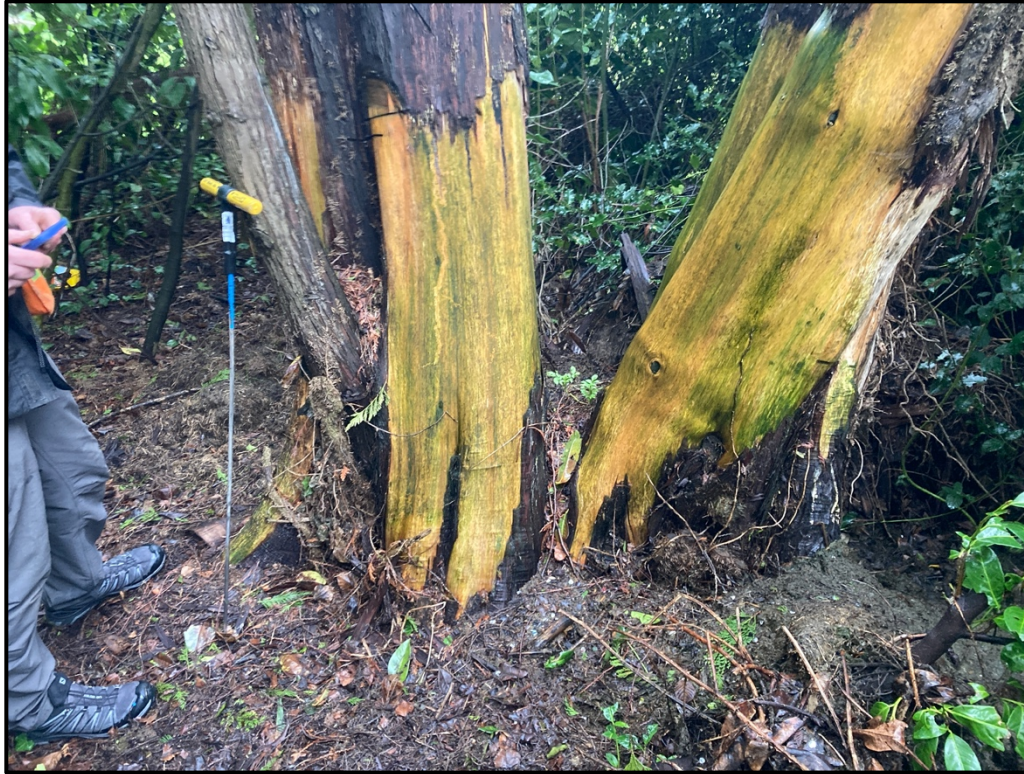
Additionally, we surveyed one dead tree of exceptional size that appeared to have been intentionally girdled by the previous property owners. We observed several trees (some over 10 inches in diameter)

Dead tree 1 was an exceptional western redcedar that was killed by the previous property owner. Because this tree was exceptional it would have been required to be retained and not damaged by development in the tree protection zone. The only proposed structure that encroaches on the minimum limits of disturbance is a deck which is to be constructed on piles. In my professional opinion, the impacts from this deck would have been manageable should the tree be alive and required for retention.

Photograph 2. Dead tree 1, An exceptional western redcedar that appeared to have been girdled by the previous property owner.

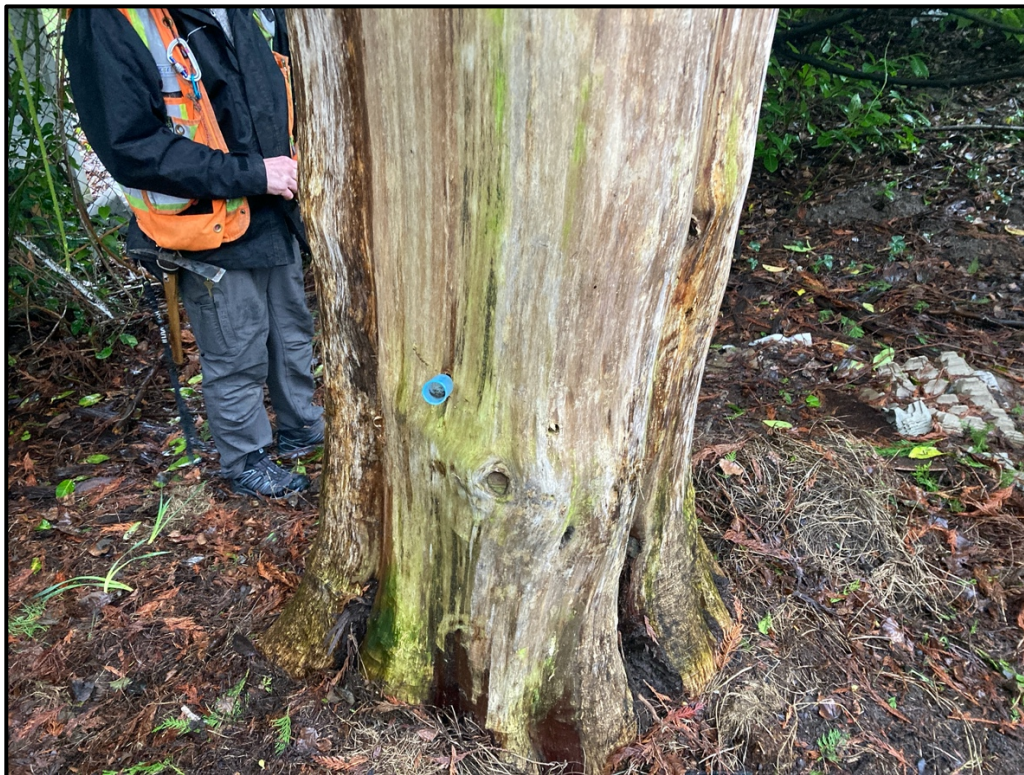
that appeared to have been killed intentionally in this manner. In one case, a dead tree had a funnel protruding from a drilled port that was presumably used to inject herbicide. (See photos 2 and 3.)

Photograph 3. Dead tree 2, a dead western redcedar with funnel and signs of intentional girdling.

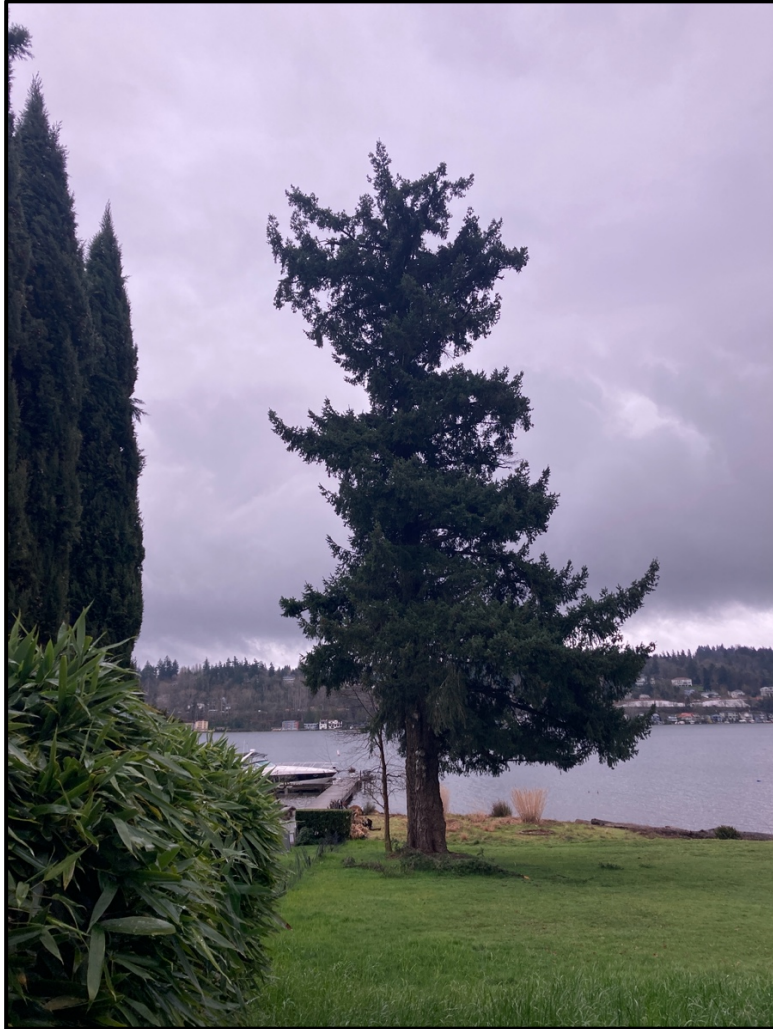
Tree 575 is an exceptional Douglas fir that is located in the northeast quadrant of the lot. (See photo 4.) This tree must be protected with tree protection fencing at the Recommended Limits of Disturbance (RLOD) listed in the attached table of trees using the specifications provided in appendix F. No machine access, or materials storage will be permitted within the RLOD. All erosion and runoff control (e.g., silt-fencing) must be surface mounted within the RLOD. Any excavation within the RLOD must be monitored by the project arborist.

Photograph 4. Tree 275, and exceptional Douglas-fir with windblown canopy that is proposed for retention.

The most recent plans show a proposed storm drain located approximately 20 feet south of tree 575. The edge of this trench must be excavated carefully under the supervision of the project arborist and any exposed roots must be cut cleanly and immediately backfilled.
