Arborist Report

~ Pre-construction Tree Inventory ~

Tree133 LLC was hired to prepare a pre-construction inventory of trees at 6610 East Mercer Way, Mercer Island, WA. A site visit was performed on the afternoon of Monday, March 1.

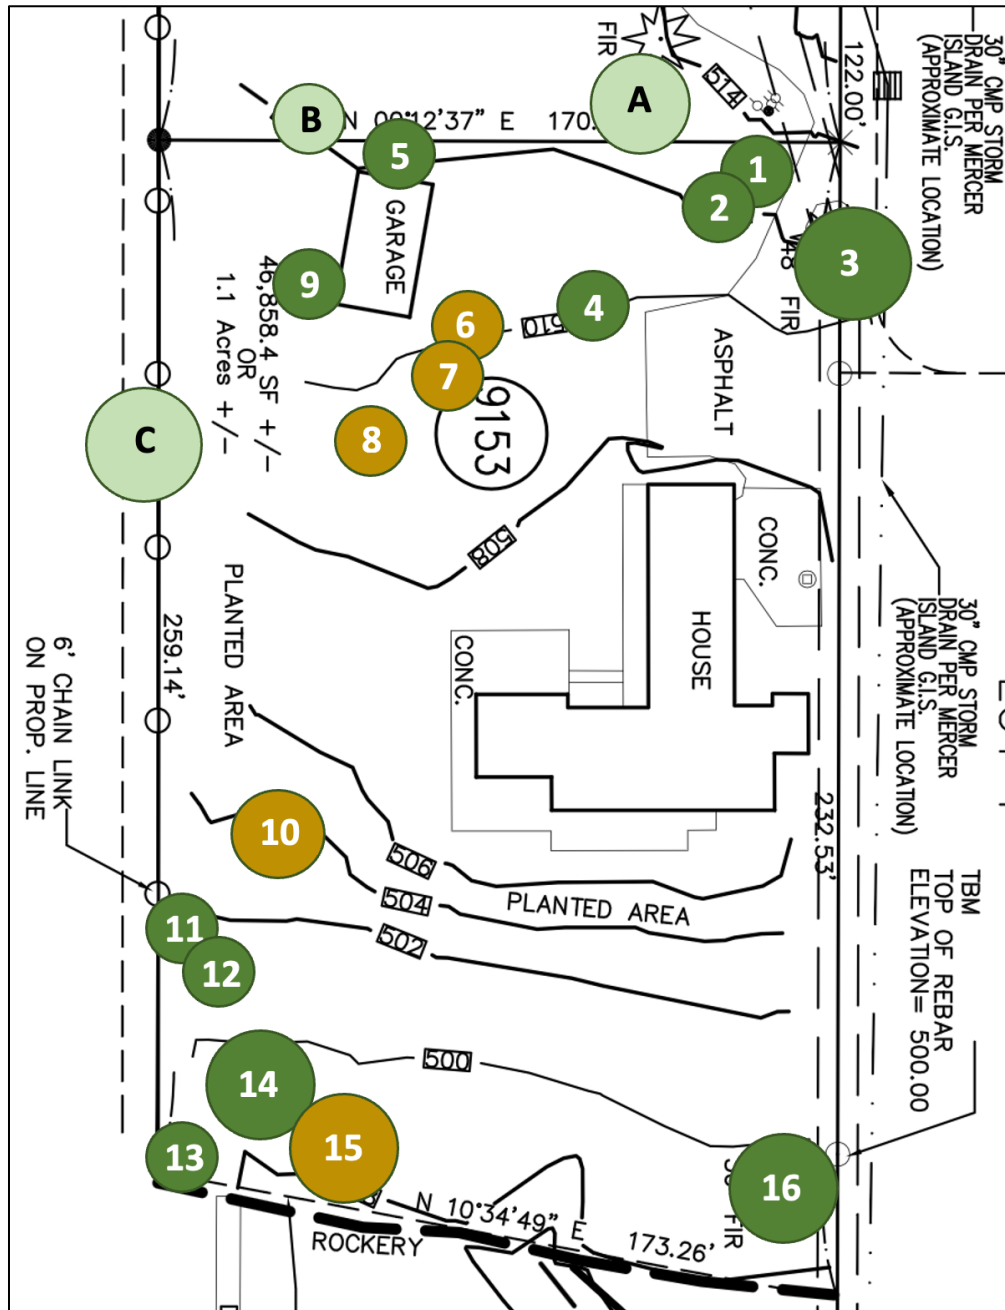
Site Map

The image below identifies the location of all trees included in this inventory. Tree location(s) and canopy size(s) are not to scale and for reference only.
