TREE INVENTORY

DHEERAJ KONERU
7002 93RD AVENUE SE
MERCER ISLAND, WA 98040

KONERU SHORT PLAT
6610 EAST MERCER WAY
MERCER ISLAND, WA 98040
TREE RETENTION PLAN

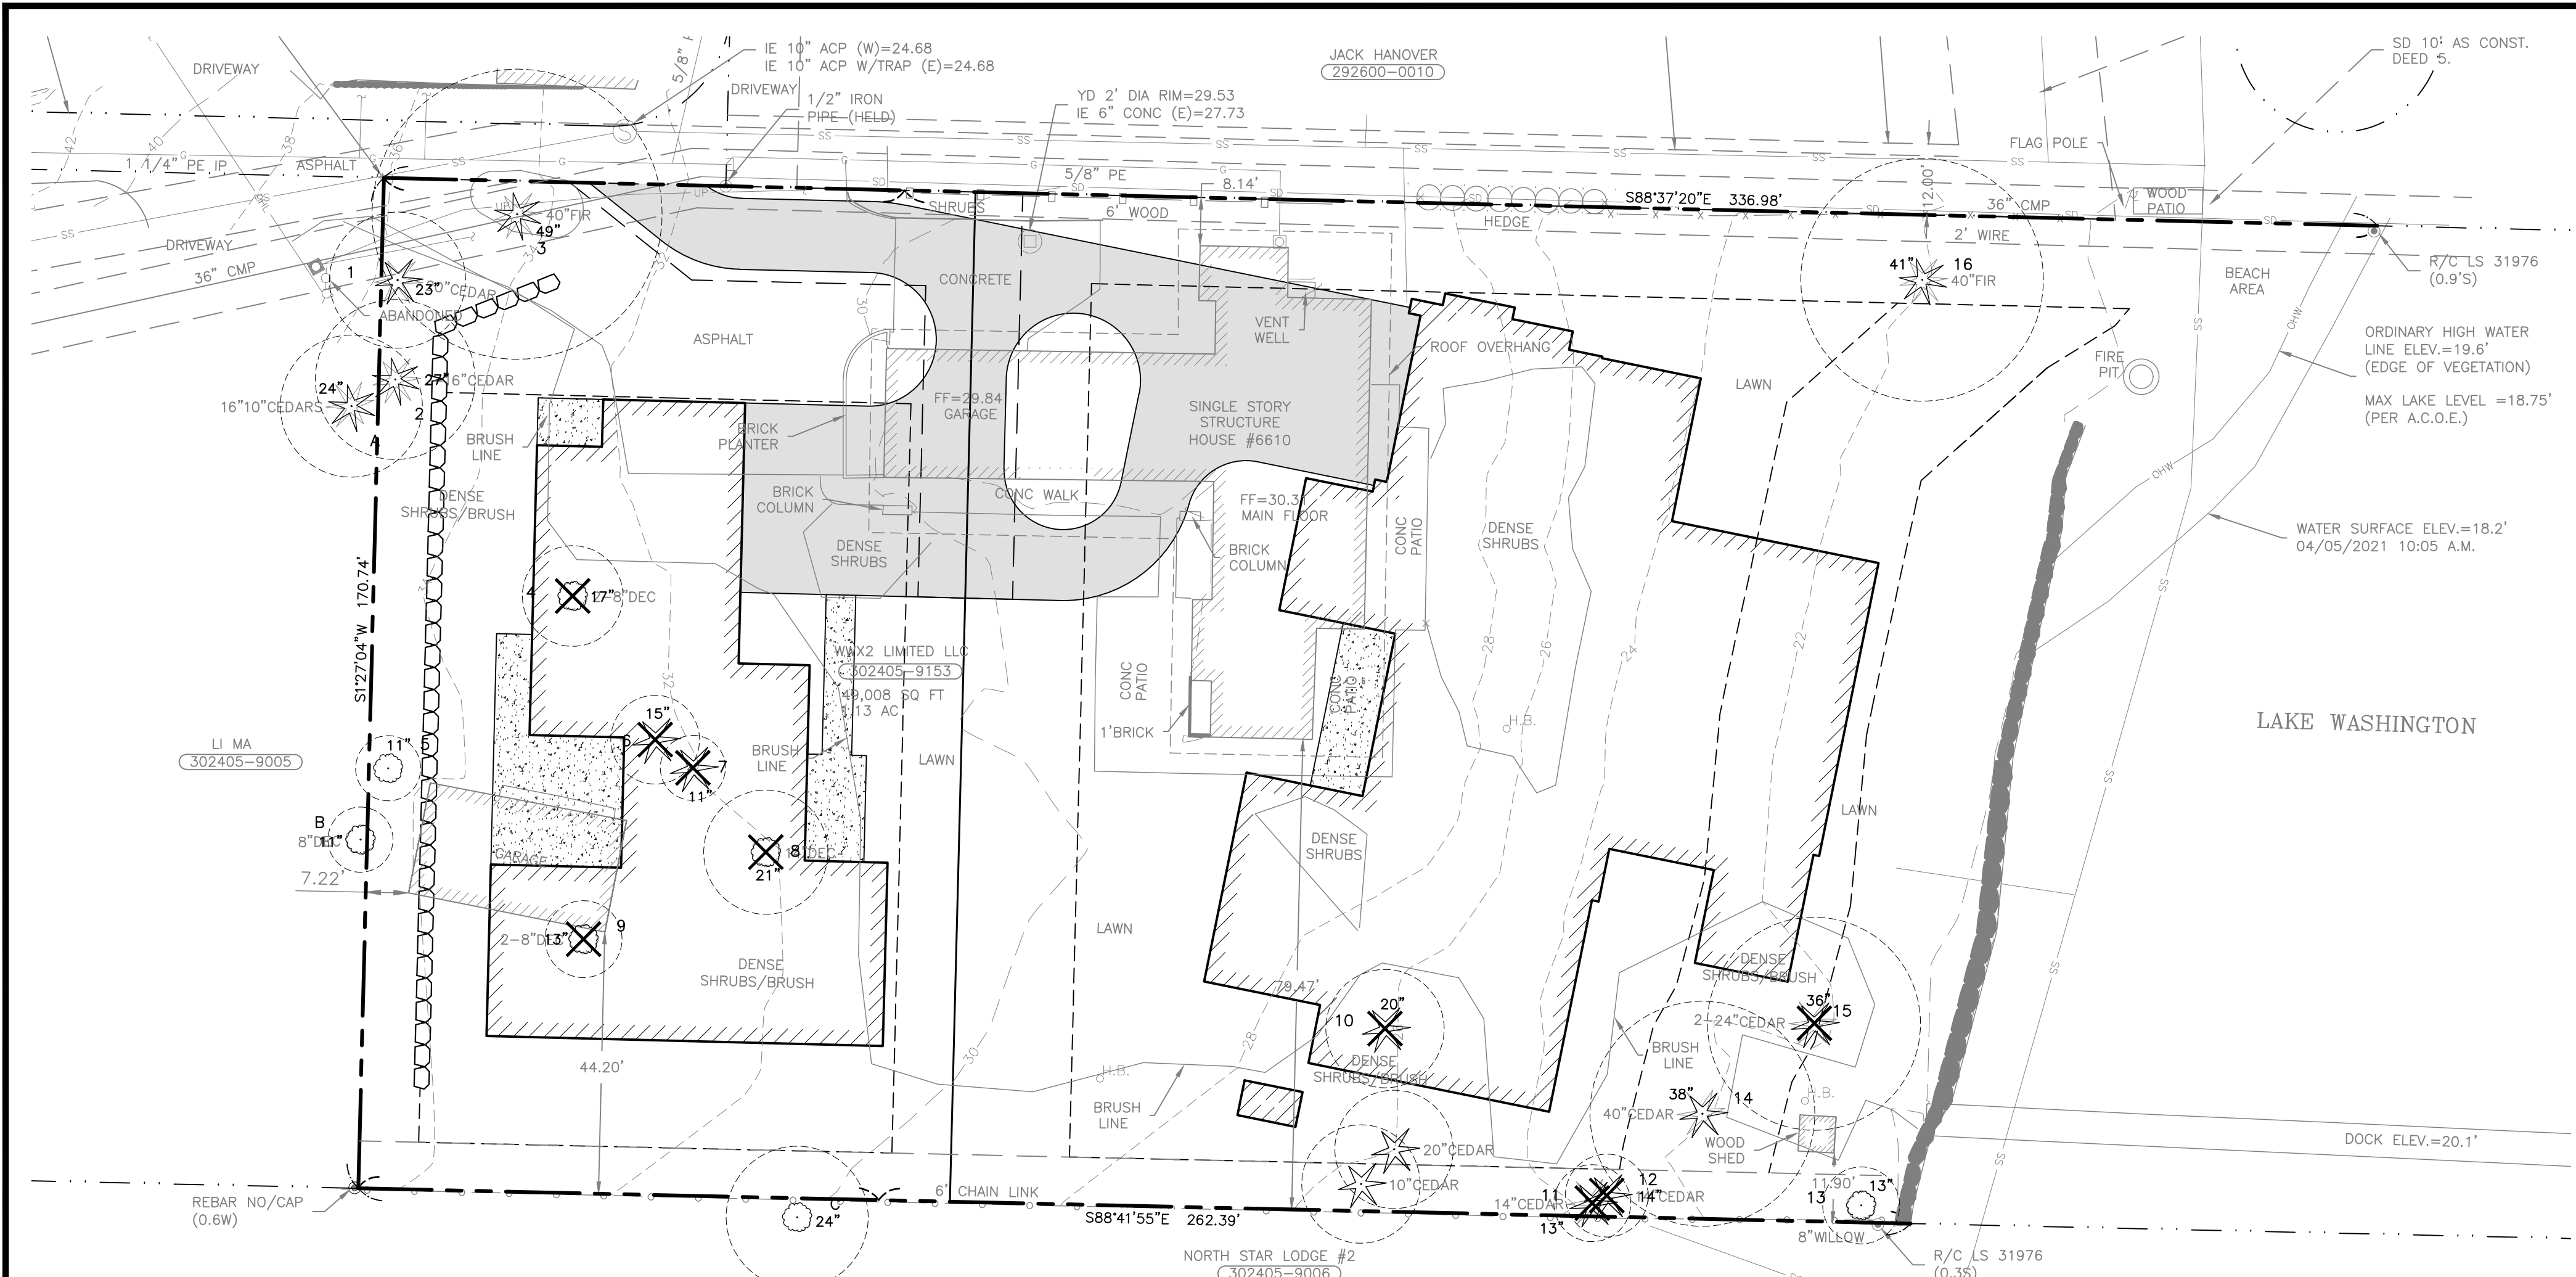
Tree #	Species	Common Name	dsh (in)	Exceptional	Suitable to Retain	Condition
1	<i>Thuja plicata</i>	Western red cedar	23.4	No	Yes	Generally good condition, asymmetric canopy, utility pruning on west side, impermeable asphalt driveway within dripline
2	<i>Thuja plicata</i>	Western red cedar	27.1	No	Yes	Codominant structure beginning at 5 feet, asymmetric canopy, foliage appears chlorotic with heavy cone crop, long-term viability uncertain
3	<i>Pseudotsuga menziesii</i>	Douglas-fir	48.5	Yes	Yes*	Canopy appears in good condition, previously raised to 30+ feet, majority of dripline area covered by impermeable asphalt, large roots lifting/cracking asphalt surface * Driveway on both sides of trunk, large/heavy vehicles during construction expected to negatively impact root zone immediately adjacent to tree
4	<i>Magnolia x soulangeana</i>	Saucer magnolia	16.7	No	Yes	Generally good condition, multi-stem structure, severe phototropic asymmetry

5	<i>Robinia pseudoacacia</i>	Black locust	11	No	Yes	Generally good condition, some visible deadwood, rooted on/near property line, dsh estimated due to blackberry brambles
6	<i>Chamaecyparis pisifera</i>	Sawara cypress	14.5	No	No	Tree girdled in multiple locations, bark stripped to 6 feet, not expected to survive
7	<i>Chamaecyparis pisifera</i>	Sawara cypress	11.0	No	No	Tree girdled, multiple 1/2-inch holes drilled, bark stripped to 6 feet, not expected to survive
8	<i>Prunus cerasifera</i>	Flowering plum	20.7	No*	No	Tree girdled in multiple locations, not expected to survive * Measured dsh is less than 1/2-inch below MICC Exceptional threshold
9	<i>Robinia pseudoacacia</i>	Black locust	12.7	No	Yes	Generally good condition, rooted adjacent to old garage structure, anticipate asymmetric root zone
10	<i>Thuja plicata</i>	Western red cedar	20.2	No	No	Bark stripped to 8 feet, multiple 1/2-inch holes drilled, not expected to survive

11	<i>Thuja plicata</i>	Western red cedar	12.7	No	Yes	Generally good condition, growing in close proximity to tree 12
12	<i>Thuja plicata</i>	Western red cedar	13.6	No	Yes	Generally good condition, growing in close proximity to tree 11
13	<i>Acer negundo</i>	Box elder	13.0	No	Yes	Heavy phototropic lean toward lake and existing dock, no visible indication of instability
14	<i>Thuja plicata</i>	Western red cedar	37.5	Yes	Yes	Generally good condition, codominant structure beginning at 4 feet, significant ivy growth on trunk
15	<i>Thuja plicata</i>	Western red cedar	36.1	Yes	No	Tree dead, bark stripped to 3-4 feet, multiple 1/2-inch holes drilled

16	<i>Pseudotsuga menziesii</i>	Douglas-fir	40.8	Yes	Yes	Good condition, may have previously lost top
A	<i>Thuja plicata</i>	Western red cedar	24	No	Yes	Overhangs from neighboring property (west), generally good condition, multi-stem structure, dsh estimated due to property boundary
B	<i>Robinia pseudoacacia</i>	Black locust	11	No	Yes	Overhangs from neighboring property (west), codominant structure beginning at 6 feet, generally good condition, dsh estimated due to blackberry brambles
C	<i>Acer negundo</i>	Box elder	24	No	Yes	Overhangs from neighboring property (south), generally good condition, dsh estimated due to property boundary

This inventory identified 19 total trees, with 16 within the site boundaries and 3 overhanging from neighboring properties. Within the site boundaries site, five (5) trees were identified as being dead, girdled, de-barked and/or drilled with the apparent intent of causing tree mortality. While some of these trees currently retain green foliage, visual inspection suggests none of these trees are expected to survive. It appears this intentional damage occurred within the past two (2) years.

This inventory identified four (4) Exceptional trees and a total of five (5) large trees greater than 24 inches diameter. One of the exceptional trees (#15) is now dead, likely due to intentional damage.

Mercer Island City Code (MICC) requires retention of at least 30% of regulated trees during/after construction. This inventory identified 11 trees that are suitable for retention. Trees with severe visible damage - as described above - are not included in this figure. At the 30% retention level per MICC, at least four (4) of the trees in good condition are required to be retained.
