**Preliminary Arborist Report
DRAFT**

To: JMK Homes c/o Jed Murphy
Site: 6610 E Mercer Way, Mercer Island, WA
Re: Tree inventory
Date: April 21st, 2022
Project Arborist: George White,
ISA Certified Arborist #PN-8908A
ISA Qualified Tree Risk Assessor
Reviewed By: Joseph Sutton-Holcomb
ISA Certified Arborist #PN-8397AM
Municipal Specialist, ISA Qualified Tree Risk Assessor
Referenced Documents: Topographic Survey (Pace Engineers, 6.6.2018)
Koneru Short Plat (Pace Engineers, Revised 4.12.2022)
Attached: Table of Trees
Tree Site Map

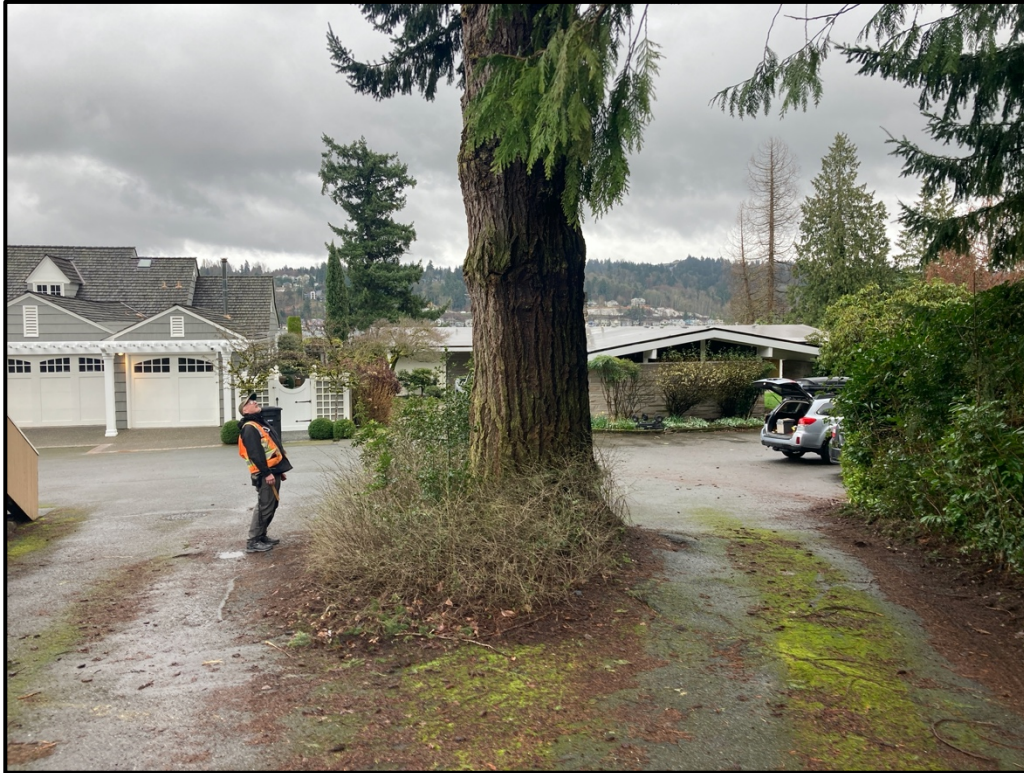
One exceptional tree that is greater than 24 inches in diameter at survey height (DSH) is currently proposed for removal. Retention of this tree would prevent the creation of an emergency vehicle egress and installation of a fire hydrant and would therefore result in an unavoidable hazardous situation.

Tree 573 is an exceptional Douglas-fir (*Pseudotsuga menziesii*) that is located in the middle of the driveway easement in the northwest corner of the property. (See photo 1.) This tree is currently proposed for removal. This tree conflicts with the construction of a driveway that would allow for emergency vehicle egress. It also conflicts with plans to install a required fire hydrant and accompanying 6" water line. Therefore, retention of this tree would result in an "unavoidable hazardous situation" as described in MICC 19.10.060.3. if the driveway and fire hydrant are installed at the proposed locations. Therefore, this tree is exempt from the restriction on the removal of exceptional trees.

Photograph 1. Tree 573, An exceptional Douglas-fir in the NW corner of the lot. This tree conflicts with required driveway improvements and new fire-hydrant.

If permitted for removal, the stump of tree 573 should be ground in place, not ripped out to avoid root damage to adjacent trees. Six replacement trees will be required for this tree in accordance with the standards outlined in MICC 19.10.070.

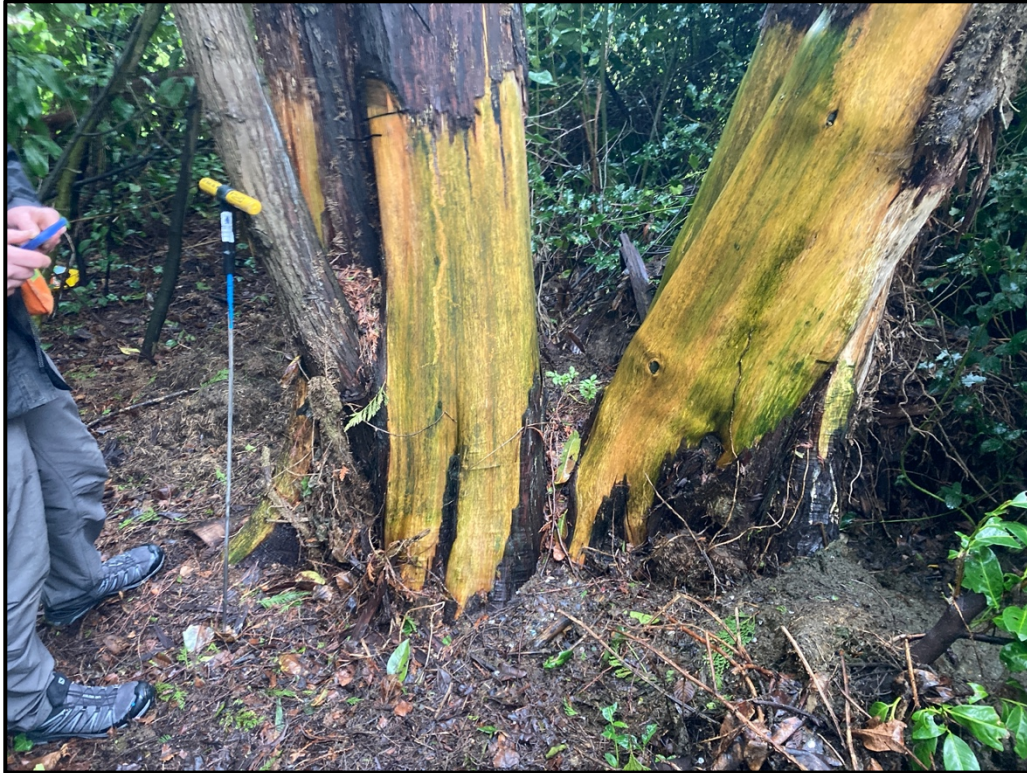
Additionally, we surveyed one dead tree of exceptional size that appeared to have been intentionally girdled by the previous property owners. We observed several trees (some over 10 inches in diameter) that appeared to have been killed intentionally in this manner. In one case, a dead tree had a funnel protruding from a drilled port that was presumably used to inject herbicide. (See photos 2 and 3.)

Photograph 2. Dead tree 1, An exceptional western redcedar that appeared to have been girdled by the previous property owner.

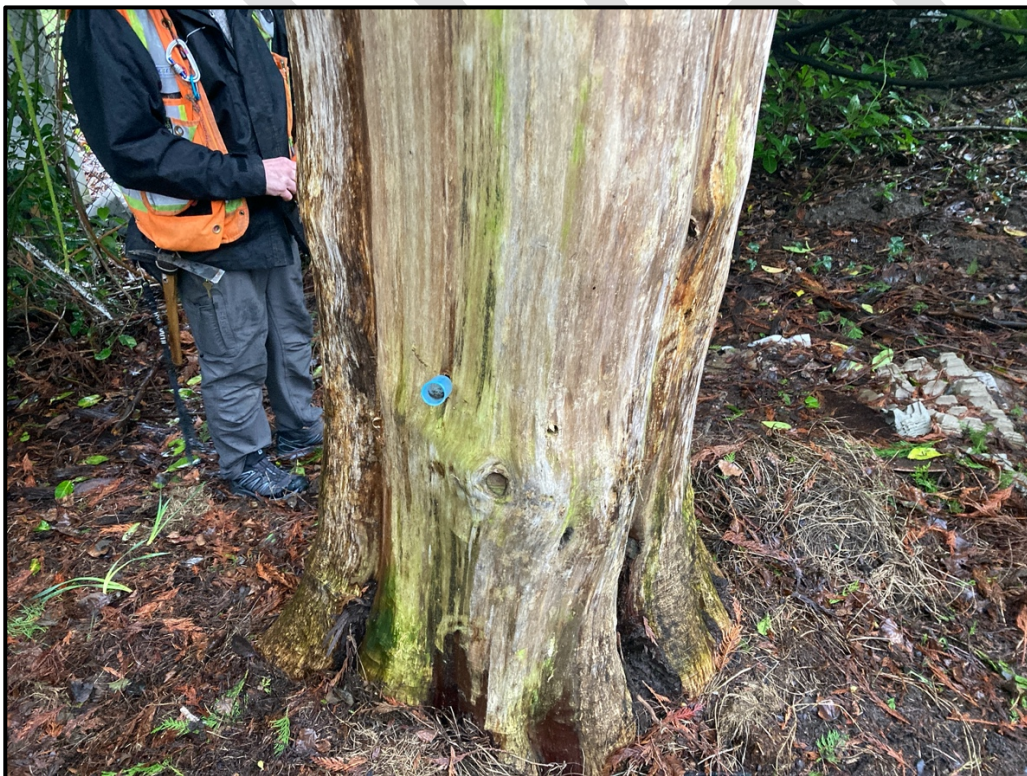
Photograph 3. Dead tree 2, a dead western redcedar with funnel and signs of intentional girdling.

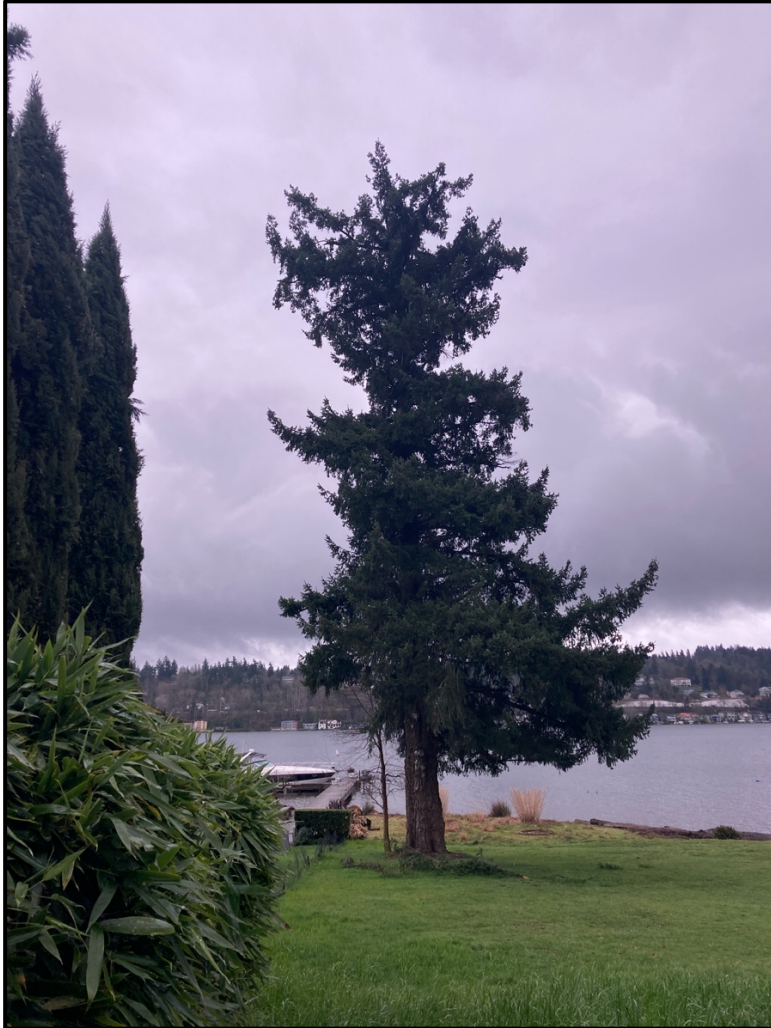
Tree 575 is an exceptional Douglas fir that is located in the northeast quadrant of the lot. (See photo 4.) This tree must be protected with tree protection fencing at the Recommended Limits of Disturbance (RLOD) listed in the attached table of trees using the specifications provided in appendix F. No machine access, or materials storage will be permitted within the RLOD. All erosion and runoff control (e.g., silt-fencing) must be surface mounted within the RLOD. Any excavation within the RLOD must be monitored by the project arborist.

The most recent plans show a proposed storm drain located approximately 12 feet south of tree 575. The edge of this trench must excavate carefully under the supervision of the project arborist and any exposed roots must be cut cleanly and immediately backfilled.

Photograph 4. Tree 275, and exceptional Douglas-fir with windblown canopy that is proposed for retention.
