**Preliminary Arborist Report
DRAFT**

To: JMK Homes c/o Jed Murphy
Site: 6610 E Mercer Way, Mercer Island, WA
Re: Tree inventory
Date: September 30th, 2022
Project Arborist: George White,
ISA Certified Arborist #PN-8908A
ISA Qualified Tree Risk Assessor
Reviewed By: Joseph Sutton-Holcomb
ISA Certified Arborist #PN-8397AM
Municipal Specialist, ISA Qualified Tree Risk Assessor
Referenced Documents: Topographic Survey (Pace Engineers, 6.6.2018)
Koneru Building Permit (Pace Engineers, Revised 5.11.2022)
Attached: Table of Trees
Tree Site Map

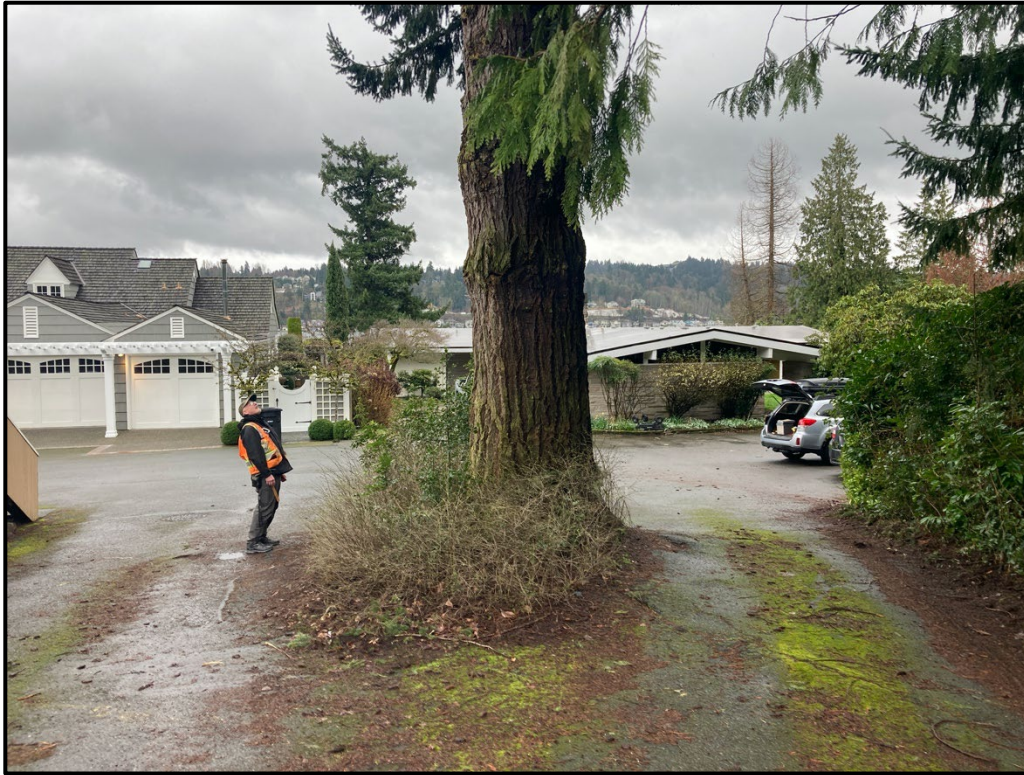
Ten large trees were tagged and assessed on site. Three of the trees assessed, trees 573, 575, and 576, were exceptional by size. (See photo 1.)

Tree 573 is an exceptional Douglas-fir (*Pseudotsuga menziesii*) that is located in the middle of the driveway easement in the northwest corner of the property. (See photo 1.) This tree is currently proposed for removal. This tree conflicts with the construction of a driveway that would allow for emergency vehicle egress. It also conflicts with plans to install a required fire hydrant and accompanying 6" water line. Therefore, retention of this tree would result in in an "unavoidable hazardous situation" as described in MICC 19.10.060.3. if the driveway and fire hydrant are installed at the proposed locations. Therefore, this tree is exempt from the restriction on the removal of exceptional trees.

Tree 573 is an exceptional Douglas fir located in the middle of the existing driveway. This tree is currently proposed for removal because it conflicts with the installation of the required fire hydrant. Although the fire hydrant itself is outside of the MLOD, it is required to be hooked up to a new 6-inch water line which parallels the existing driveway. A 6-inch waterline will require a minimum 4-foot trench. There is no way to install this water line without routing it through the MLOD of tree 573 (See Figure 1).

Photograph 1. Tree 573, An exceptional Douglas-fir in the NW corner of the lot. This tree conflicts with required driveway improvements and new fire-hydrant.

If permitted for removal, the stump of tree 573 should be ground in place, not ripped out to avoid root damage to adjacent trees. Six replacement trees will be required for this tree in accordance with the standards outlined in MICC 19.10.070.

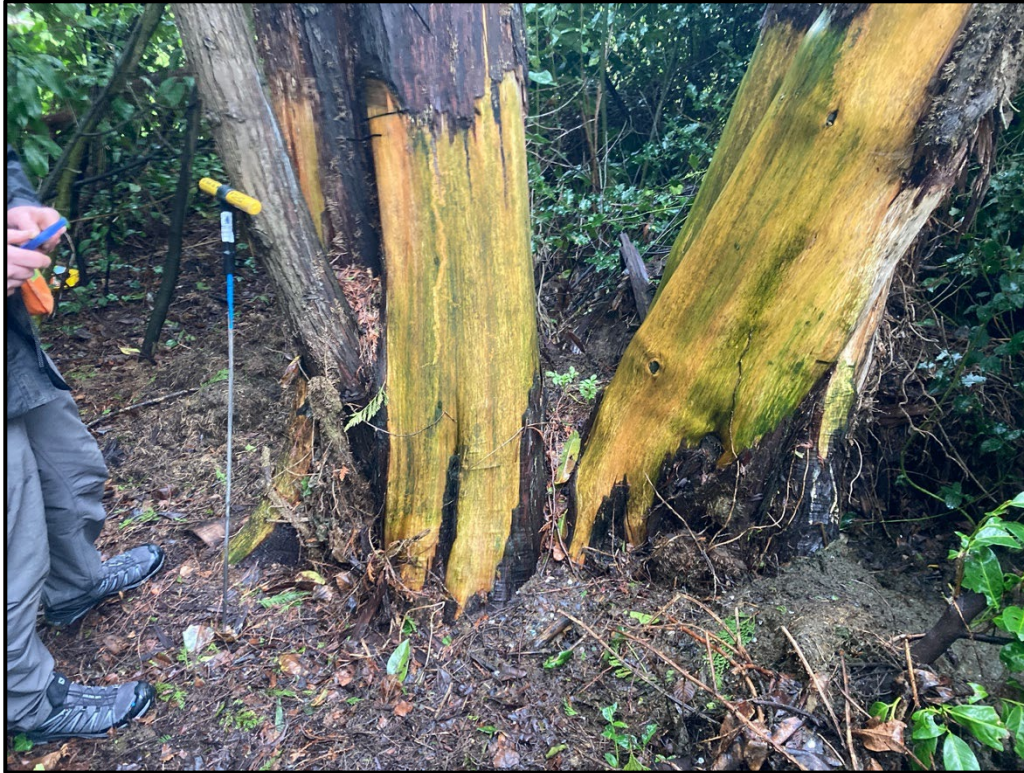
Additionally, we surveyed one dead tree of exceptional size that appeared to have been intentionally girdled by the previous property owners. We observed several trees (some over 10 inches in diameter)

Dead tree 1 was an exceptional western redcedar that was killed by the previous property owner. Because this tree was exceptional it would have been required to be retained and not damaged by development in the tree protection zone. The only proposed structure that encroaches on the minimum limits of disturbance is a deck which is to be constructed on piles. In my professional opinion, the impacts from this deck would have been manageable should the tree be alive and required for retention.

Photograph 2. Dead tree 1, An exceptional western redcedar that appeared to have been girdled by the previous property owner.

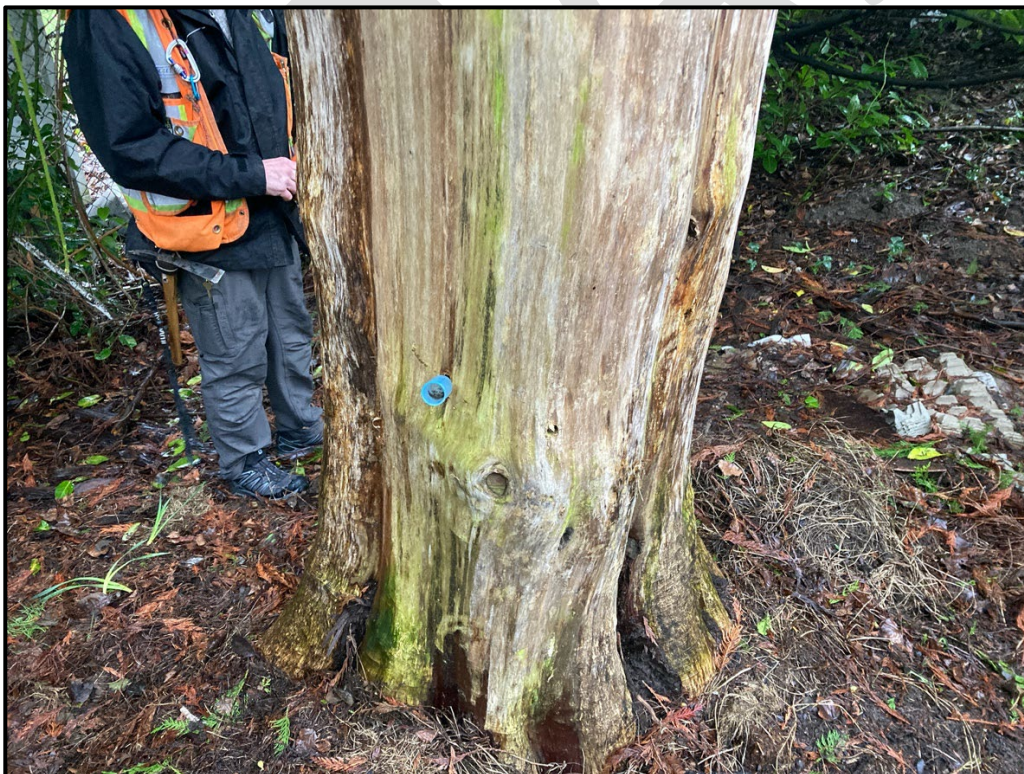
that appeared to have been killed intentionally in this manner. In one case, a dead tree had a funnel protruding from a drilled port that was presumably used to inject herbicide. (See photos 2 and 3.)

Photograph 3. Dead tree 2, a dead western redcedar with funnel and signs of intentional girdling.

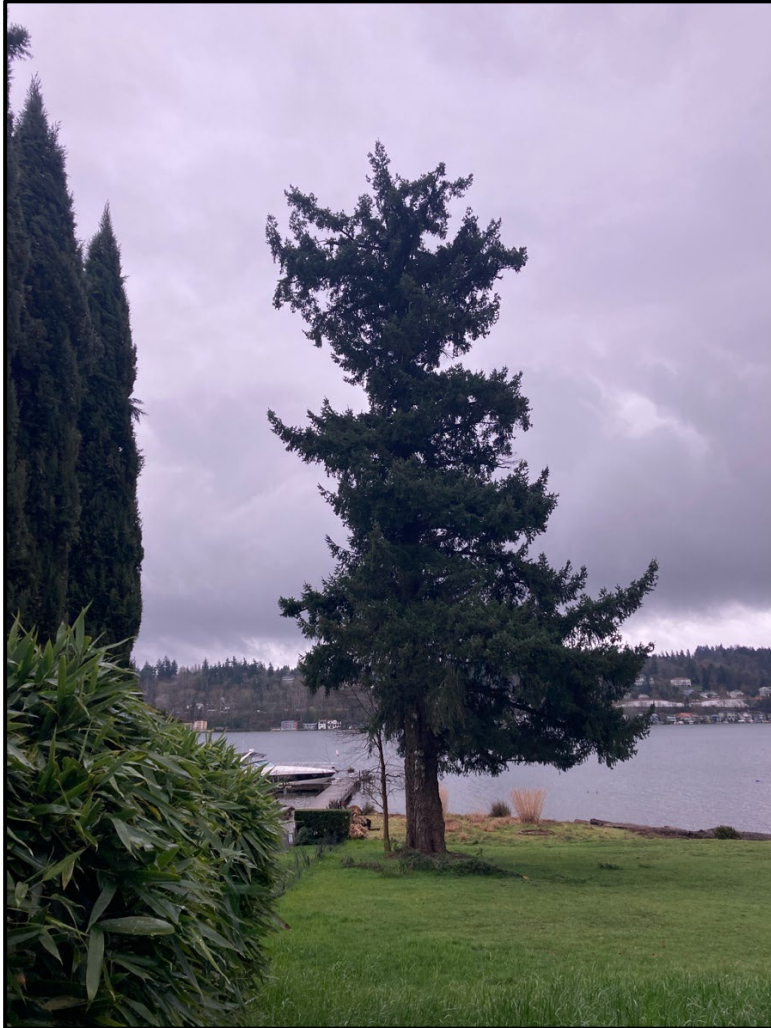
Tree 575 is an exceptional Douglas fir that is located in the northeast quadrant of the lot. (See photo 4.) This tree must be protected with tree protection fencing at the Recommended Limits of Disturbance (RLOD) listed in the attached table of trees using the specifications provided in appendix F. No machine access, or materials storage will be permitted within the RLOD. All erosion and runoff control (e.g., silt-fencing) must be surface mounted within the RLOD. Any excavation within the RLOD must be monitored by the project arborist.

The most recent plans show a proposed storm drain located approximately 20 feet south of tree 575. The edge of this trench must be excavated carefully under the supervision of the project arborist and any exposed roots must be cut cleanly and immediately backfilled.

Photograph 4. Tree 275, and exceptional Douglas-fir with windblown canopy that is proposed for retention.

Tree 575 is an exceptional Douglas-fir located north of the proposed structure. There is currently a proposed storm drain approximately 20 feet from the base of this tree. All trenching within the RLOD of this tree is to be conducted under arborist supervision.

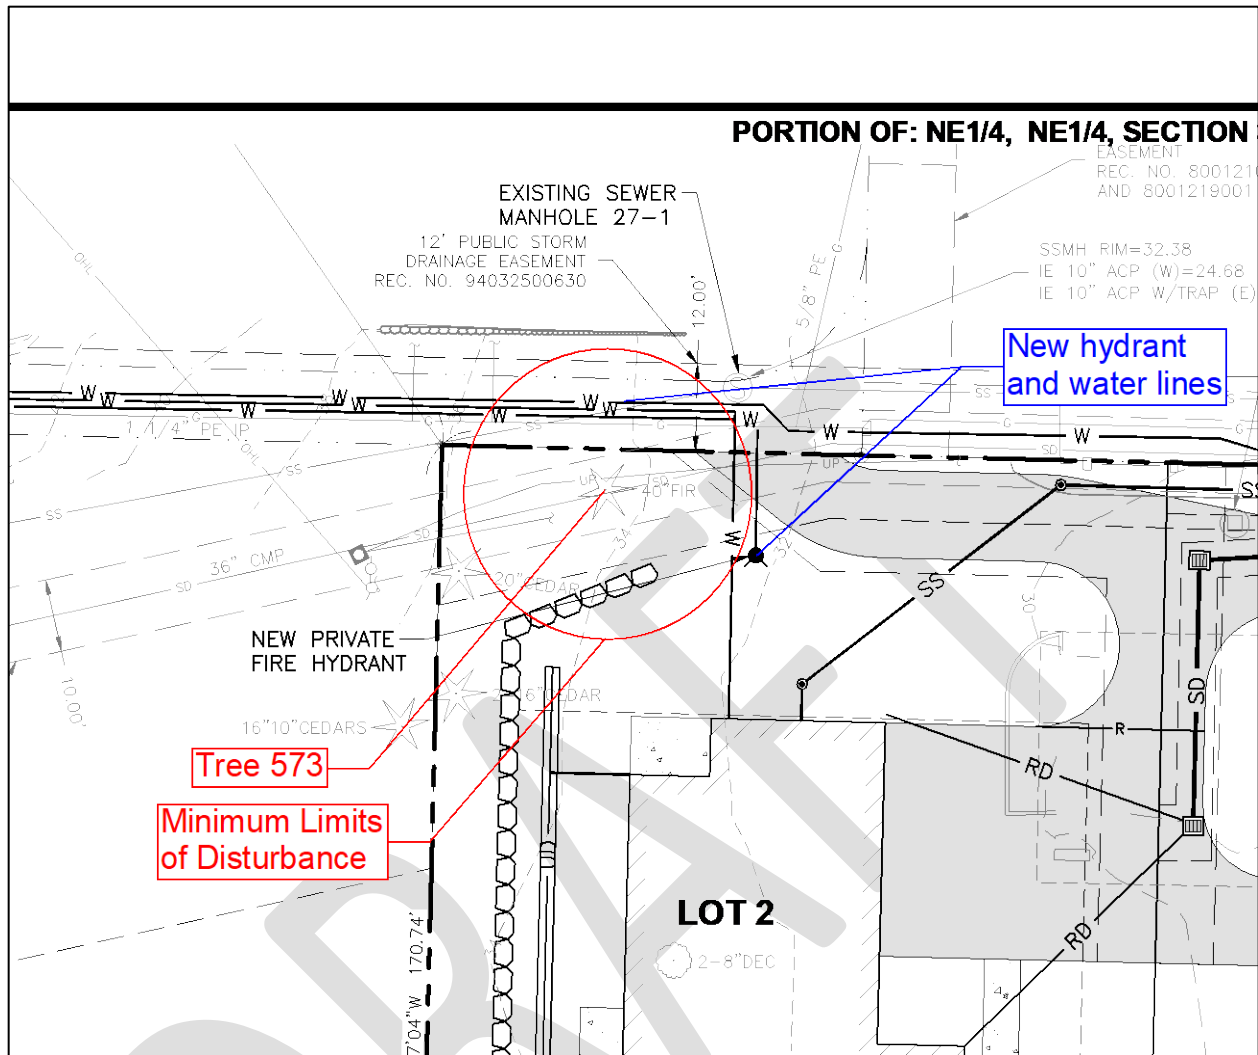
Figure 1. An excerpt from Composite Utility Plan C3.0 (7.20.2021) indicating the location of the new fire hydrant and water lines in relation to tree 573
