LAYTON TREE CONSULTING, LLC

ARBORIST REPORT/TREE PLAN

7204 78th Avenue SE
Mercer Island, WA

March 7, 2022
Updated December 12, 2022

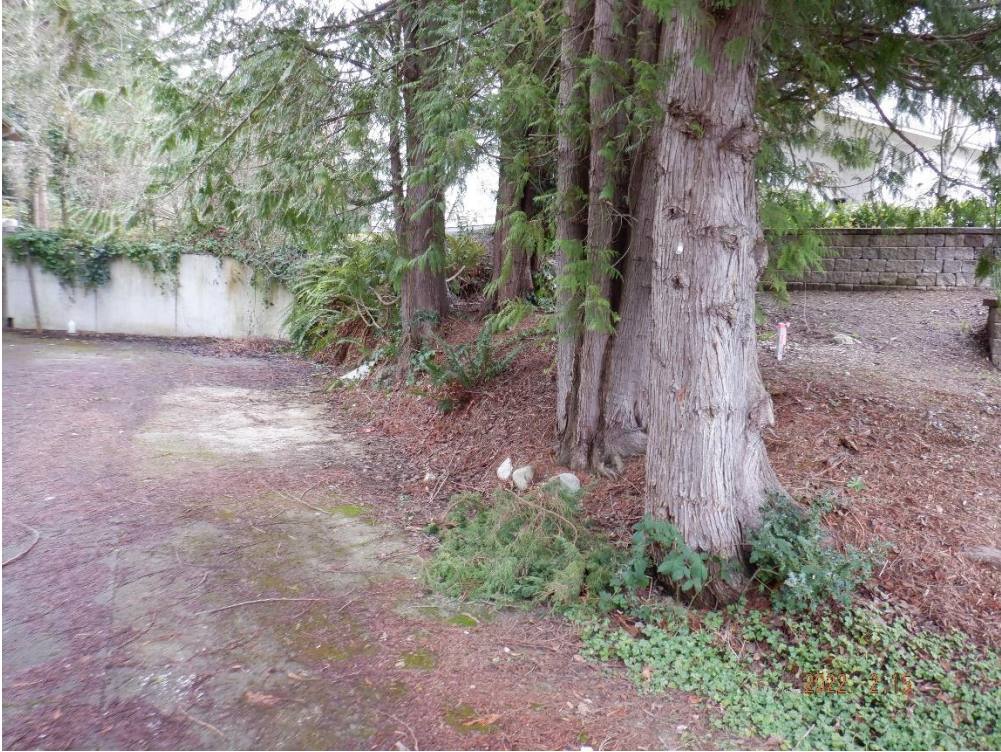
Trees #833 and #834 are semi-mature Western red cedar, located close to the existing driveway in the southwest corner of the property. Both are of fairly good vigor. Lower trunks appear sound with no outward indicators of any internal decay issues. #833 is in ‘good’ condition. The trunk of #834 forks into multiple tops. Condition is ‘fair’.

Tree #101 is a semi-mature Western red cedar located directly southwest of #833 and #834. The main trunk forks at 4-feet above ground into multiple small diameter stems/tops. It is in 'fair' condition.

Trees #833 > #836 close to existing driveway

Trees #833, #834 and #101 next to the existing concrete driveway are not expected to be significantly impacted. The new driveway will be constructed at the same or slightly higher elevation as the existing. If the existing concrete is to be removed, it shall be broken up using a manual jack-hammer and removed from within the driplines by hand-labor only. Care shall be taken not to disturb roots that can be expected to exist just below the existing concrete. Once concrete is removed, immediately cover with gravel to create subbase for the new driveway. Use a tracked mini-excavator for this work to reduce the risk of unnecessary damage to roots and soil compaction.

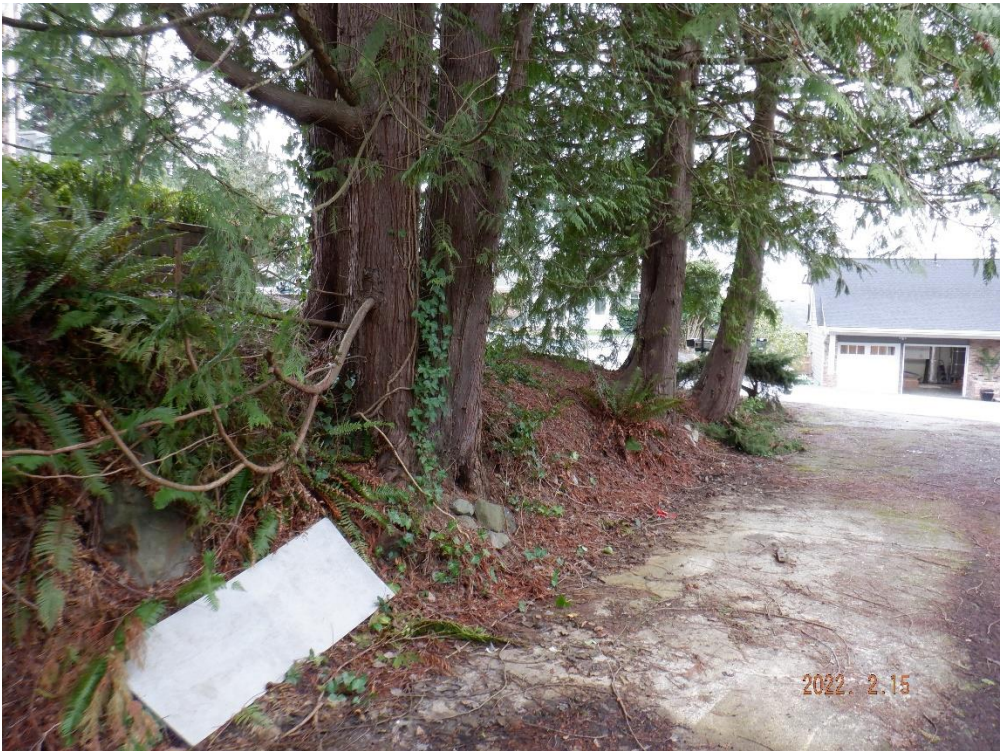
Right-of-way Trees #835, #836 and #837 are very close to the proposed new driveway and will be significantly impacted and compromised by new construction. The existing grade in this area needs to be lowered.

Trees #833 > #836 close to existing driveway

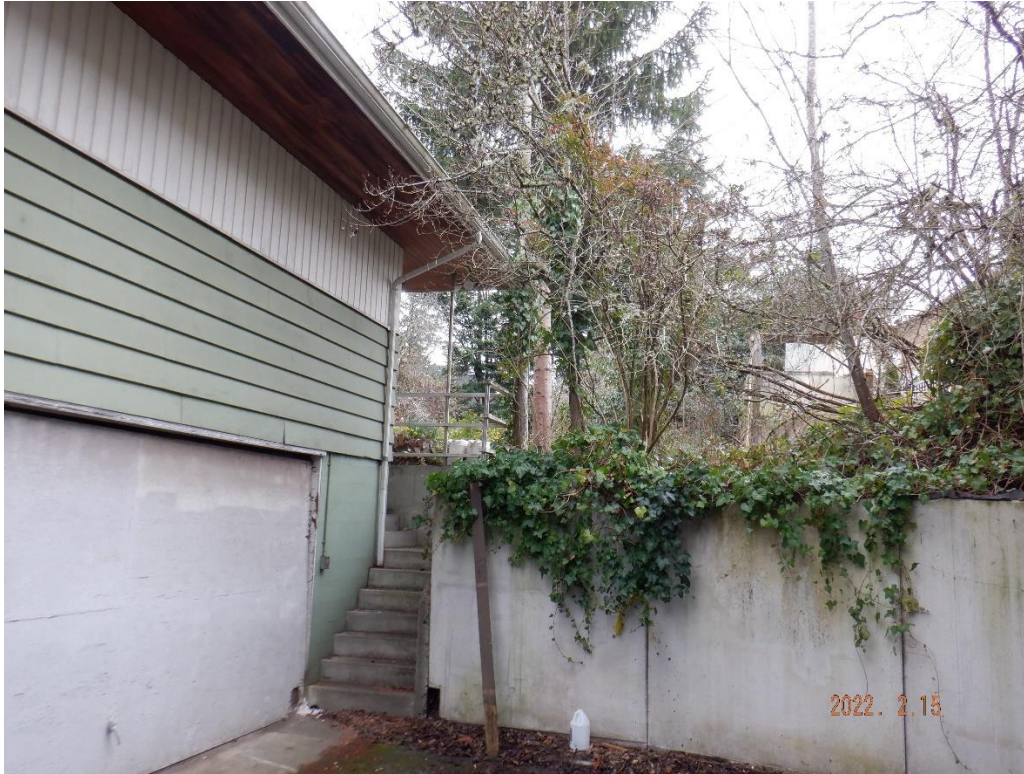
Trees #890 and #891 close to existing house

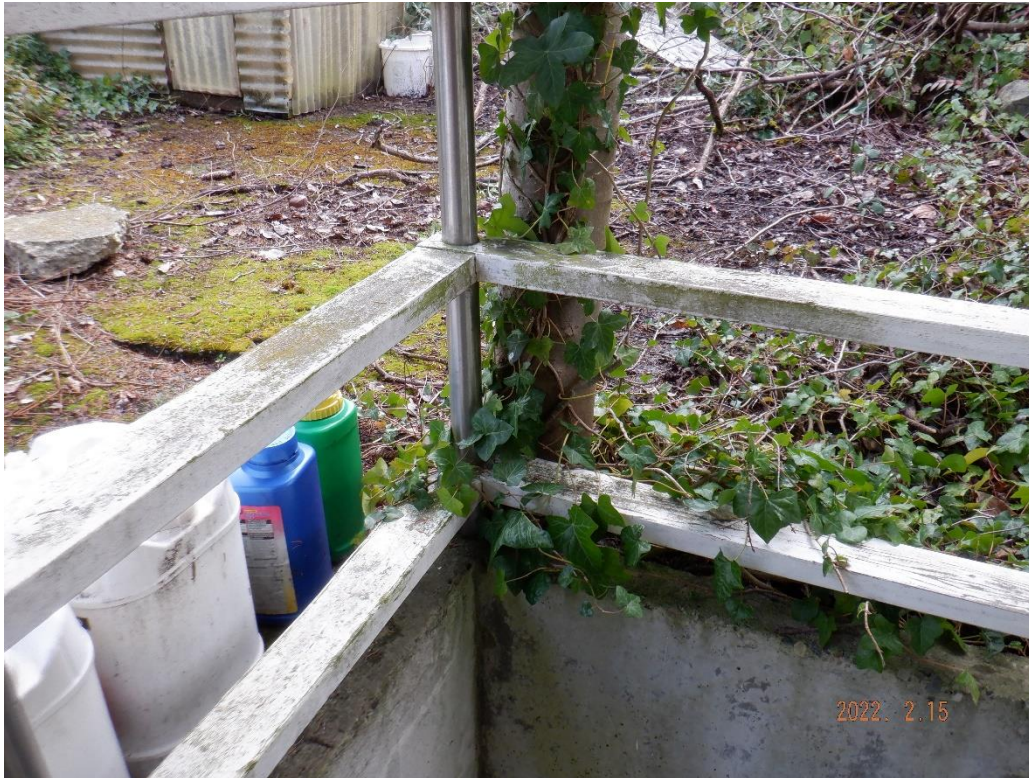
Tree #890 is a young to semi-mature Pacific dogwood that naturally regenerated at the site, very close to the existing structure. The base of the tree is abutting the concrete steps. See picture below. It is not viable due to its location. This is considered an 'exceptional' tree species in the city at 6-inches in diameter or larger.

Base of Tree #890 growing up against concrete wall/steps

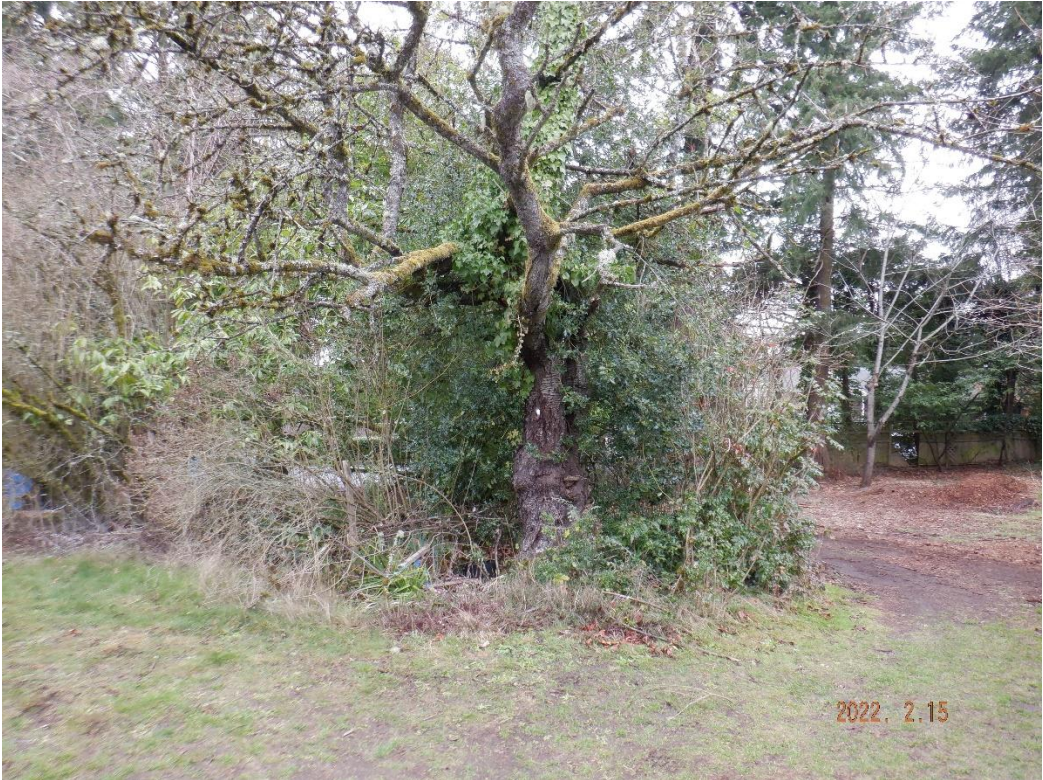
Tree #858 in middle of site

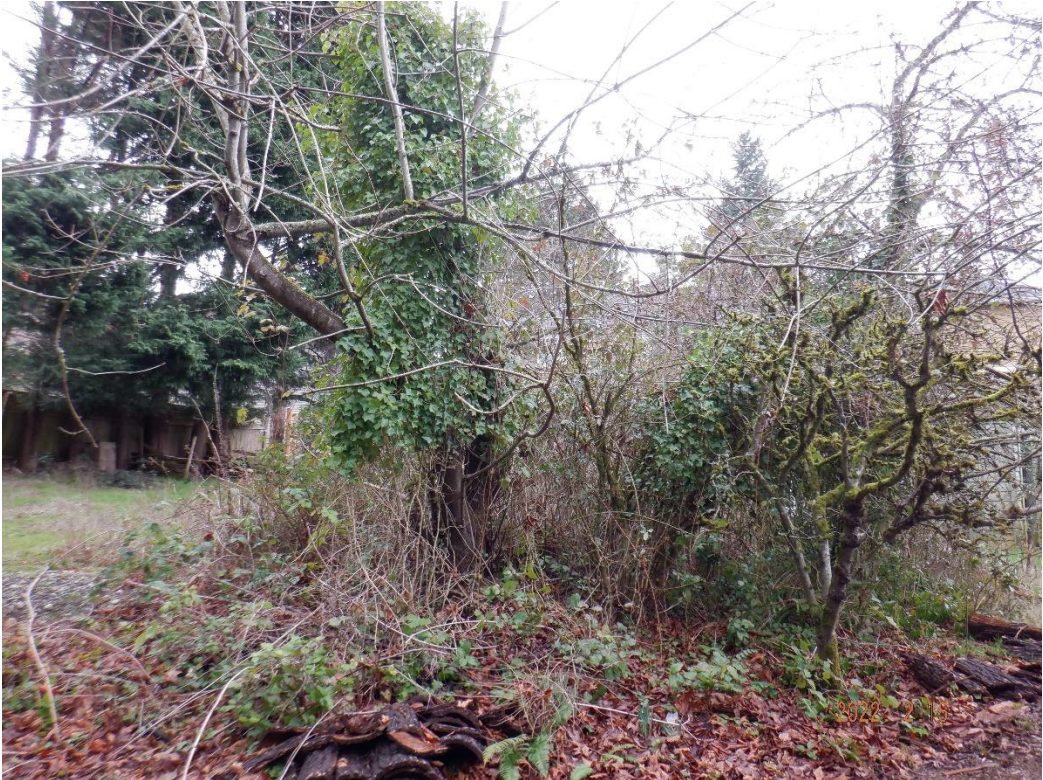
Trees #888 and #889 in middle of site

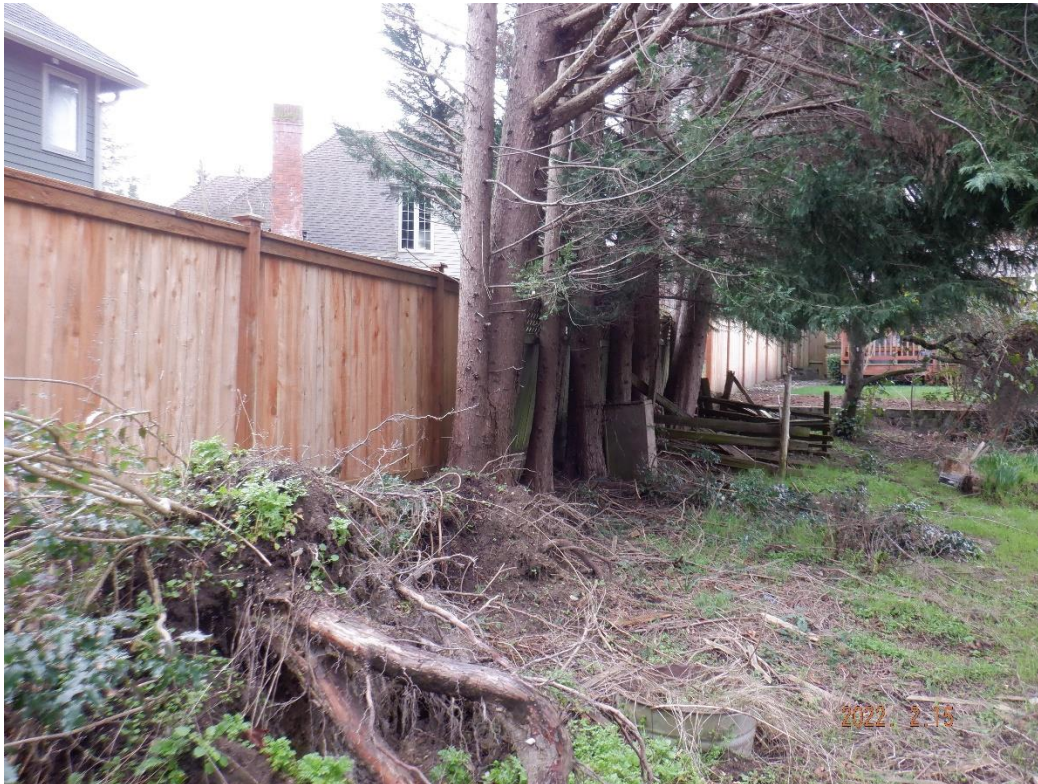
Trees #880 > #886 are a planted row of Leyland cypress adjacent to the east property line. Two Leyland cypress north of #880 uprooted in the past and failed. The remaining cypress have been significantly pruned back on their east sides by the neighbor and have asymmetric crowns to the west. These are in 'fair' condition.

Trees #880 > #886 on east property line

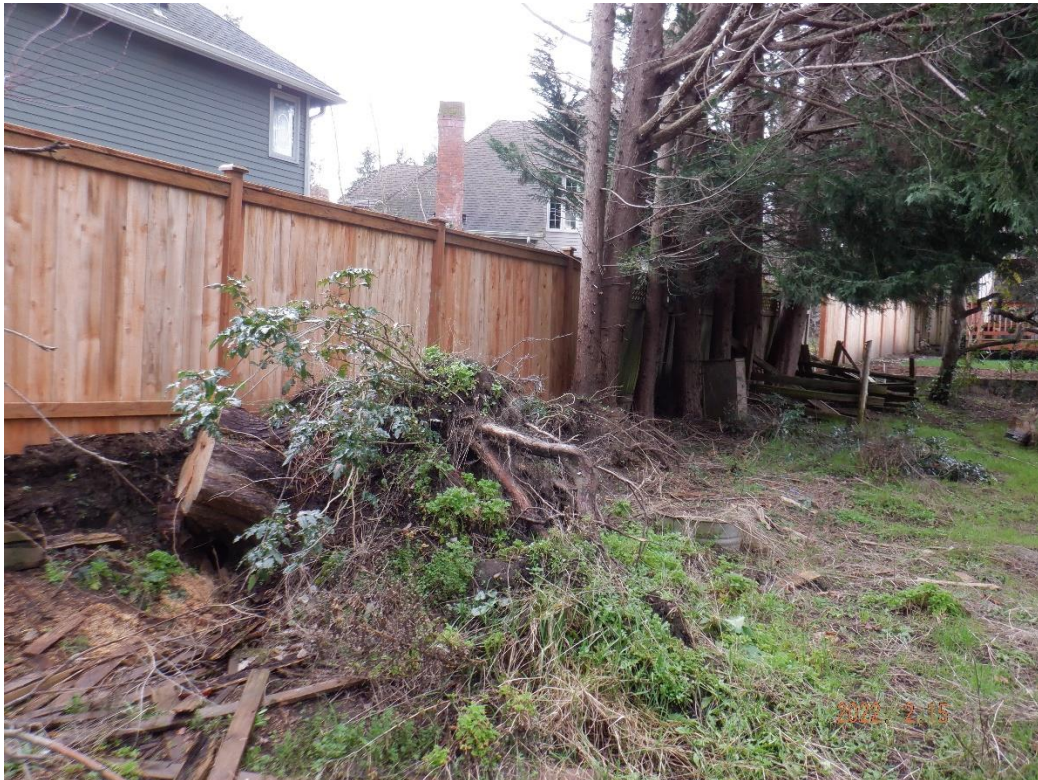
Trees #880 > #886 on east property line, previously uprooted cypress trees in foreground

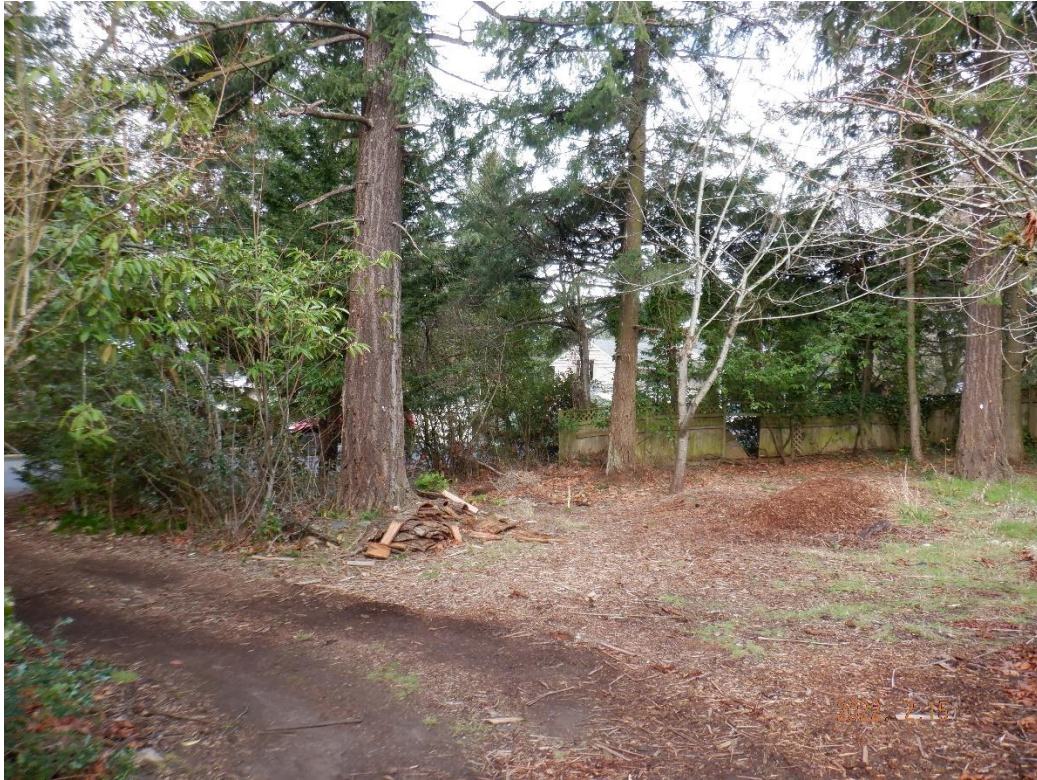
Douglas fir grouping in northeast corner

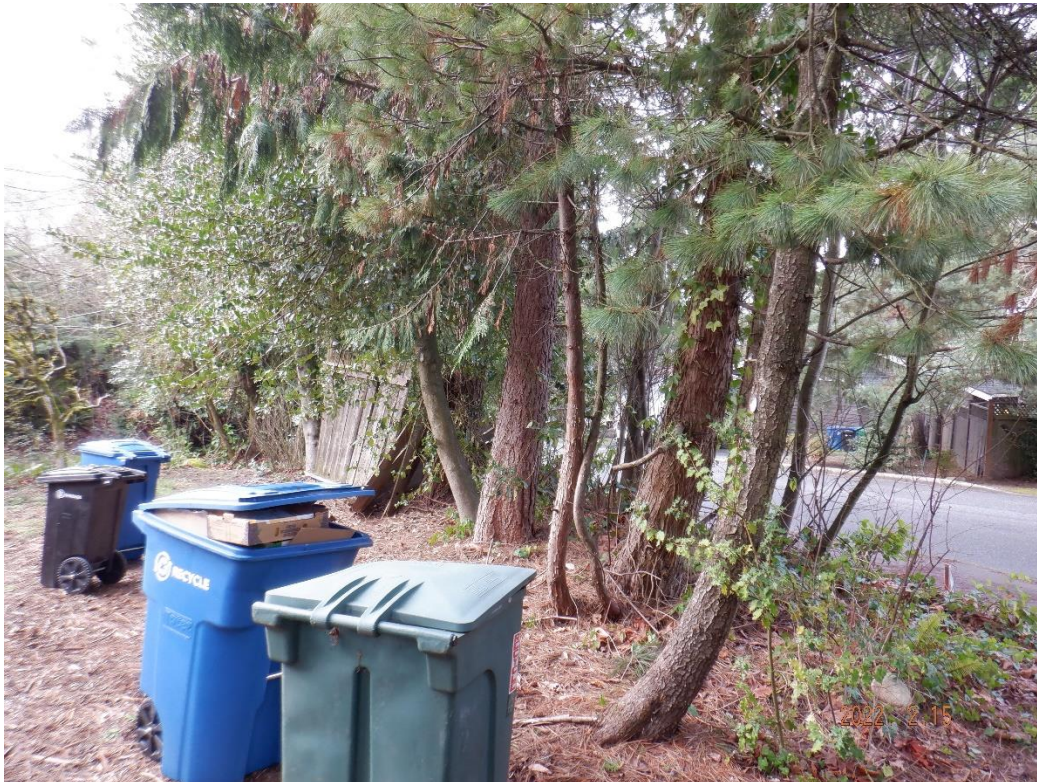
Trees #854 > #857 at edge of ROW

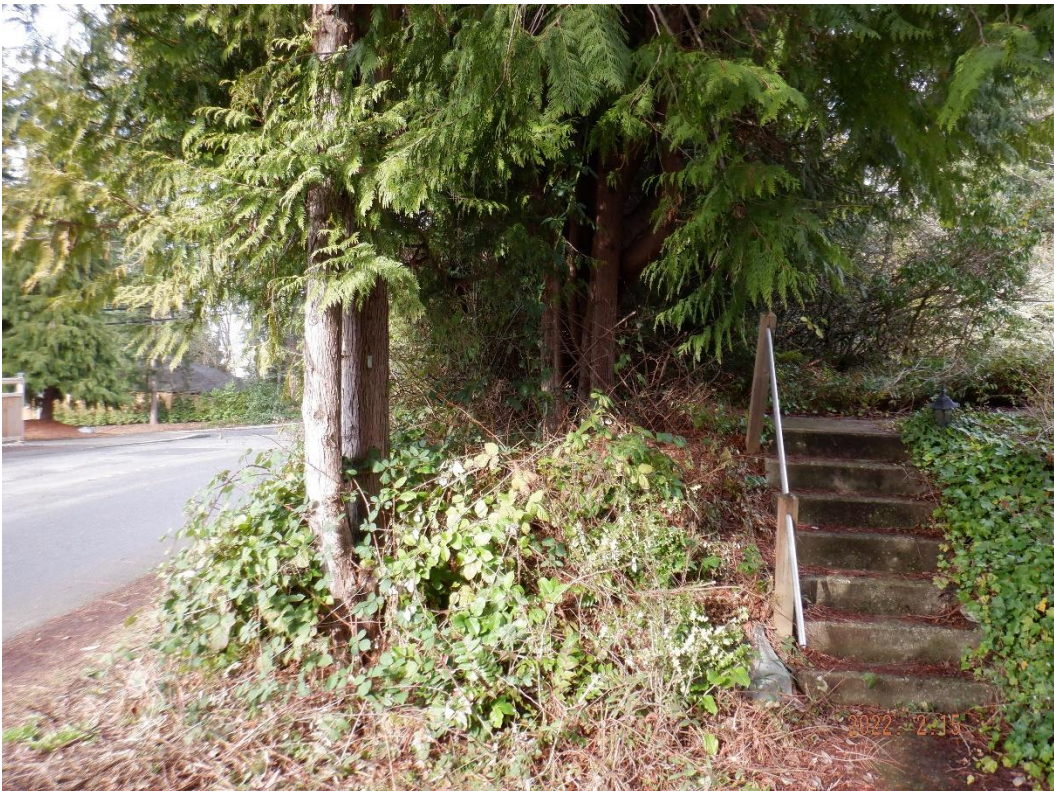
ROW trees west of existing house

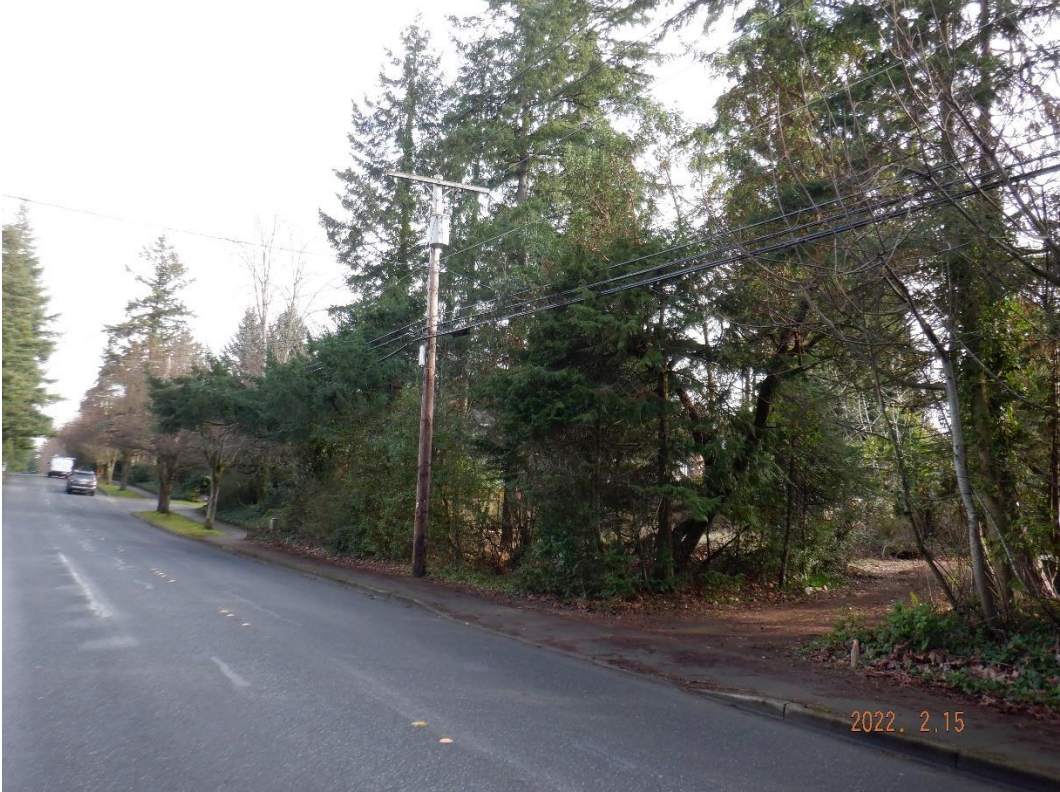
Looking east to SE 72nd Street ROW trees

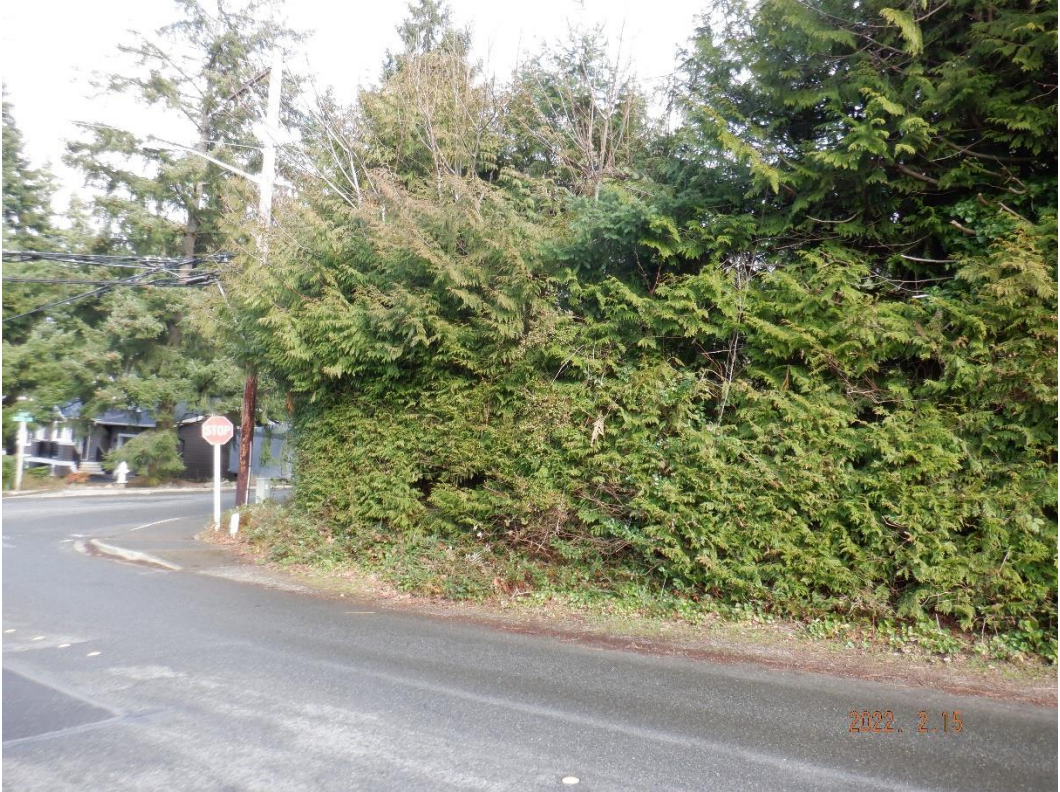
78th Ave SE ROW trees
