# LAYTON TREE CONSULTING, LLC

## ARBORIST REPORT/TREE PLAN

7216 93<sup>rd</sup> AVE SE  
Mercer Island, WA

**October 29, 2019**  
**Updated March 6, 2021**

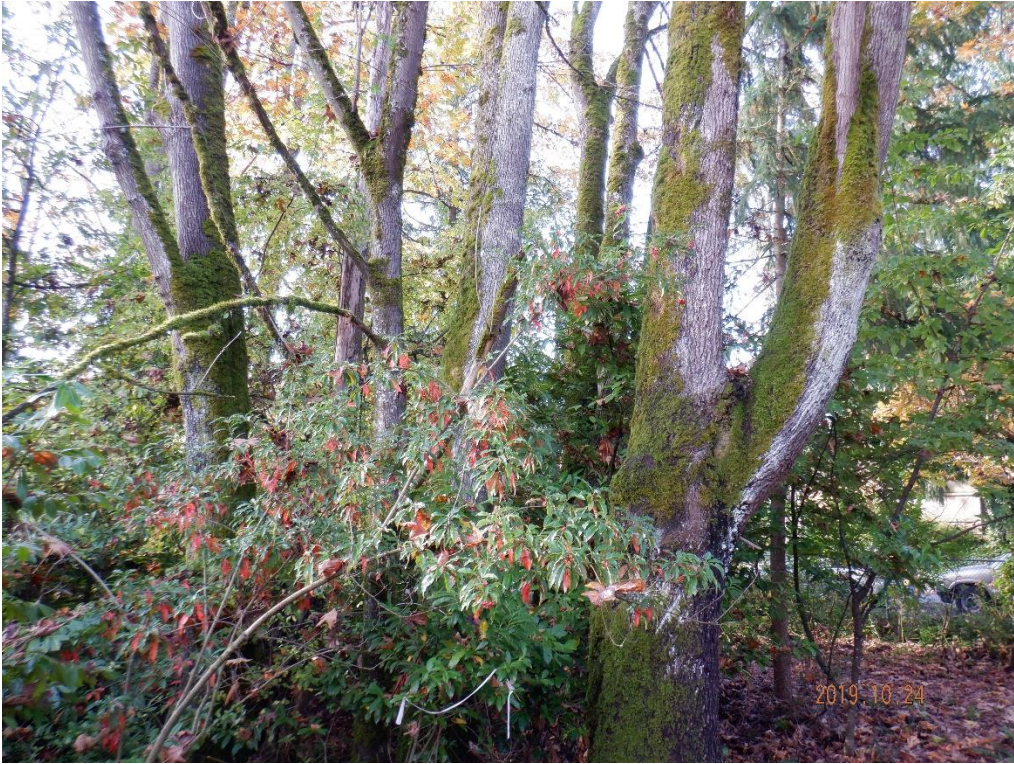
43 large (regulated) trees were identified within the parcel boundaries. 39 of these are bigleaf maple which form a continuous grove over much of the property. Maple trees range from semi-mature to mature, estimated at 50 to 100 years of age. These have not developed ideal form due to past growing conditions. Trees have developed poor stem taper under heavy competition with each other for sunlight and space. Overall vigor is fair. Some are in moderate decline, evident by upper crown dieback. Three of the subject maples are in poor condition. These have developed extensive trunk decay. Another seven are rated as 'fair to poor' condition due to structural defects, low vigor and general decline.

Subject maple, typical of maples on property

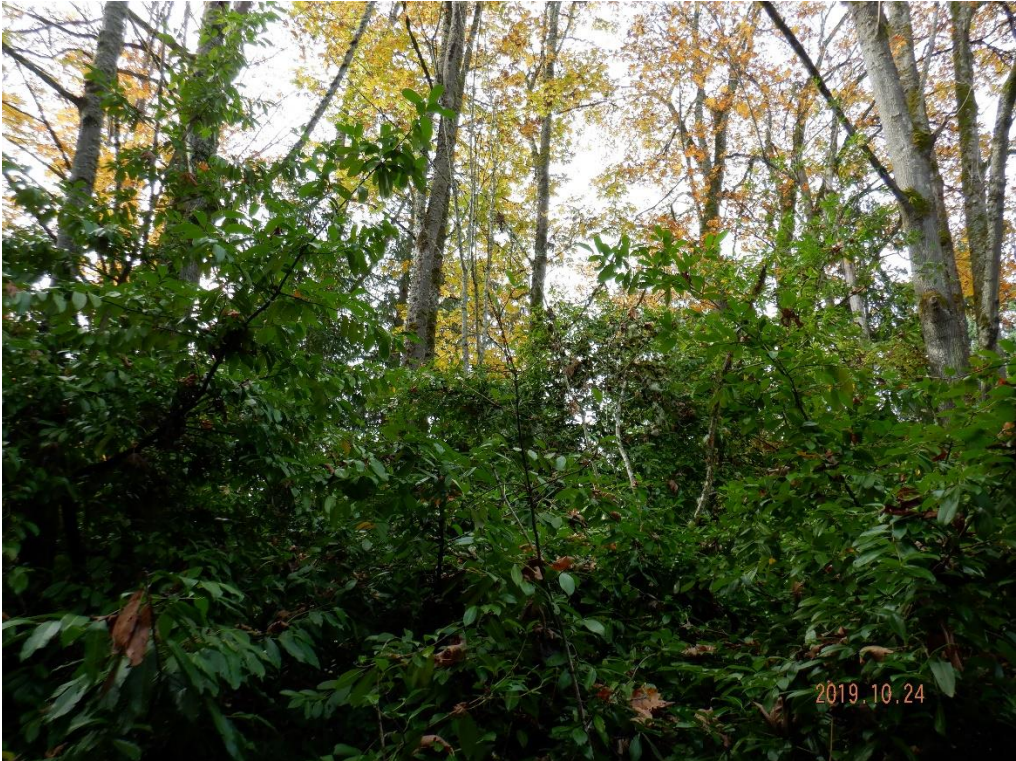
The property has a major infestation of English laurel, which is found throughout. It is quite dense in places. There is also a moderate component of invasive English holly and a minor component of Himalayan blackberry. Most of the native vegetation is found in the southeast portion of the property. Here there are minor to moderate components of sword fern, Oregon grape, beaked hazelnut and oceanspray.

Middle portion of property, dense English laurel

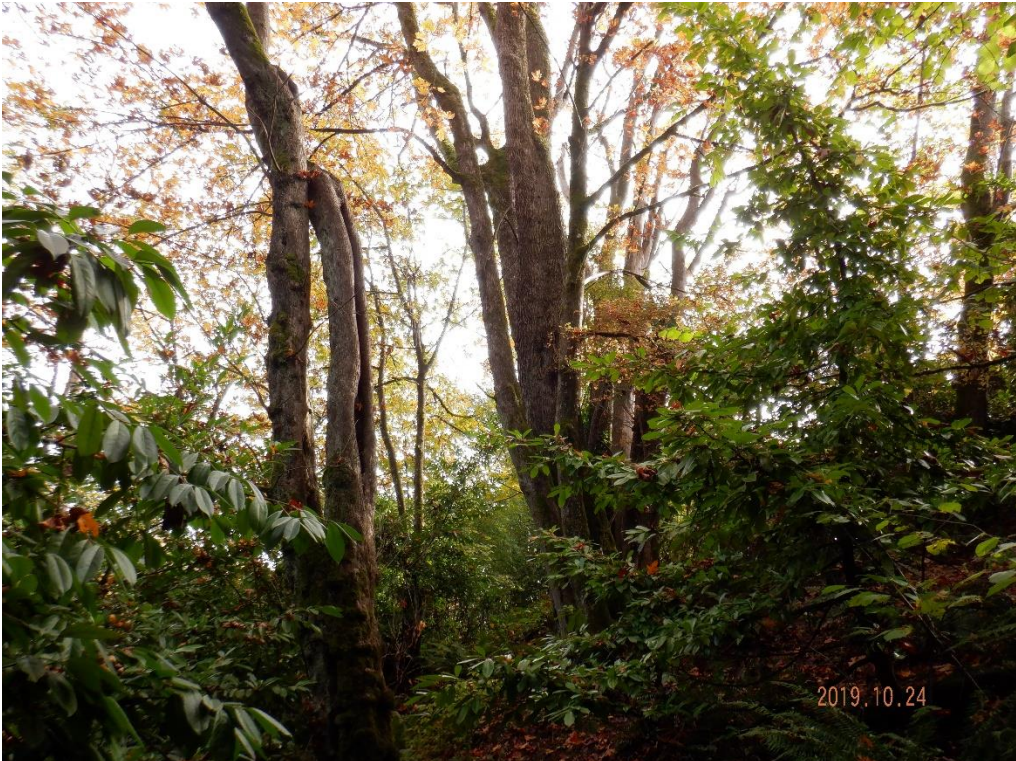
Maples in southeast portion of property

The grove of trees within the southeast portion of the site will be retained. Some of these are in poor condition with a high potential for failure in the future. However, there are few targets in the area. Tree parts are likely to fall into the wooded tree retention area. The retention of the poor condition trees within the preserved grove is feasible at this time as they are considered low risk and provide valuable wildlife habitat.

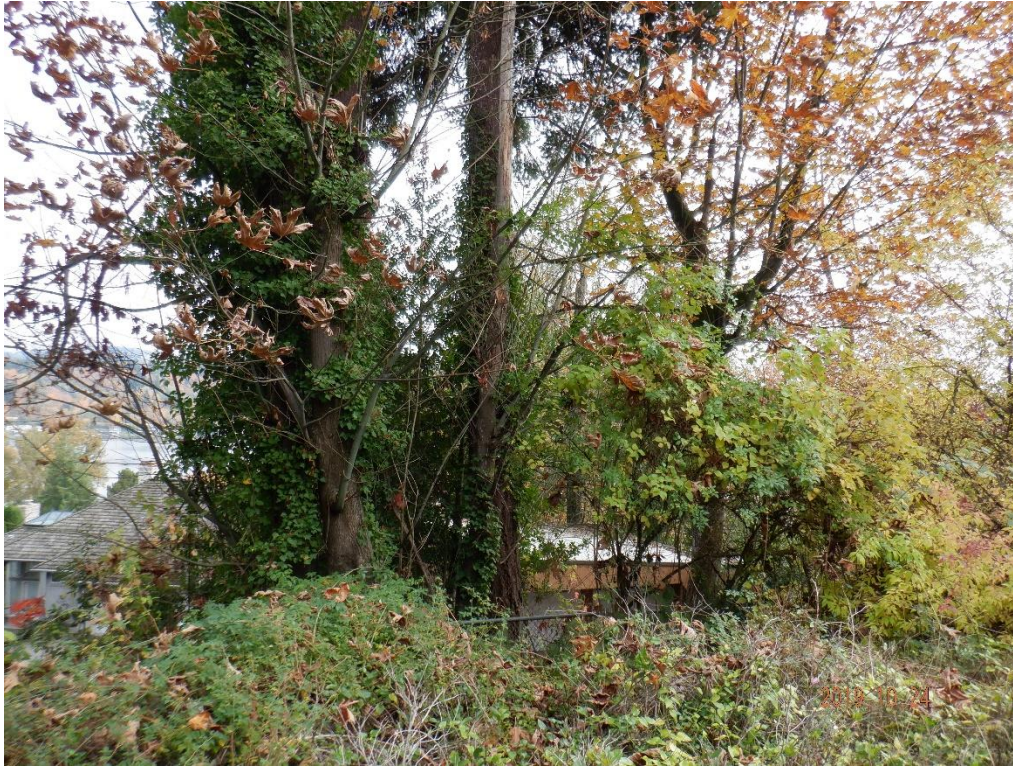
Trees #101, #102 and #103 are located on the neighboring property to the north. #101 and #102 are approximately 10-feet off of the property line and not likely to be impacted by re-development of the

property. Tree #103 which is located closest to the property line is in poor condition. This is a semi-mature bigleaf maple cluster in ultimate decline. The tops have broken out in the past.

Neighboring trees #101, #102 and #103

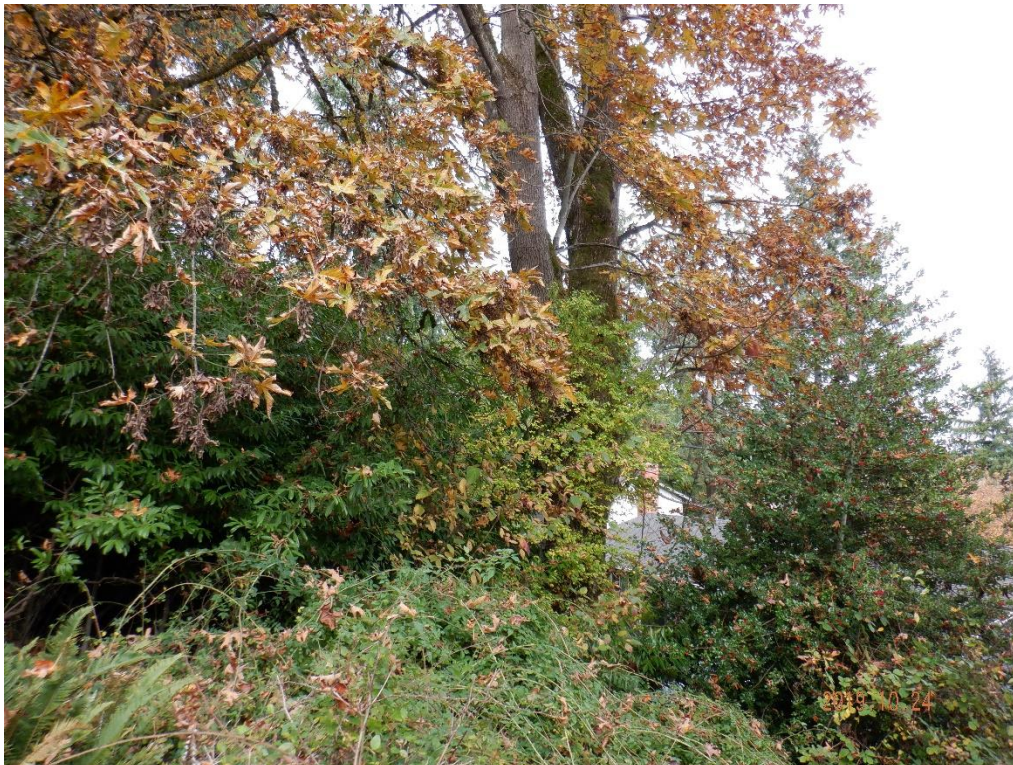
Neighboring trees #104, #105, #106 and #107 are located on the neighboring property to the north. #104 is a mature bigleaf maple. This exceptional tree has developed good form and is of good vigor. #105 is a mature European white birch. It is of fairly good vigor. Only minor top decline was observed. #106 is an exceptional Japanese maple in good condition. #107 is a cluster of English holly near the northwest property corner. It has developed typical form and is in fair condition.

Neighboring tree #104

In order to adequately protect neighboring Trees #105 and #106, provide a 10-foot protection zone from the property line. #106 is 'exceptional' and warrants protection. Tree #104 is not likely to be impacted because of existing steep slopes. If the slope is landscaped in the future, all work shall be done by hand within the driplines of retained and off-site protected trees. Soils shall not be disturbed. No grading is allowed within the LOD.

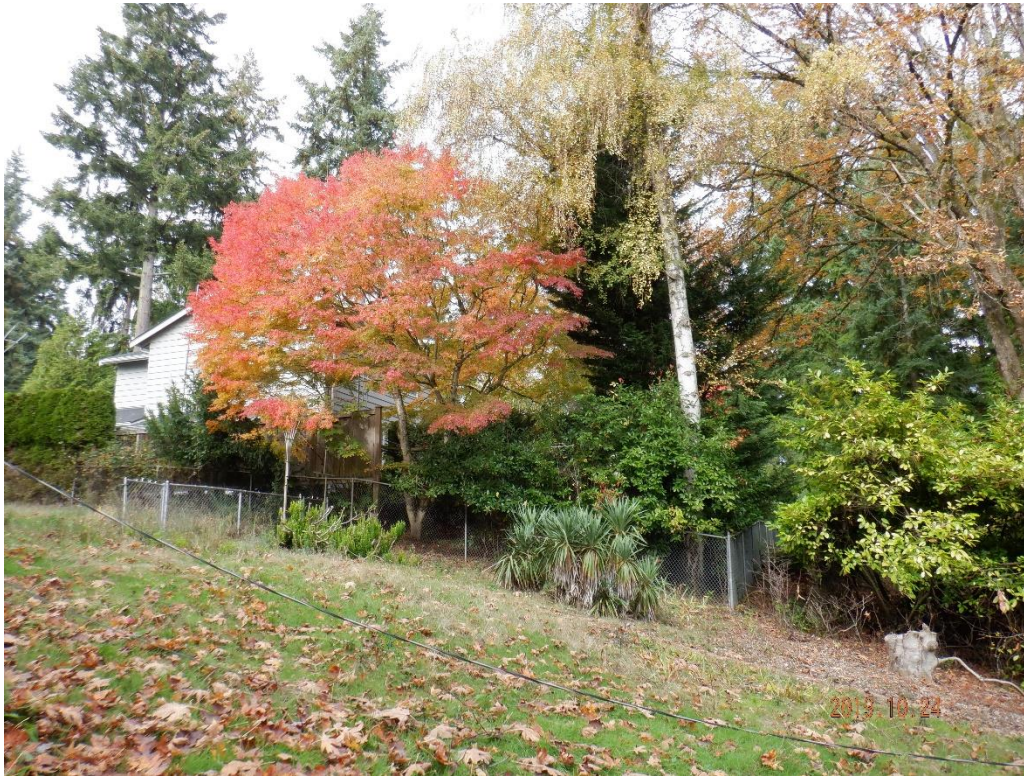
Neighboring trees #105 and #106

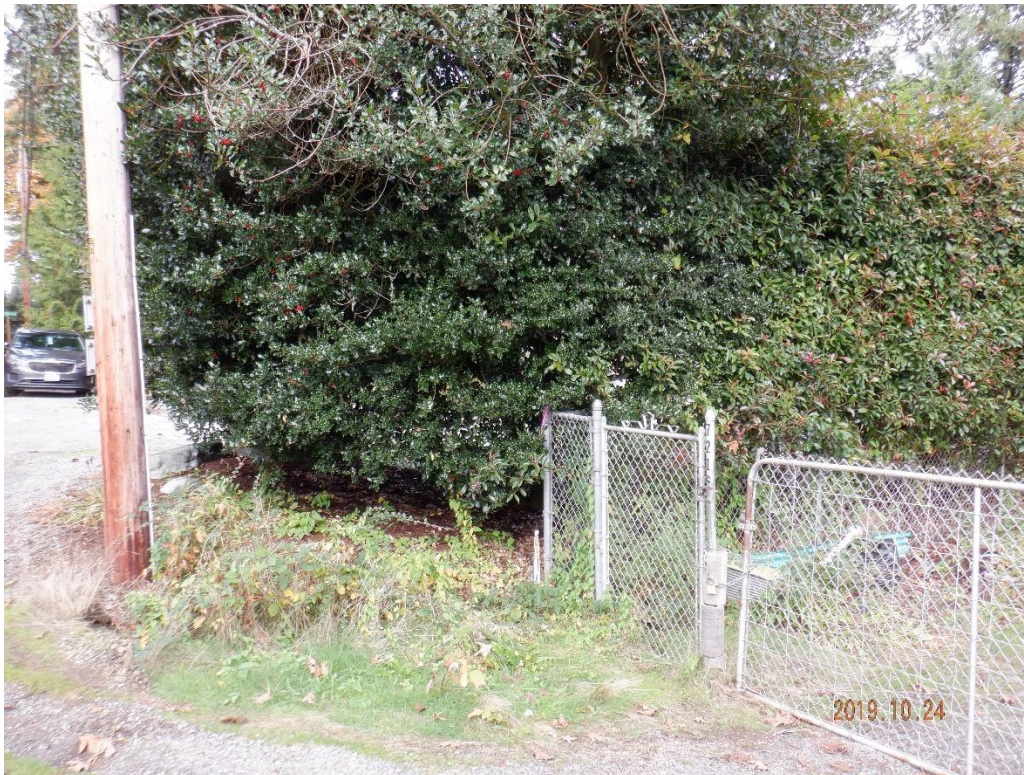
Neighboring tree #107

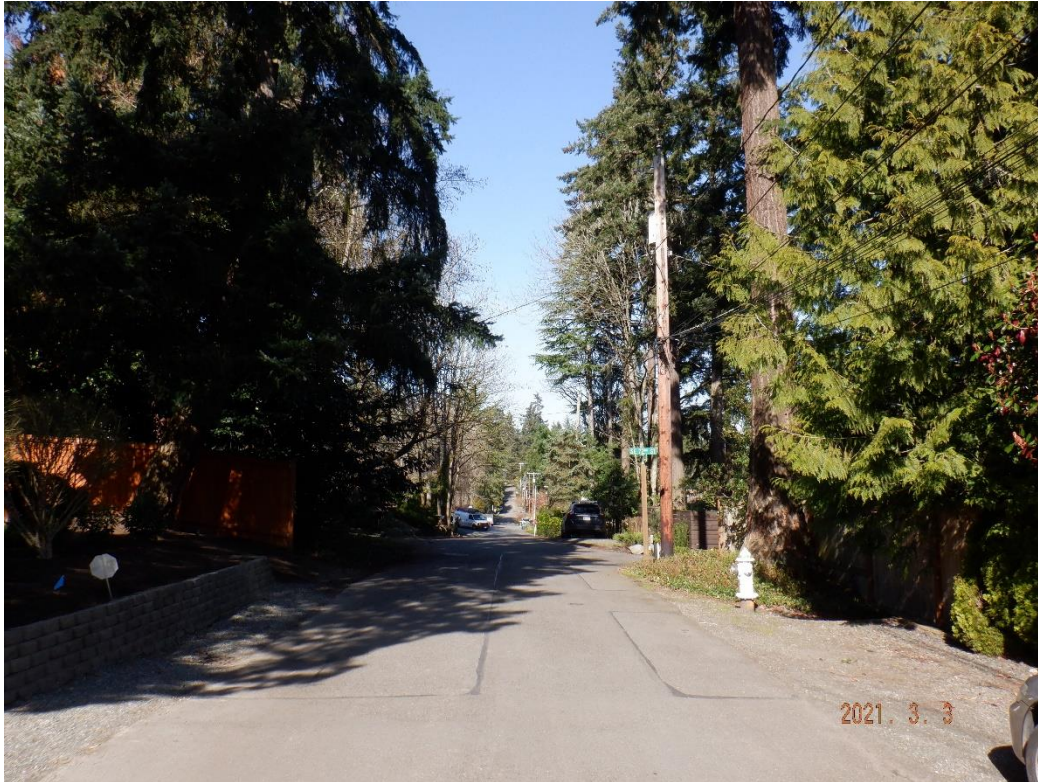
Trees #108 > #115 are in the right-of-way of 93<sup>rd</sup> Avenue SE. These are within a proximity of the proposed storm utility improvement work. There has been work on the existing storm utility in the recent past. The asphalt pavement has been cut in the recent past. These are primarily native species of Douglas fir, bigleaf maple and one red alder. The two Douglas fir are of 'exceptional' size. Both appear sound and in good condition. The maple has developed typical form. All appear to be of fairly good vigor. The alder is also of decent vigor with no concerning defects.

93<sup>rd</sup> AVE SE ROW, Tree #109 on left, #110 on right

Trees #108 > #115 in the right-of-way of 93<sup>rd</sup> AVE SE are not likely to be impacted. This utility was recently excavated and improved. The pavement adjacent to it has been cut and patched in the recent past. So long as work is kept to those same limits, there shouldn't be any further impacts to nearby trees.

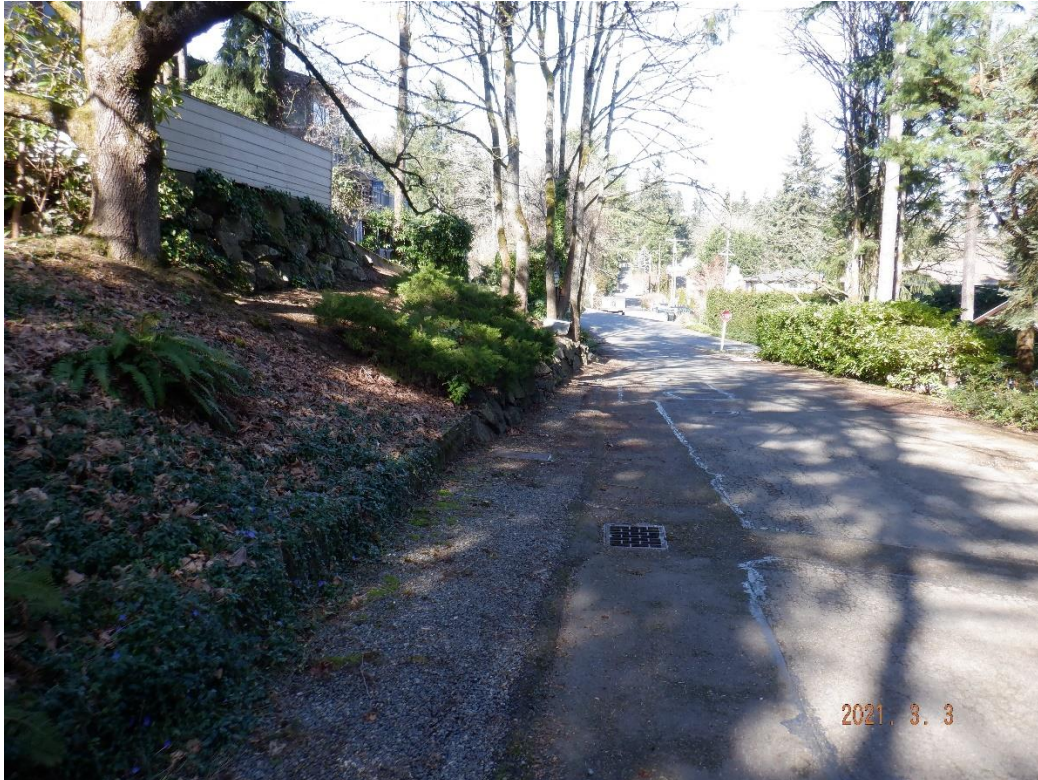
93<sup>rd</sup> AVE SE ROW, Tree #112 on left, #113, #114 and #115 in background
