RE: 8247 E Mercer Way, Mercer Island, WA.

A crew from ArboristsNW LLC inspected the trees affected by your project on your lot and the neighboring properties. Each tree now sports a numbered metal tag that corresponds to the attached site map and drawing. We will address the condition of one exceptional tree (32) that is hazardous and needs to be removed for your project. In addition, there will be discussions on the location of the tree protection fences and why they will protect the remaining trees while being located within the driplines of the several trees. Irrigation for the replacement trees will be part of the discussions.

RUDD SHORT PLAT

ARBORIST TREE PLAN

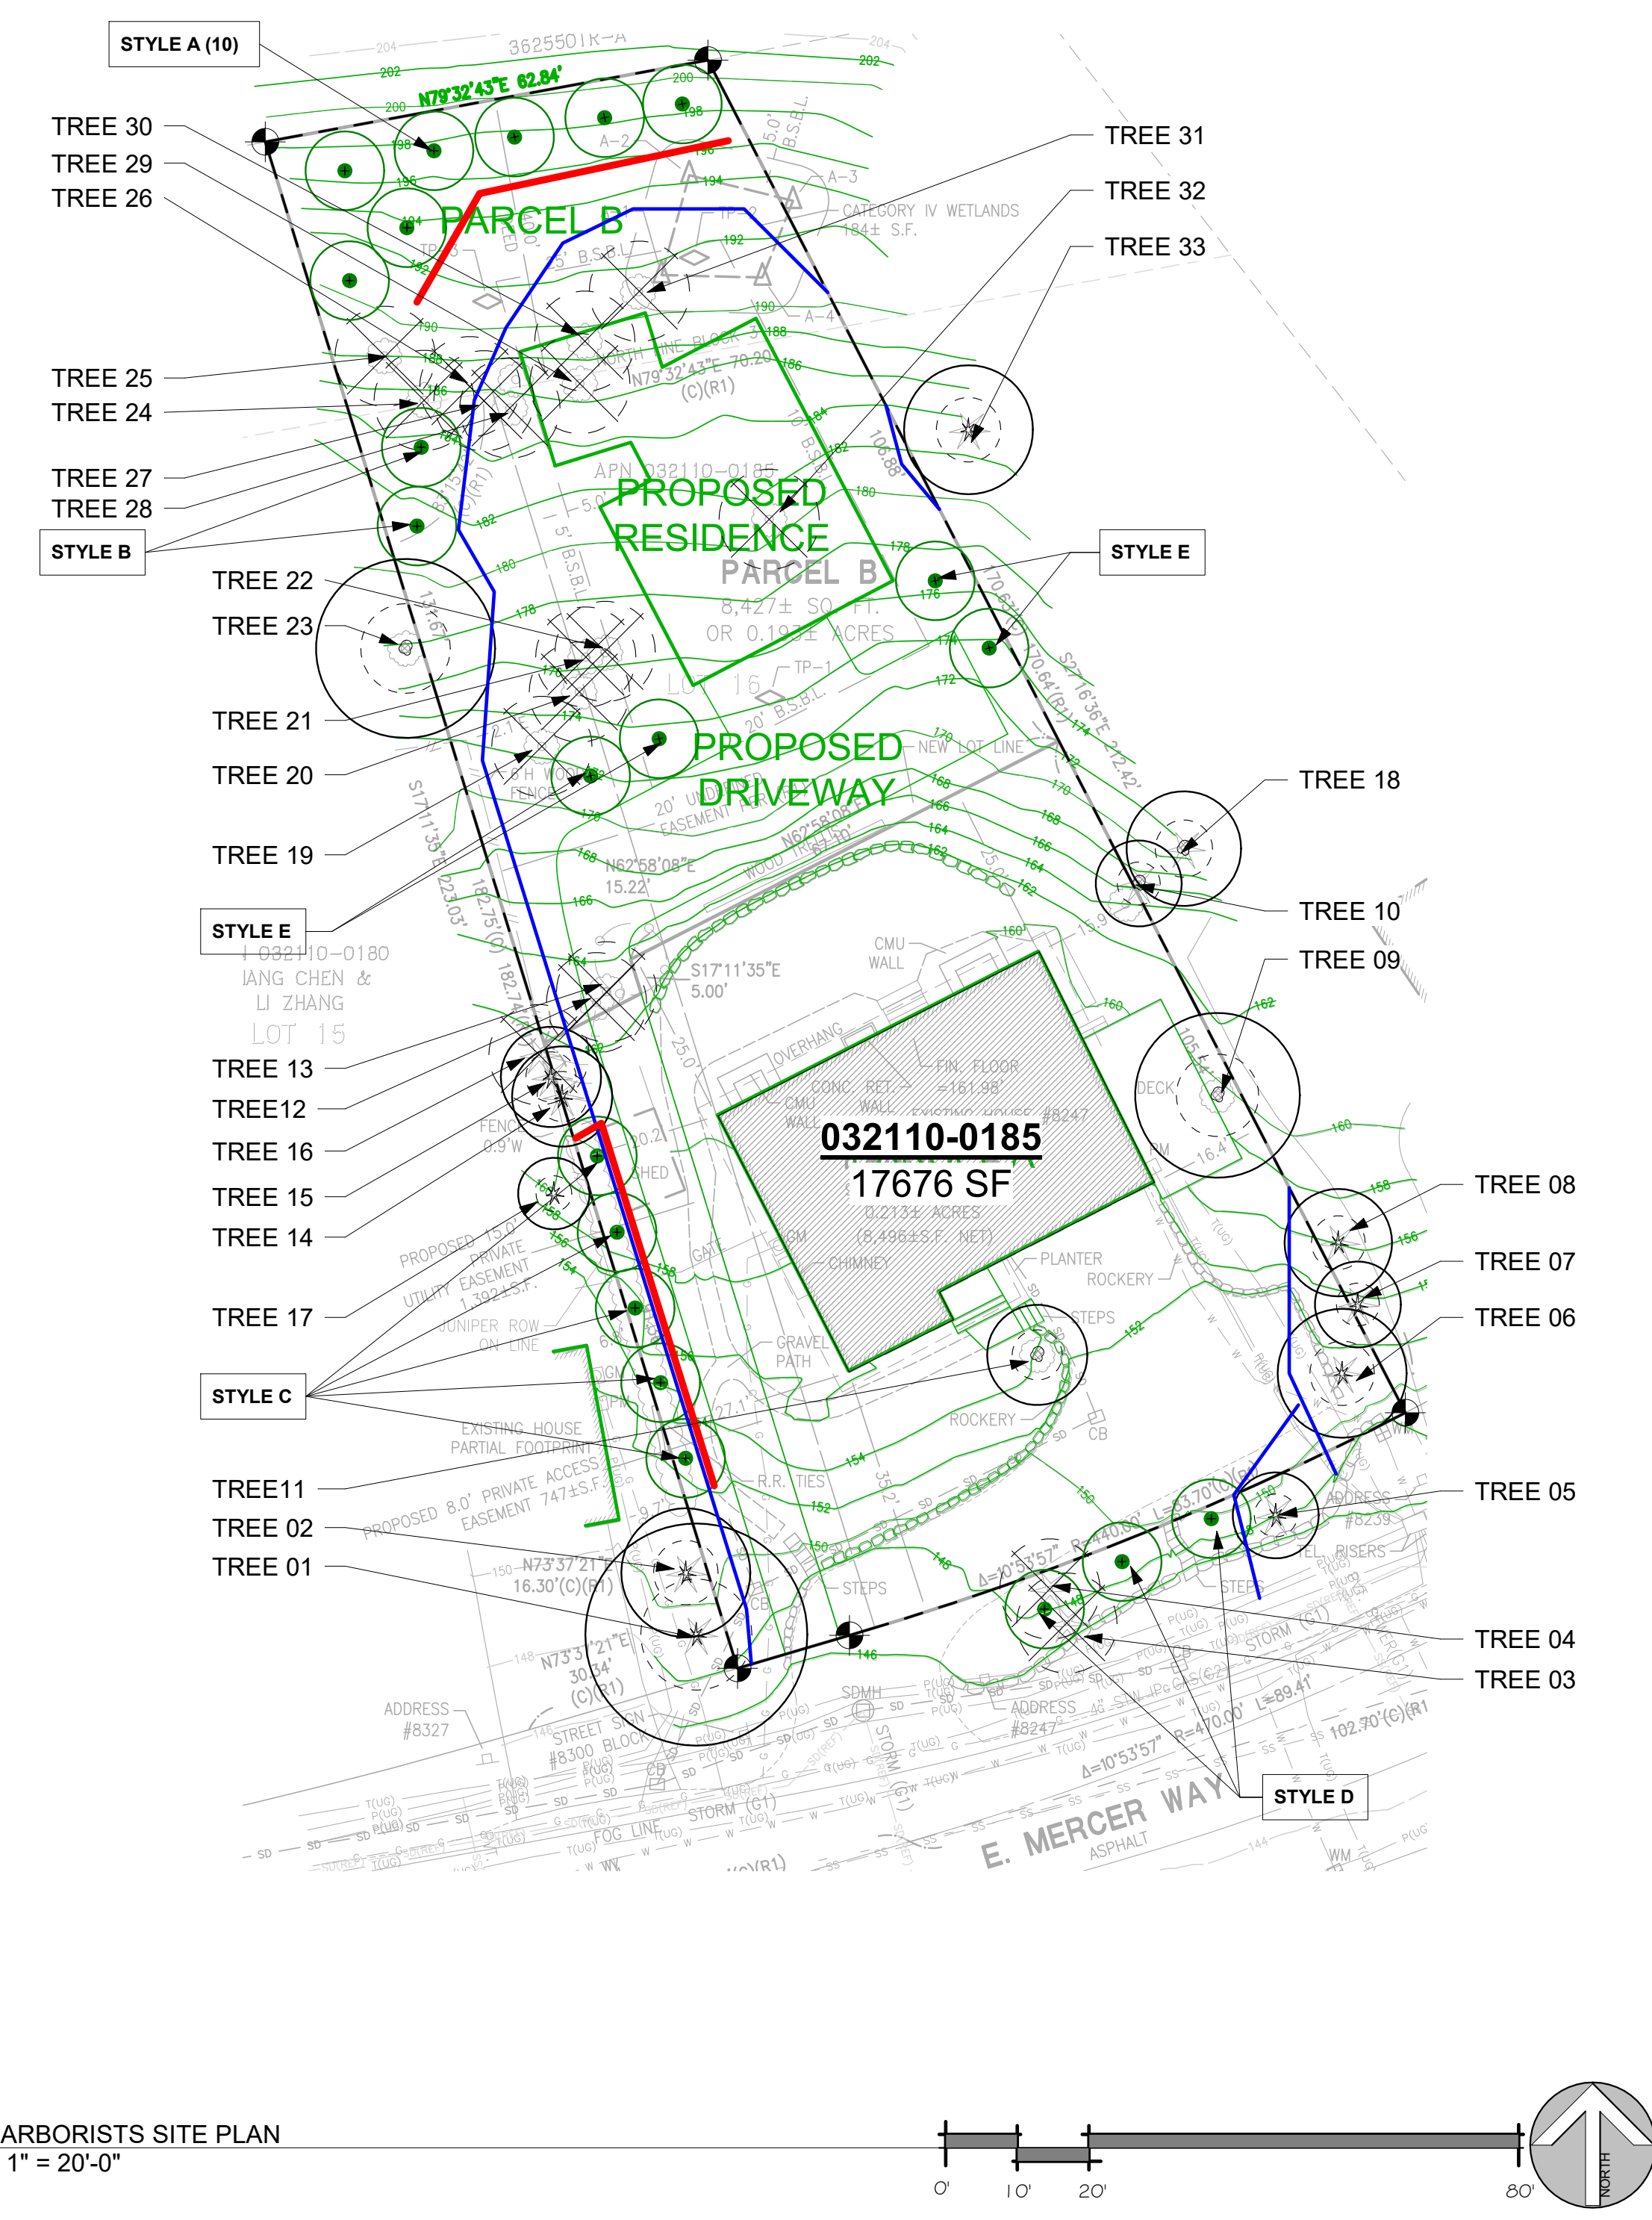
First off is tree 32, a 31.8" DBH Big Leaf Maple. This tree has had one-half of its top break off. Two main scaffolding branches formed the top; one has broken off at the division of the main trunk into the two scaffolds. The tear/wound (3' long and 10" wide) has not compartmentalized, and a cavity is observable. The two scaffolds had an east-west orientation, and the western scaffold failed. This situation gives the tree a lean towards the existing home with all the weight pulling to the east. There are two more critical factors: the stump is undermined, with voids under the root crown, and decay was observed under the root crown. The second issue is that the soil on the west side uphill side of the tree is saturated. One sinks 4-5" into the ground when walking in this area. It is our professional opinion that this tree though exceptional tree, be removed and replaced with an appropriate species for the location and number of trees as required by the city. The replacement numbers and species are incorporated in the site drawing and within the Tree inventory form.

Finally, to address the removal of two ROW trees (3-4). Both trees have a Bark Beetle infestation and pitch with frass weeping for the lower trunks. The current condition of the tree's canopy has good color. Still, there is no cure presently once a tree has been infested, so these trees can be removed and replaced now rather than waiting for them to deteriorate to become increasingly hazardous, getting a jump on the eventual replacement of the canopies. They both have deformed canopies due to the damage from the south-westerly winds that wrap around the island's southeast end.

3.	NORWAY SPRUCE (<i>PICEA ABIES</i>)	13	12'	FAIR	REMOVE	RIGHT OF WAY TREE - BEETLE INFESTED
4.	NORWAY SPRUCE (<i>PICEA ABIES</i>)	14	12'	FAIR	REMOVE	RIGHT OF WAY TREE - BEETLE INFESTED

30.	BIG LEAF MAPLE (<i>ACER MACROPHYLLUM</i>)	6	10'	POOR	REMOVE	
31.	HOLLY (<i>ILEX</i>)	6	7'	GOOD	REMOVE	SATURATED SOIL
32.	BIG LEAF MAPLE (<i>ACER MACROPHYLLUM</i>)	31.8	20'	POOR	REMOVE	MAJOR CROWN ASYMMETRY SCAFFOLD FAILURE AND DECAY SATURATED SOIL LEAN TOWARD THE HOME. EXCEPTIONAL (HAZEROUS)

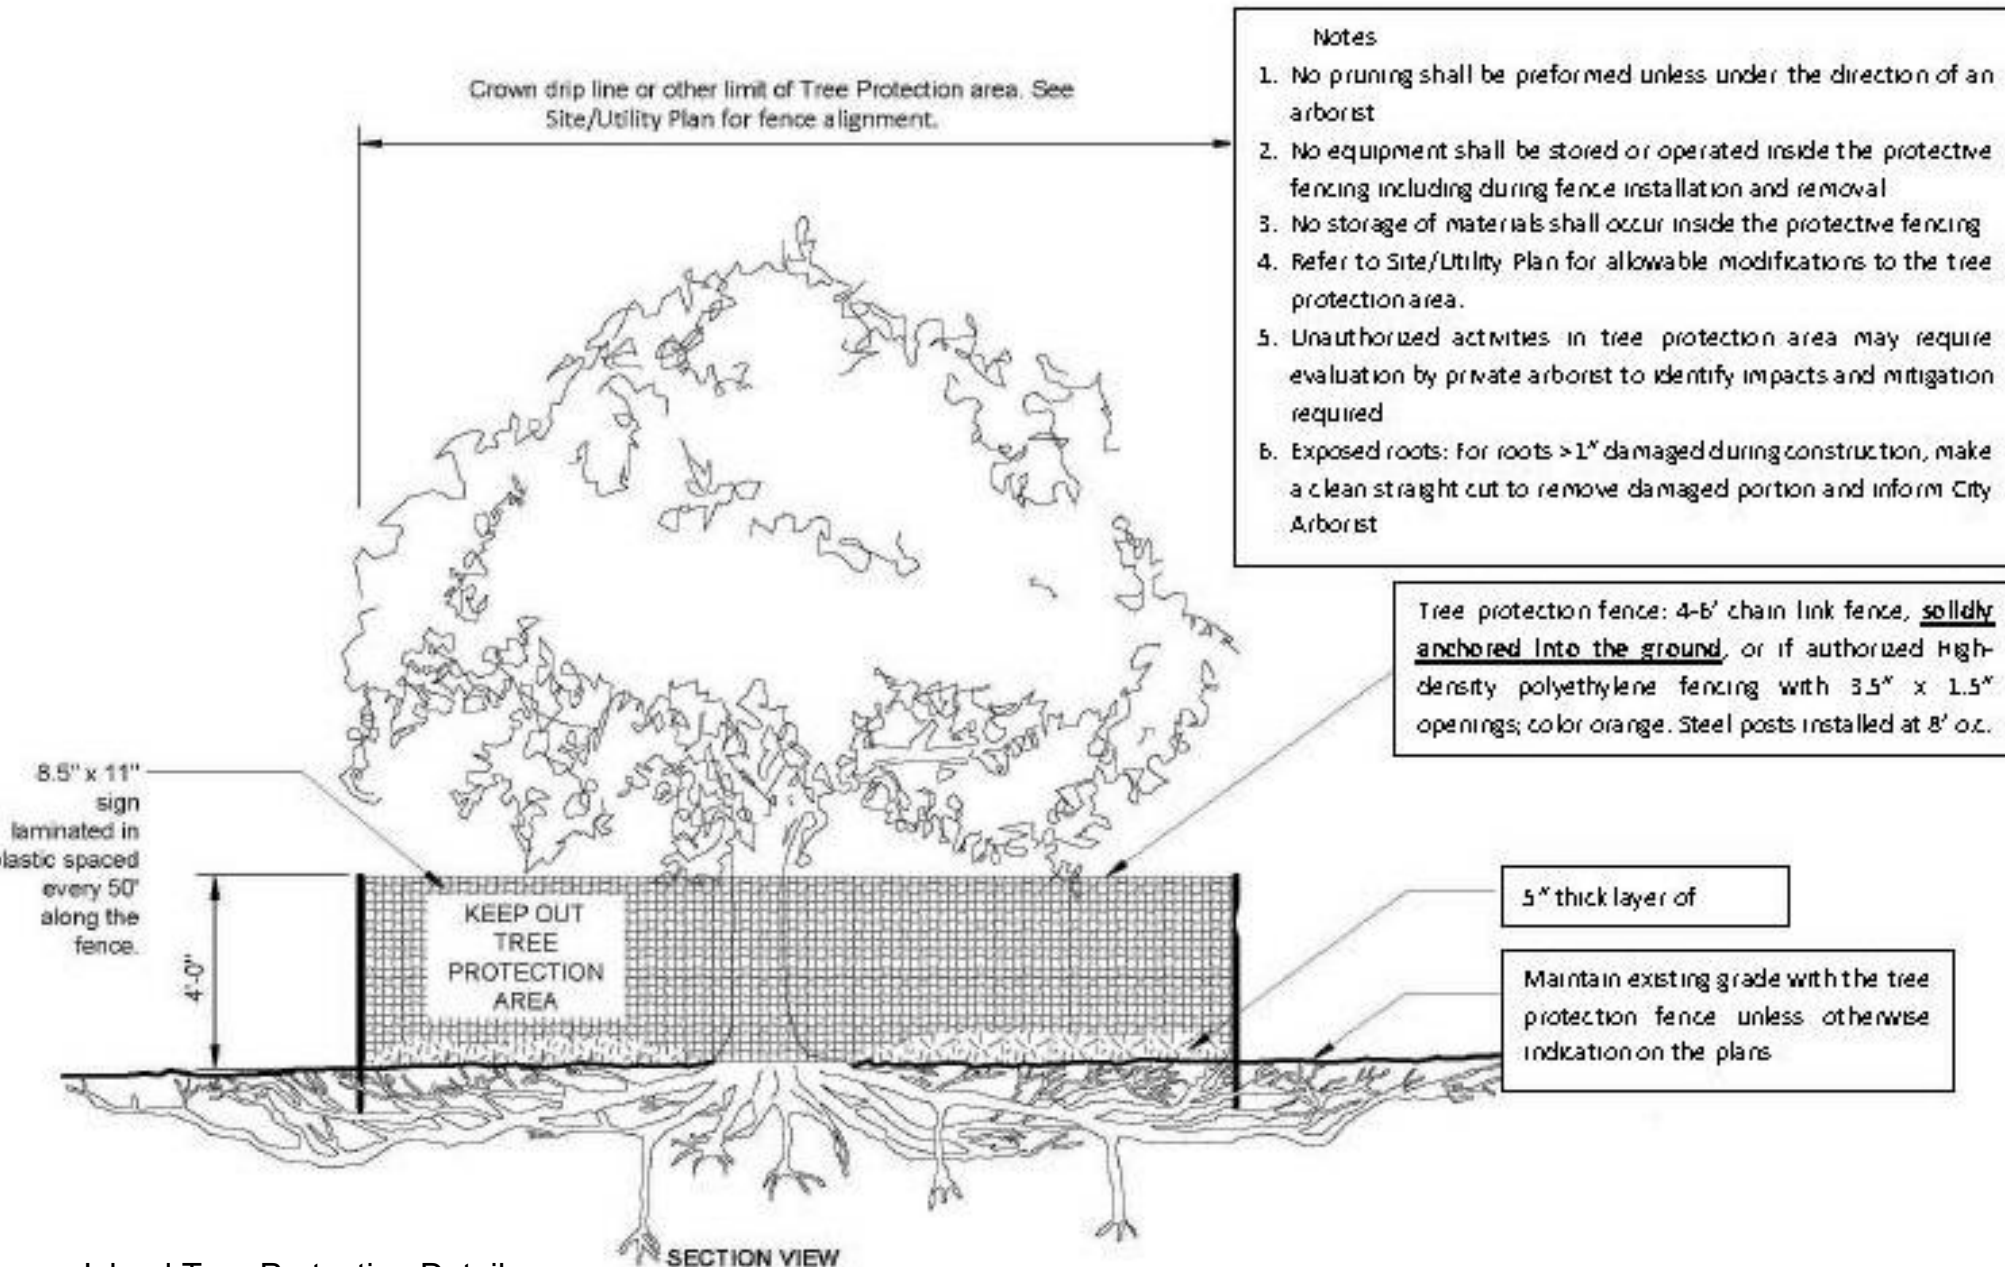
3 Mercer Island Tree Protection Detail
 1/4" = 1'-0"

It will be noticed that several trees have tree protection fencing well within their driplines/CRZs. The reason for this and why the fencing should be allowed is because of existing structures that will protect the trees from damage. One, the existing asphalt driveways will not be touched. Then all along the edges of the driveway are raised rock walls. The trees are in elevated beds. These same structures surround the ROW trees, and roots and trunks are already buffered from possible damage and or soil compaction.
