## ARBORIST REPORT

REFERENCE: Arborist Report RE: SUB22-009 (Cui Preliminary Short Subdivision)

SITE ADDRESS: 4833 90<sup>th</sup> Ave SE, Mercer Island, WA

DATE: 8/9/2023

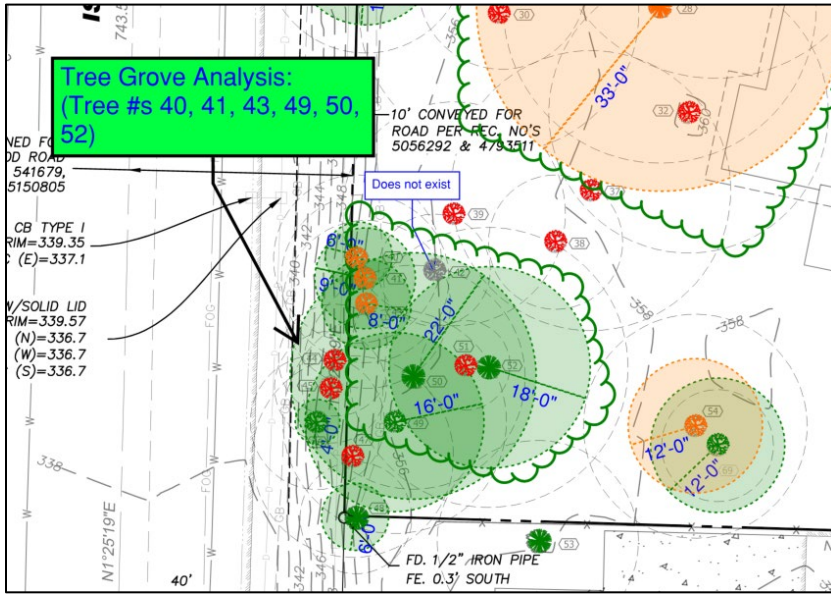
Figure 1. Tree Grove Analysis #1

**Analysis #1:** Southwest corner of site. Viable tree #s 40, 41, 43, 49, 50, 52.

**Conclusion:** While this area has a dense concentration of trees, there are only six viable trees with overlapping canopies (see Figure 1).

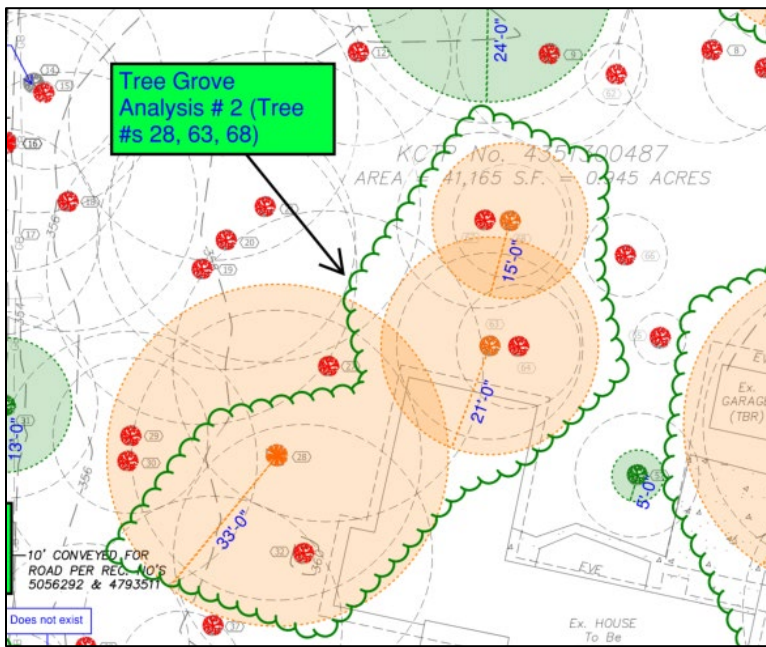
Figure 2. Tree Grove Analysis #2

**Analysis #2:** Central area of site near Lots 1 and 2. Viable tree #s 28, 63, 68,

**Conclusion:** While this area has a dense concentration of trees, there are only three viable trees with overlapping canopies (see Figure 2).

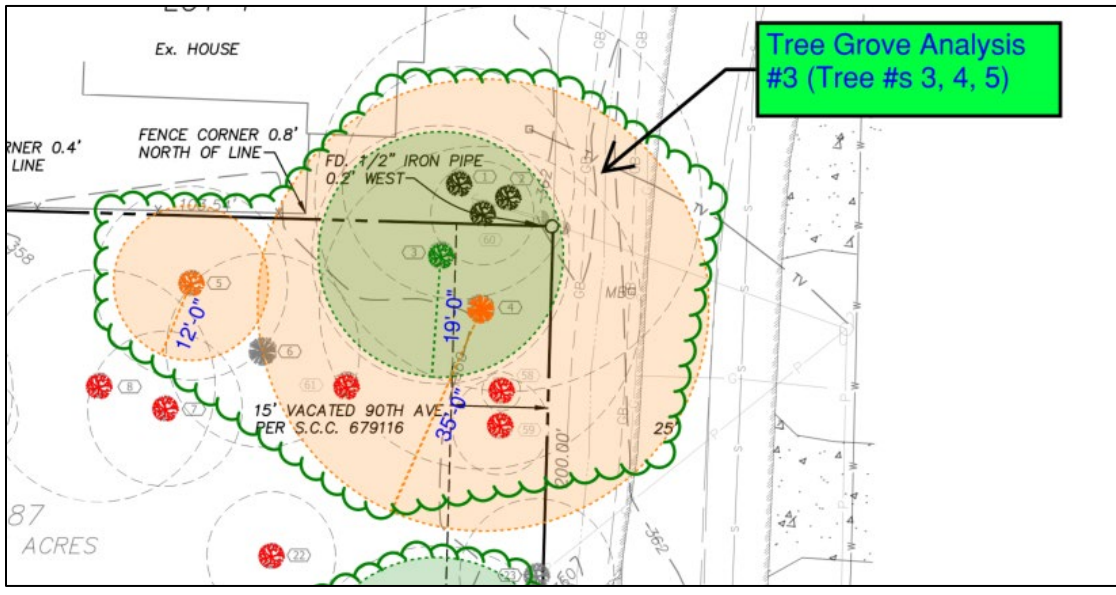
Figure 3. Tree Grove Analysis #3

**Analysis #3:** Northeast corner of site near Lot 3. Viable tree #s 3, 4, 5.

**Conclusion:** There are only three viable trees with overlapping canopies (see Figure 3).

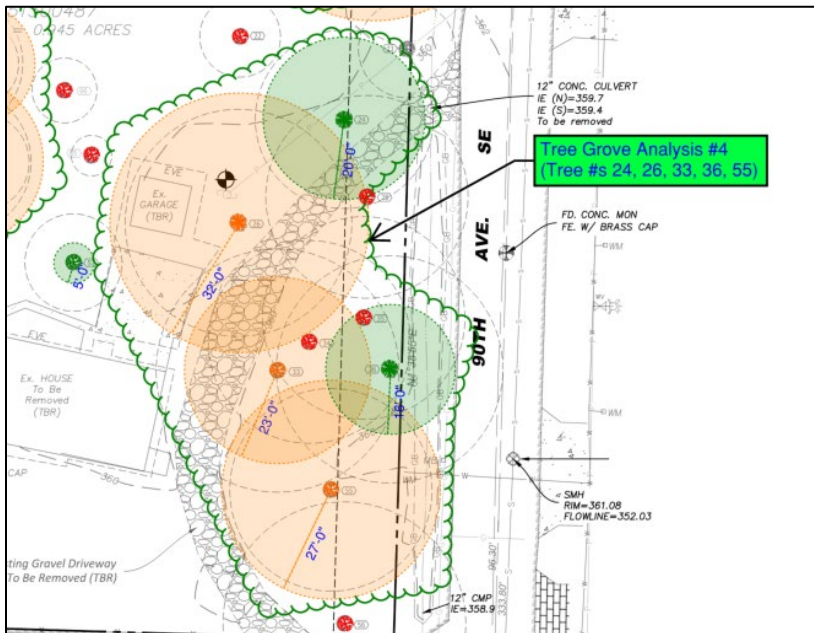
Figure 4. Tree Grove Analysis #4

**Analysis #4:** Southeast corner of site near Lot 4. Viable tree #s 24, 26, 33, 36, 55.

**Conclusion:** There are only five viable trees with overlapping canopies (see Figure 4).

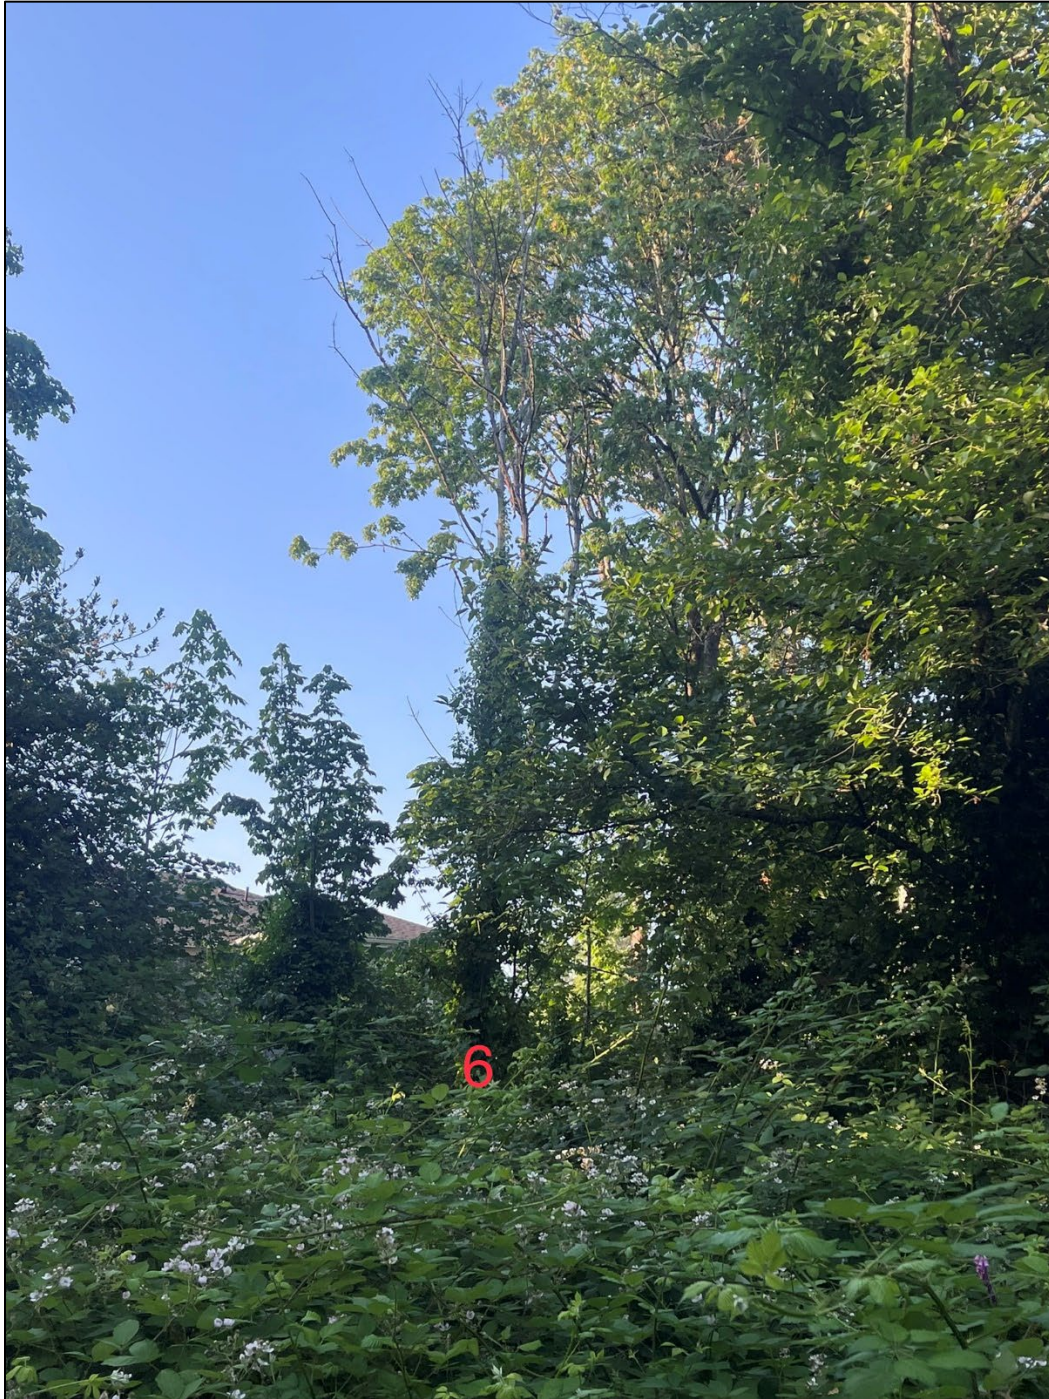
*Photo 1. Tree # 6, dying.*

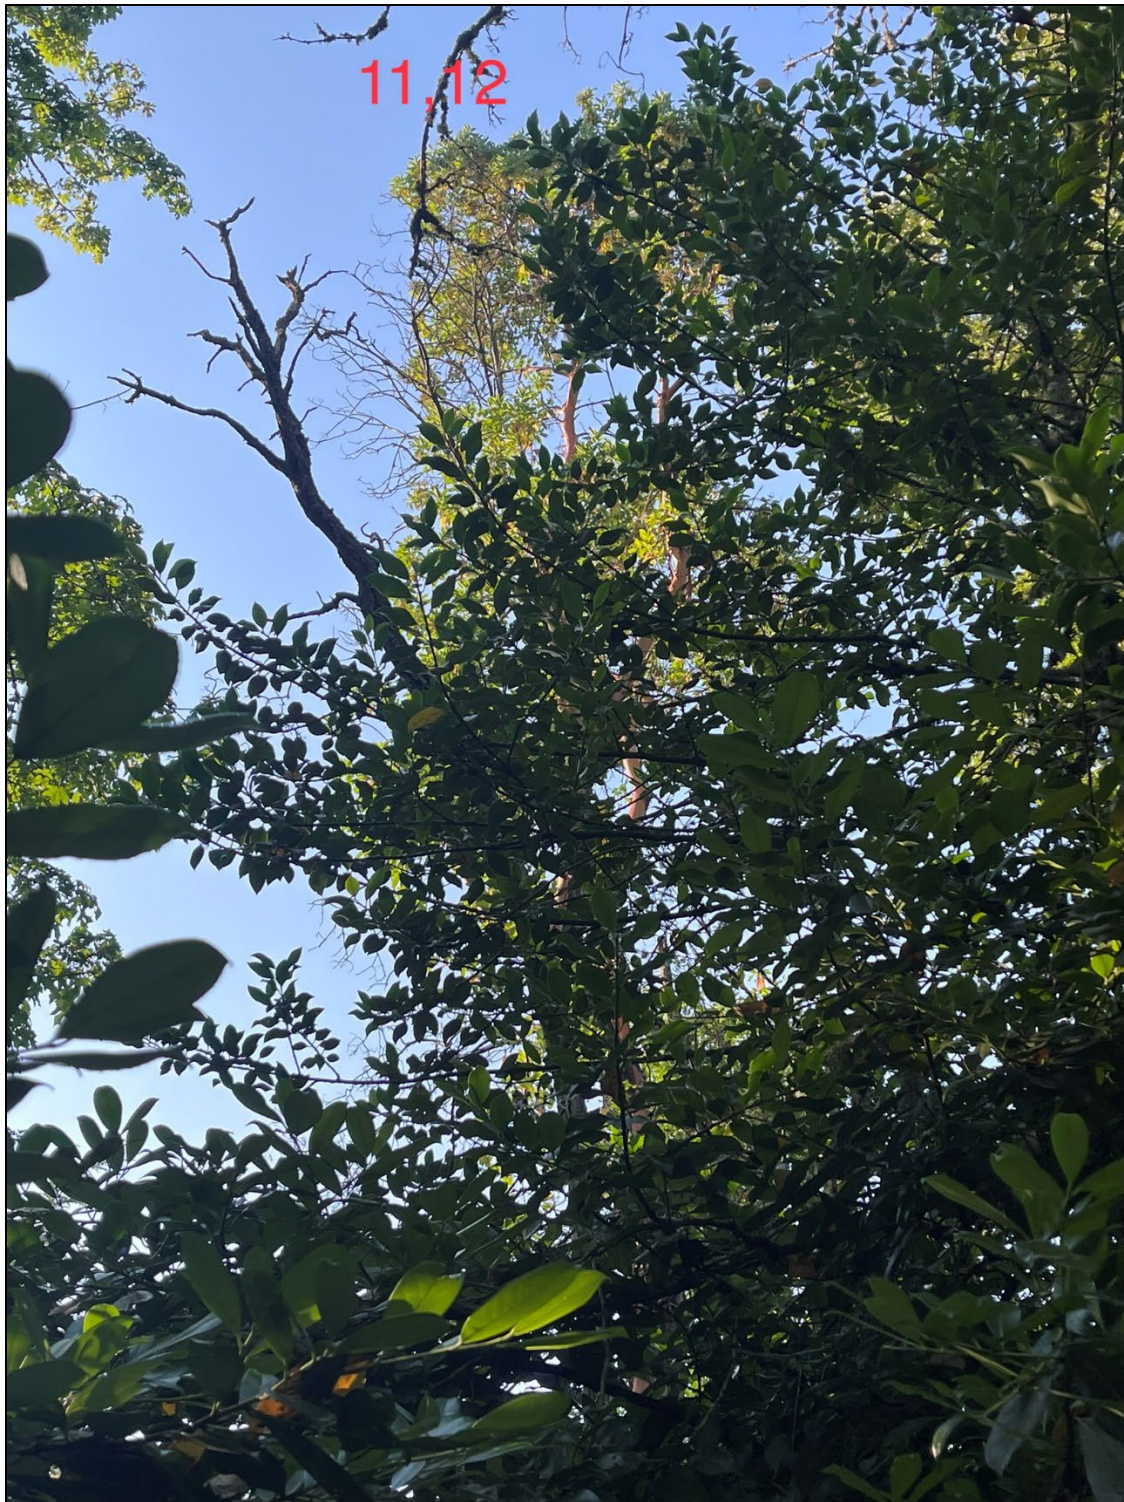
*Photo 2. Tree #s 11, 12, dying/dead.*

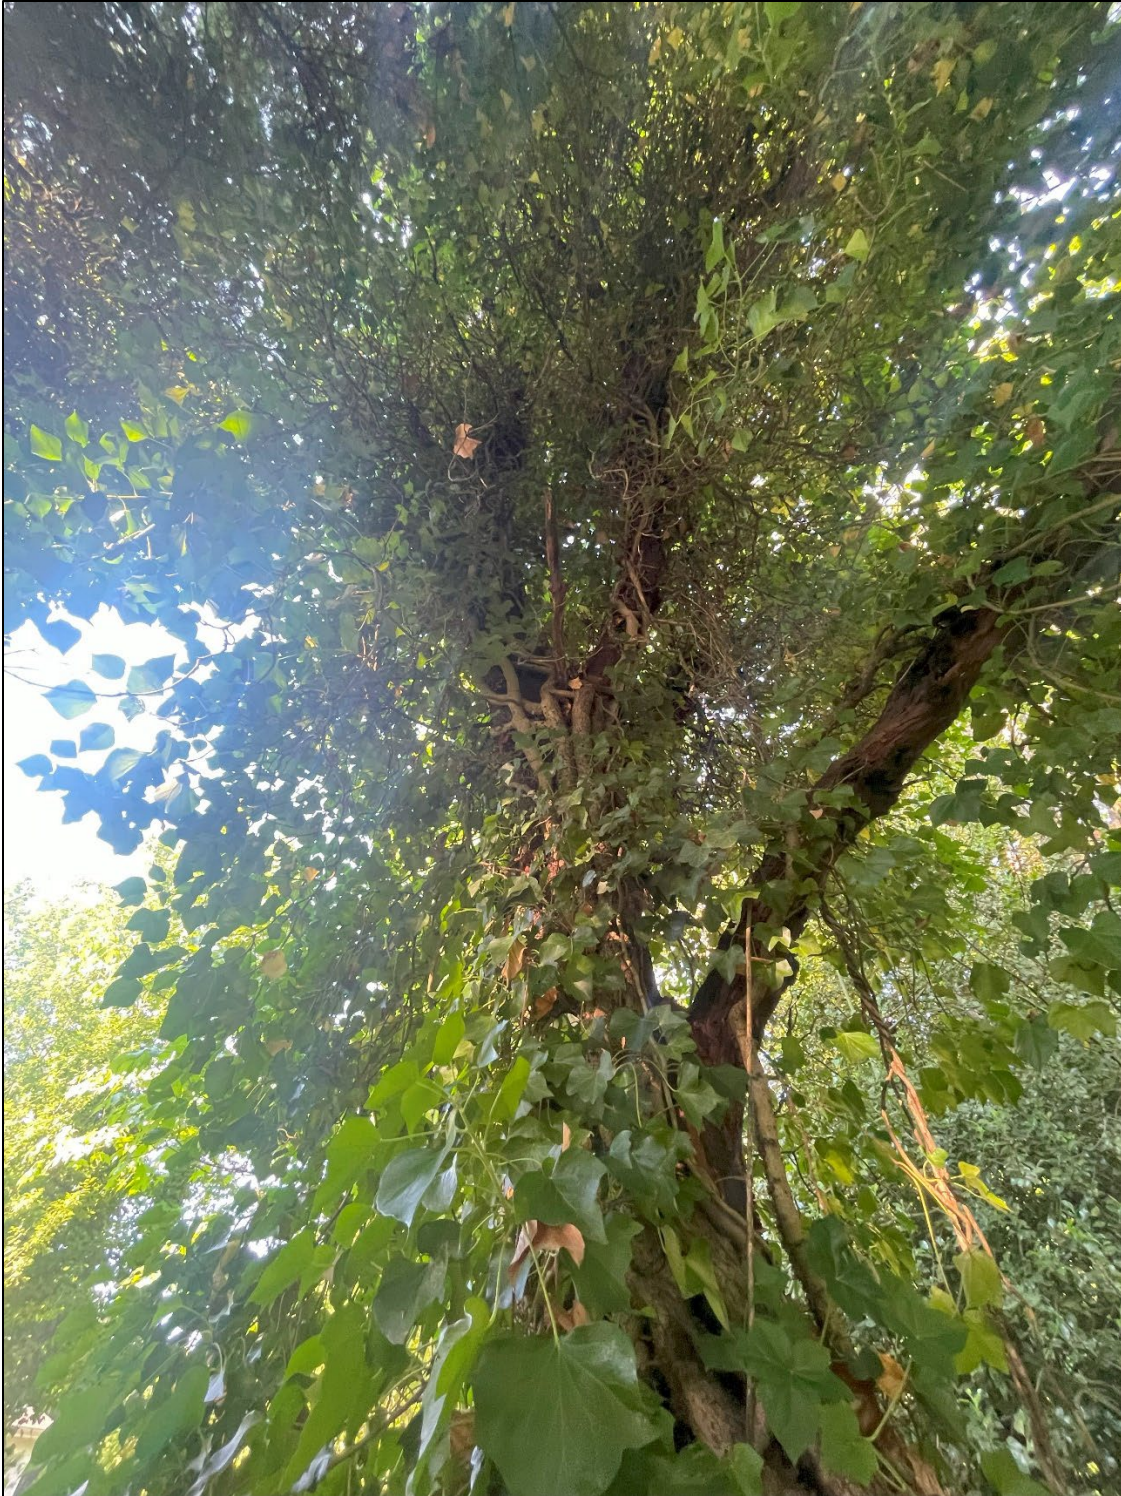
*Photo 3. Tree #15 covered in ivy vines and dying.*

15	<i>Acer macrophyllum</i>	Bigleaf Maple	14.5	Poor	Fair	No	6	4	4	4	30		Remove	Completely dead and covered in ivy vines
16	<i>Pseudotsuga menziesii</i>	Douglas-fir	17.5	Fair	Poor	No	14	17	8	18	30		Remove	Previously topped with visible decay at old topping wound, very poor long-term form, not ideal long-term tree
18	<i>Arbutus menziesii</i>	Madrone	20.1	Poor	Fair	No	6	8	12	12	6	Not Viable	Remove	Tree completely suppressed, large 5 inch ivy vines on trunk with minimal live canopy remaining
19	<i>Acer macrophyllum</i>	Bigleaf Maple	19.6	Fair	Poor	No	8	20	4	22	30		Remove	Very narrow trunk attachment at base, staining on north trunk - possibly fungal, north trunk is completely dead, remaining trunk has dead top and additional dieback throughout
20	<i>Ilex aquifolium</i>	English holly	12.7	Good	Good	No	16	16	16	16	-		Remove	Invasive species not recommended for retention
21	<i>Acer macrophyllum</i>	Bigleaf Maple	21.2	Poor	Fair	No	30	8	4	4	30		Remove	North trunk is nearly dead with top dieback, south trunk is also completely dead except for one small sprout

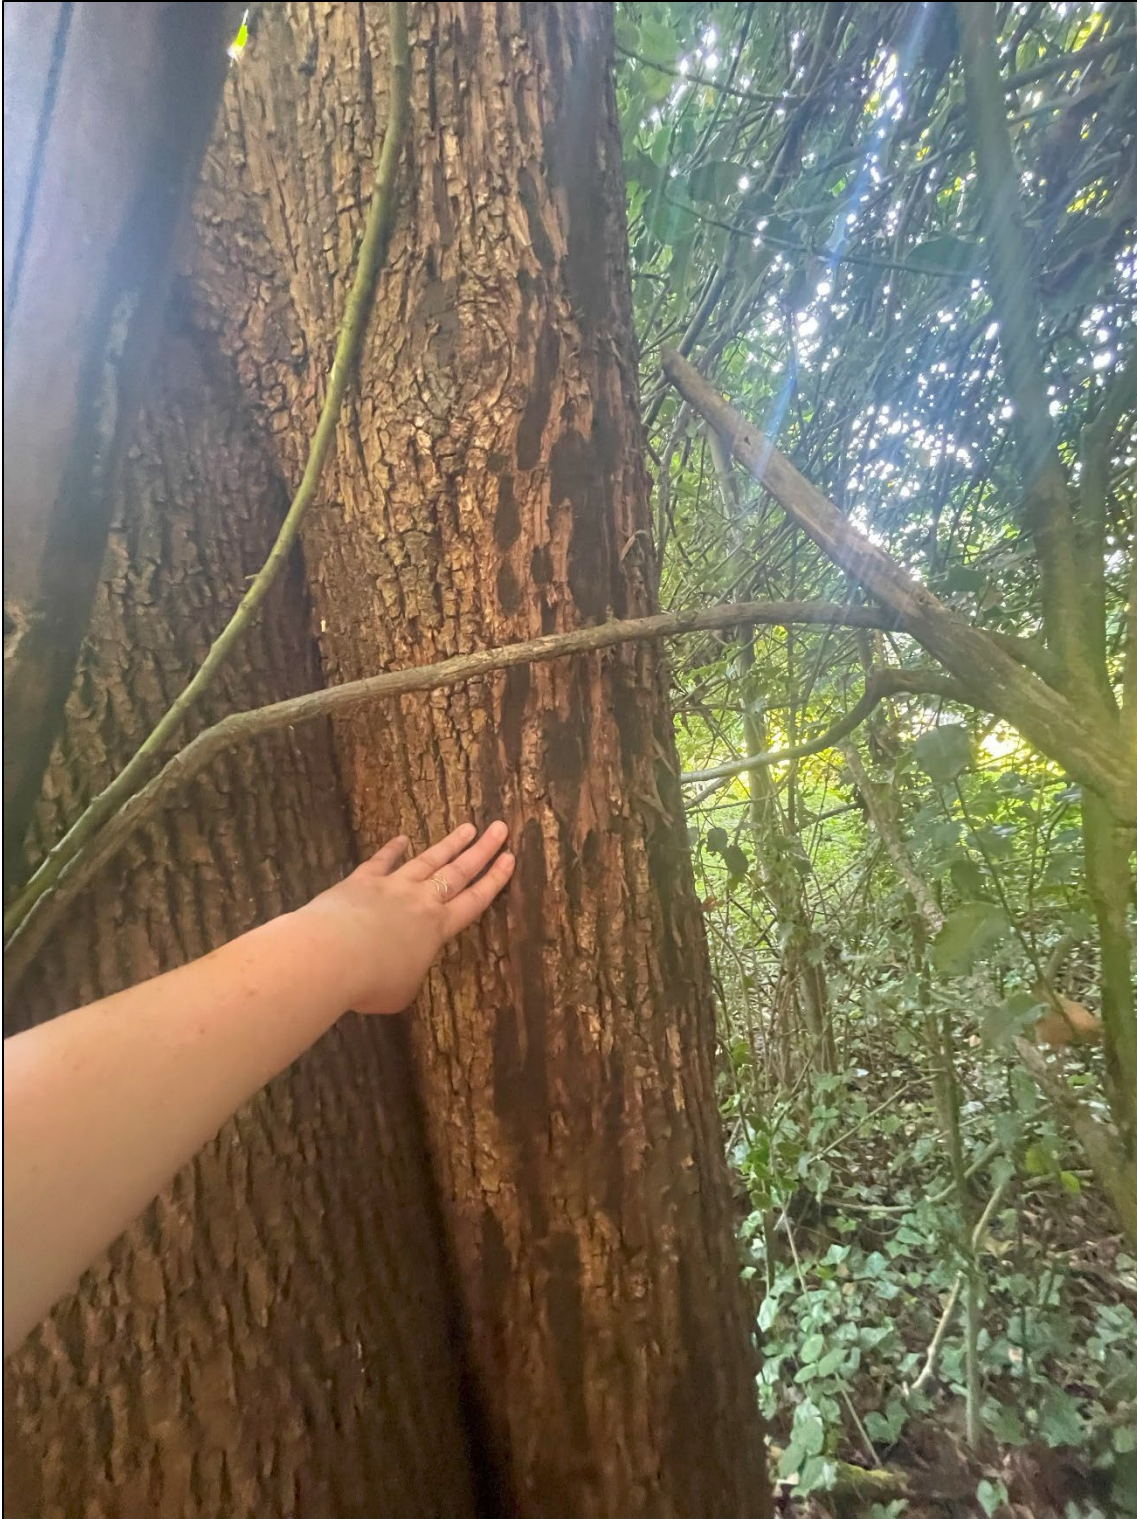
*Photo 4. Tree #19 with one dead trunk.*

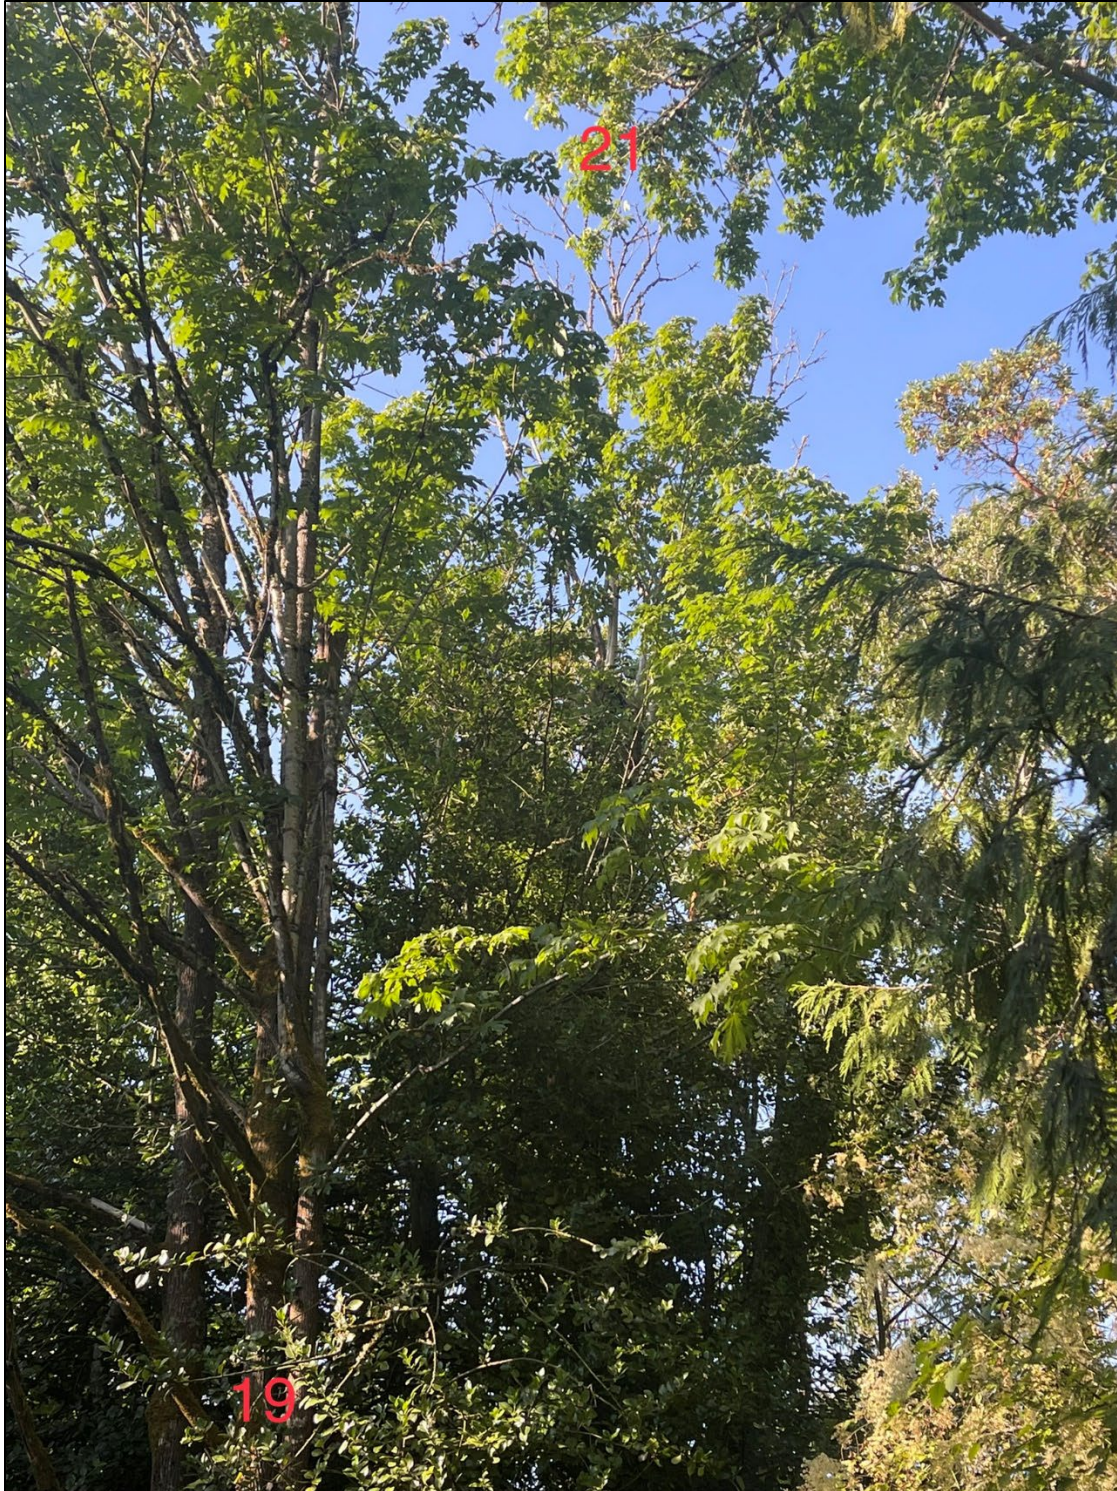
*Photo 5. Tree #21 with dead top.*

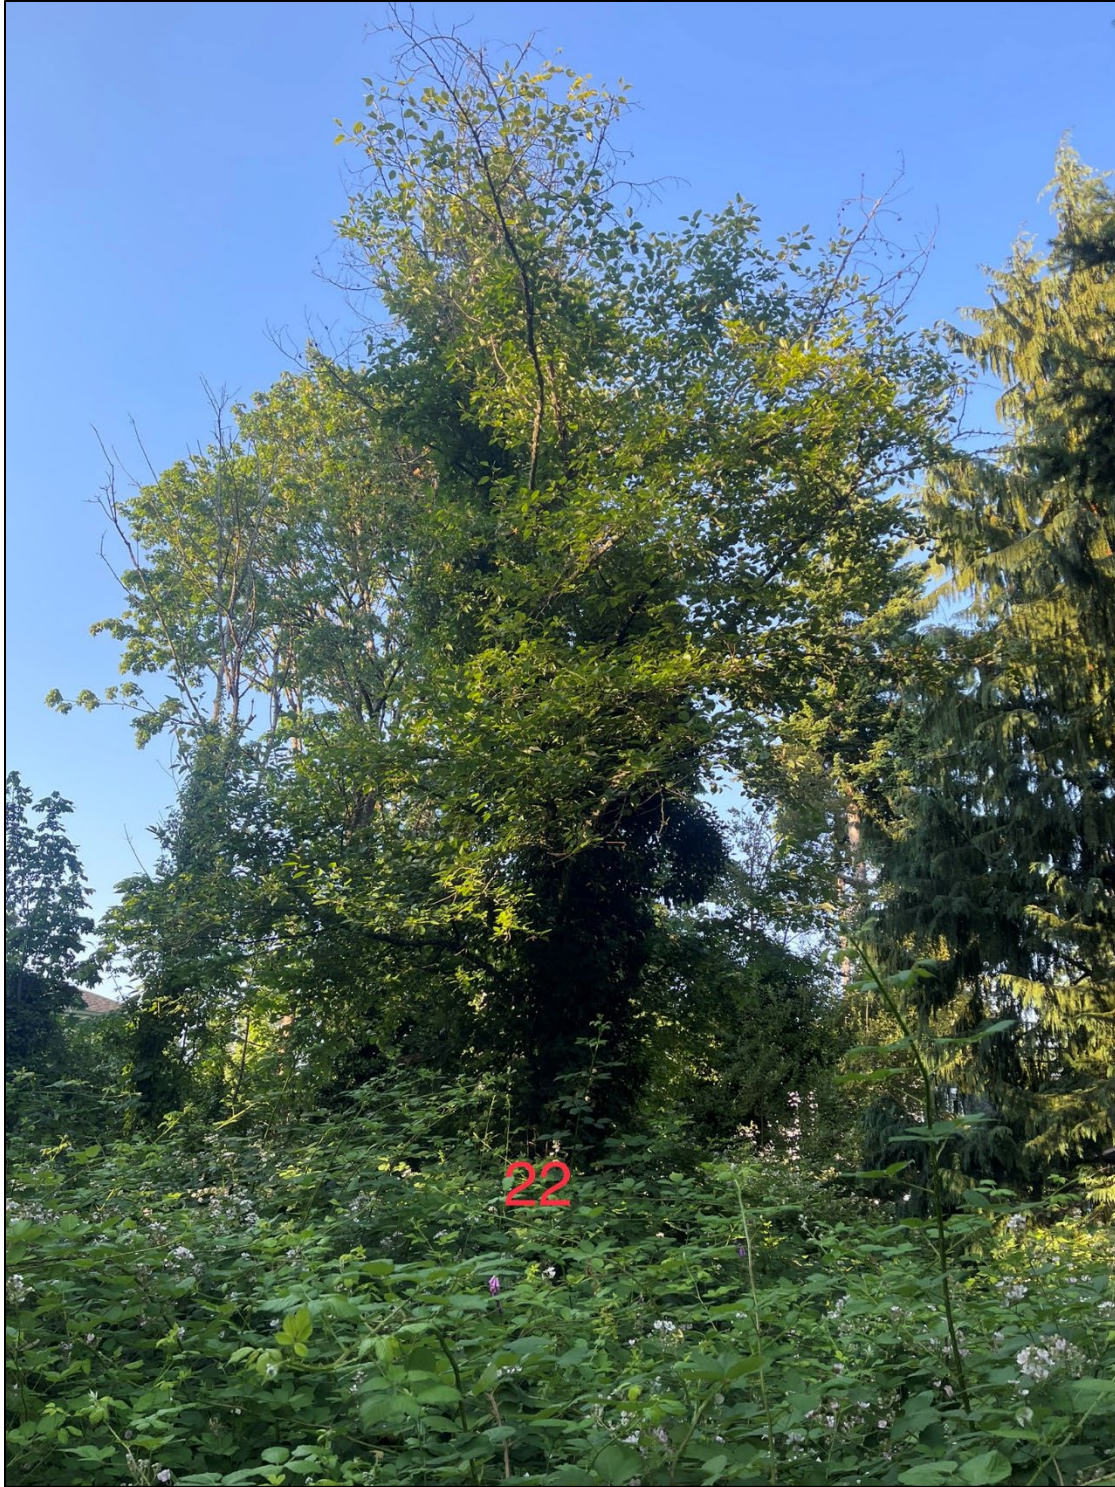
*Photo 6. Tree # 22, dying.*

22	<i>Alnus rubra</i>	Red alder	12.2	Poor	Fair	No	8	24	0	24	-		Remove	Top dieback, nearly 100% covered and ivy vines
23	<i>Alnus rubra</i>	Red alder	19.0	Fair	Poor	Removed	0	0	0	0	-	-	-	Stump found - diameter ~19 inches cut at 1.5 feet above ground, tree was previously topped and was a living snag
24	<i>Thuja plicata</i>	Western Redcedar	23.5	Good	Good	Yes	16	16	16	16	30		Remove	
25	<i>Acer macrophyllum</i>	Bigleaf Maple	19.6	Fair	Fair	No	20	20	20	18	30		Remove	Three stems at based with narrow unions, visible dieback throughout canopy, not good long-term tree
26	<i>Pseudotsuga menziesii</i>	Douglas-fir	38.6	Good	Good	Yes	26	26	26	26	30	Exceptional - Size	Remove	Dominant Douglas fir tree with extensive ivy on trunk, nearly 90% live crown ratio
27	<i>Acer macrophyllum</i>	Bigleaf Maple	32.9	Fair	Poor	No	28	28	34	30	30	Not Viable	Remove	Very narrow codominant union at base with large seam of included bark, <i>Kretzschmaria deusta</i> observed at union, more than 50% canopy dieback and evident decay present in central columns

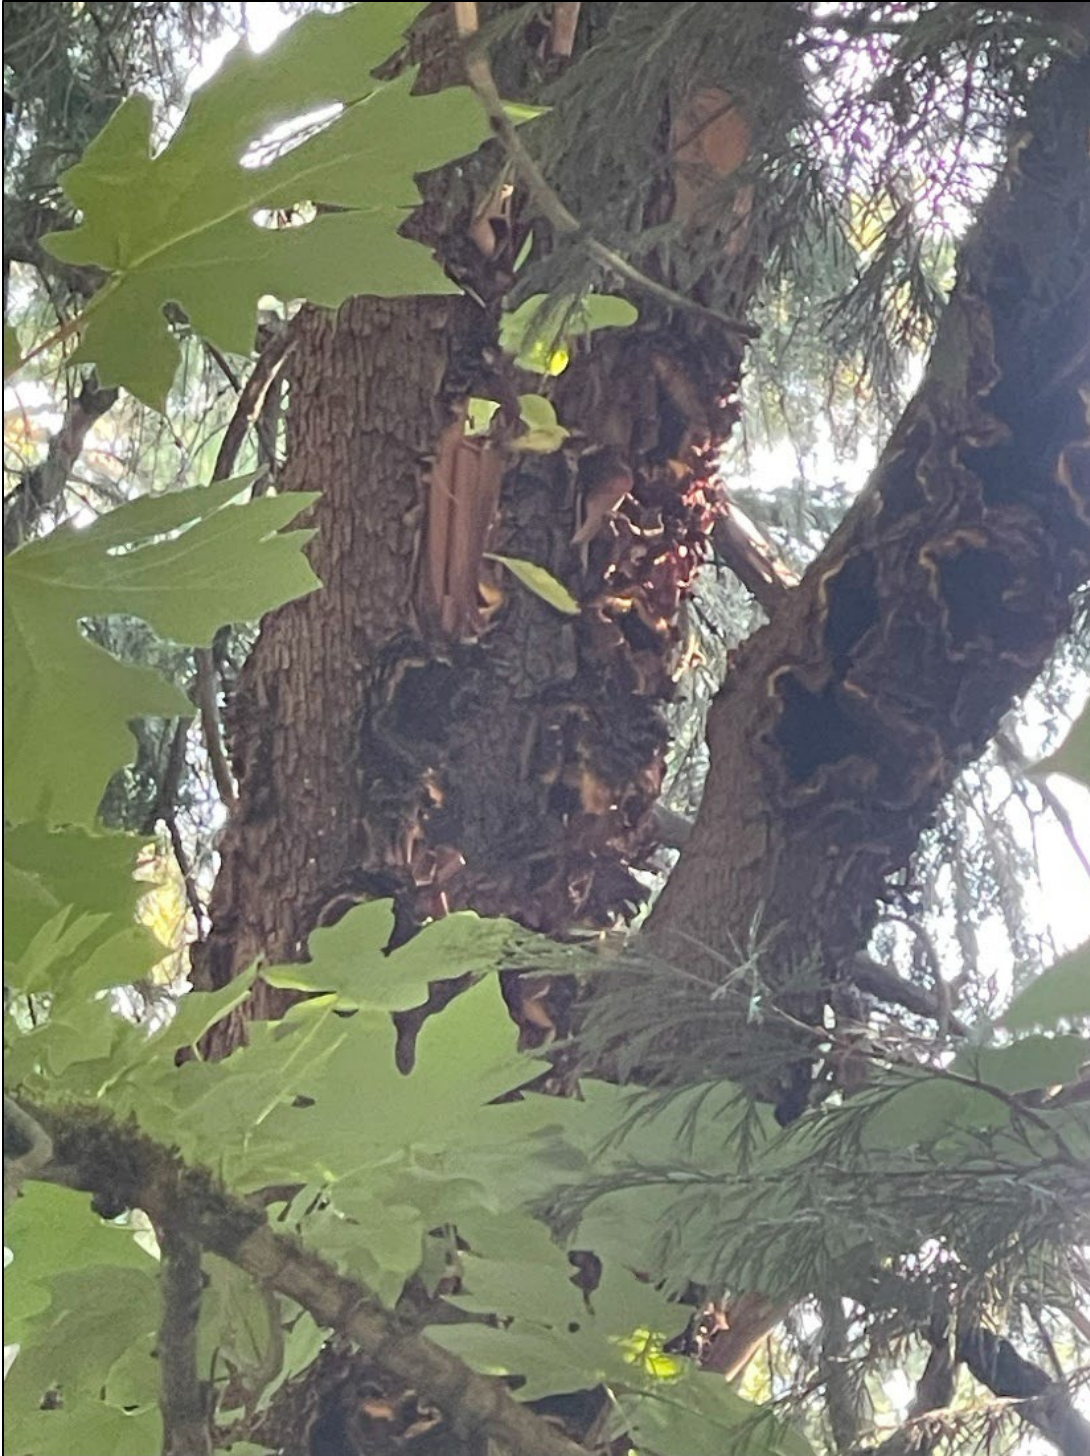
Fourteen pacific madrone (*Arbutus menziesii*) trees are present on the site; six of which were in poor health and/or structural condition. Canopy decline was evident on many of the madrone trees which is a common symptom throughout the Seattle Region. I also observed cankers on the trunks of most of the madrone trees, which is likely due to the fungus *Neofusicoccum arbuti*.

*Photo 7. Typical madrone cankers observed throughout the site.*

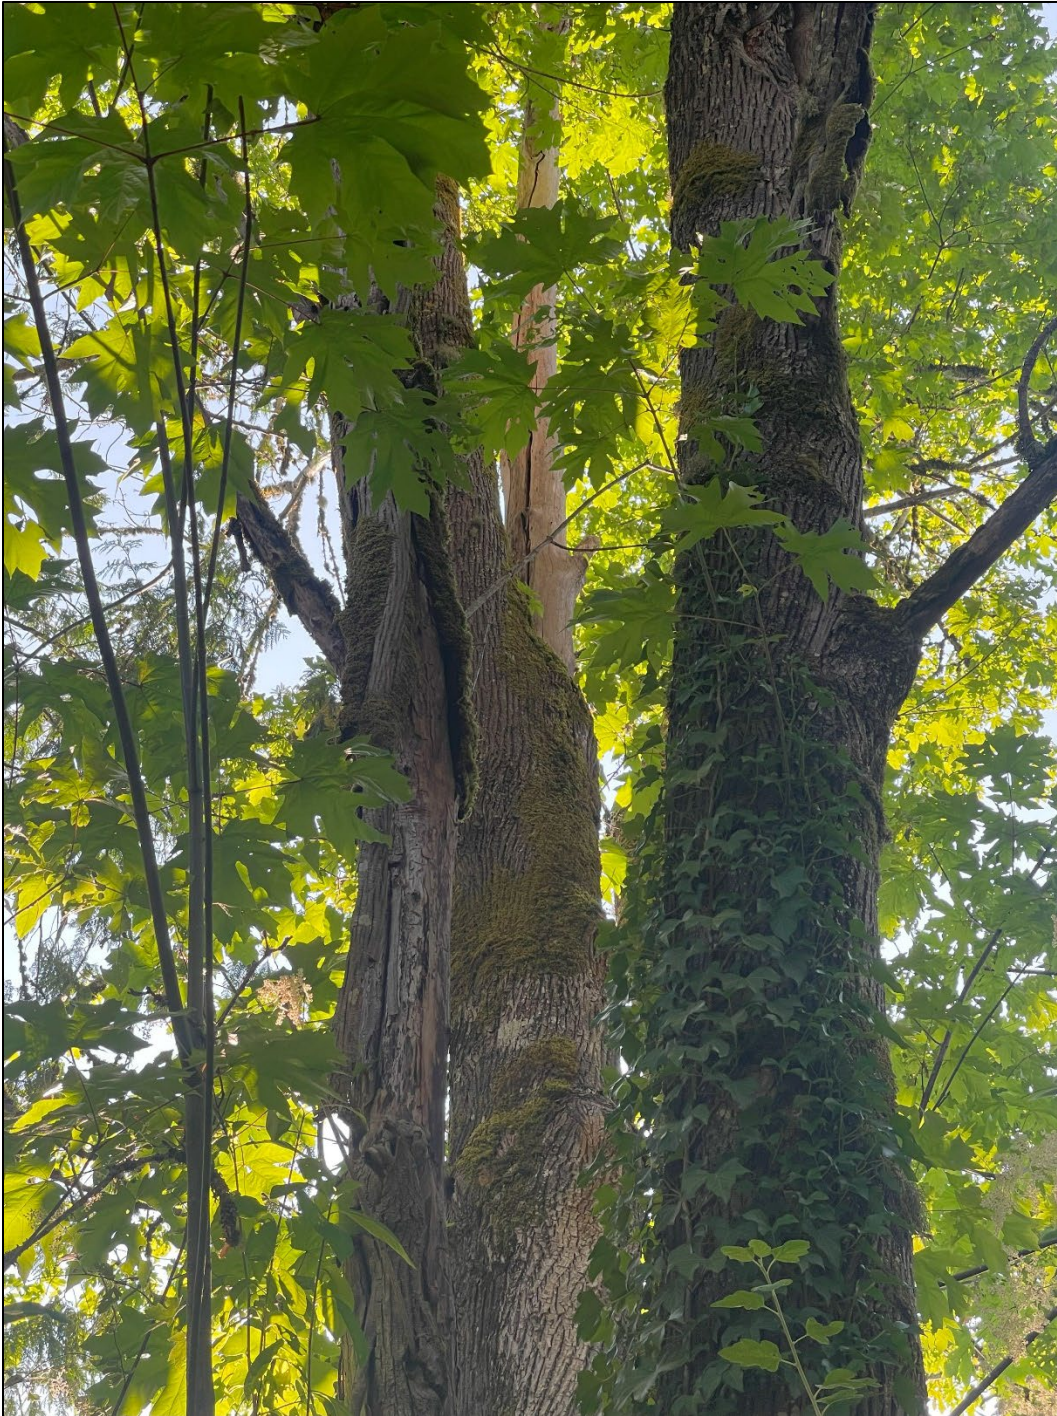
27	Bigleaf Maple	32.9	Fair/Poor	No	Remove	Very narrow codominant union at base with large seam of included bark, <i>K. deusta</i> at union, more than 50% canopy dieback and evident decay present in central columns	<b>MICC 19.10.060.a.3.a:</b> Unavoidable hazardous situation

*Photo 8. Tree #27 with decaying and dead trunk.*

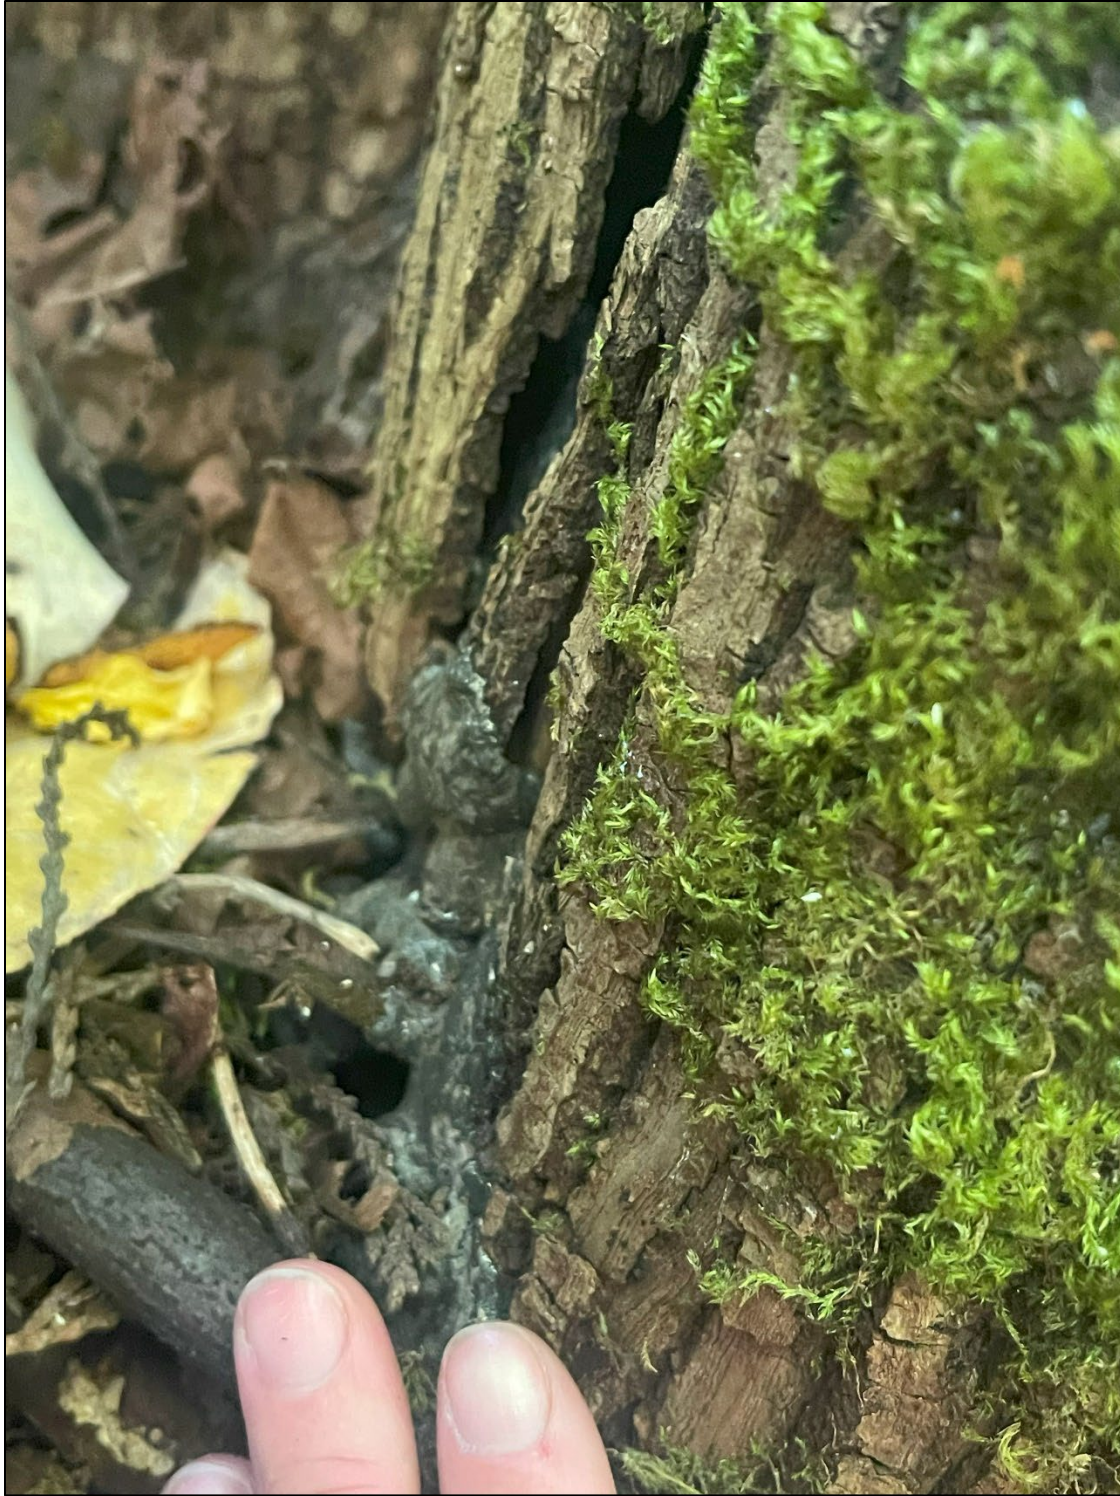
Photo 9. *K. deusta* on trunk of Tree #27.

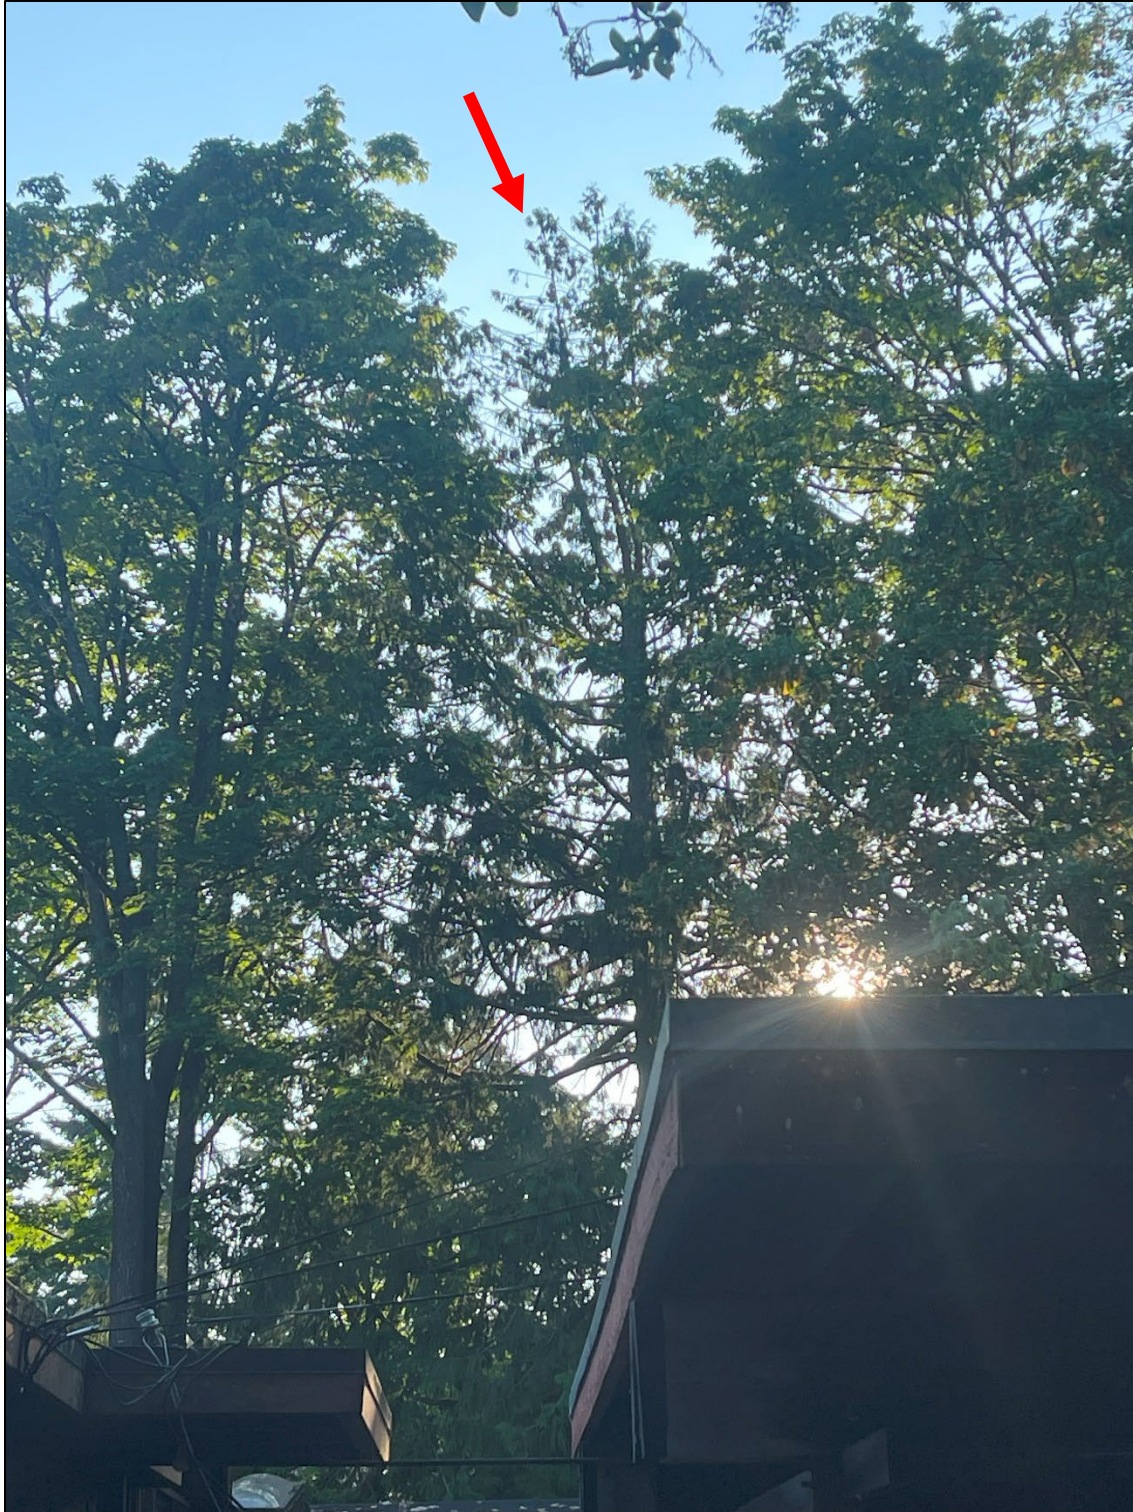
Tree #28 – is a dominant western redcedar tree located between proposed Lots 1 and 2. Impacts to this tree include the hammerhead turnaround and storm drainpipe. This species of tree has a relatively low tolerance to construction impacts and is particularly affected by changes to soil hydrology. I observed early symptoms of canopy stress, as is more common throughout the region for this species of tree, and even if the stormwater pipe could be realigned it is unlikely to survive impacts. While it may be feasible to shift the footprint of Lot 1 further north and reduce the setback, impacts from Lot 2 construction would be substantial and there is no alternative location for this building footprint that would not require removal of additional trees.

*Photo 10. Tree # 28, cedar with thinning canopy.*

28	<i>Thuja plicata</i>	Western Redcedar	39.1	Fair	Good	Yes	24	24	24	24	30	Exceptional - Size	Remove	Canopy slightly thin and chlorotic, species is intolerant of changes to soil conditions and level of protection needed to successfully retain tree would make site on buildable
29	<i>Arbutus menziesii</i>	Madrone	10.4	Poor	Fair	No	24	6	18	0	6	Not Viable	Remove	In a state of decline, cankers on trunk
30	<i>Acer macrophyllum</i>	Bigleaf Maple	20.0	Fair	Poor	No	24	18	16	16	30		Remove	10 inch diameter trunk failed at codominant union, significant decay evident throughout tree
31	<i>Pseudotsuga menziesii</i>	Douglas-fir	15.5	Good	Fair	Yes	14	14	14	14	30		Remove	Topped for utilities
32	<i>Acer macrophyllum</i>	Bigleaf Maple	28.3	Fair	Fair	No	18	30	28	28	30		Remove	Visible branch dieback ~ 10 to 20% on southside of canopy, <i>Kretzschmaria deusta</i> observed at lower codominant union, multiple weak attachments

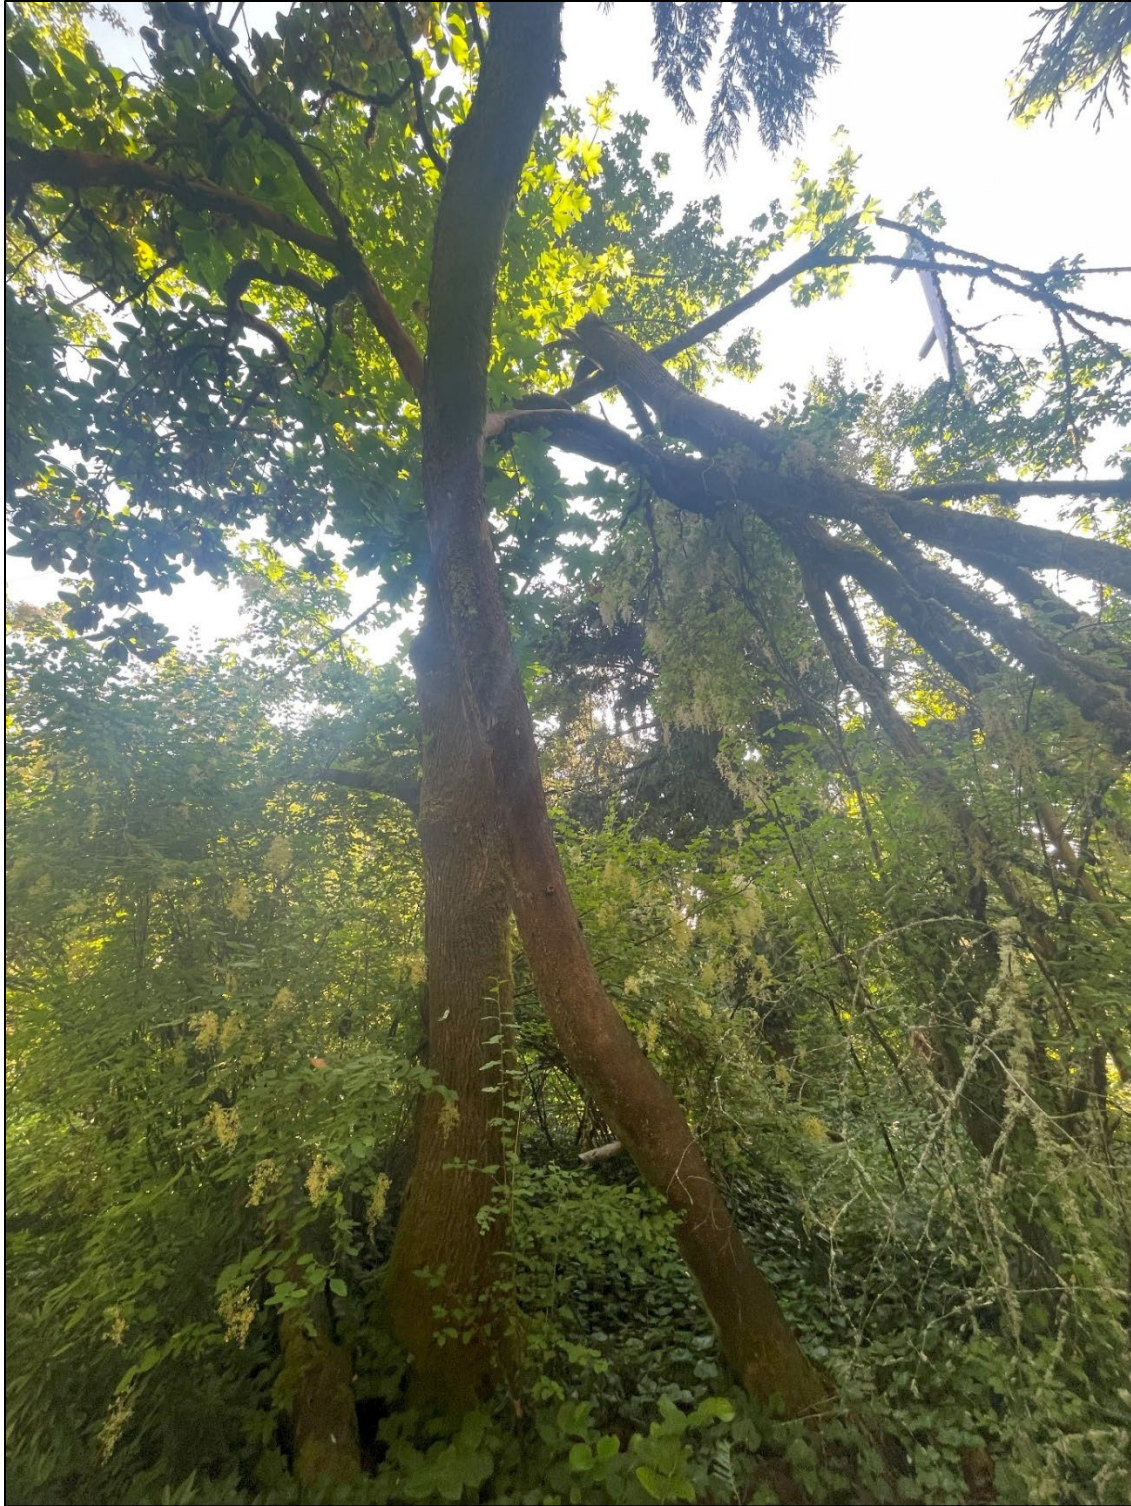
*Photo 11. Broken stem of Tree #30.*
