## ARBORIST REPORT

REFERENCE: Arborist Report RE: SUB22-009 (Cui Preliminary Short Subdivision)

SITE ADDRESS: 4833 90<sup>th</sup> Ave SE, Mercer Island, WA

DATE: 8/9/2023

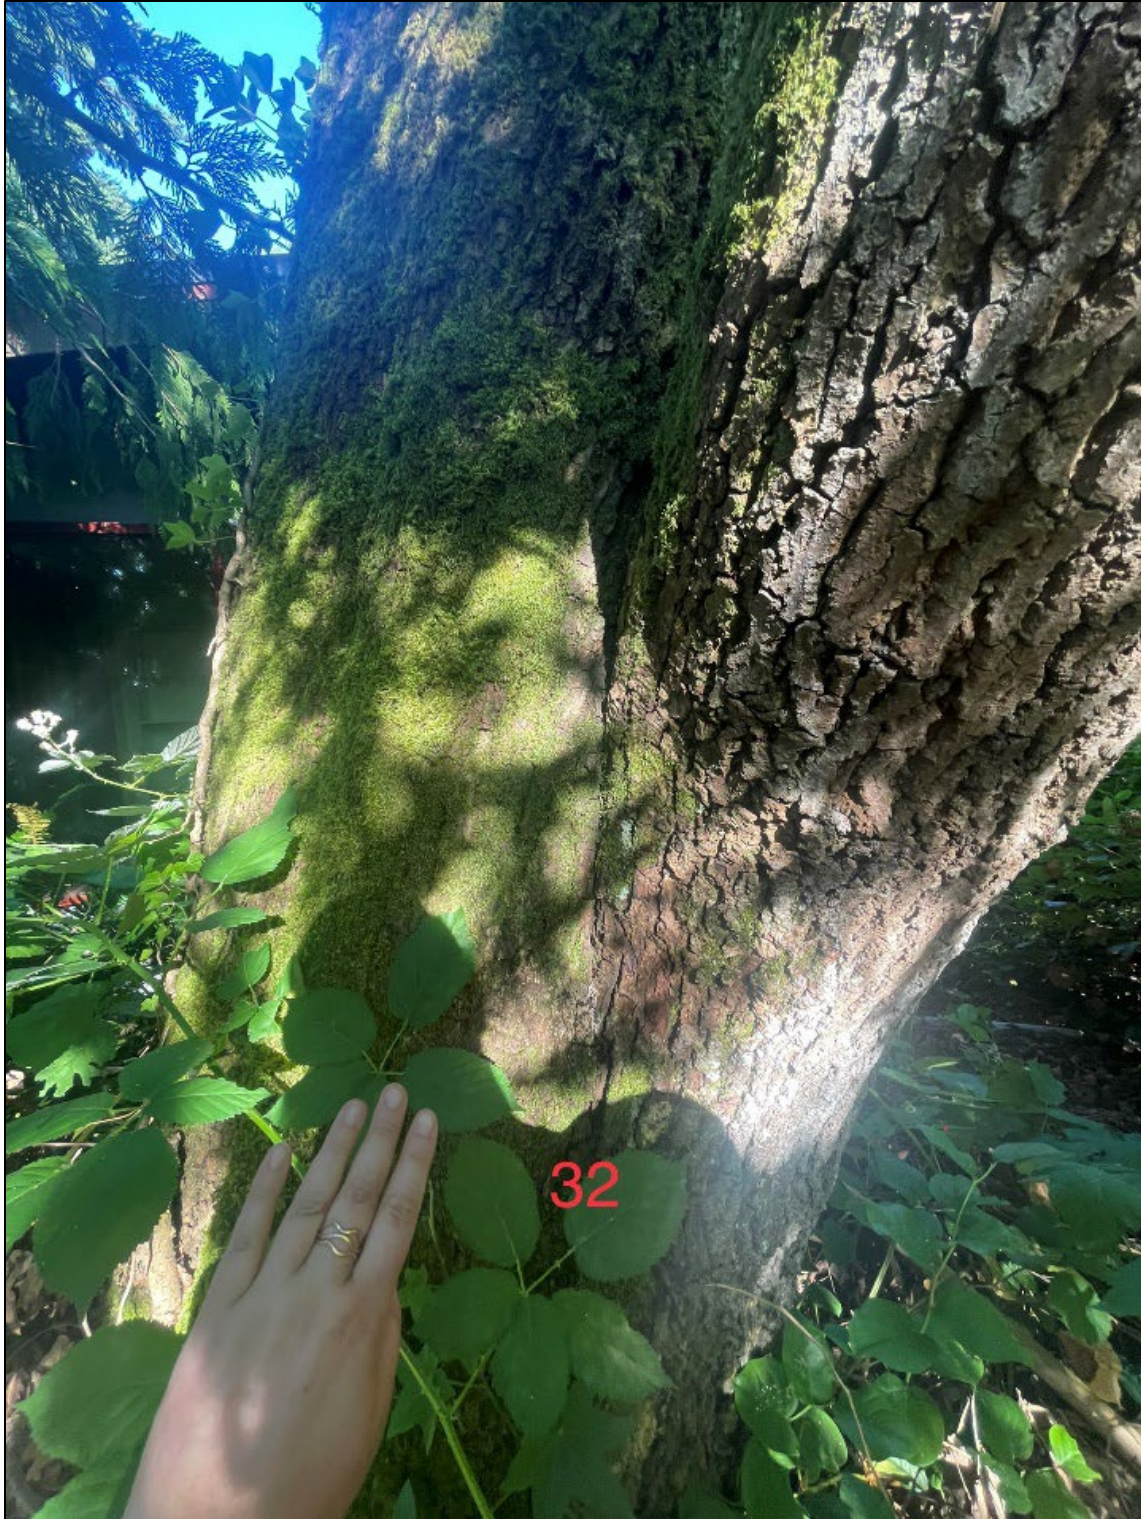
*Photo 12. Narrow union of Tree #32.*

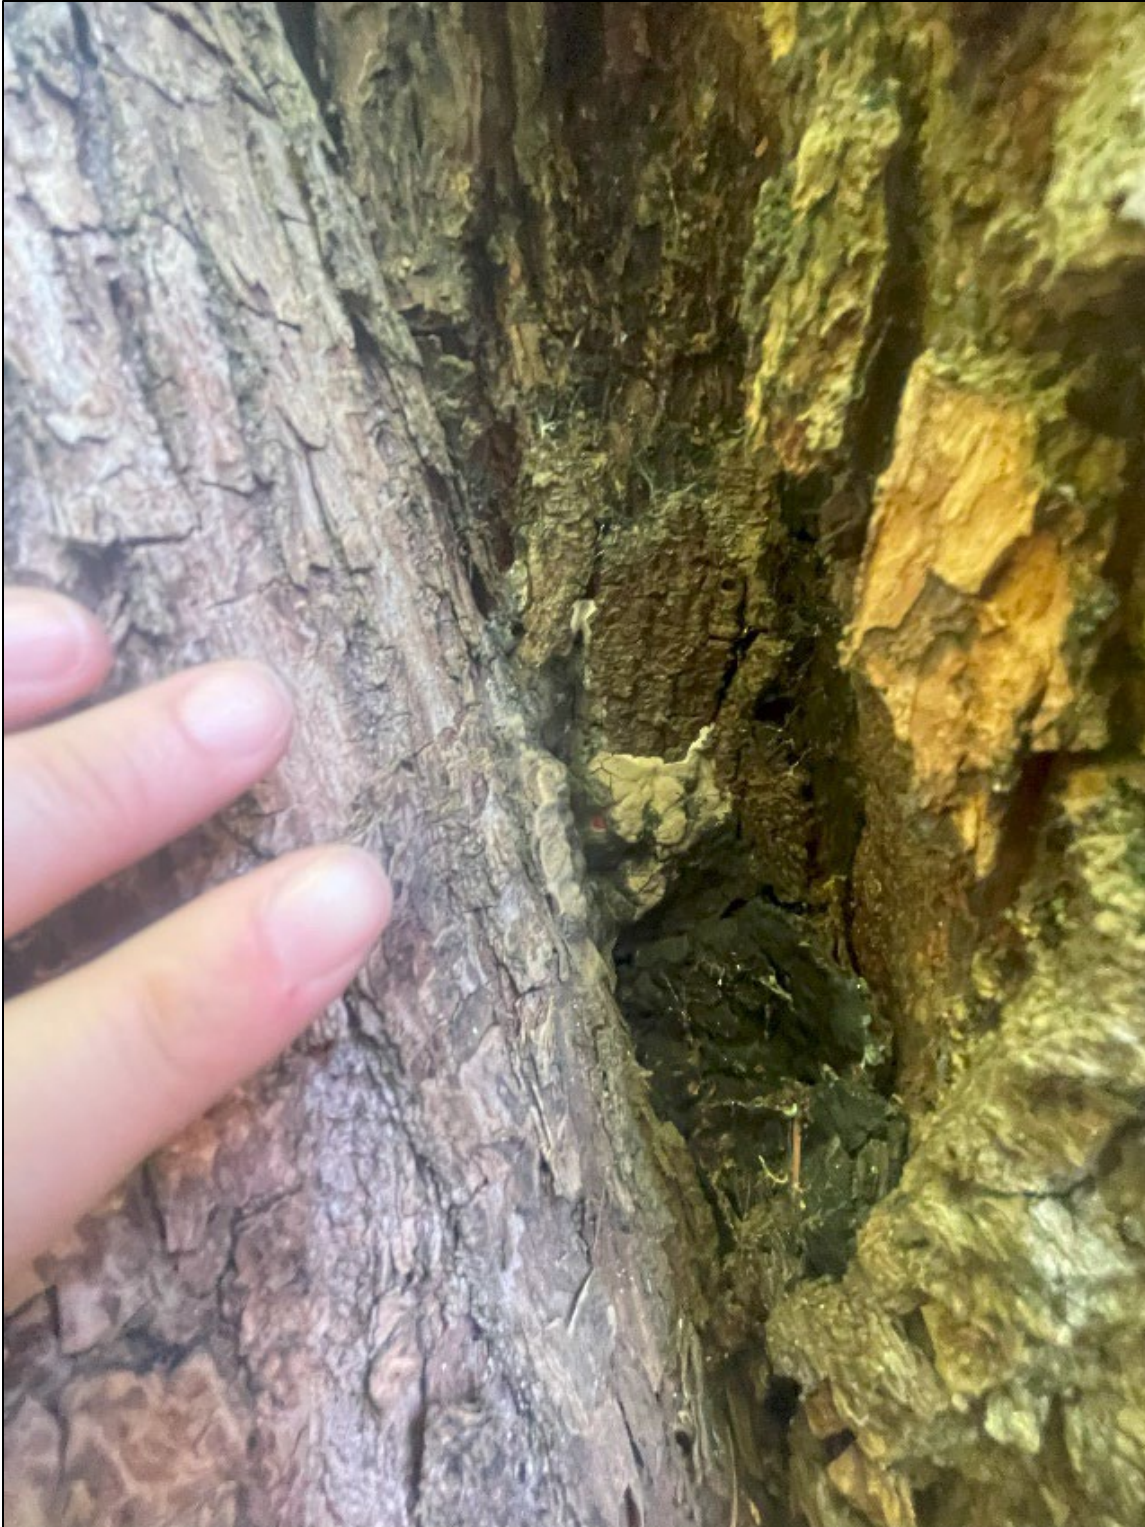
*Photo 13. K. deusta on Tree #32.*

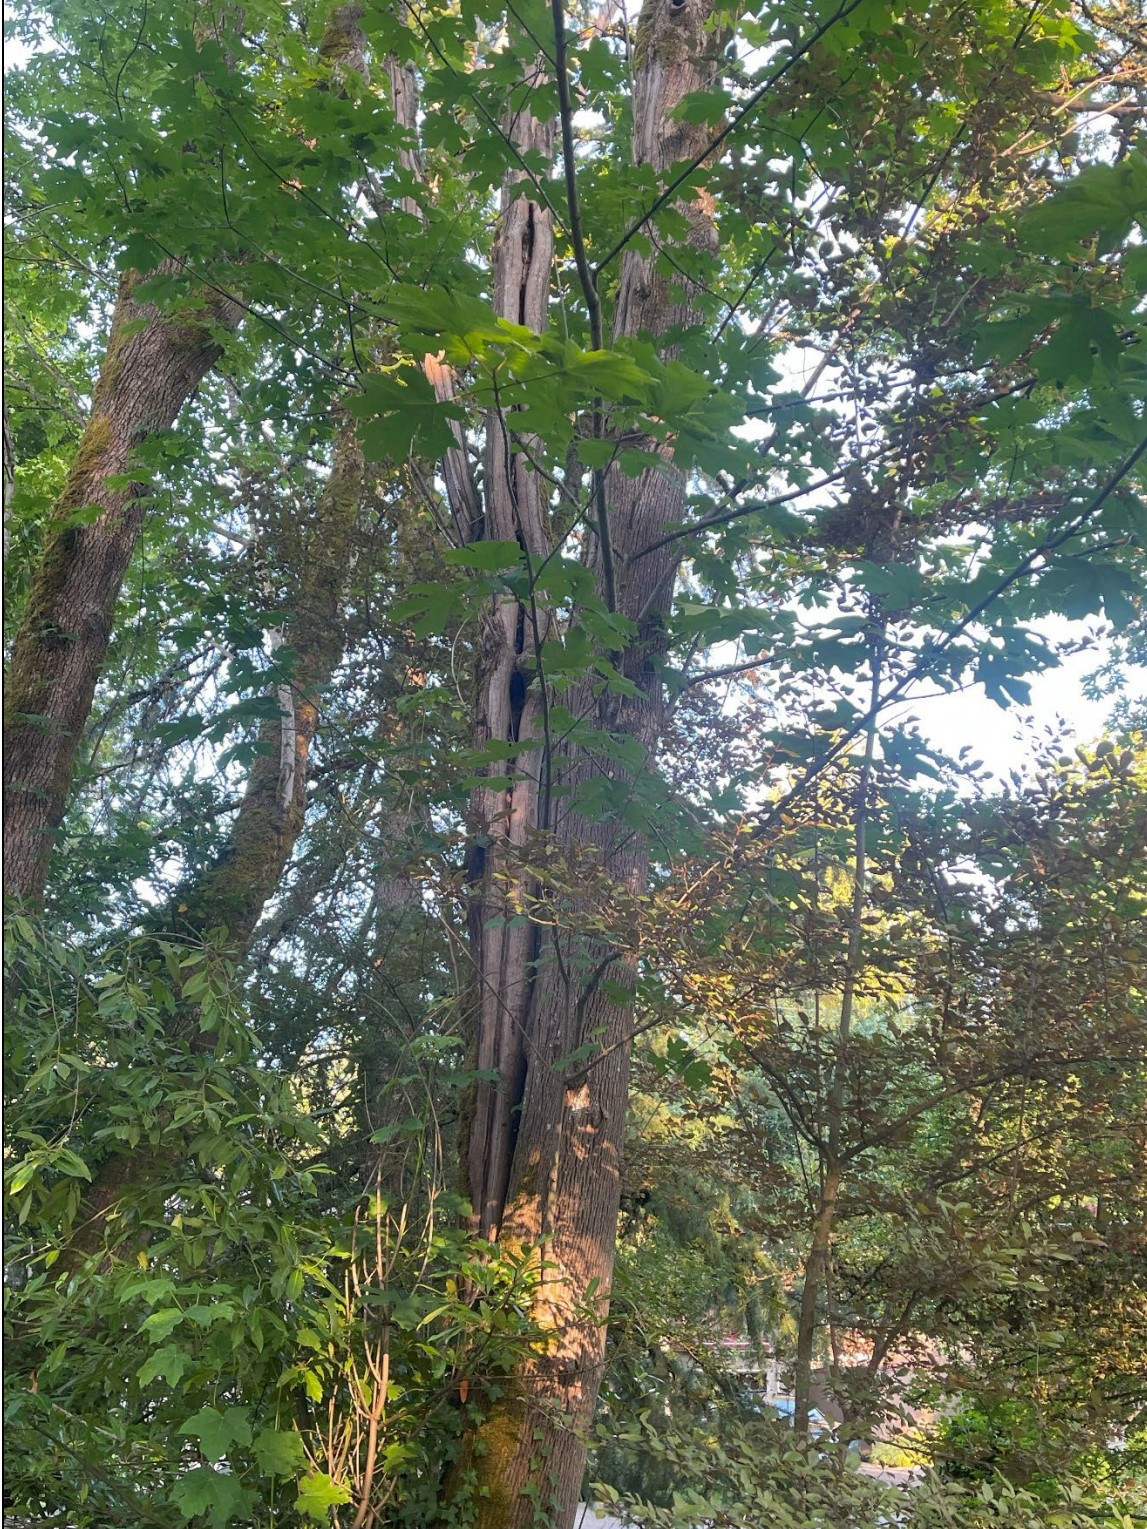
*Photo 14. Tree # 34 with decayed trunks.*

33	<i>Arbutus menziesii</i>	Madrone	28.1	Good	Good	Yes	12	35	0	40	6	Exceptional - Size	Remove	Leans to the west, dominant madrone tree
34	<i>Acer macrophyllum</i>	Bigleaf Maple	25.1	Fair	Fair	No	14	18	0	25	30		Remove	Smaller codominant is dead, large column of decay in trunk with visible areas of significant decay
35	<i>Acer macrophyllum</i>	Bigleaf Maple	31.6	Fair	Poor	No	28	32	20	26	30	Not Viable	Remove	Growing on nurse stump, <i>Kretzschmaria deusta</i>
36	<i>Cedrus deodara</i>	Deodar Cedar	19.4	Good	Good	Yes	7	16	16	16	30		Retain	One sided canopy Island Crest Way
37	<i>Acer macrophyllum</i>	Bigleaf Maple	17.6	Fair	Fair	No	30	20	6	28	30		Remove	Visible dieback in approximately 1/4 of the canopy, cavities and decay columns observed
38	<i>Acer macrophyllum</i>	Bigleaf Maple	7.1	Poor	Poor	No	0	16	16	0	30		Remove	Nearly 100% dead
39	<i>Acer macrophyllum</i>	Bigleaf Maple	21.2	Fair	Fair	No	14	6	6	6	30		Remove	In a state of decline with top dieback, heavily pruned on one side for utilities, stunted growth

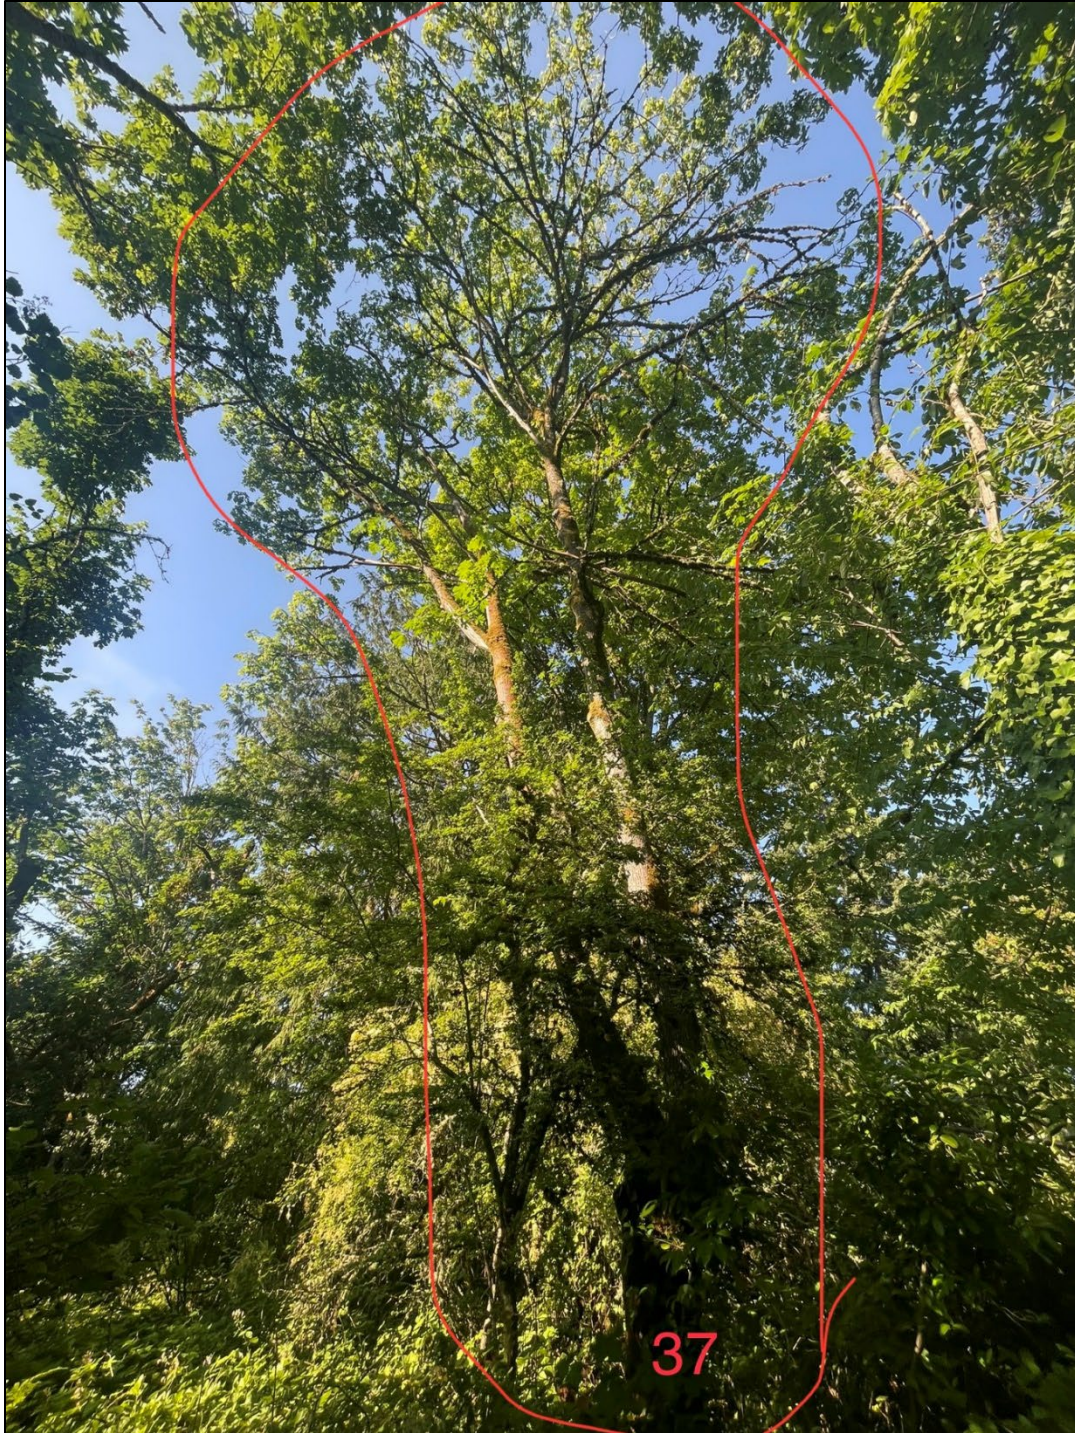
*Photo 15. Tree #37 with canopy decline.*

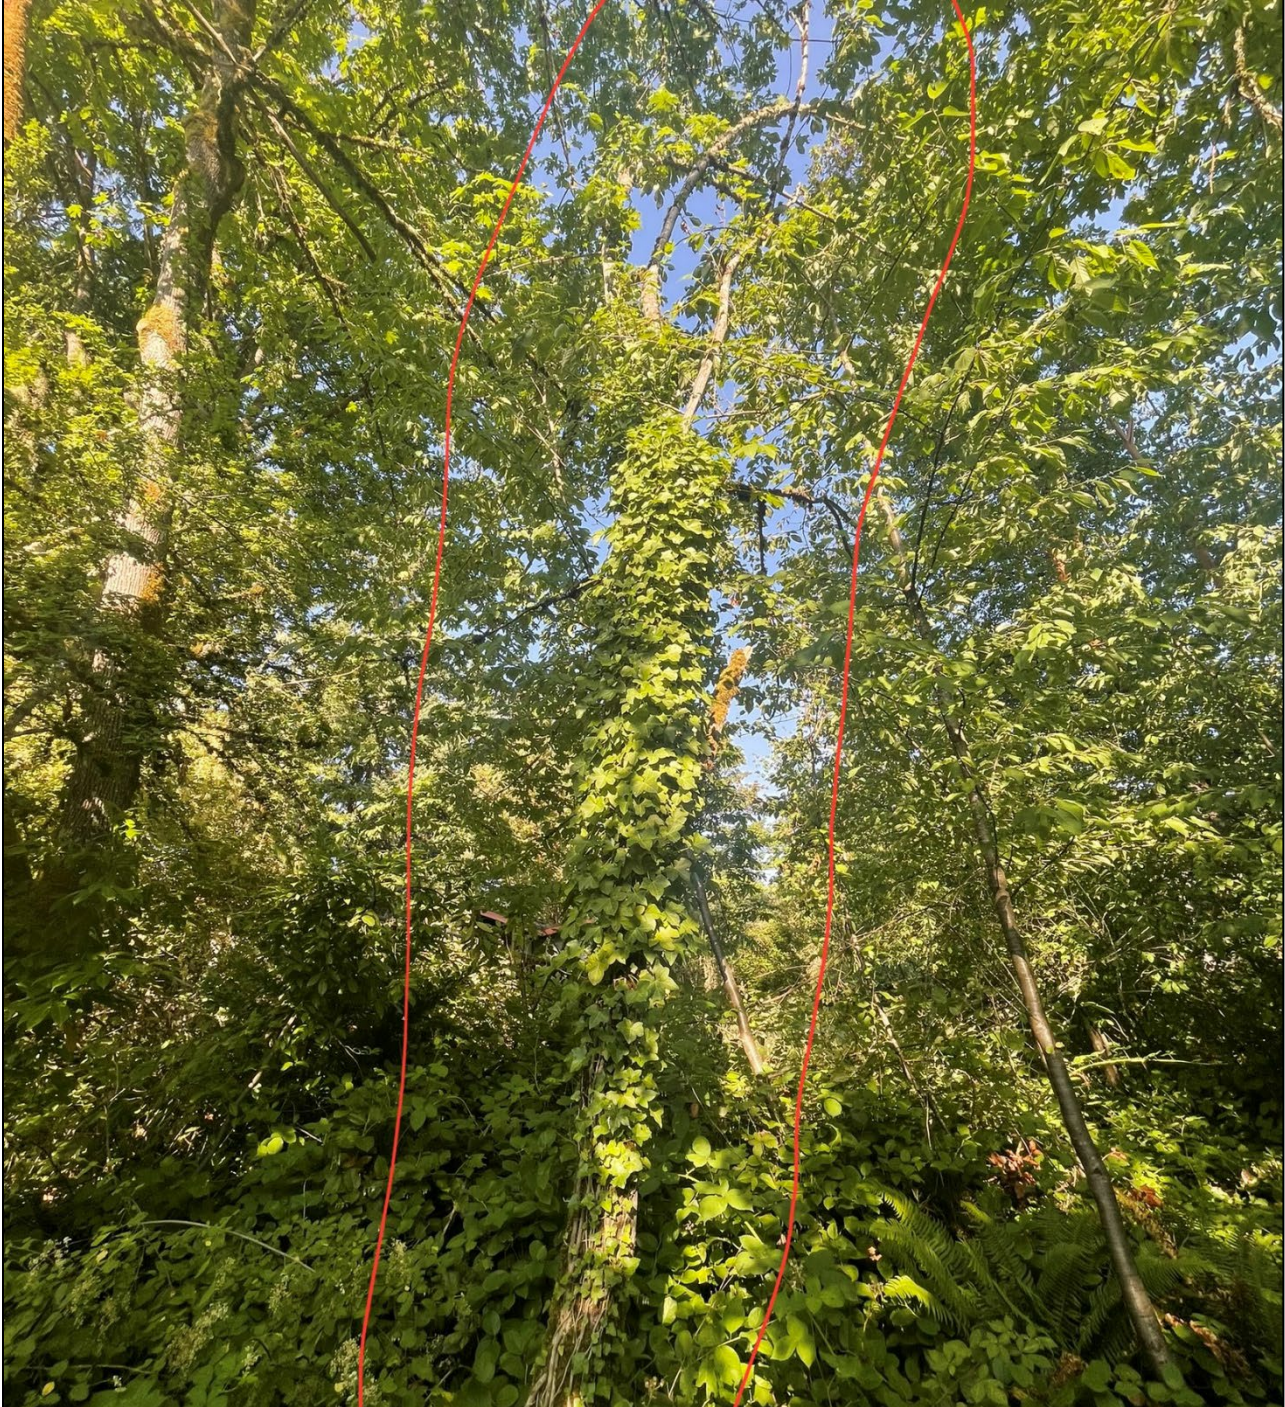
*Photo 16. Tree # 38 with dead top.*

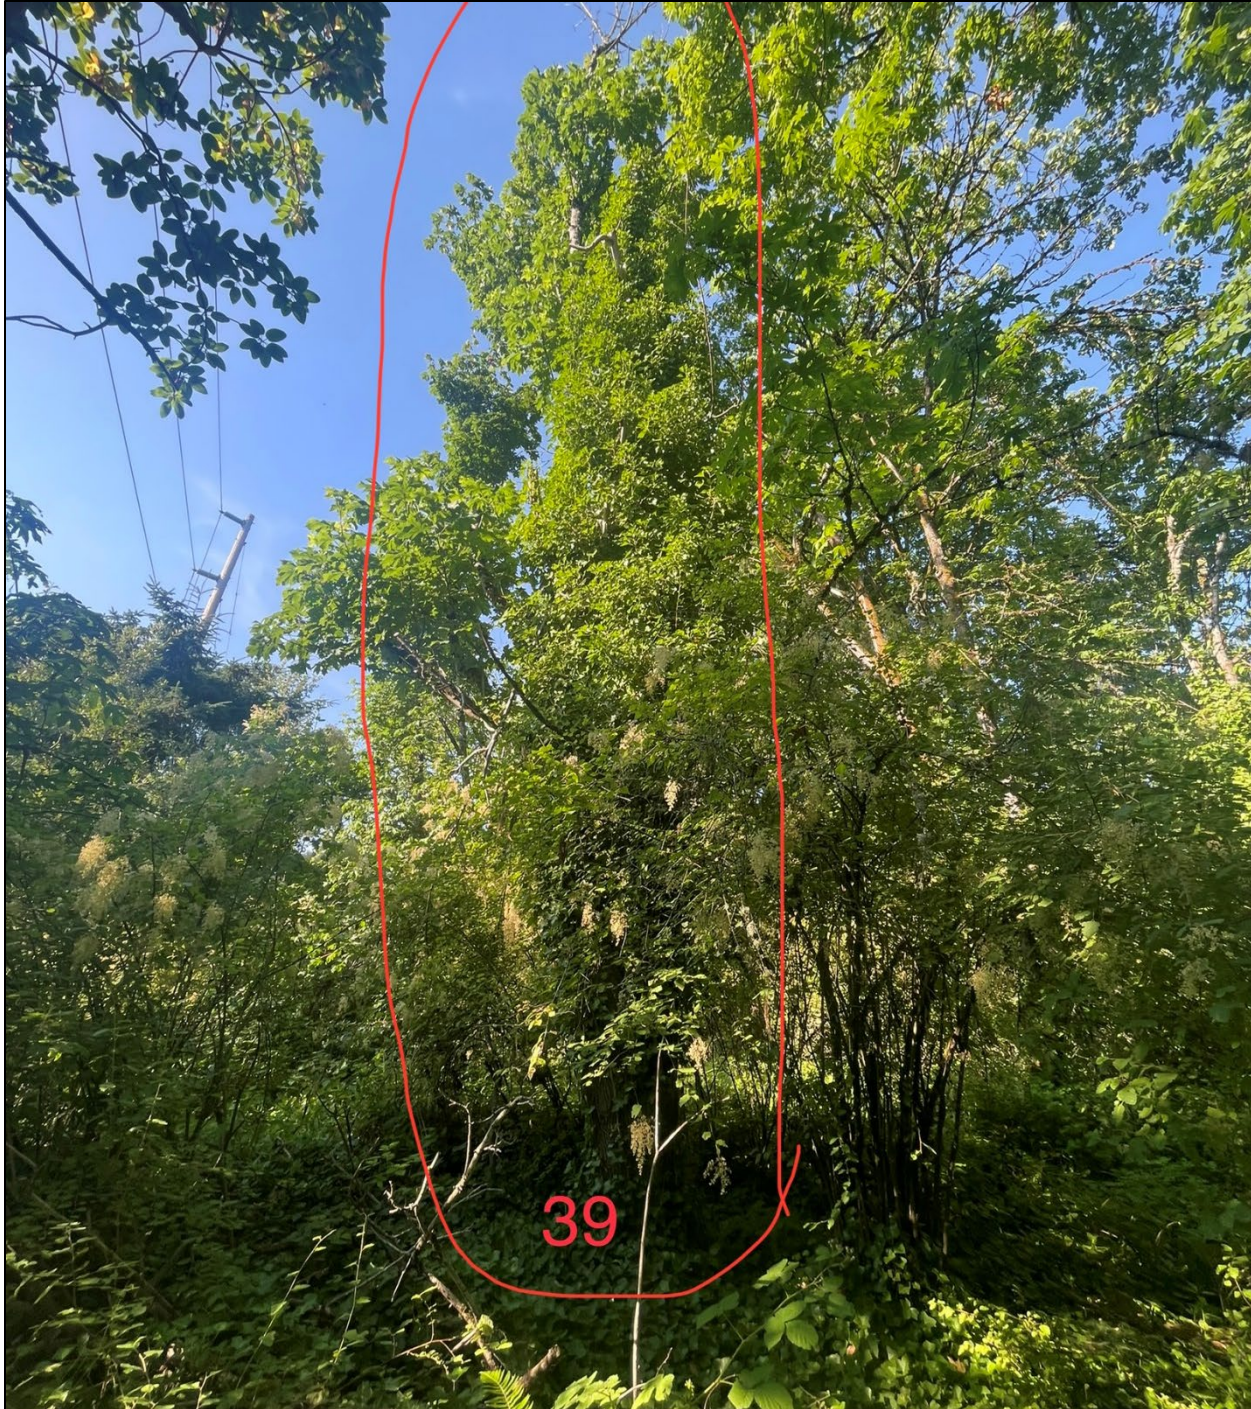
*Photo 17. Tree #39 dying with heavy ivy.*

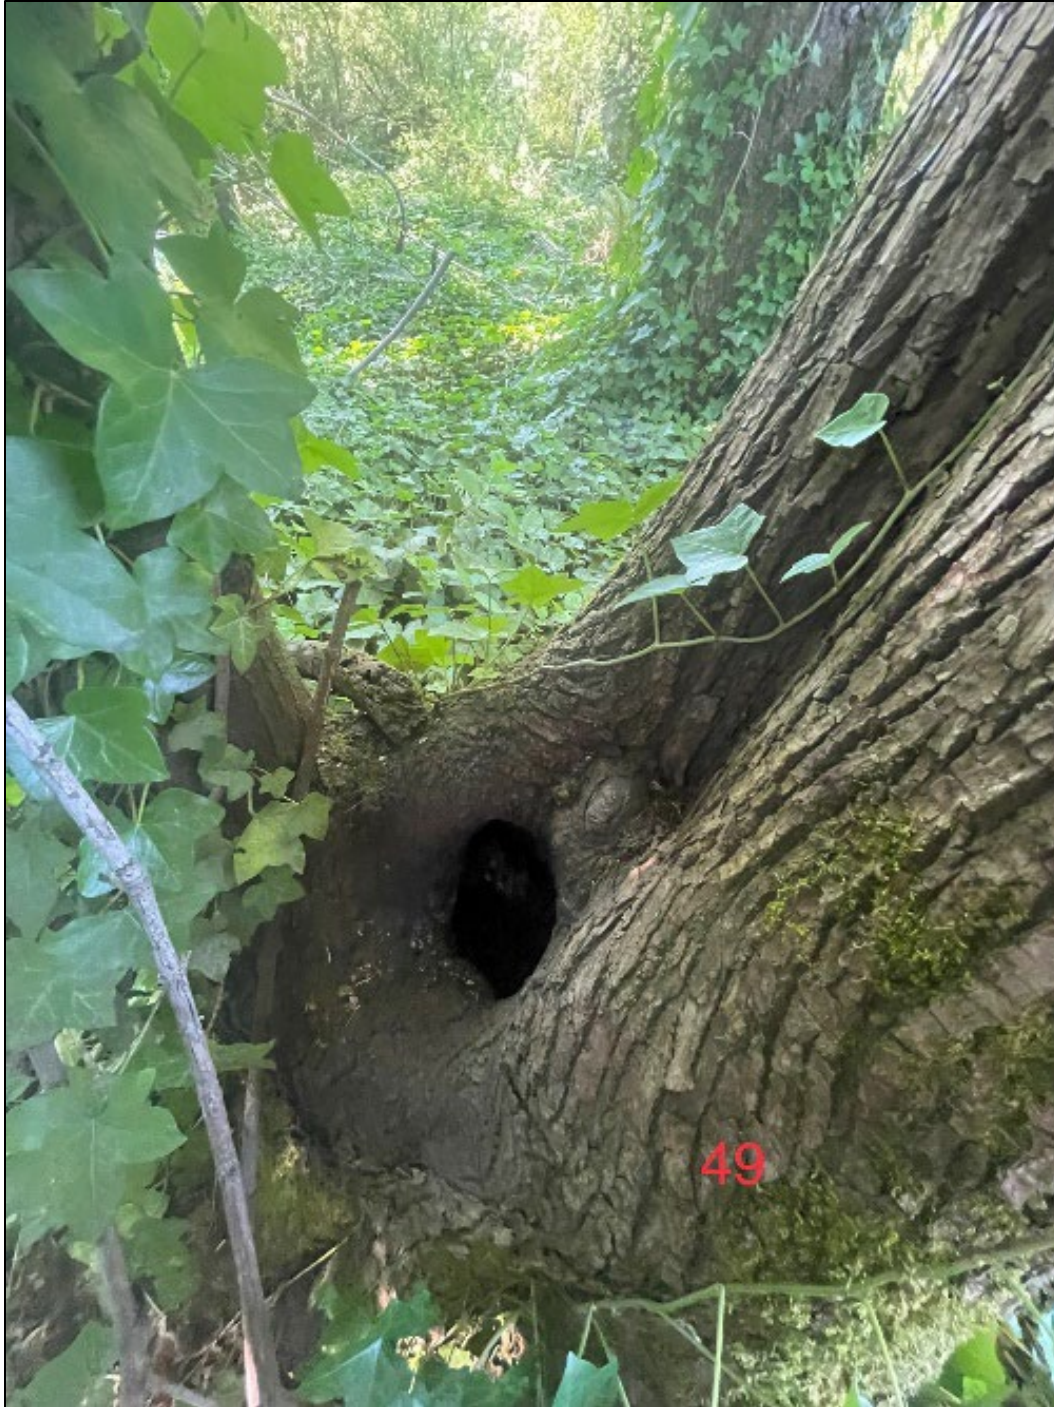
Photo 18. Tree #49 with hollow trunk.

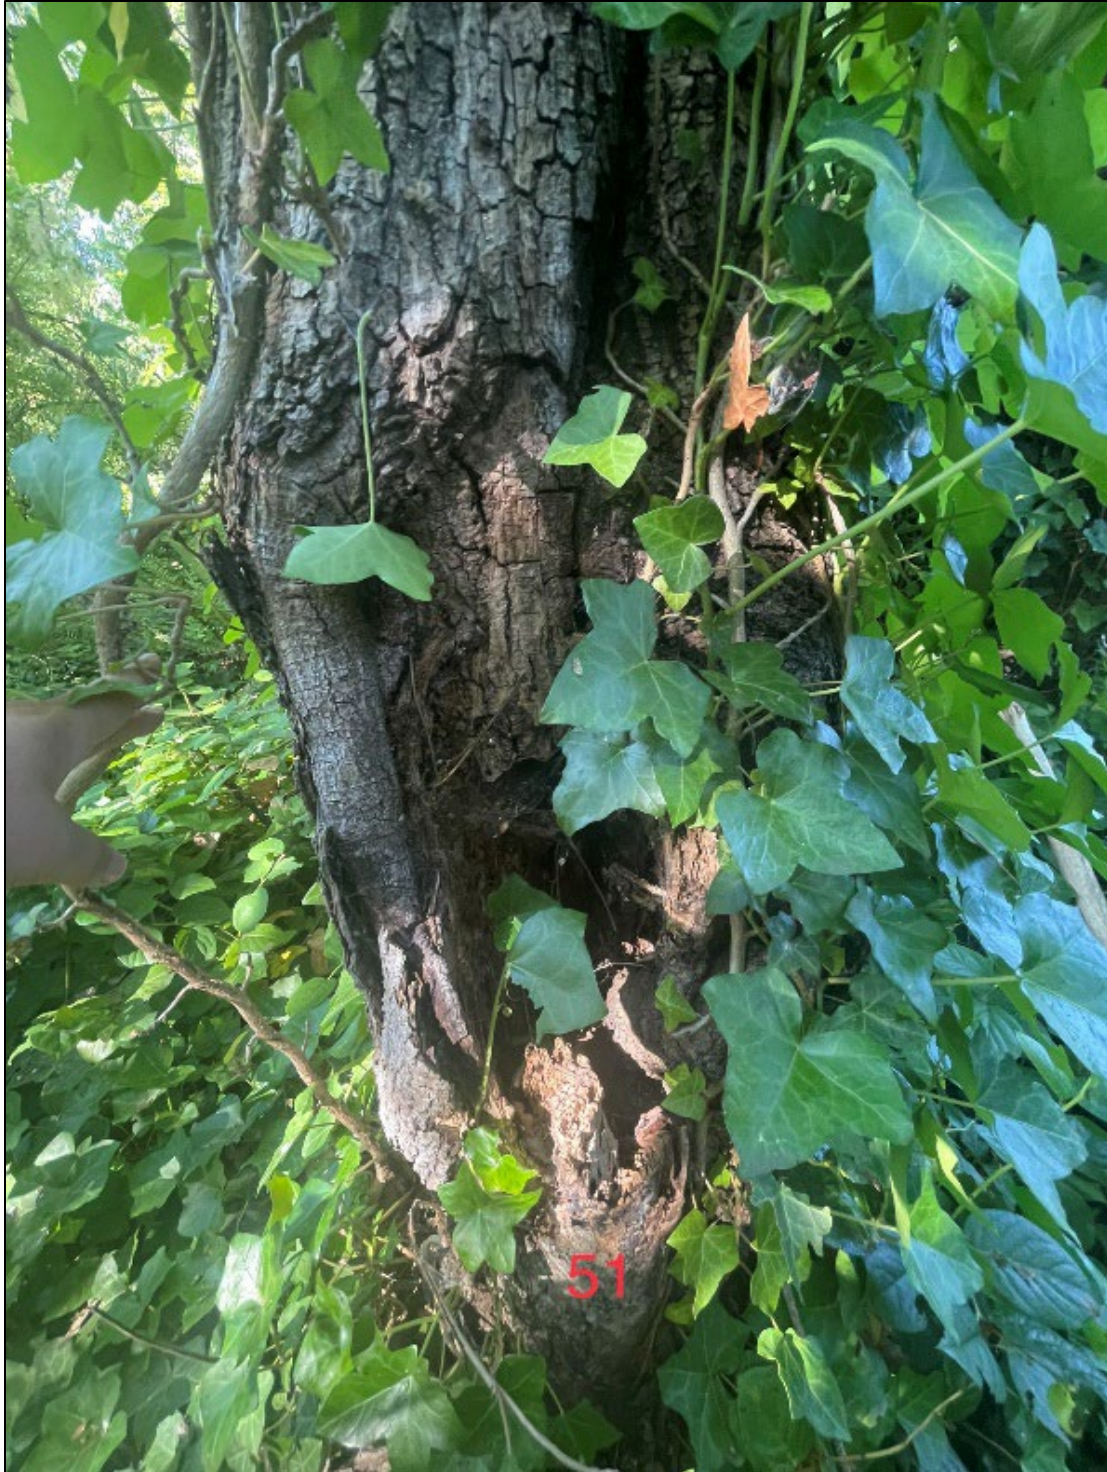
*Photo 19. Tree #51 with substantial decay.*

51	<i>Acer macrophyllum</i>	<i>Bigleaf Maple</i>	11.1	Poor	Fair	No	1	0	0	0	30			Remove	Large wound with decay at base
52	<i>Acer macrophyllum</i>	<i>Bigleaf Maple</i>	21.9	Fair	Fair	Yes	23	28	28	6	30			Remove	Visible central decay with moderate levels of dieback throughout canopy, codominant union at base with slow growth, columns of decay in trunk, not ideal long-term tree
54	<i>Arbutus menziesii</i>	<i>Madrone</i>	13.9	Good	Good	Yes	16	8	8	8	6		Exceptional - Size	Remove	Overall healthy canopy
55	<i>Acer macrophyllum</i>	<i>Bigleaf Maple</i>	32.0	Good	Fair	Yes	20	24	20	29	30		Exceptional - Size	Remove	Ivy on trunk, dominant maple tree with three narrowly attached trunks at about 20 feet
56	<i>Acer macrophyllum</i>	<i>Bigleaf Maple</i>	36.9	Poor	Fair	No	25	30	25	25	30		Not viable	Remove	Substantial canopy dieback, top is dead, over 50% dead overall
57	<i>Cornus florida</i>	<i>Eastern Dogwood</i>	6.4	Good	Good	Yes	9	9	9	9	12			Remove

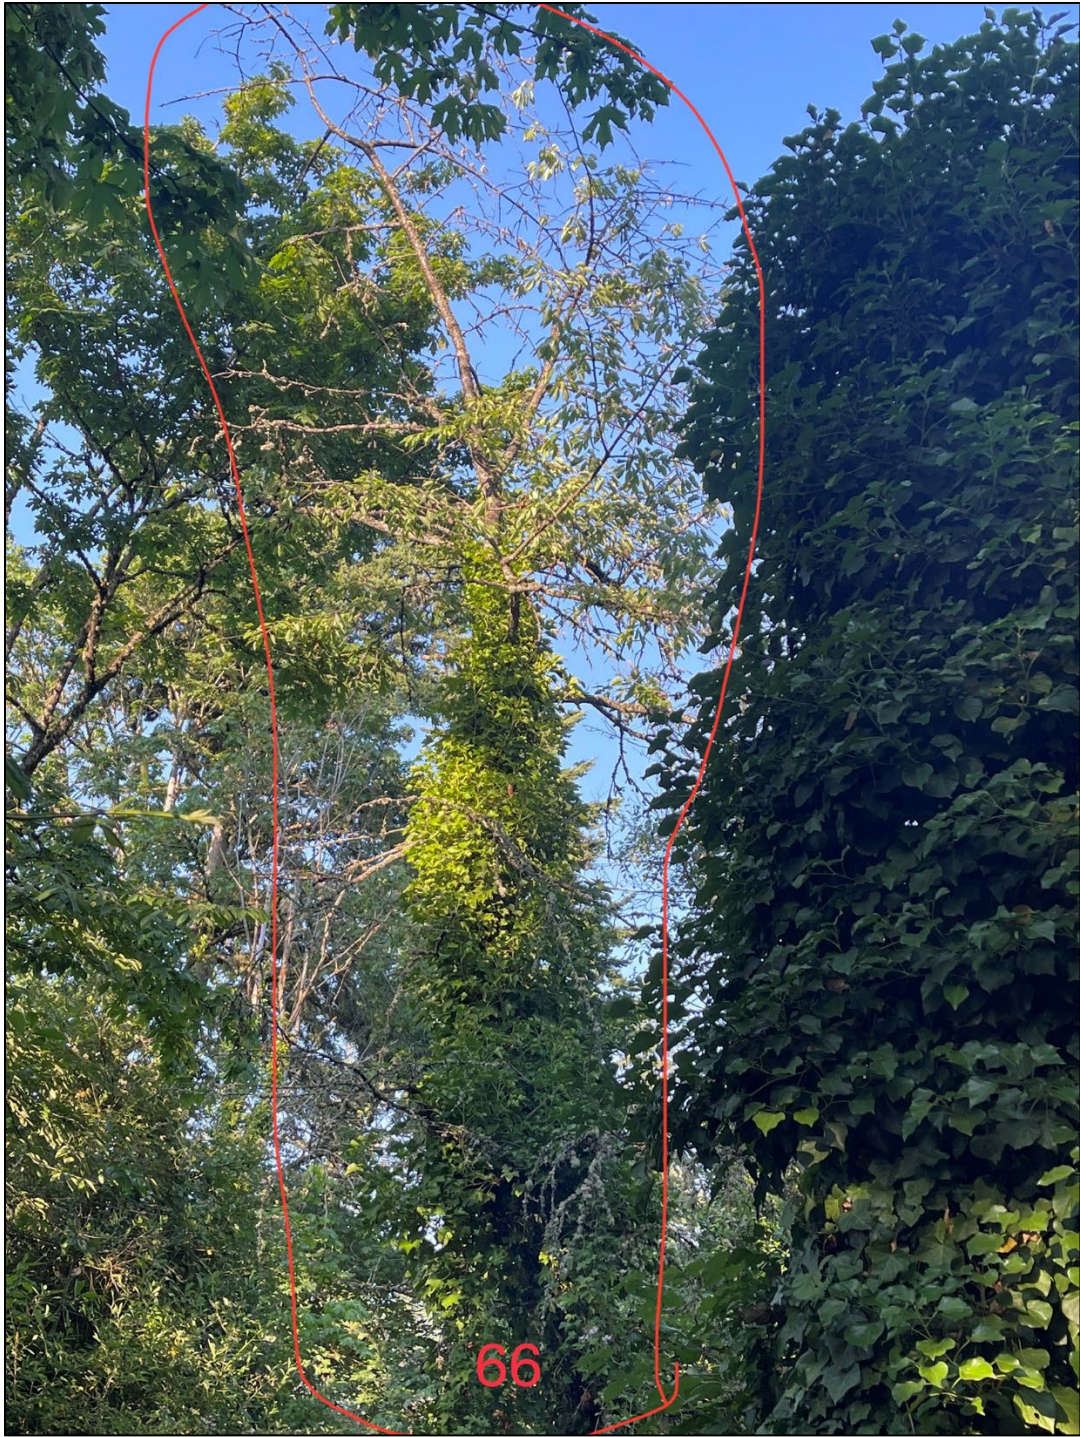
Photo 20. Tree #66 with dead top.

66	<i>Prunus emarginata var. mollis</i>	<i>Bitter cherry</i>	10.1	Fair	Fair	No	16	8	6	12	-			Remove	Nearly 100% dead
67	<i>Acer macrophyllum</i>	<i>Bigleaf Maple</i>	15.6	Good	Fair	No	0	12	0	34	30			Remove	Nearly 100% dead
68	<i>Arbutus menziesii</i>	<i>Madrone</i>	18.1	Fair	Good	Yes	22	0	0	14	6		Exceptional - Size	Remove	Growing with trunk of a tree #67 touching and wrapping around trunk of #68, canopy appears to be in decent condition, care would need to be taken when reducing maple tree #67 and retention may not be possible
69	<i>Prunus emarginata var. mollis</i>	<i>Bitter cherry</i>	14.8	Good	Good	Yes	18	16	20	8	-			Retain	Condition stable
<b>Off Site Trees</b>															
1	<i>Acer macrophyllum</i>	<i>Bigleaf Maple</i>	15.4	Good	Good	Yes	10	3	0	16	30			Retain	Asymmetric
2	<i>Acer macrophyllum</i>	<i>Bigleaf Maple</i>	25.5	Good	Fair	Yes	36	18	20	22	30			Retain	Leans northeast
17	<i>Acer macrophyllum</i>	<i>Bigleaf Maple</i>	8.4	Good	Poor	No	3	14	10	12	30			Retain	Topped for utilities, overhangs Island Crest Way

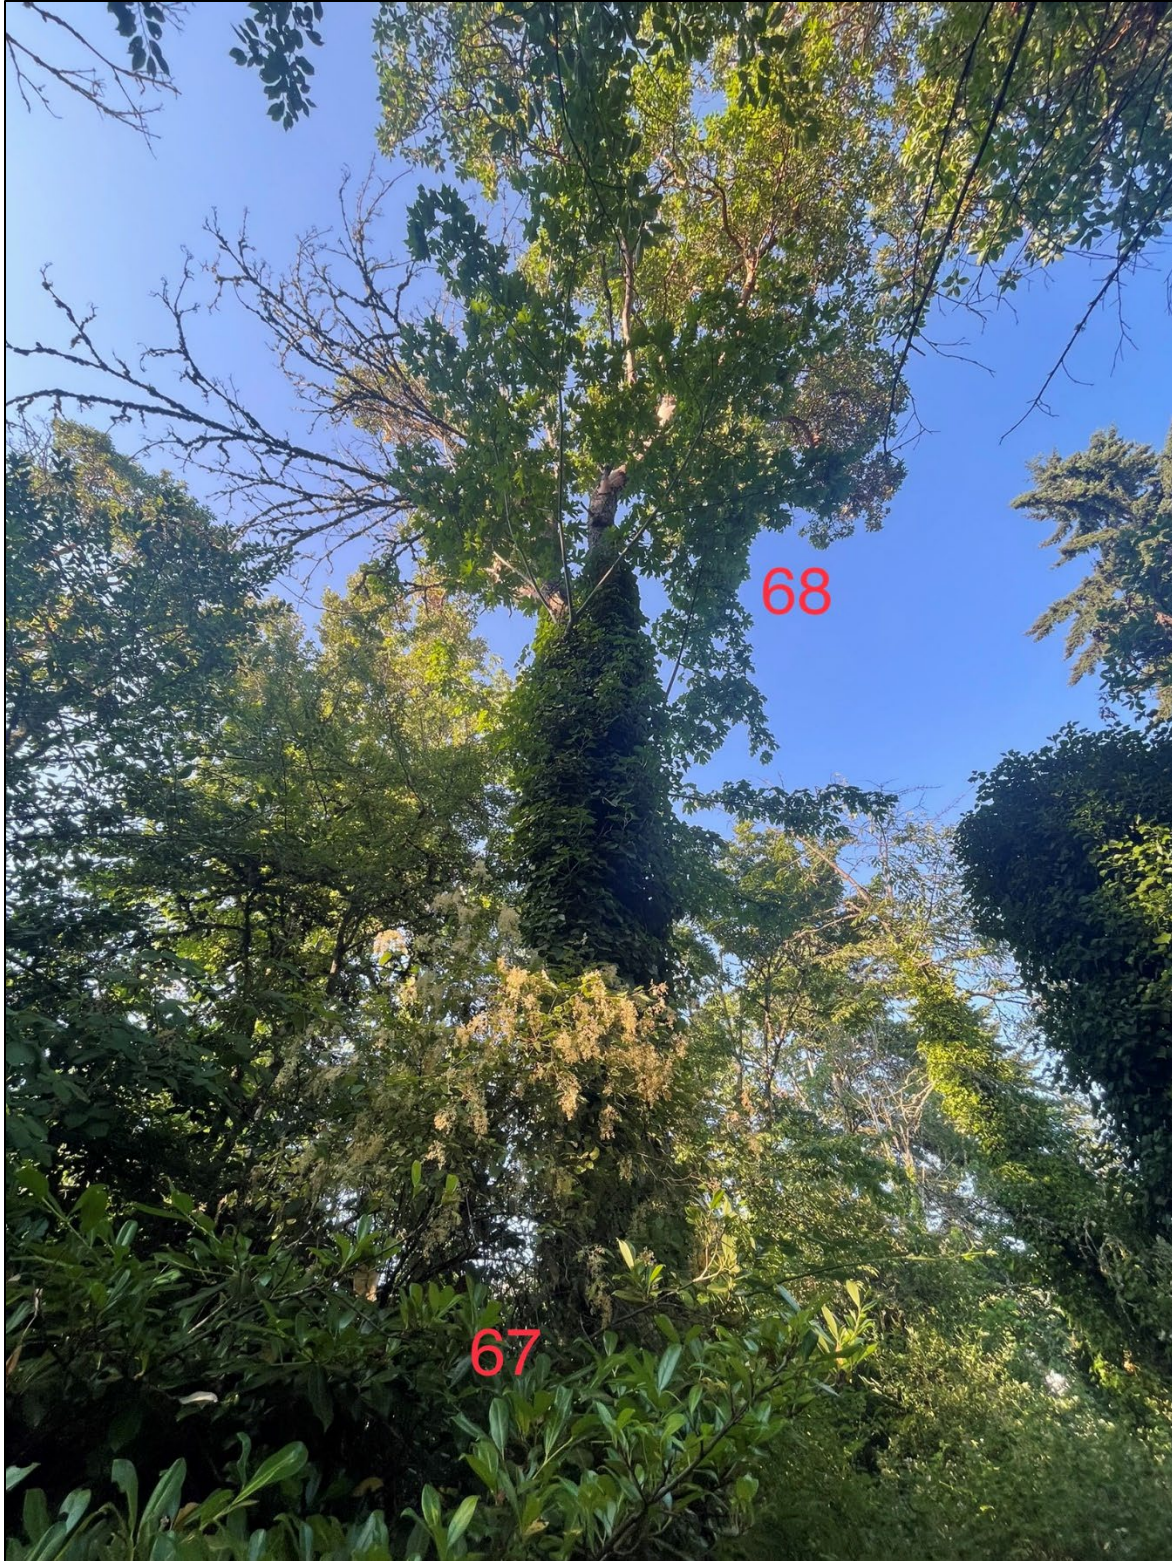
Photo 21. Tree #s 67 (dying/dead) and 68.

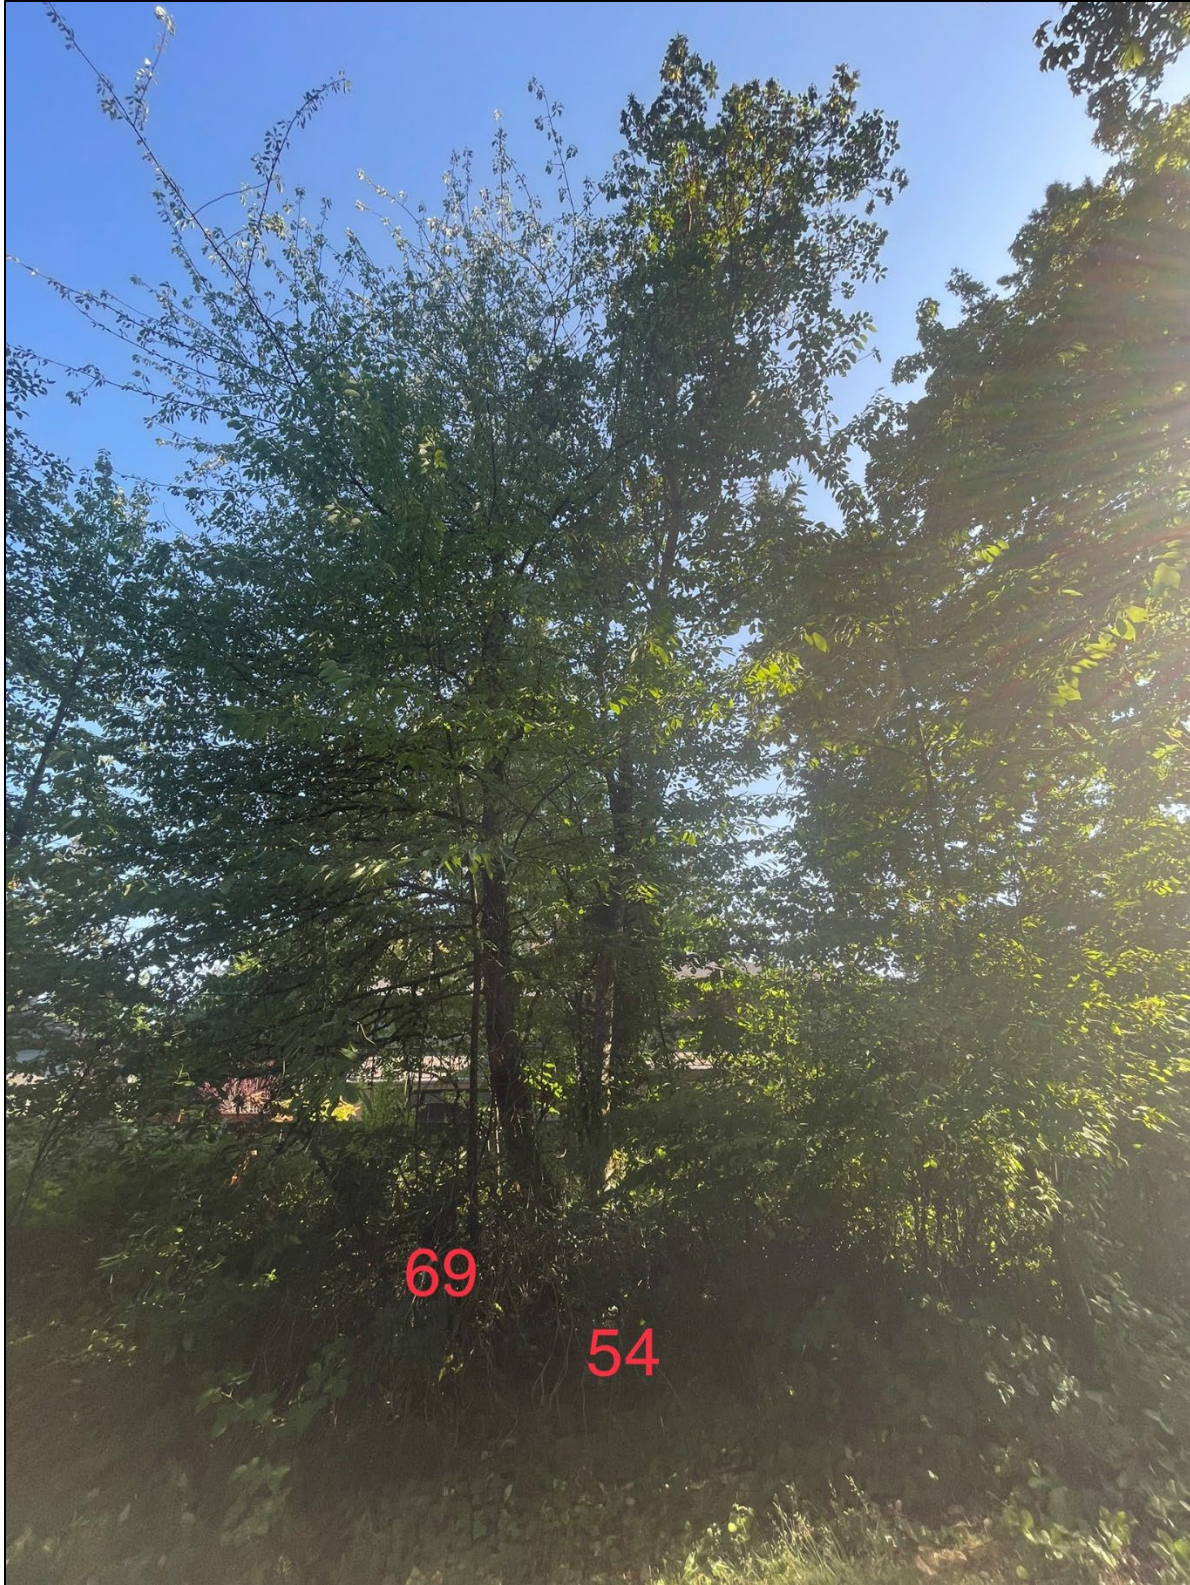
*Photo 22. Tree #69 is proposed for retention on Lot 2.*
