January 2, 2024

Site: 7414 78th Ave SE
Mercer Island, WA 980404
TPN: 2524049075
Area: 68,825 sq. ft. = 1.6 acre

Re: RFI dated November 27th, 2023, changes itemized below, on the report and on the city response matrix highlighted in yellow.

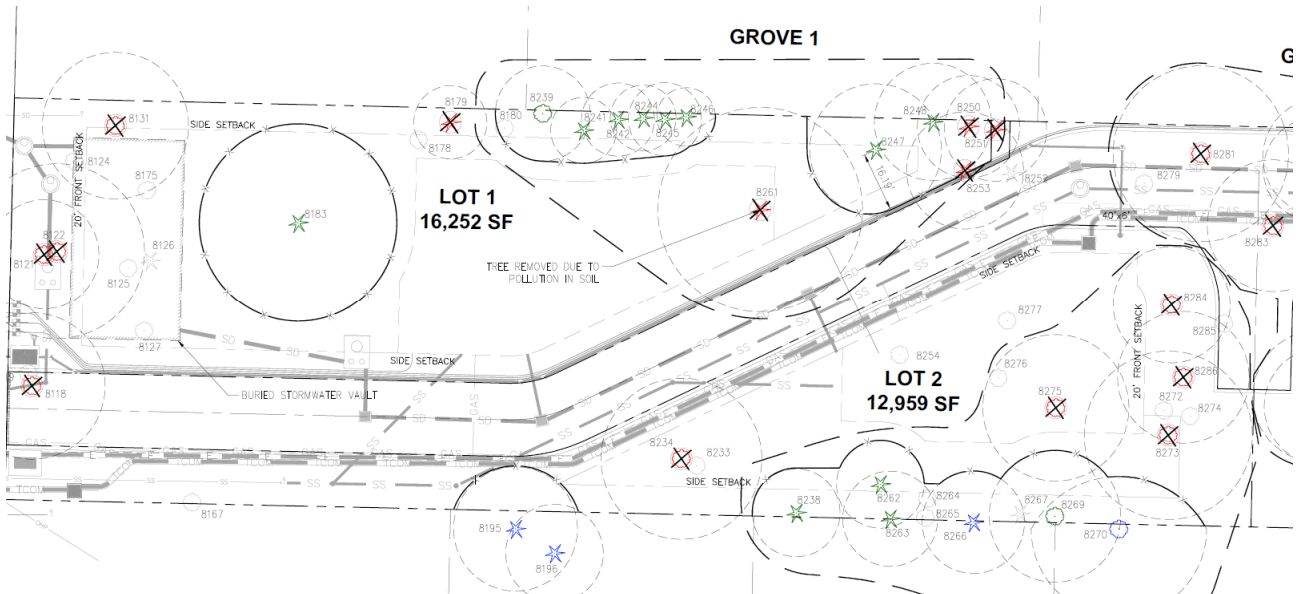
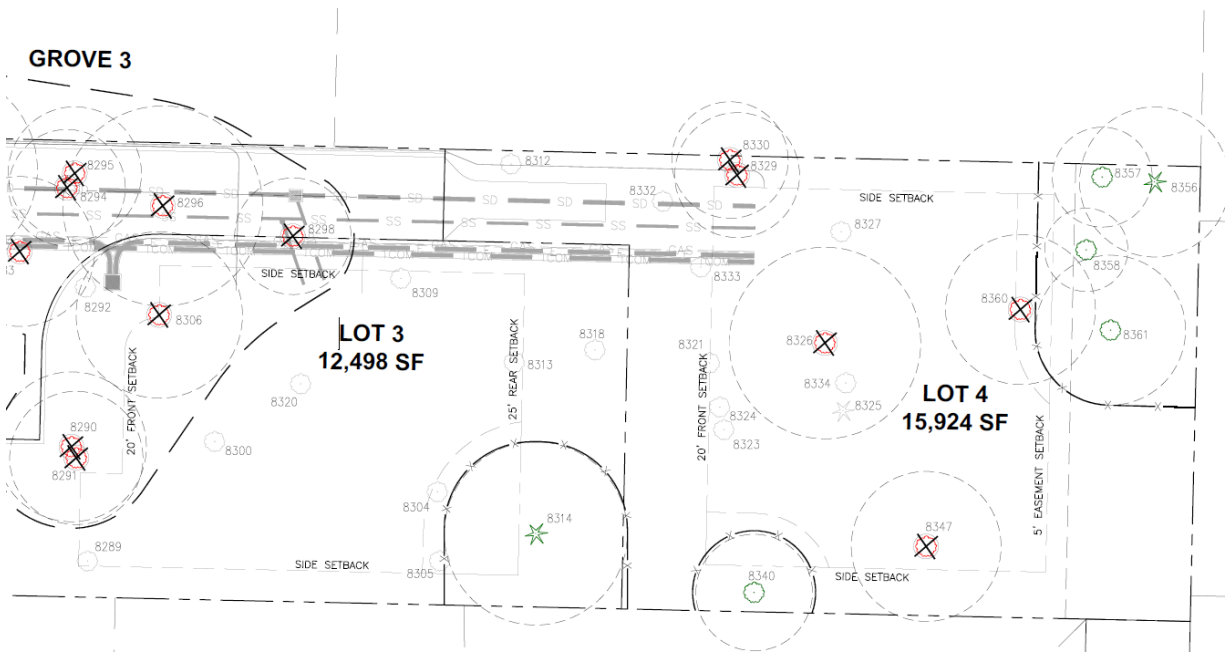
Proposed site Improvements: (for reference only, see civil plans for details)

1. The tree protection shown on the site plan is right on the building pad, which would be unrealistic in the field. The building pads will need at least five feet of clearance for walking and machine access. The tree protection and limits of allowable disturbance will need to be adjusted to account for the five-foot clearance. (Building pads were reduced to allow for a 5' buffer, completed by Navix; site plan is copied and pasted onto page 21)
