February 6, 2024

Site: 7414 78th Ave SE  
Mercer Island, WA 980404  
TPN: 2524049075  
Area: 68,825 sq. ft. = 1.6 acre

Re: RFI dated November 27th, 2023, changes itemized below, on the report and on the city response matrix highlighted in yellow.

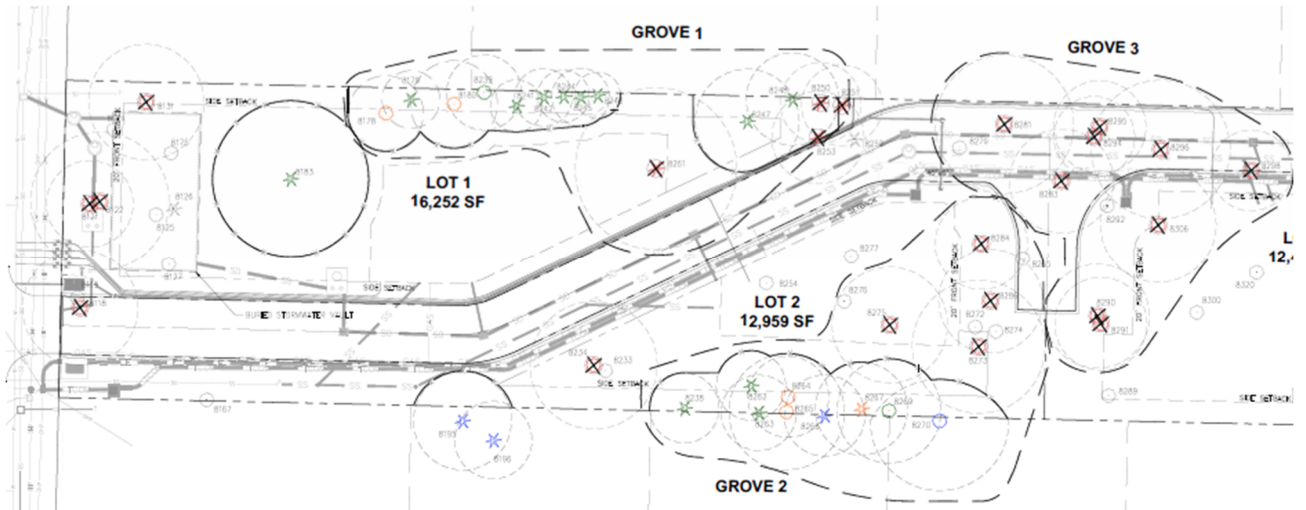
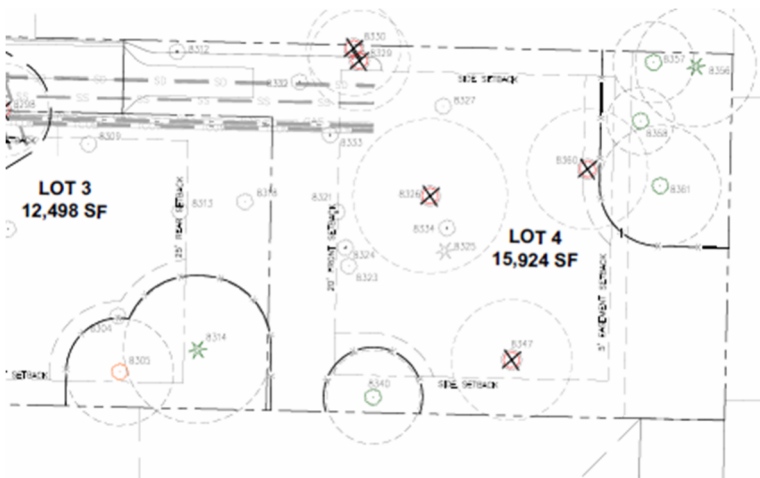
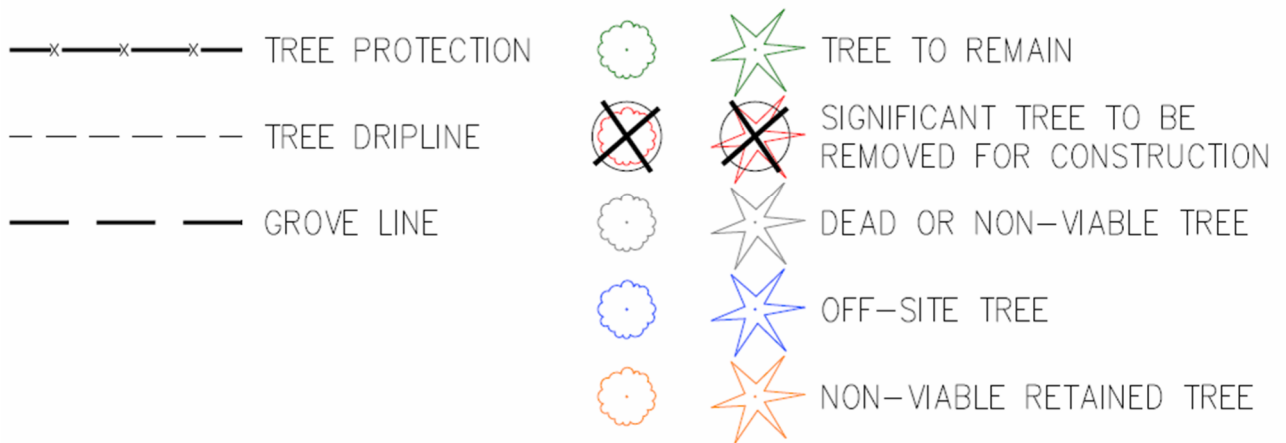
**Proposed site Improvements: (for reference only, see civil plans for details)**

1. The tree protection shown on the site plan is right on the building pad, which would be unrealistic in the field. The building pads will need at least five feet of clearance for walking and machine access. The tree protection and limits of allowable disturbance will need to be adjusted to account for the five-foot clearance. (Building pads were reduced to allow for a 5' buffer, completed by Navix; site plan is copied and pasted onto page 21)
