ARBORIST REPORT/TREE PLAN

7204 78th Avenue SE
Mercer Island, WA

March 7, 2022
Updated April 28, 2023

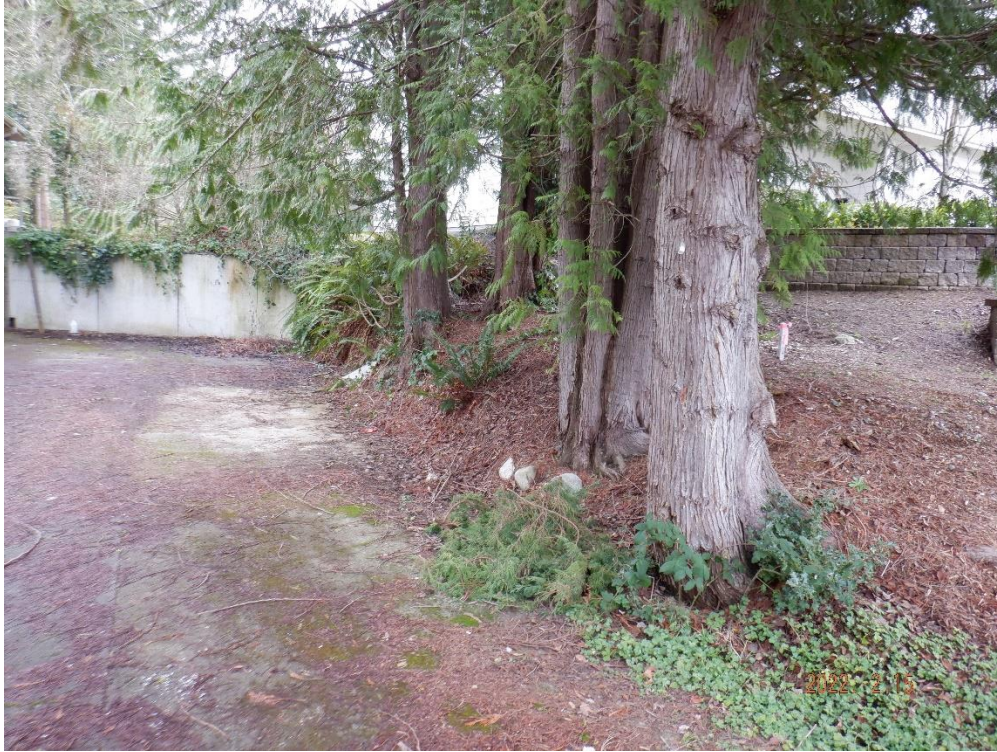
Trees #833 and #834 are semi-mature Western red cedar, located close to the existing driveway in the southwest corner of the property. Both are of fairly good vigor. Lower trunks appear sound with no outward indicators of any internal decay issues. #833 is in ‘good’ condition. The trunk of #834 forks into multiple tops. Condition is ‘fair’.

Trees #833 > #836 close to existing driveway

Trees #833, #834 and #101 next to the existing concrete driveway are not expected to be significantly impacted. The new driveway will be constructed at the same or slightly higher elevation as the existing. If the existing concrete is to be removed, it shall be broken up using a manual jack-hammer and removed from within the driplines by hand-labor only. Care shall be taken not to disturb roots that can be expected to exist just below the existing concrete. Once concrete is removed, immediately cover with gravel to create subbase for the new driveway. Use a tracked mini-excavator for this work to reduce the risk of unnecessary damage to roots and soil compaction.

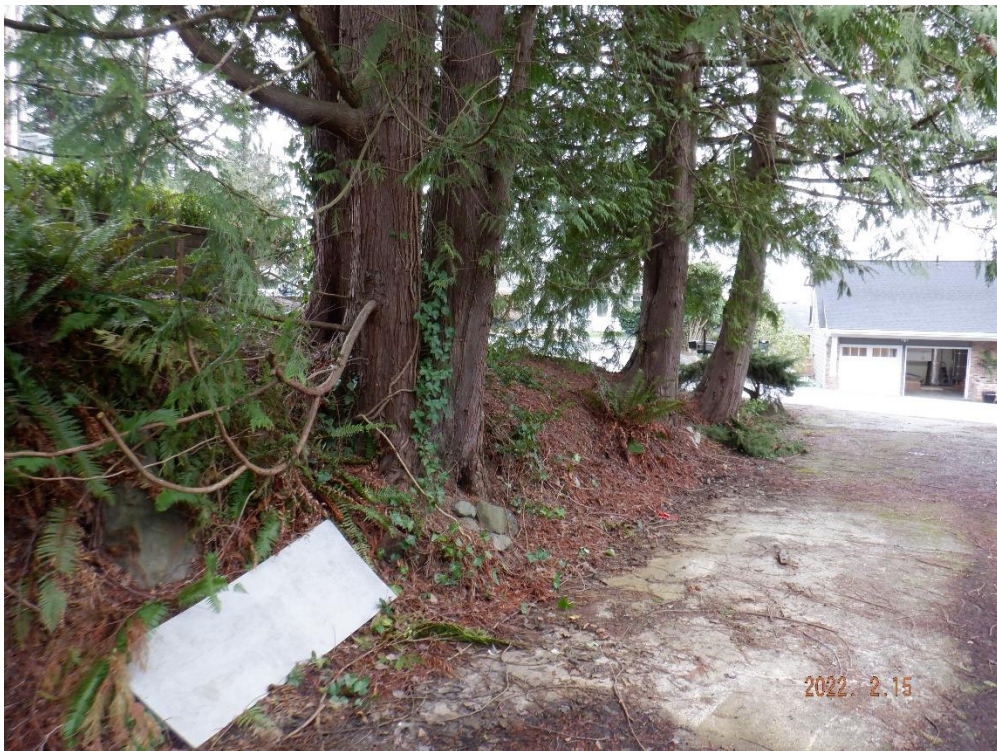
Right-of-way Trees #835, #836 and #837 are very close to the proposed new driveway and will be significantly impacted and compromised by new construction. The existing grade in this area needs to be lowered.

Trees #833 > #836 close to existing driveway

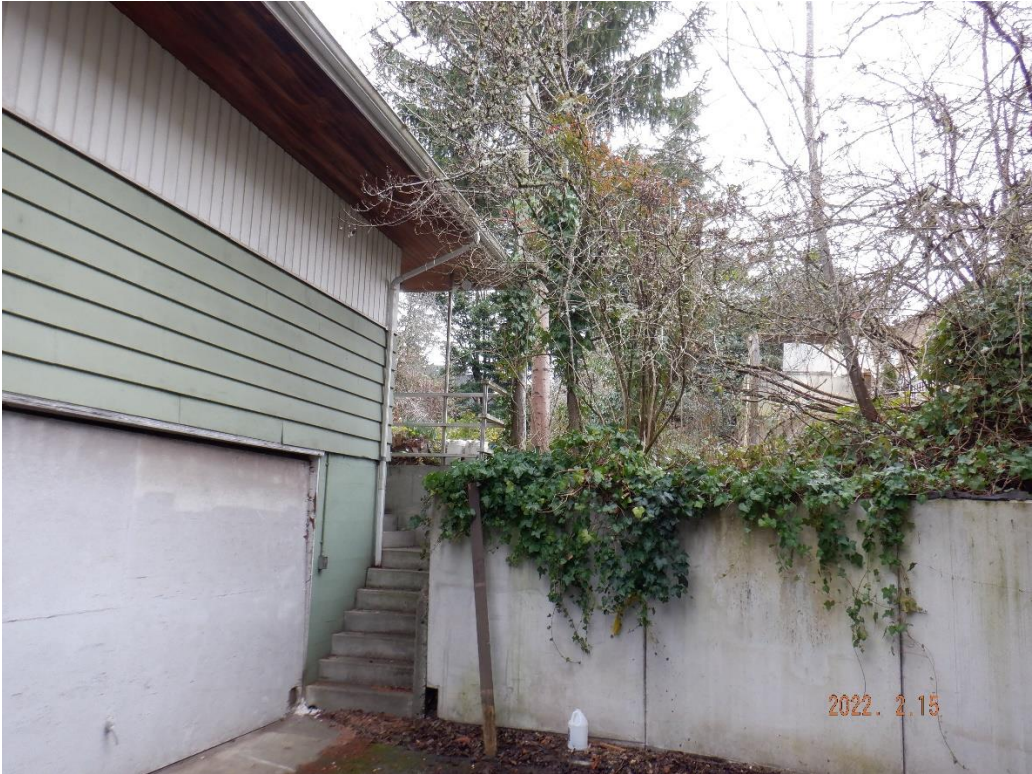
Tree #890 is a young to semi-mature Pacific dogwood that naturally regenerated at the site, very close to the existing structure. The base of the tree is abutting the concrete steps. See picture below. It is not viable due to its location. This is considered an 'exceptional' tree species in the city at 6-inches in diameter or larger.

Trees #890 and #891 close to existing house

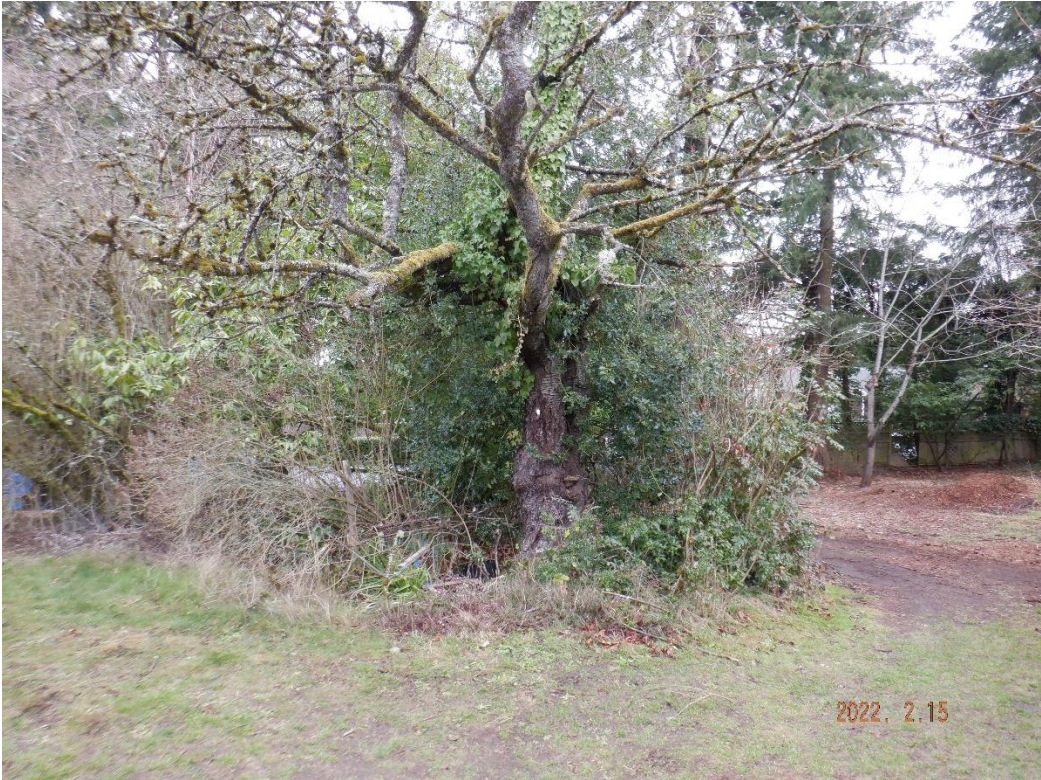
Tree #858 in middle of site

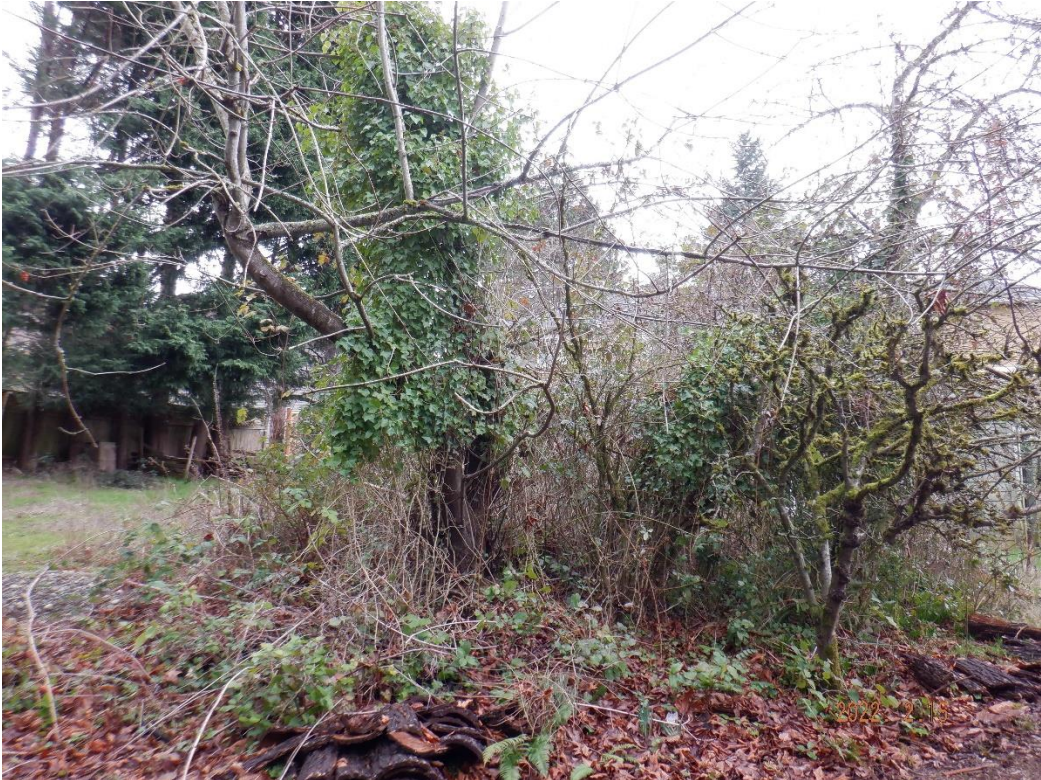
Trees #888 and #889 in middle of site

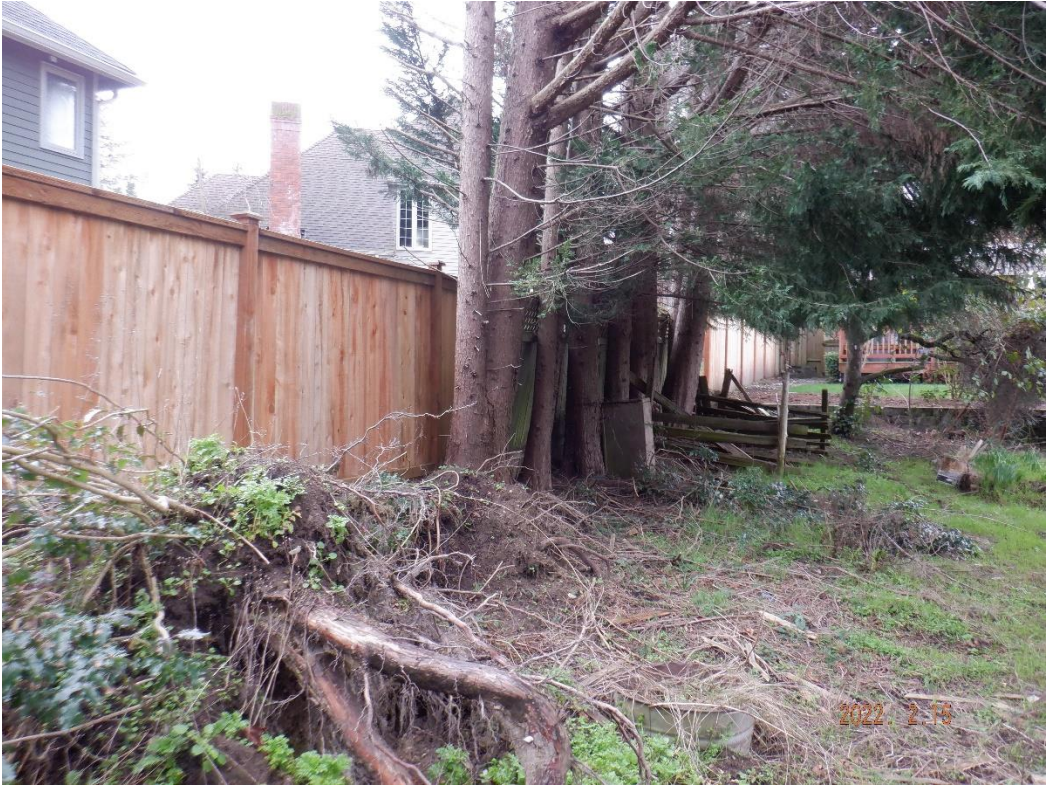
Trees #880 > #886 are a planted row of Leyland cypress adjacent to the east property line. Two Leyland cypress north of #880 uprooted in the past and failed. The remaining cypress have been significantly pruned back on their east sides by the neighbor and have asymmetric crowns to the west. These are in 'fair' condition.

Trees #880 > #886 on east property line

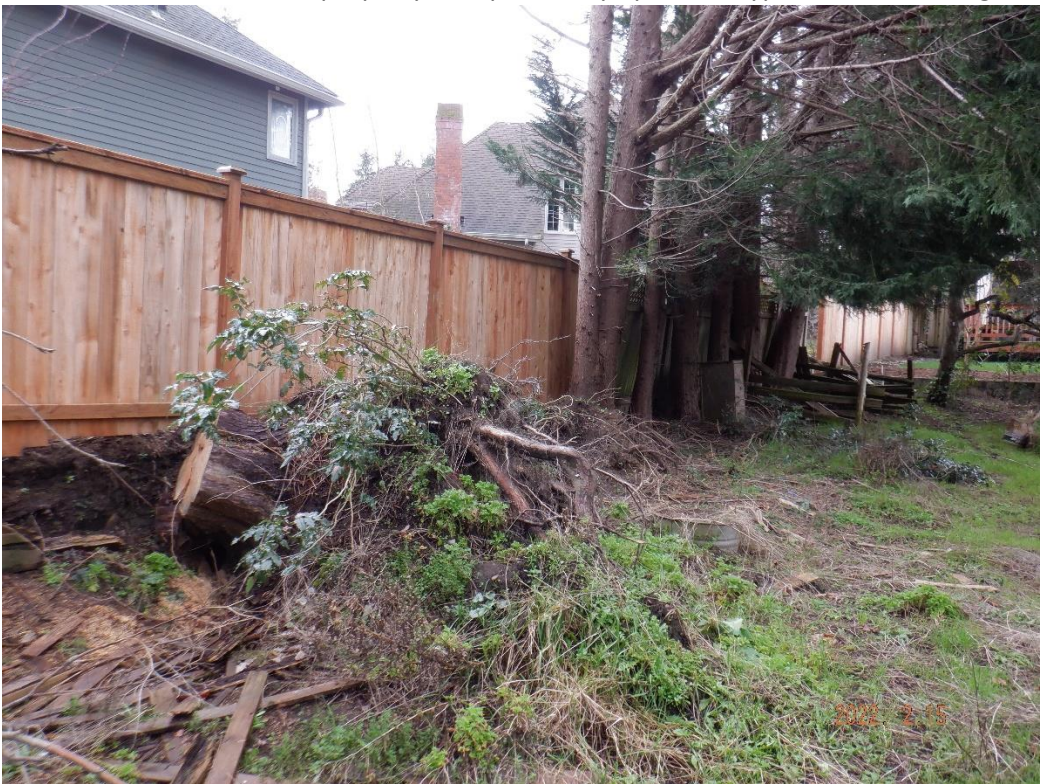
Trees #880 > #886 on east property line, previously uprooted cypress trees in foreground

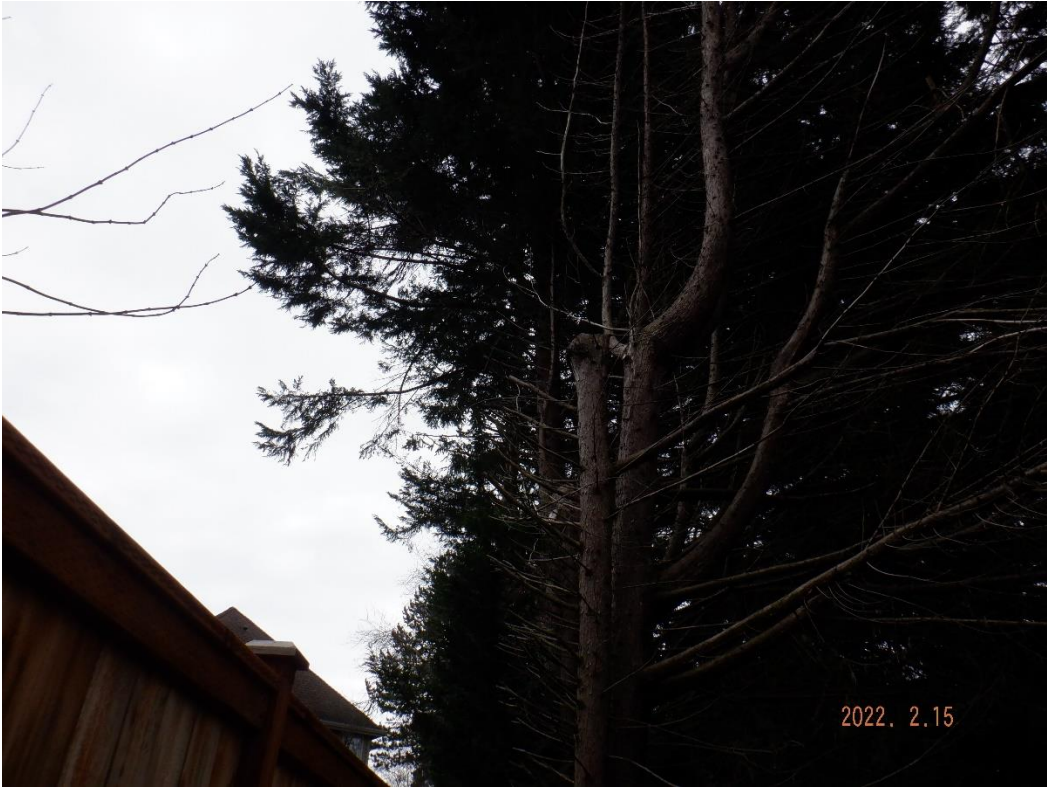
Leyland cypress row significantly cut back on east sides

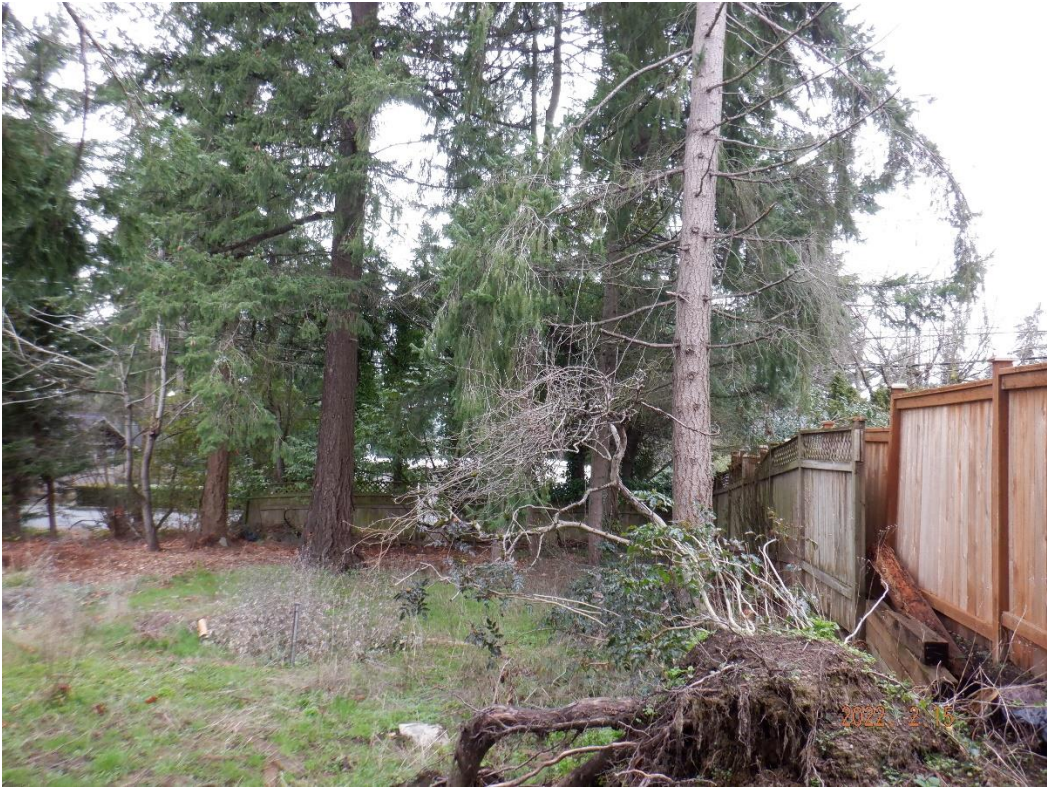
Trees #860, #864 and #873 > #879 comprise a large grouping of Douglas fir in the northeast corner of the property. Conditions range from ‘fair’ to ‘good’. All are of fairly good vigor. Trees #860 and #873 are larger than 30-inches in diameter and therefore considered ‘exceptional’.

Douglas fir grouping in northeast corner

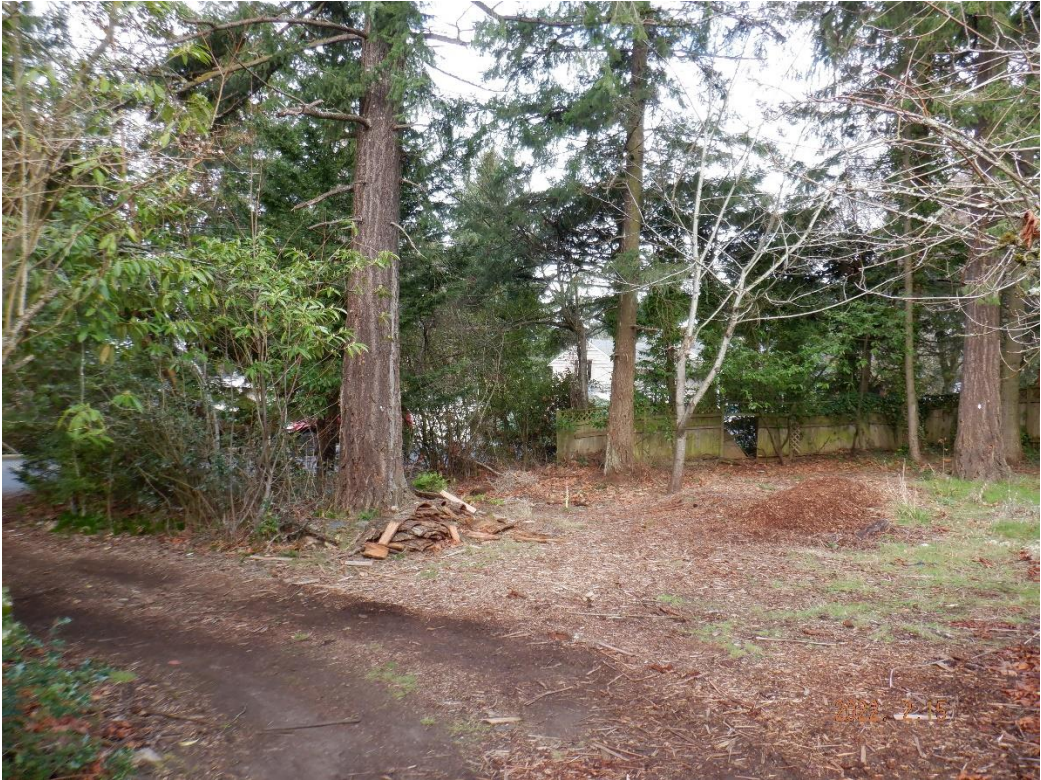
Douglas fir grouping in northeast corner

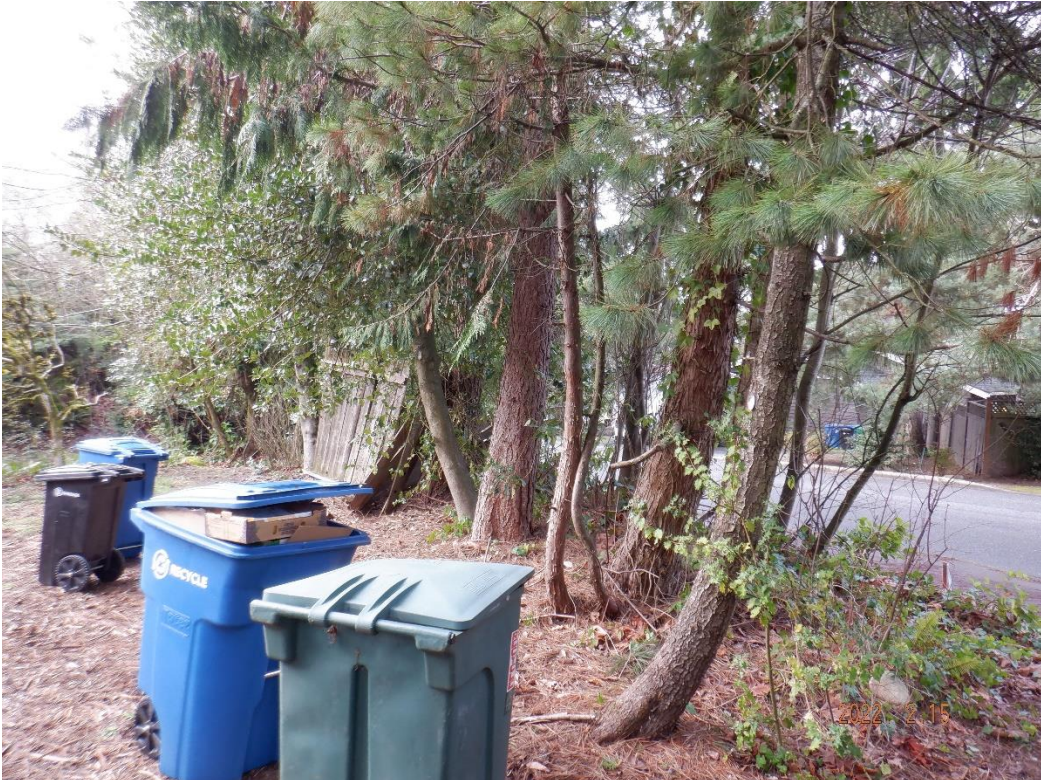
Trees #854 > #857 at edge of ROW

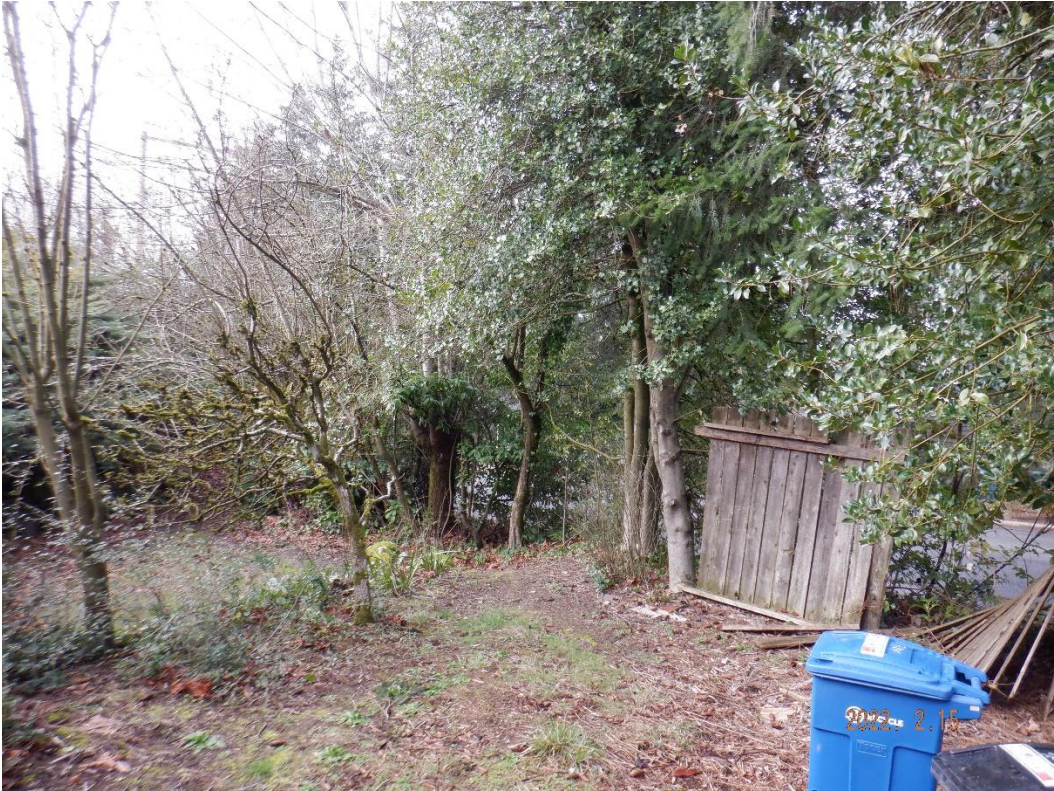
All of the right-of-way (ROW) trees have been repeatedly topped in the past for power line clearance. There are many small, non-regulated trees in the ROW. These make up a dense screening between the subject property and adjacent streets. Species include a mix of native and volunteer species to include bigleaf maple, Douglas fir, Pacific madrone, Western red cedar, English holly, English hawthorn and a few planted coniferous species.

ROW trees north of existing house

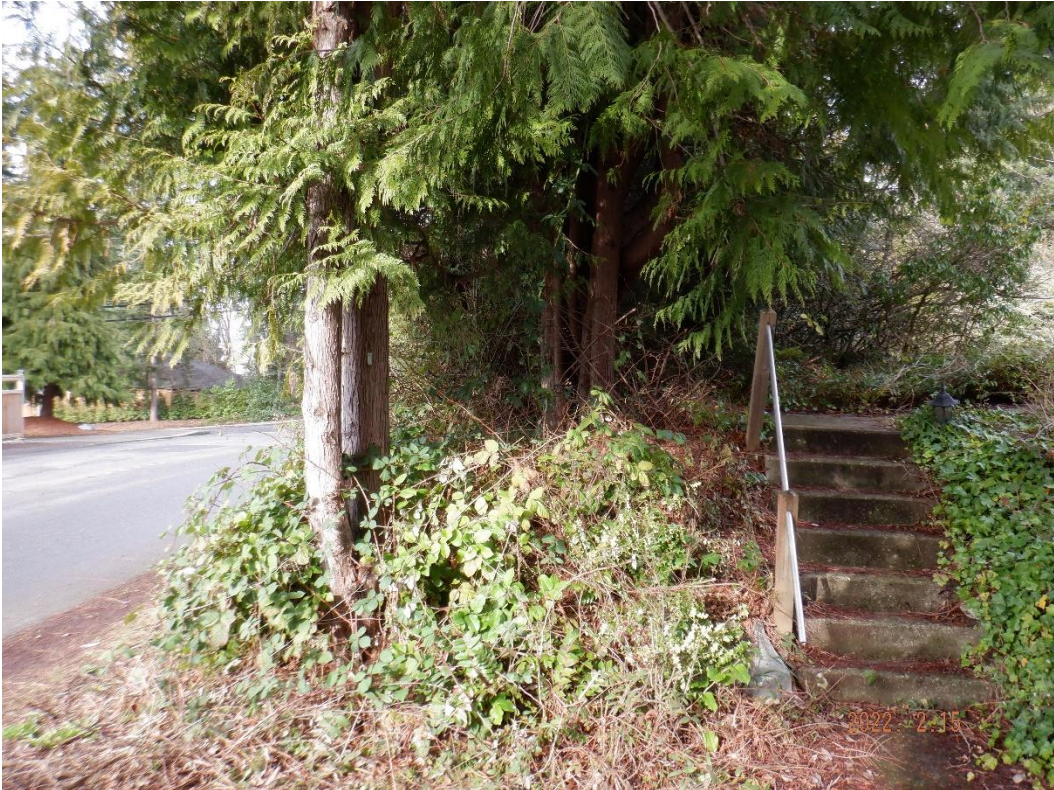
ROW trees west of existing house

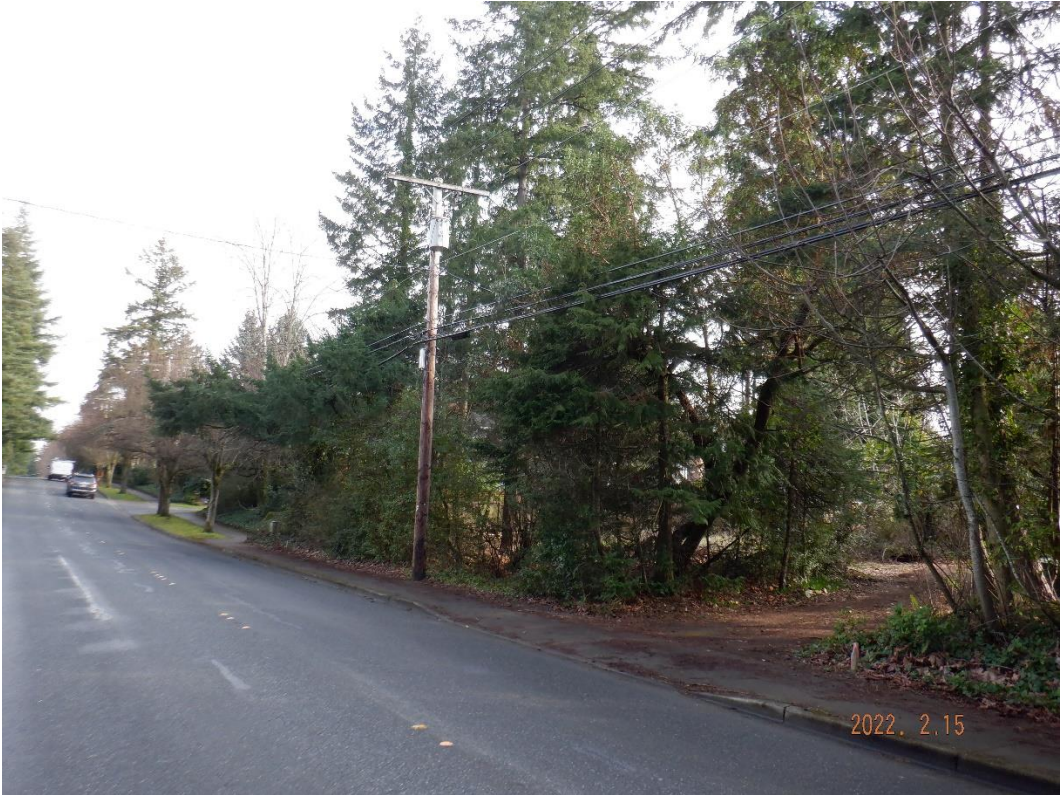
Looking east to SE 72nd Street ROW trees

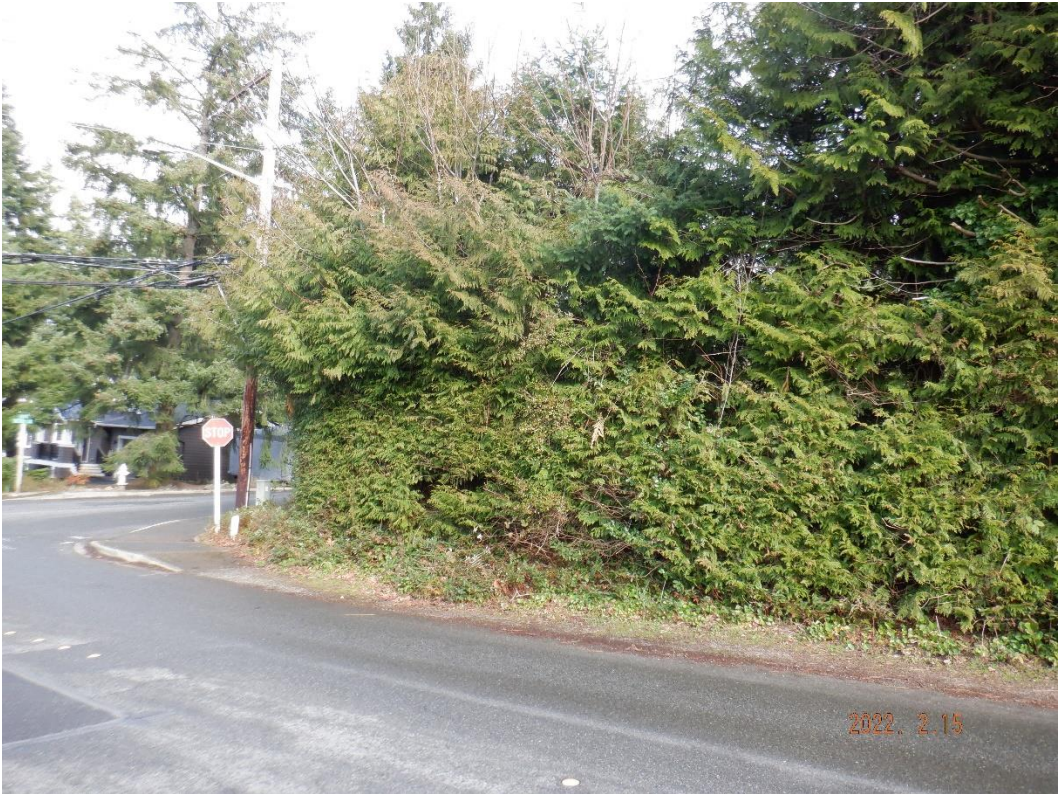
78th Ave SE ROW trees

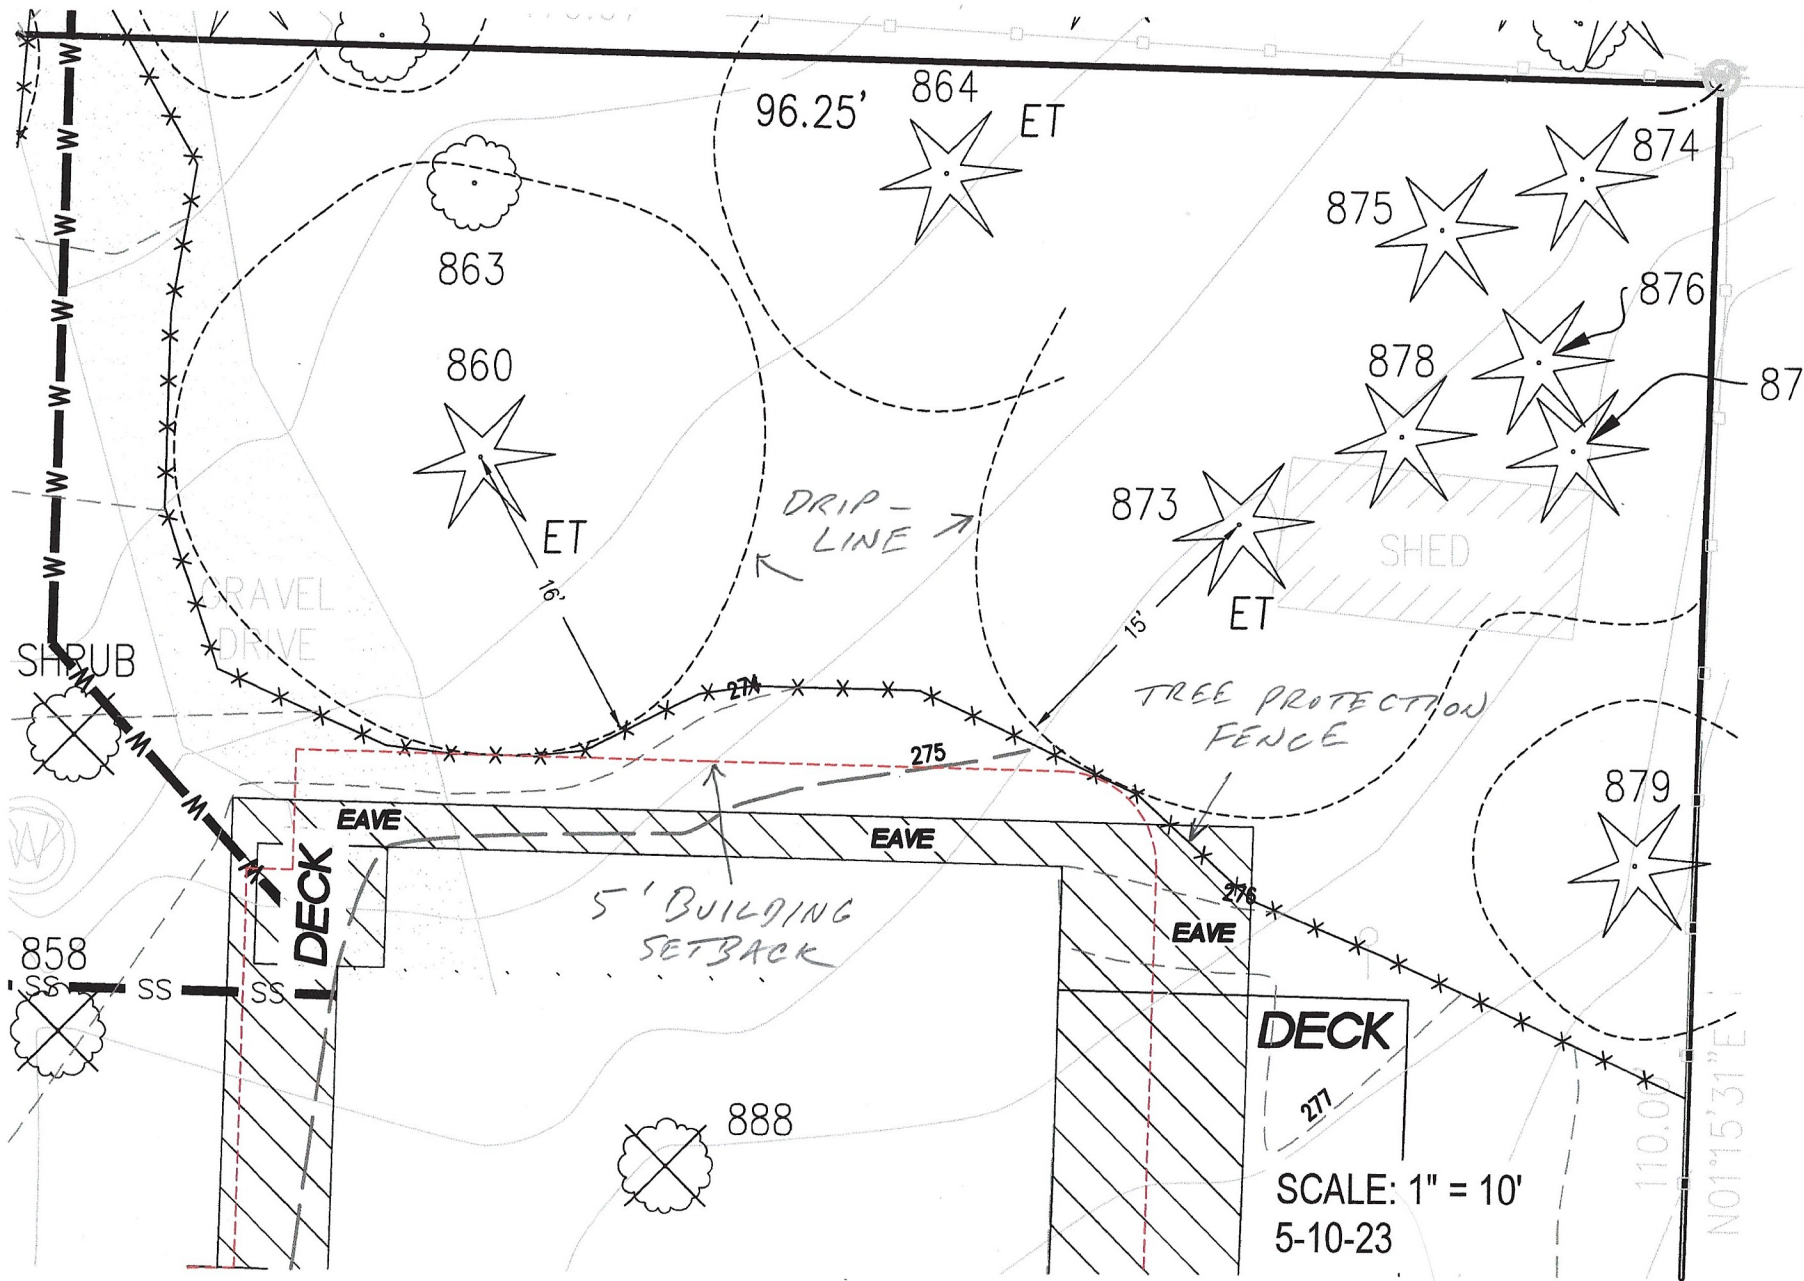
TREE #860/#873 PROTECTION PLAN

The house has been moved 8 ½-feet south away from Tree #860 to provide a 14-foot protection zone from the trunk face and 5-feet of clearance for access and construction. See the attached protection plan map. The re-design of the house will minorly impact the outer dripline area of Tree #873. To protect soils and feeder roots, cover the area with a +/- 6-inch layer of coarse arborist wood chip mulch or hog fuel. Tree protection fencing shall be phased to provide better protection during house construction. When deck is ready to be constructed, move protection fencing as shown on the attached

map. This minor impact is not expected to have any adverse effects on the tree so long as the tree protection guidelines and measures discussed in this report are adhered to.
