LAYTON TREE CONSULTING, LLC

ARBORIST REPORT/TREE PLAN

7204 78th Avenue SE
Mercer Island, WA

March 7, 2022
Updated November 9, 2023

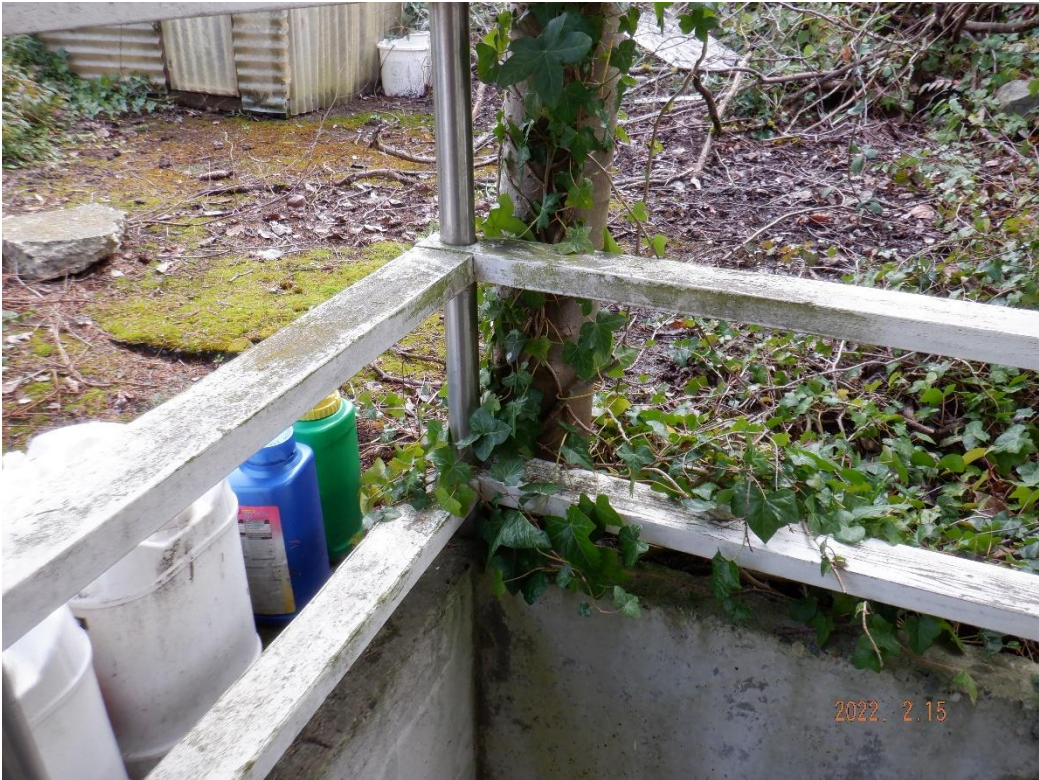
Tree #890 is a young to semi-mature Pacific dogwood that naturally regenerated at the site, very close to the existing structure. The base of the tree is abutting the concrete steps. See picture below. It is not viable due to its location. This is considered an 'exceptional' tree species in the city at 6-inches in diameter or larger.

Base of Tree #890 growing up against concrete wall/steps

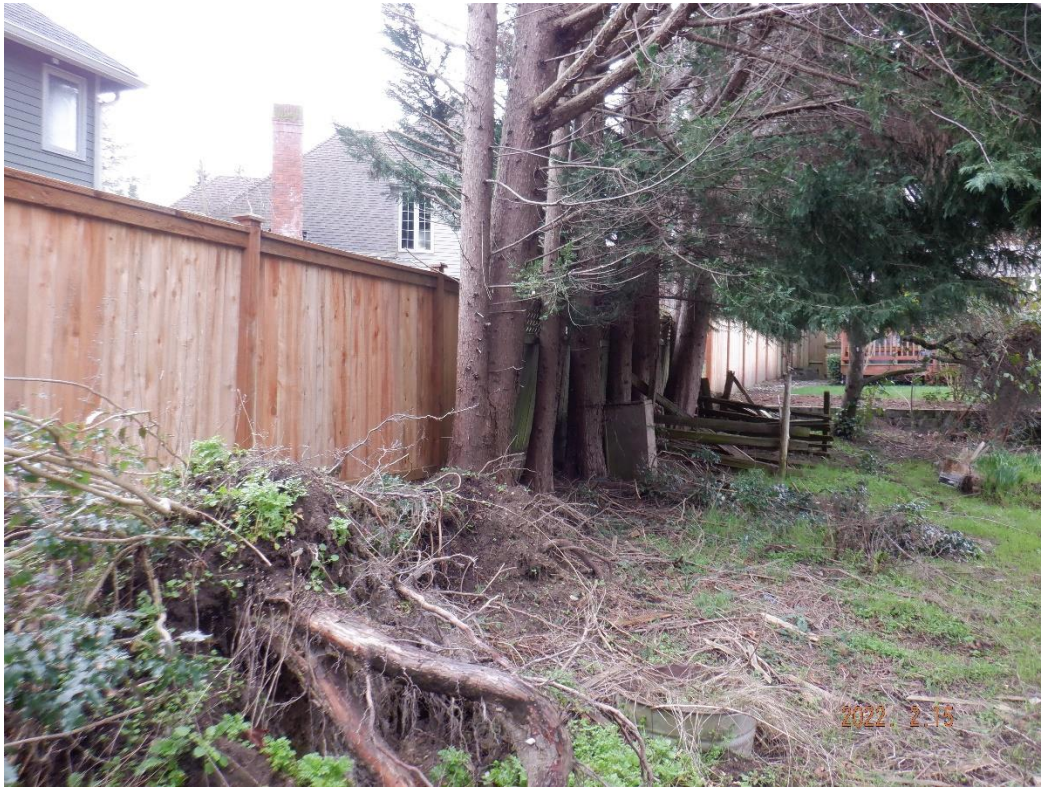
Trees #880 > #886 are a planted row of Leyland cypress adjacent to the east property line. Two Leyland cypress north of #880 uprooted in the past and failed. The remaining cypress have been significantly pruned back on their east sides by the neighbor and have asymmetric crowns to the west. This is considered a non-regulated hedge by the city.

Trees #880 > #886 on east property line, non-regulated hedge

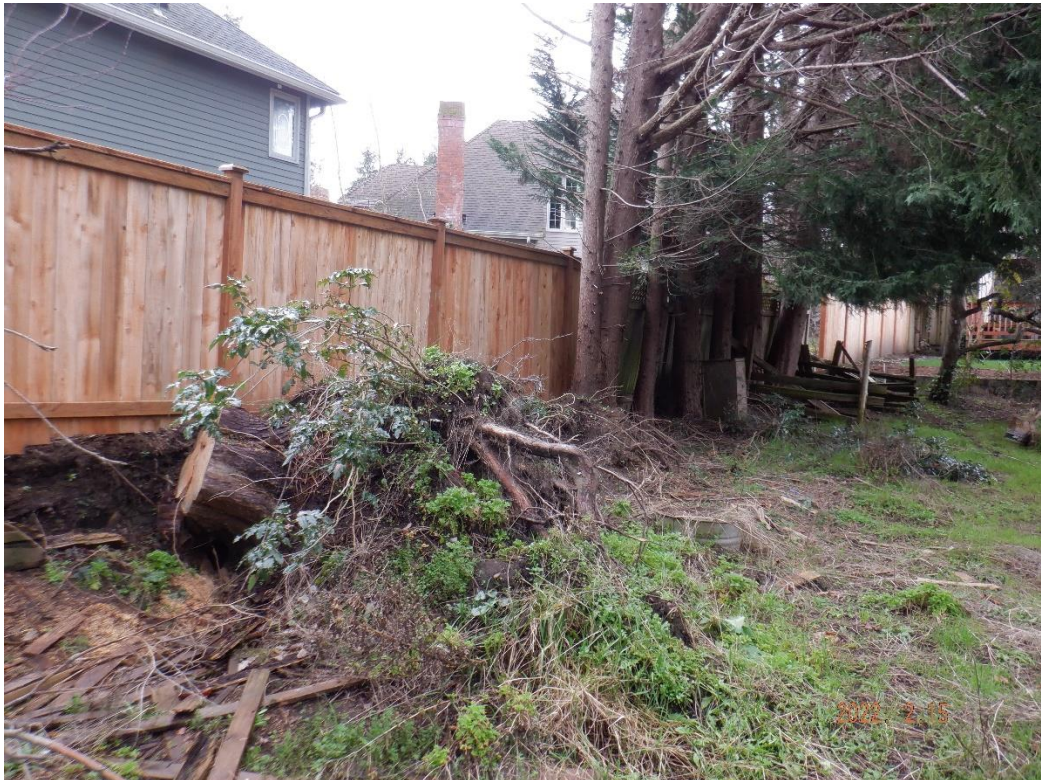
Trees #880 > #886 on east property line, previously uprooted cypress trees in foreground

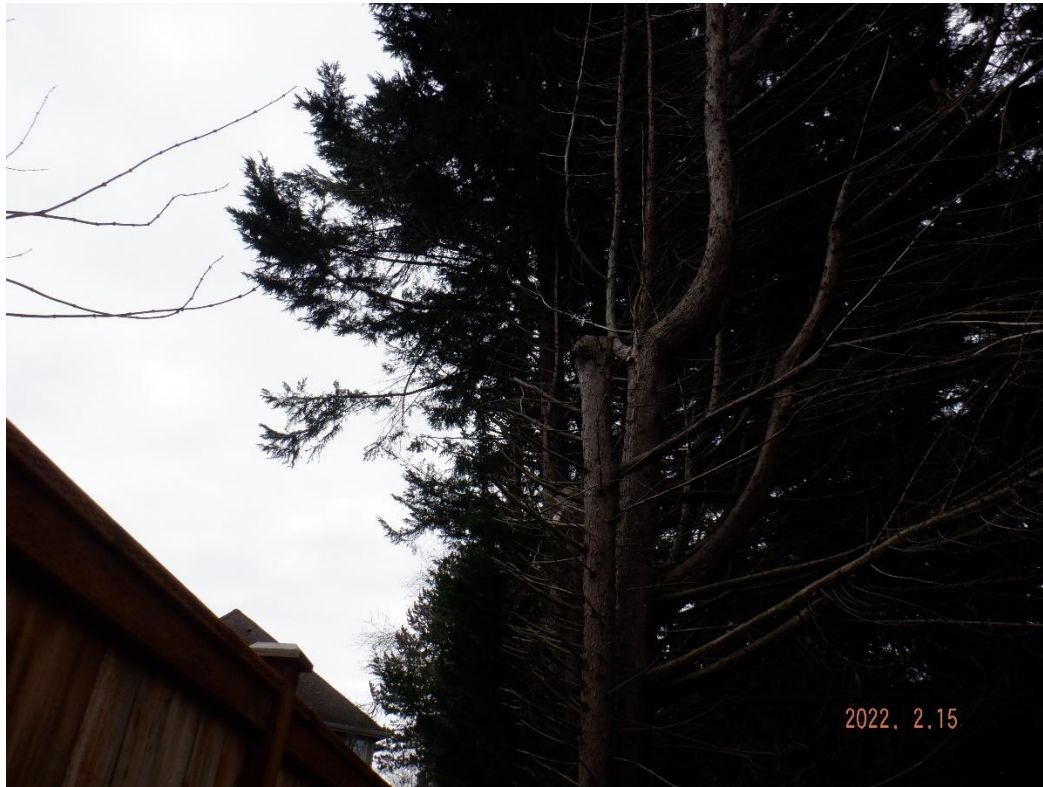
Non-regulated cypress row significantly cut back on east sides

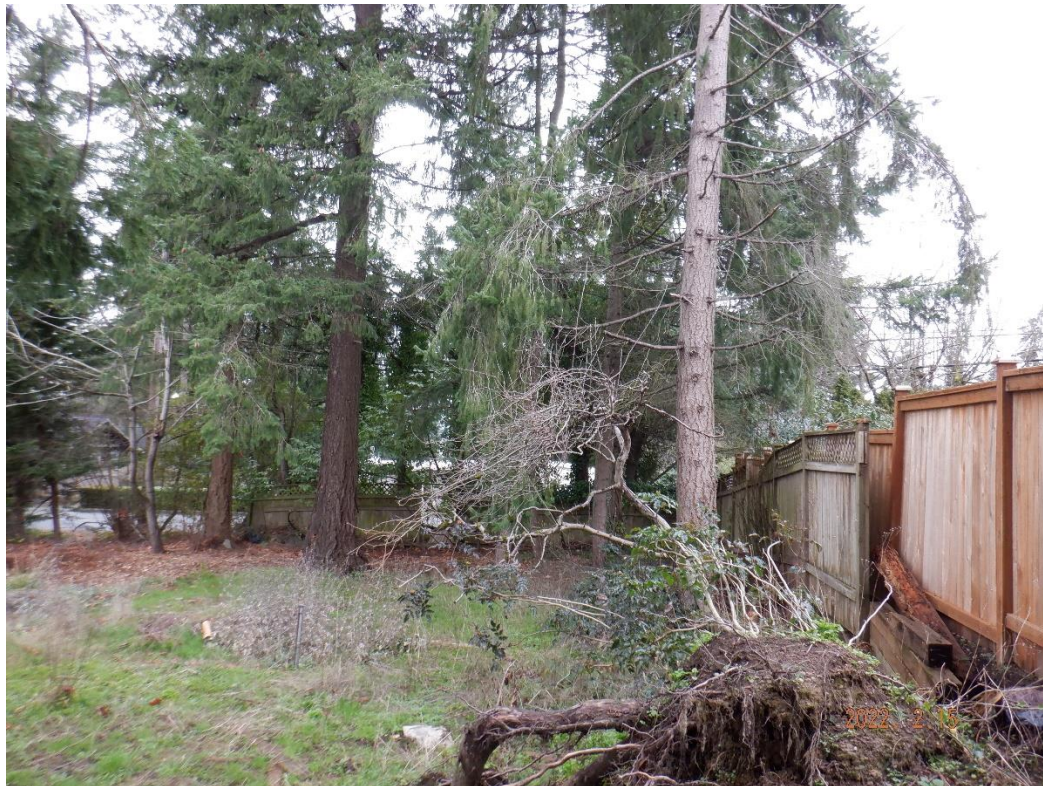
Trees #860, #864 and #873 > #879 comprise a large grouping of Douglas fir in the northeast corner of the property. Conditions range from ‘fair’ to ‘good’. All are of fairly good vigor. Trees #860 and #873 are larger than 30-inches in diameter and therefore considered ‘exceptional’.

Douglas fir grouping in northeast corner

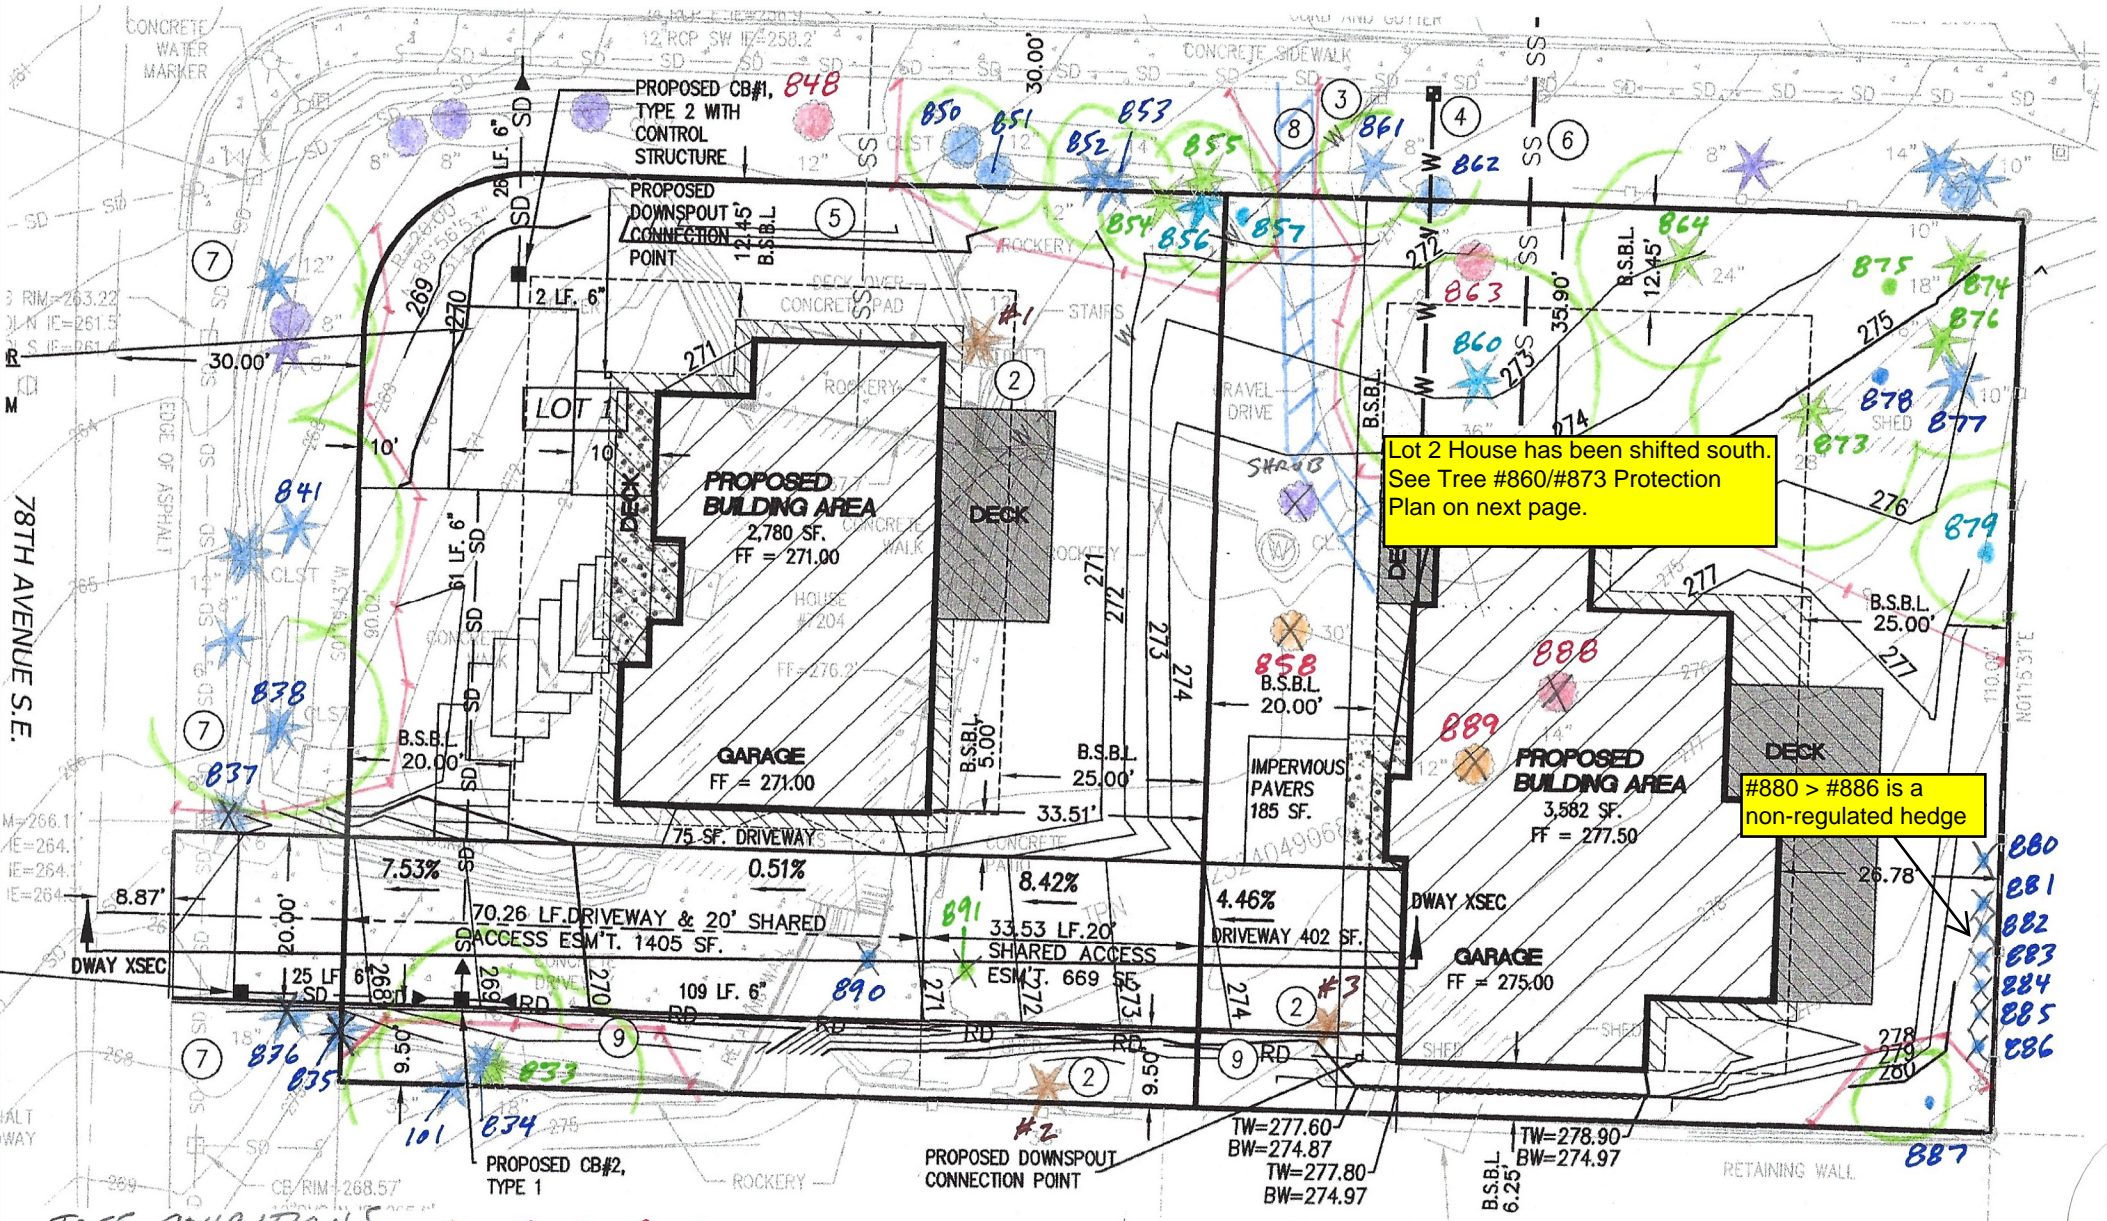
TREE PLAN MAP

Lot 2 House has been shifted south. See Tree #860/#873 Protection Plan on next page.

#880 > #886 is a non-regulated hedge

Lot 2 utilities shall be routed west of Tree #860 outside of the dripline and between the driplines of Trees #857 and #861 down the existing gravel driveway, as shown on the attached tree plan map.
