October 3, 2023

Site: 4719 86th Ave SE SP
Mercer Island, WA 98040
TPN: 7598100420
Area: 28,644 sq ft. = .66 acres

Re: Results of air-vac-ing the soil at the CRZ of trees 233, 234, 249, 253, 254

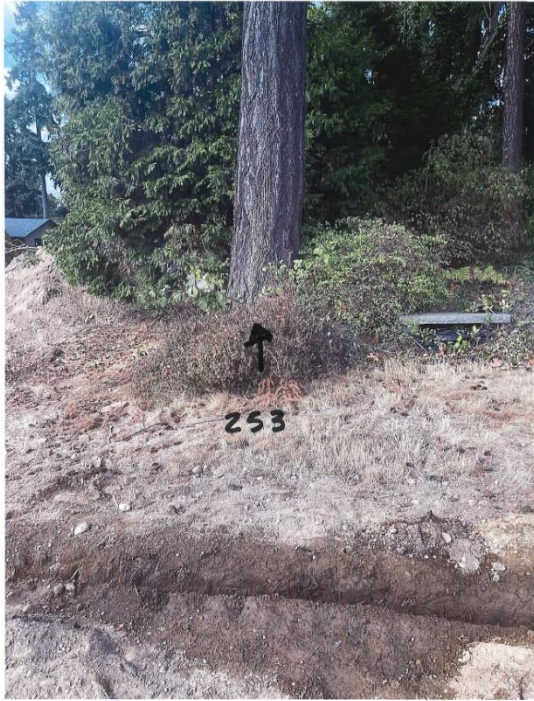
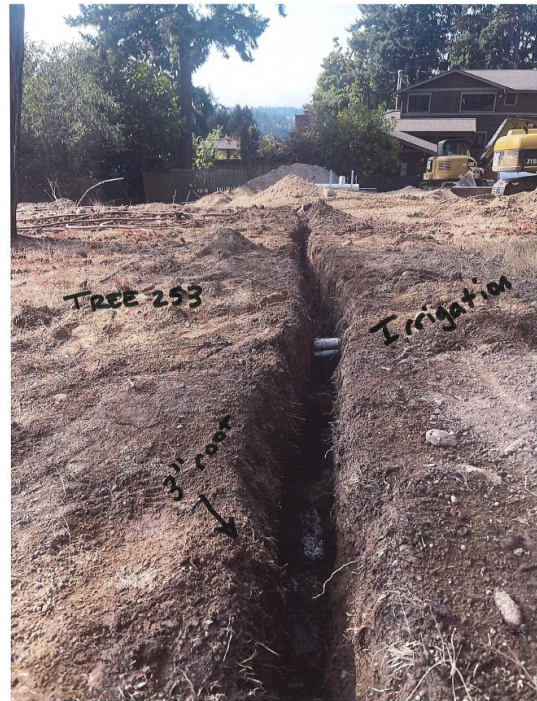
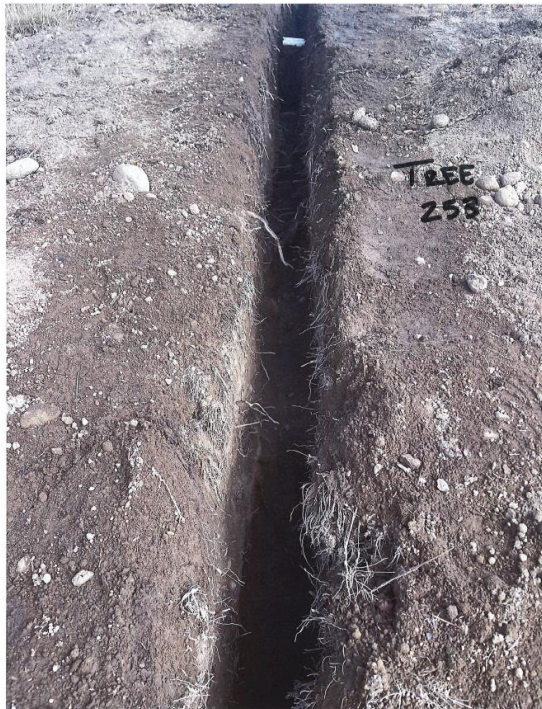
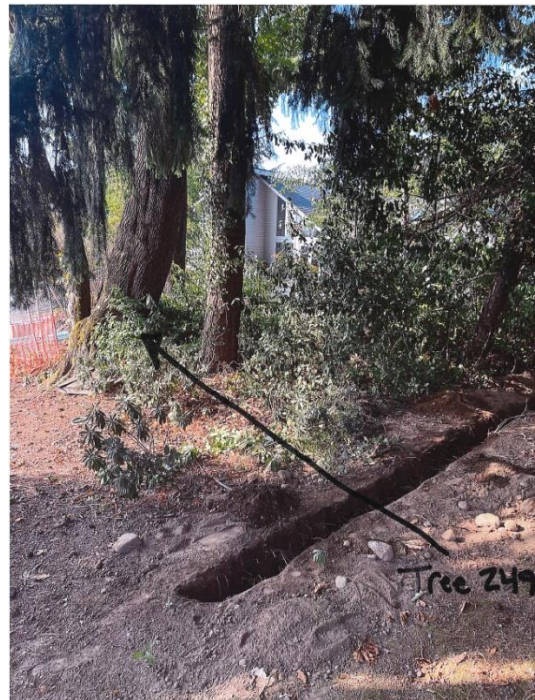
Tree #253 & 249

Tree #253:

One 3" root was exposed from the air-evacuation of the soil around tree #253. The root can be cut cleanly and should not destabilize the tree, nor significantly impact the absorption of water and nutrition.

Tree # 249:

This tree is located among a group of similar trees. At the point of air=evacuation, three (3) roots were uncovered. One (1) was a four (4") diameter root that appears to be from tree #246 – a tree proposed to be removed, and two (2") roots that appear to originate from this tree. Cutting of these roots should not destabilize nor significantly negatively impact the tree.

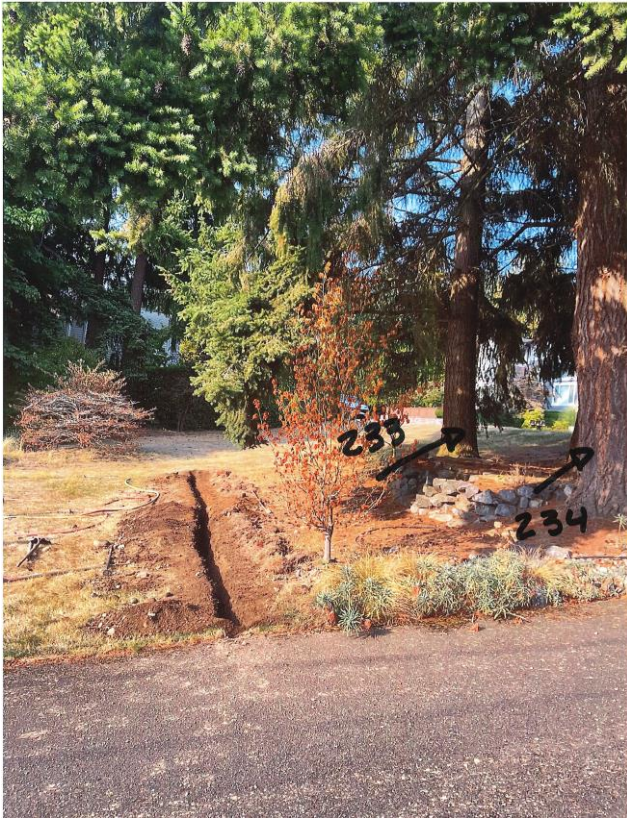
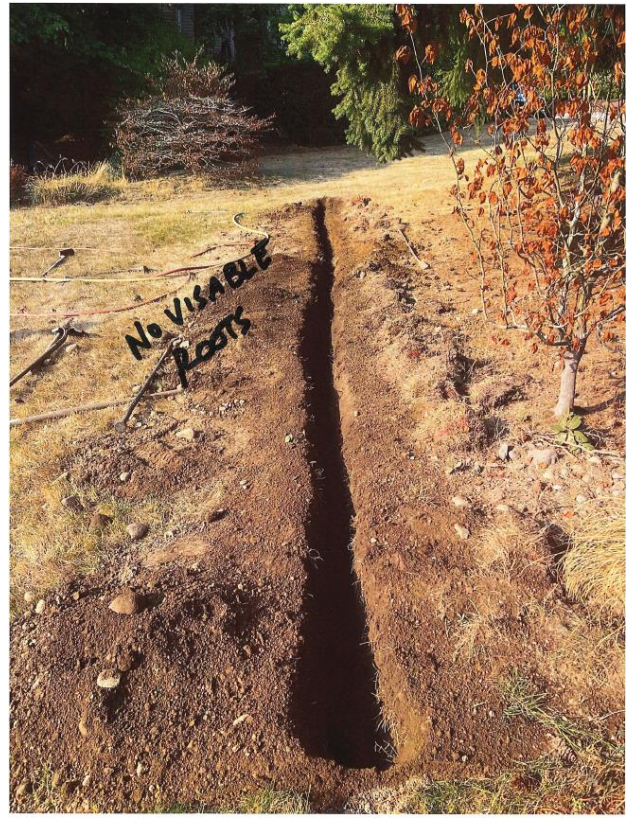
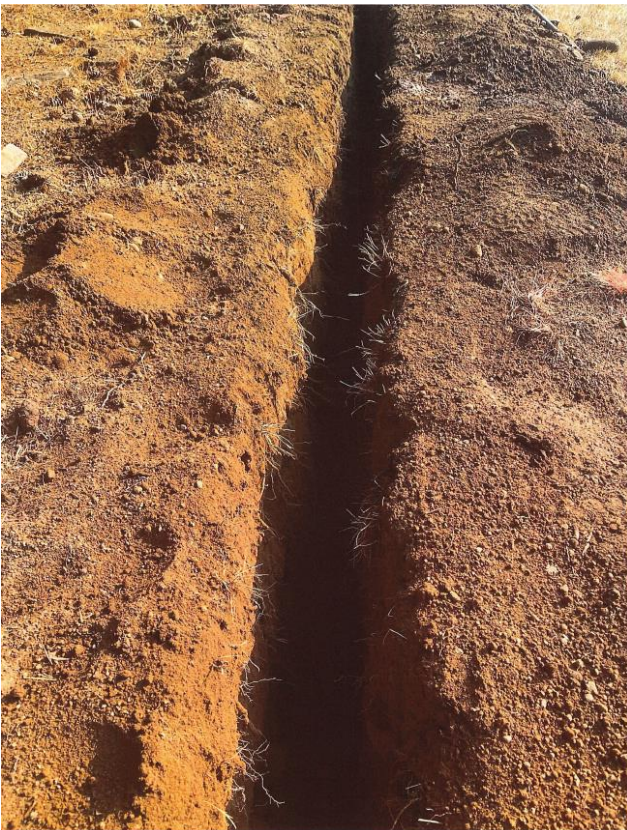
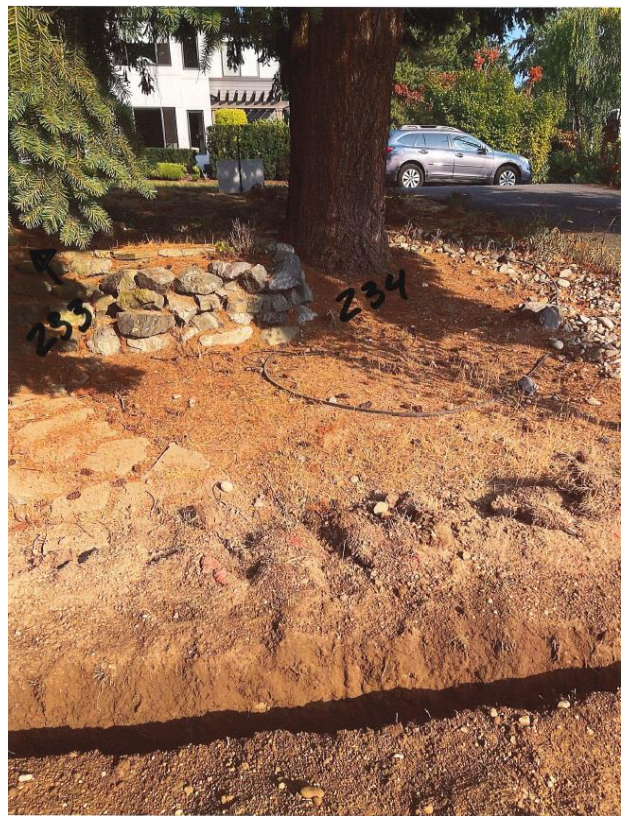
Tree #233 & 234:

Tree # 233 & 234:

The air-evacuation of the soil along the proposed point of excavation for the new building footing did not expose any roots.

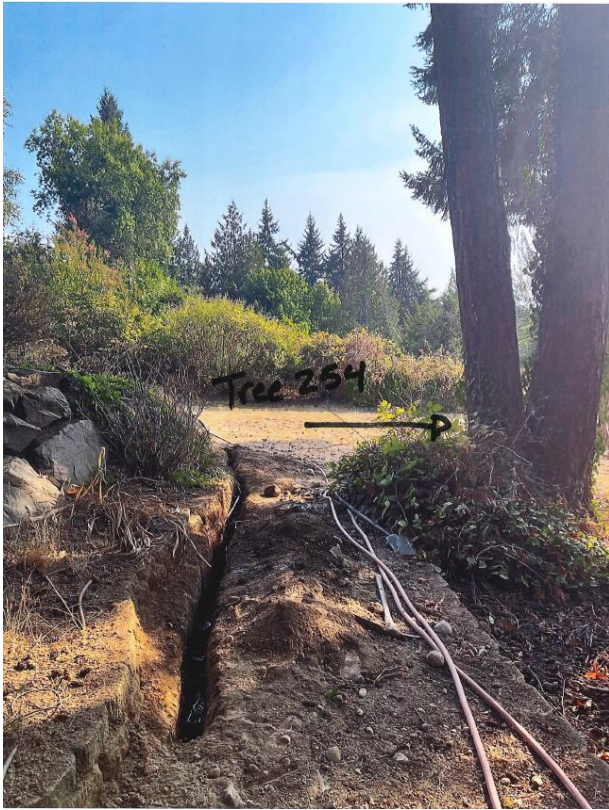
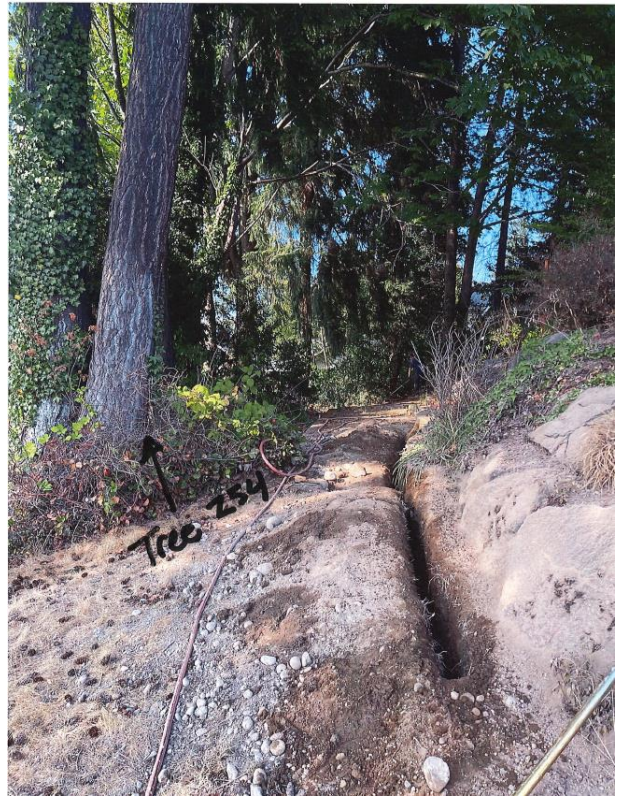
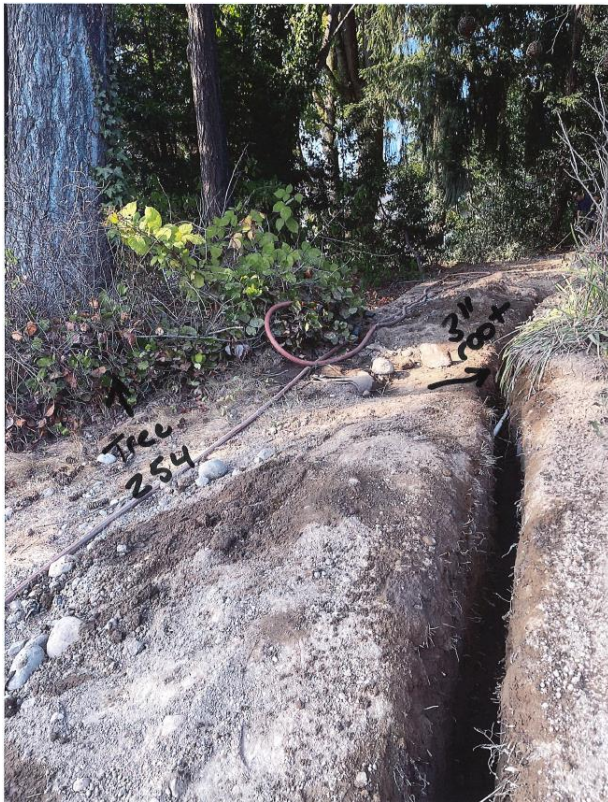
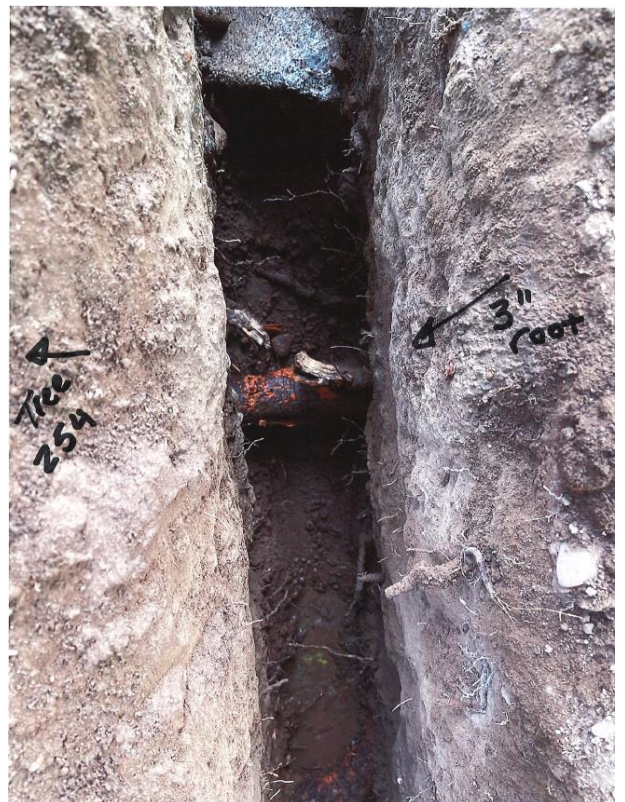
Tree # 254

5	254	Douglas fir	36, 28	16	OK	Co-dominant leaders with included bark x2 @ 1', previous top loss @ 50', strong laterals, dead wood, broken branches, abnormal bark, popping bark, woodpecker activity	16	16	16	6	Y	(1) 3" root growing to the east. No other roots visible.

Tree # 254:

One 3" root was exposed from the air-evacuation of the soil around tree #254 growing to the east. The root can be cut cleanly and should not destabilize the tree, nor significantly impact the absorption of water and nutrition.
