8215 SE 78th Street

Arborist Report

September 18, 2020

Tom Early, Otak, Inc.
tom.early@otak.com
206-250-8821
Project No. 33331

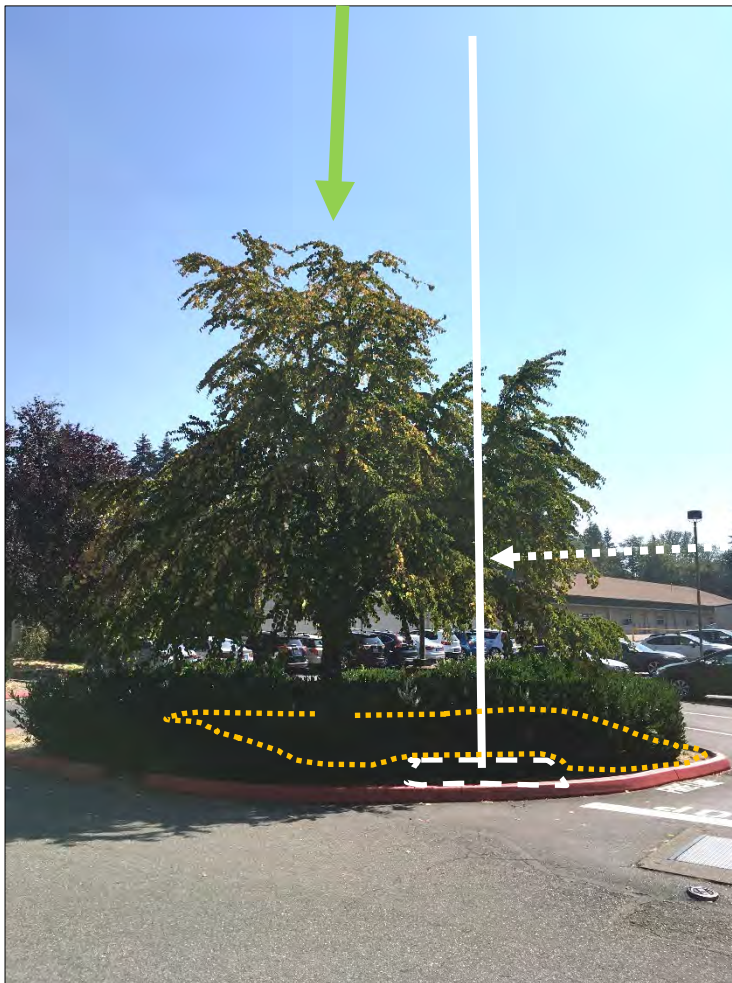
Image 1: tree #1 indicated with green arrow, white dashed line showing approximate vaults location at base of proposed pole, dashed white arrow indicates approximate location of minor pruning to provide clearance to equipment on pole between 6 and 8' above ground surface, orange dotted line shows approximate base of tree protection fencing encircling tree #1; view is looking east-southeast

Laurel shrub removal should use a pinch, lift and shake approach with a mini excavator rather than excavating into the ground with the bucket; this will minimize damage to the roots of tree #1. Root pruning should target clearance for pole installation, utility box excavation and trenching alignment. Likely root sizes encountered are 1-inch diameter and less; roots requiring pruning shall be cut cleanly at edge of excavation. Damaged roots, i.e. split or torn roots during laurel shrub removals, shall be pruned no more than 4-inches closer to the trunk than the root injury. Tree protection should be placed after laurel shrubs are removed, and before trenching. Tree protection fencing should be placed approximately 3 feet north of the trunk, extending linearly east to west from curb to curb and wrapping southward around the planting island on the inside of the curb. After pole is placed, excavate two vaults using hand or vector truck. The vector truck is recommended to avoid impacts to unknown utilities.

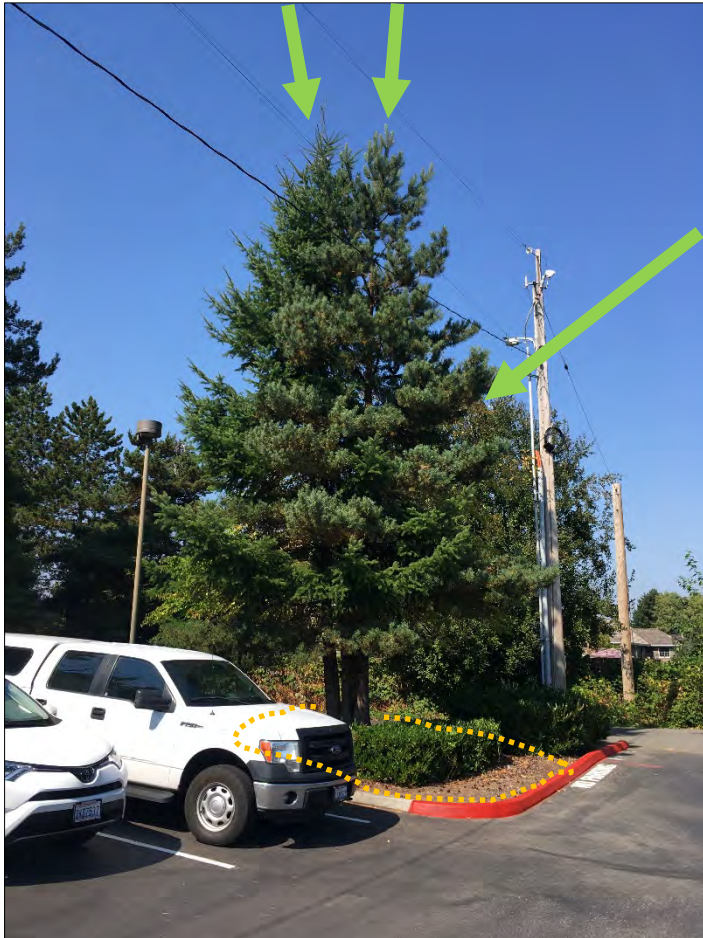
Image 2: Trees #2, 3 and 4 in planter west of proposed pole location, dotted orange line indicates approximate tree protection fencing encircling trees #2, 3 and 4, laurel shrub at northeast corner of planter is likely to be removed for trenching; view is northwest

Laurel shrub removal should use a pinch, lift and shake approach with a mini excavator rather than excavating into the ground with the bucket. An alternative would be to remove the shrubs by hand, this will minimize damage to the roots of tree #2, 3 and 4. Root pruning shall be for trenching alignment. Likely root sizes encountered are 1-inch diameter and less; roots requiring pruning shall be cut cleanly at edge of trench excavation. Damaged roots shall be pruned no more than 4-inches closer to the trunk than the root injury. Tree protection should be placed after laurel shrubs are removed and before trenching. Using a vactor truck for trenching after pavement removal is completed is recommended to avoid impacts to unknown utilities.

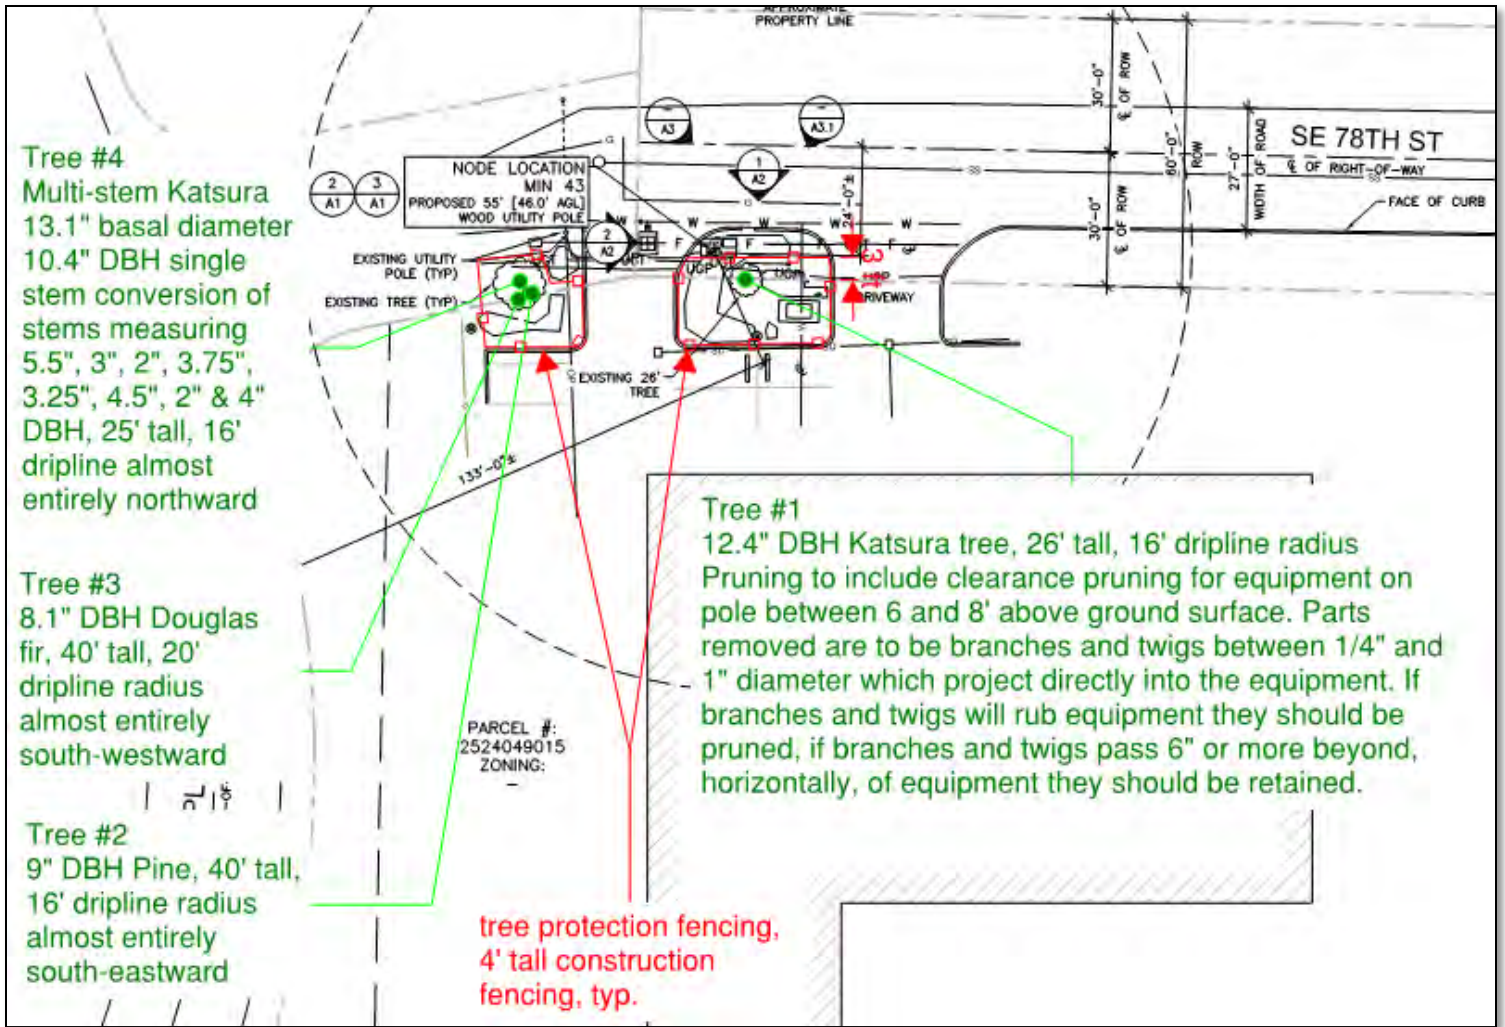
Figure 1-Tree Map and Notes

No trees are recommended for removal. The construction impacts are likely to have minimal root zone loss. There are four trees within the project area; these four trees are also in the SE 78th Street right-of-way. All four trees are located on figure 1. Species, size, dripline radius and height are also noted on figure 1.

Chapter 19.10 of the Mercer Island City Code applies to this project. This report documents the trees near and within the work zone which have a potential to be impacted. A permit is not required because no trees are proposed for removal, but this work requires tailored tree protection based on the ISA Managing Tree During Construction BMP. The tailored tree protection recommendations are overlaid onto the site plan, sheet A1, in figure 1.

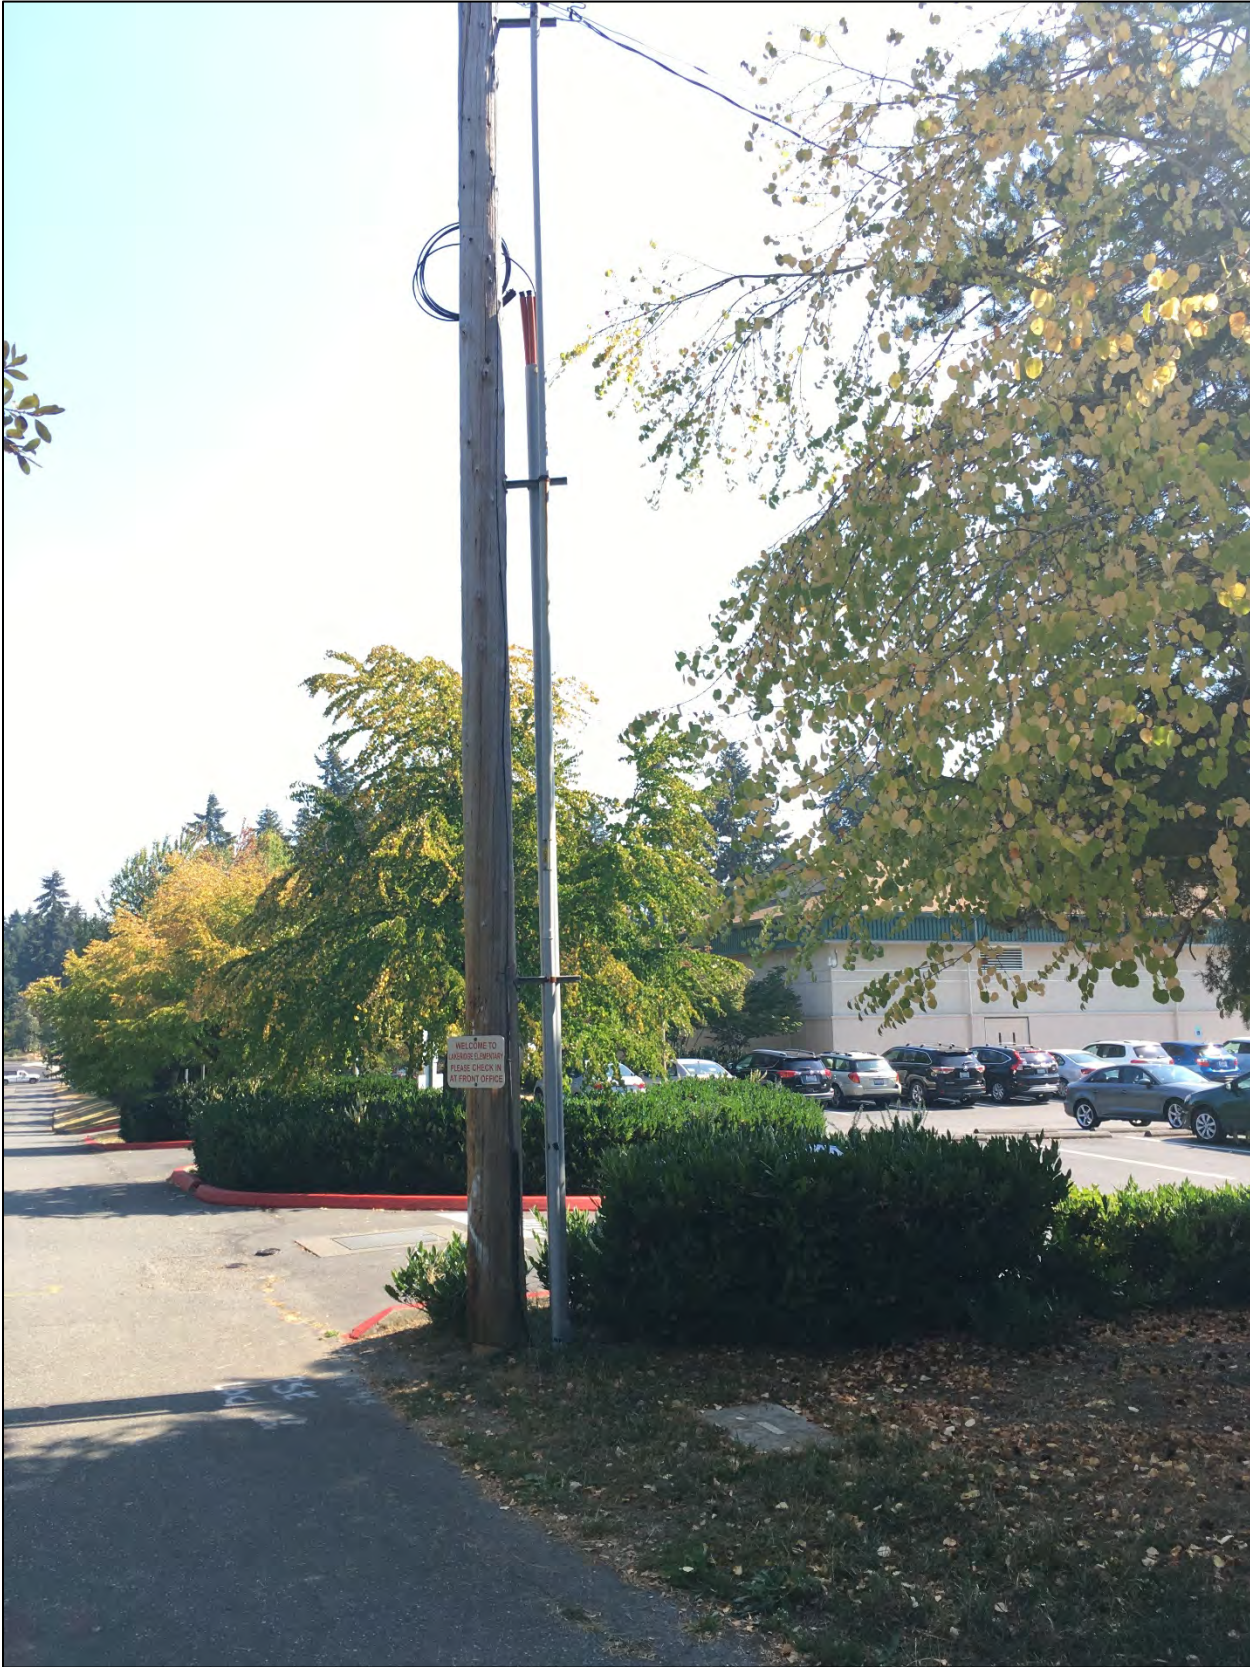
Image 1: existing pole in foreground with tree #2, 3, and 4 at right edge of photo; tree #1 is just beyond existing pole; image is looking east

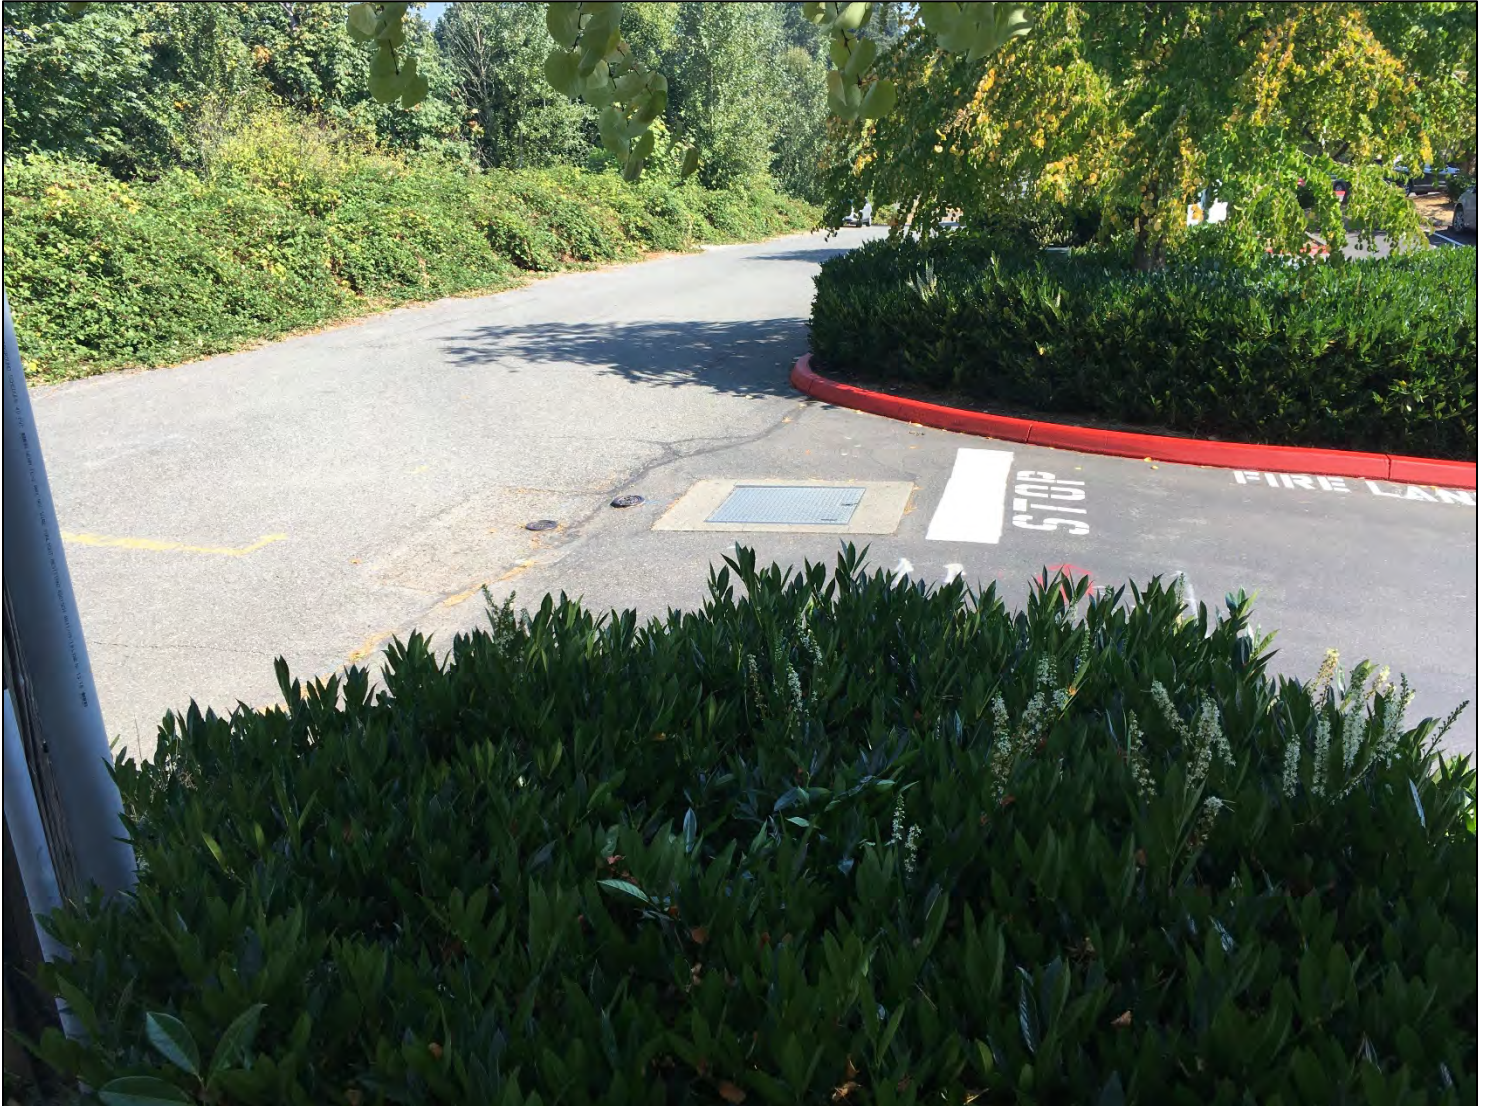
Image 2: existing pole on left edge of image; approximately trenching will align with "Stop" bar on pavement; view is eastward with back to trees #2, 3 and 4

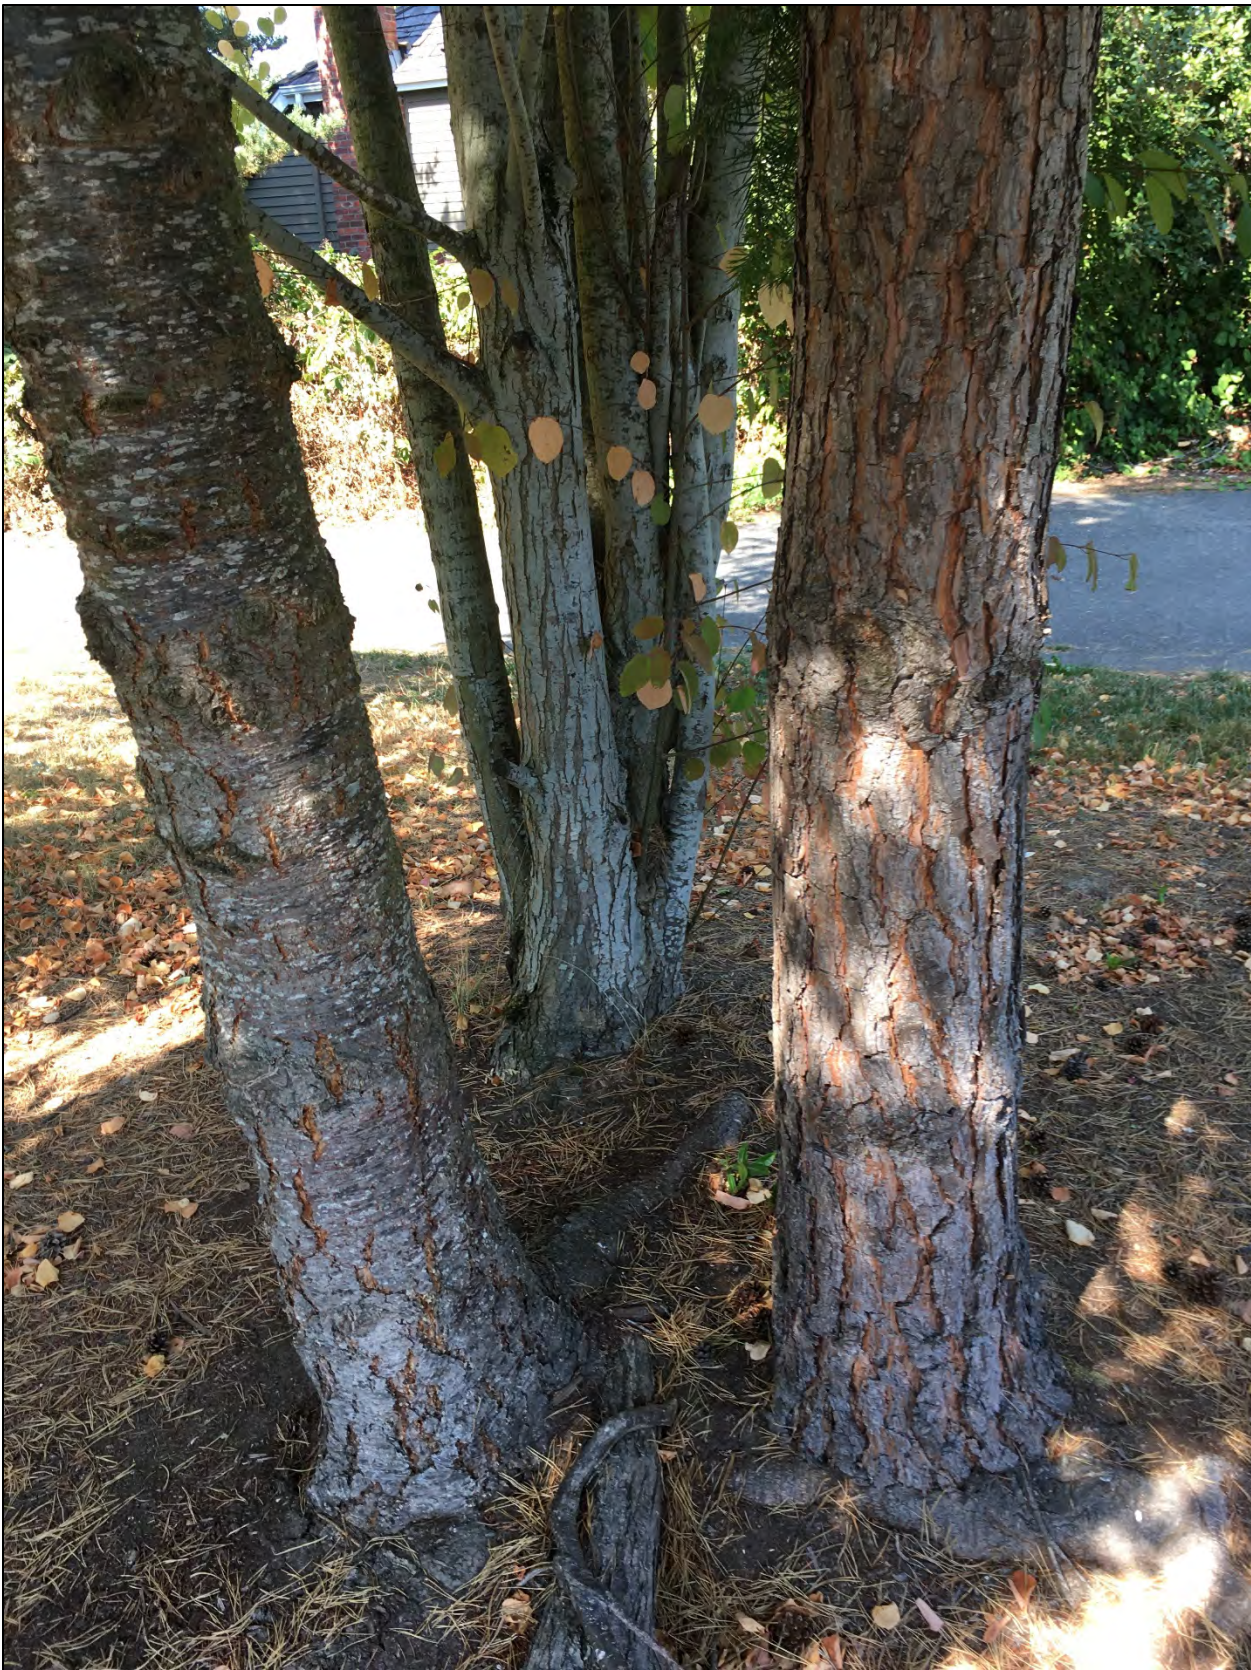
Image 3: proximity of trees #2, 3 and 4; view is looking northwest

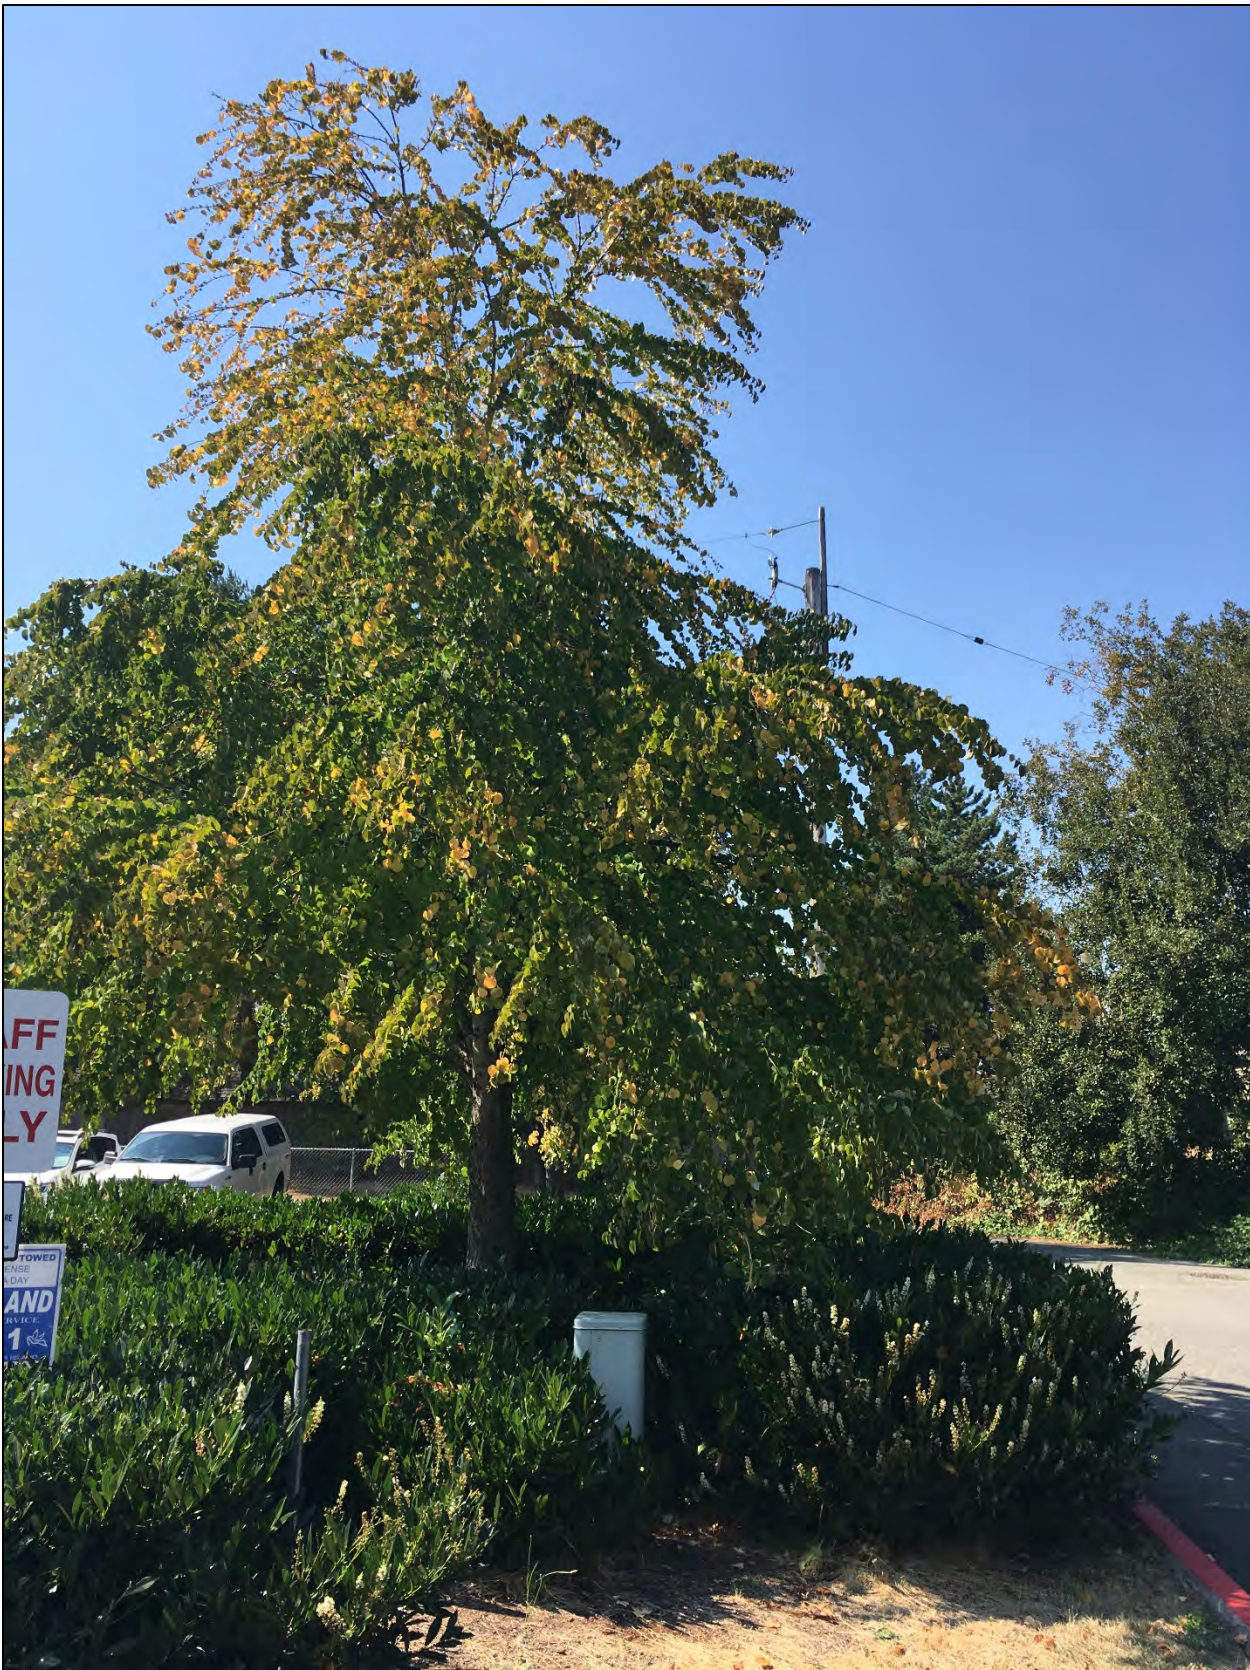
<i>Tree #</i>	<i>Species</i>	<i>DBH (inches)*</i>	<i>Health Rating**</i>	<i>Image</i>	<i>Notes</i>
1	<i>Cercidiphyllum japonicum</i>	12.4	fair	1	Lack of summer irrigation adding stress to tree; constrained vertical growth hypothesized to be resulting from reduced root anchorage due to compacted soil in planting bed
2	<i>Pinus contorta</i>	9	good	2	Poor location beneath overhead power lines, will be power line clearance pruned in next few cycles of pruning; canopy space competition with tree #3 and 4 creates naturally unbalanced canopy
3	<i>Pseudotsuga menziesii</i>	8.1	good	2	Poor location beneath overhead power lines, will be power line clearance pruned in next few cycles of pruning; canopy space competition with tree #2 and 4 creates naturally unbalanced canopy
4	<i>Cercidiphyllum japonicum</i>	10.4	Fair	2, 3	Canopy space competition with tree #2 and 3 creates naturally unbalanced canopy; lack of summer irrigation adding stress to tree

Image 4: tree #1 showing signs of late summer stress hypothesized to be from limited soil volume, compacted soils and lack of irrigation; view is westward
