October 31, 2017

RE Existing Side Sewers and Easements at 8000 SE 20th Street, Mercer Island

Excavation Locations

Project: NFH 8000 SE 20th St

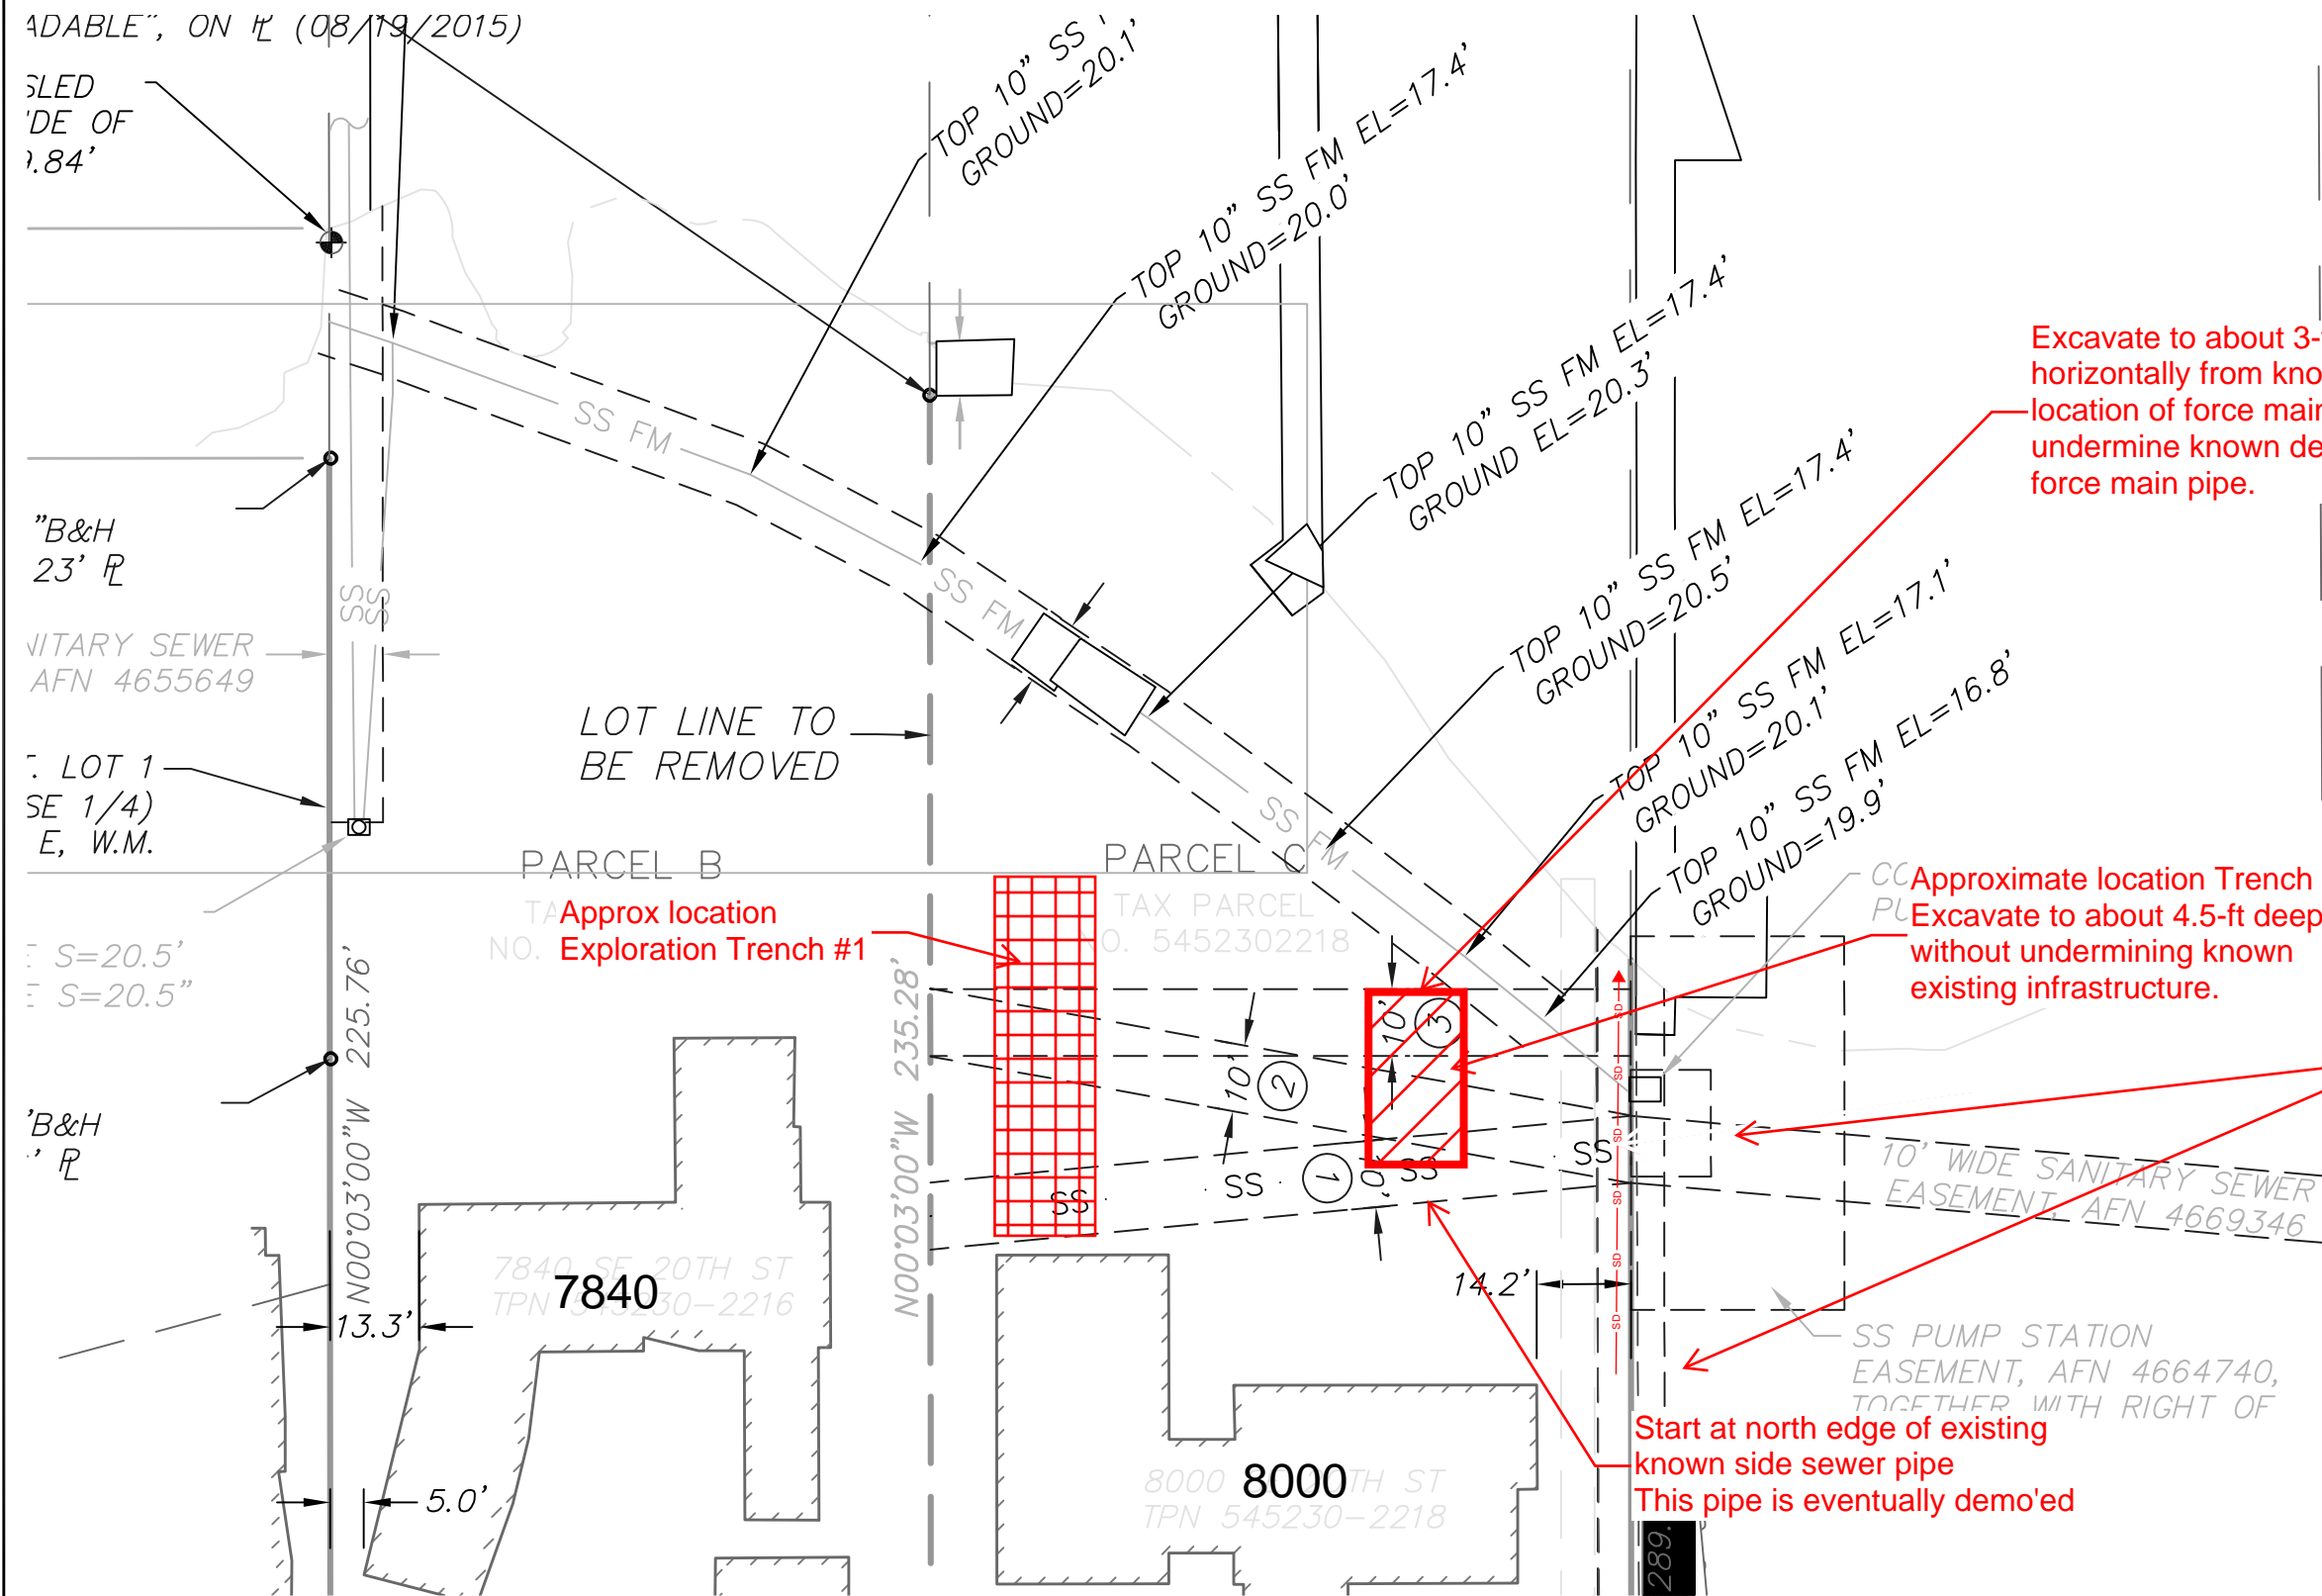
Excavate to about 3-feet horizontally from known location of force main, Do not undermine known depth of force main pipe.

Approximate location Trench #2
Excavate to about 4.5-ft deep without undermining known existing infrastructure.

Note that survey has the existing City sewer main and pump station on property to the east of this project

Start at north edge of existing known side sewer pipe
This pipe is eventually demo'ed

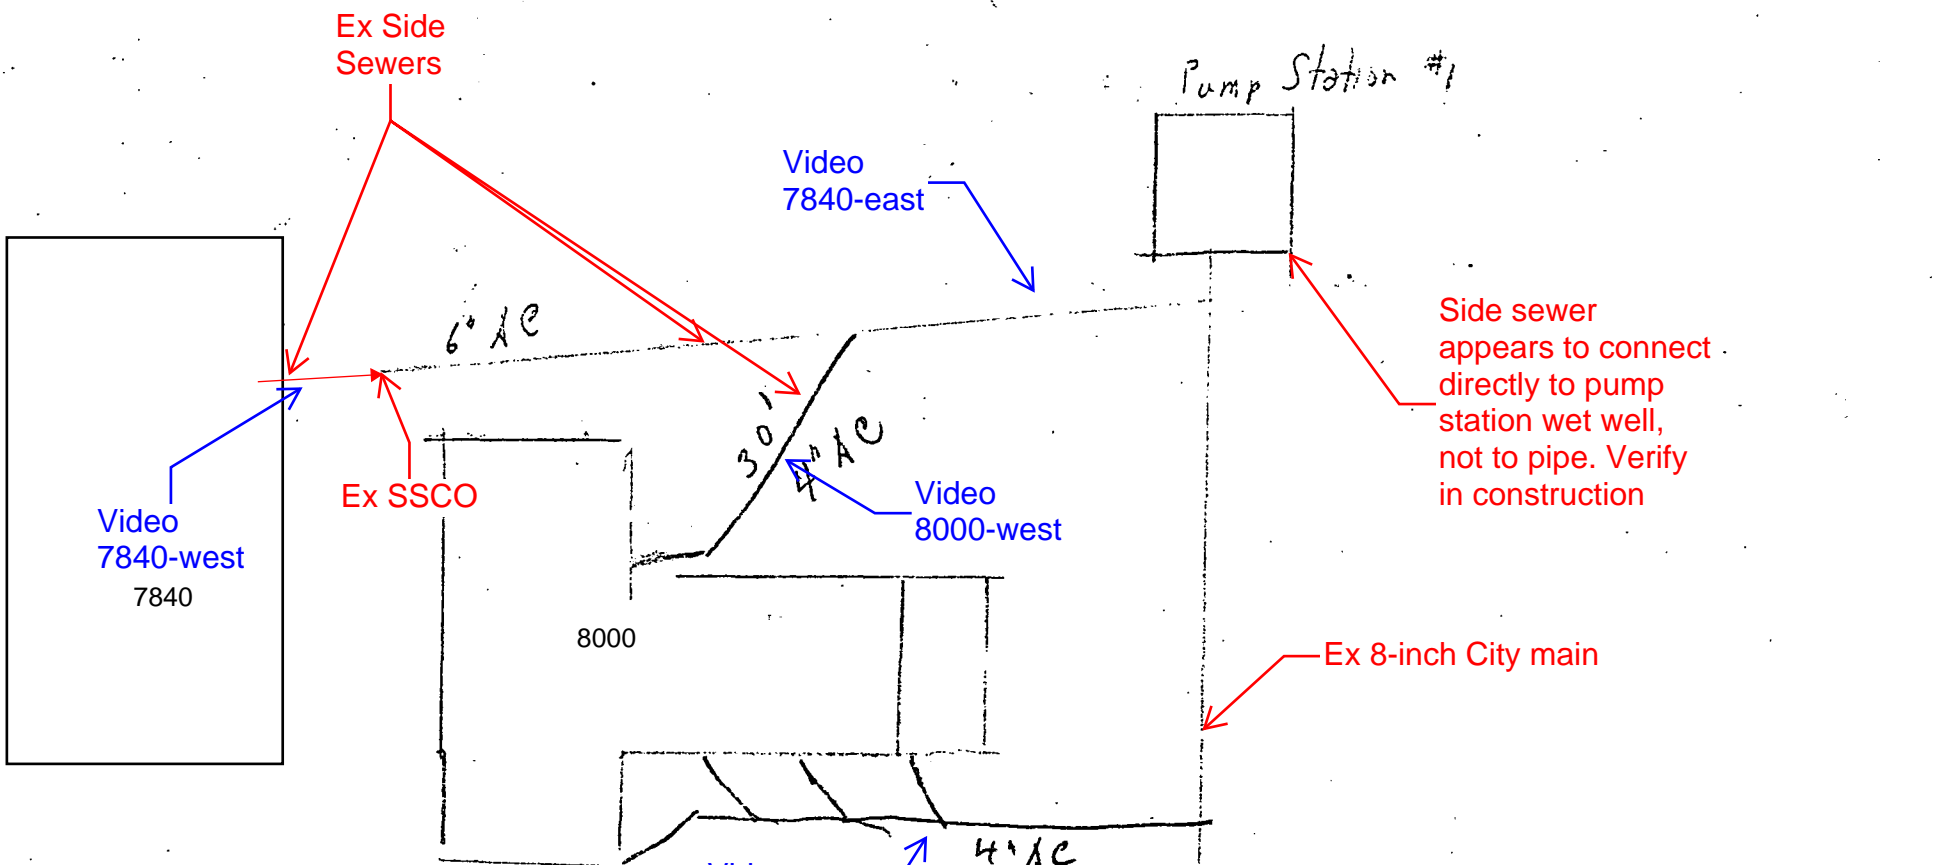
Side sewer appears to connect directly to pump station wet well, not to pipe. Verify in construction

the side sewer connects directly to the City's pump vault, in the wet well. This condition will be verified in construction and the new side sewer reconnected where the existing side sewer connects.

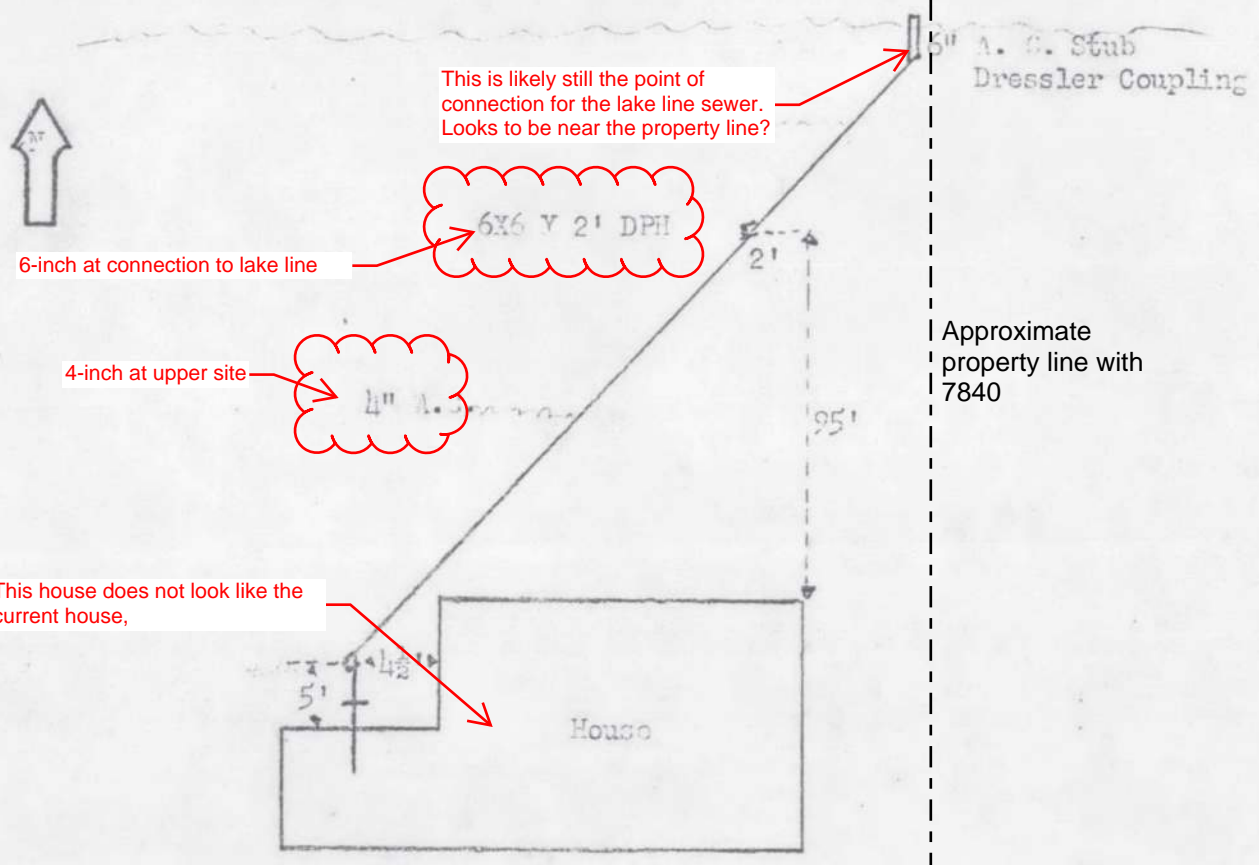
This is likely still the point of connection for the lake line sewer. Looks to be near the property line?

6-inch at connection to lake line

4-inch A.C. Stub

4-inch at upper site

This house does not look like the current house,

Approximate property line with 7840

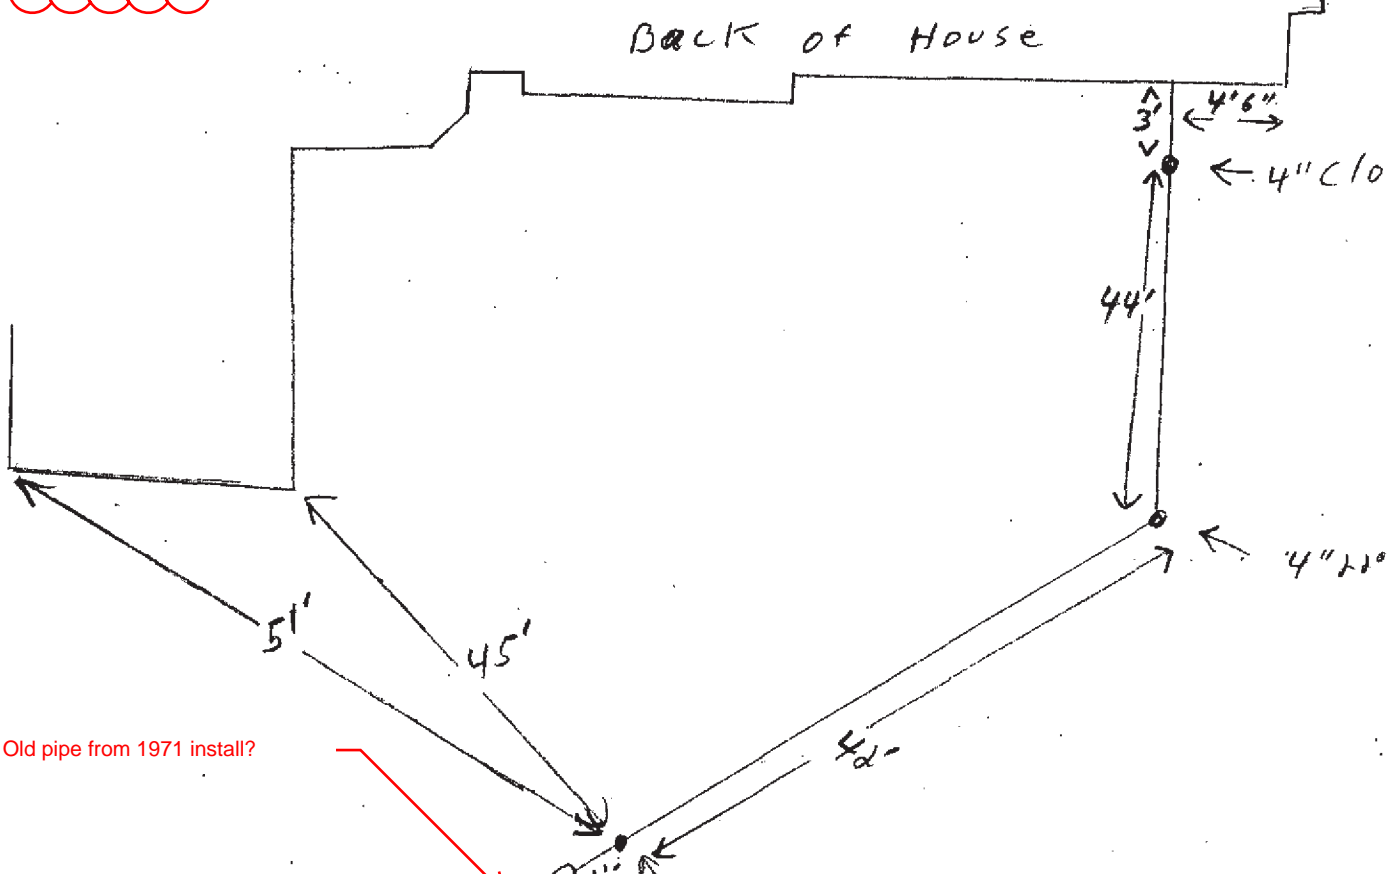
Old pipe from 1971 install?

Original install shows 6-inch further down the pipe

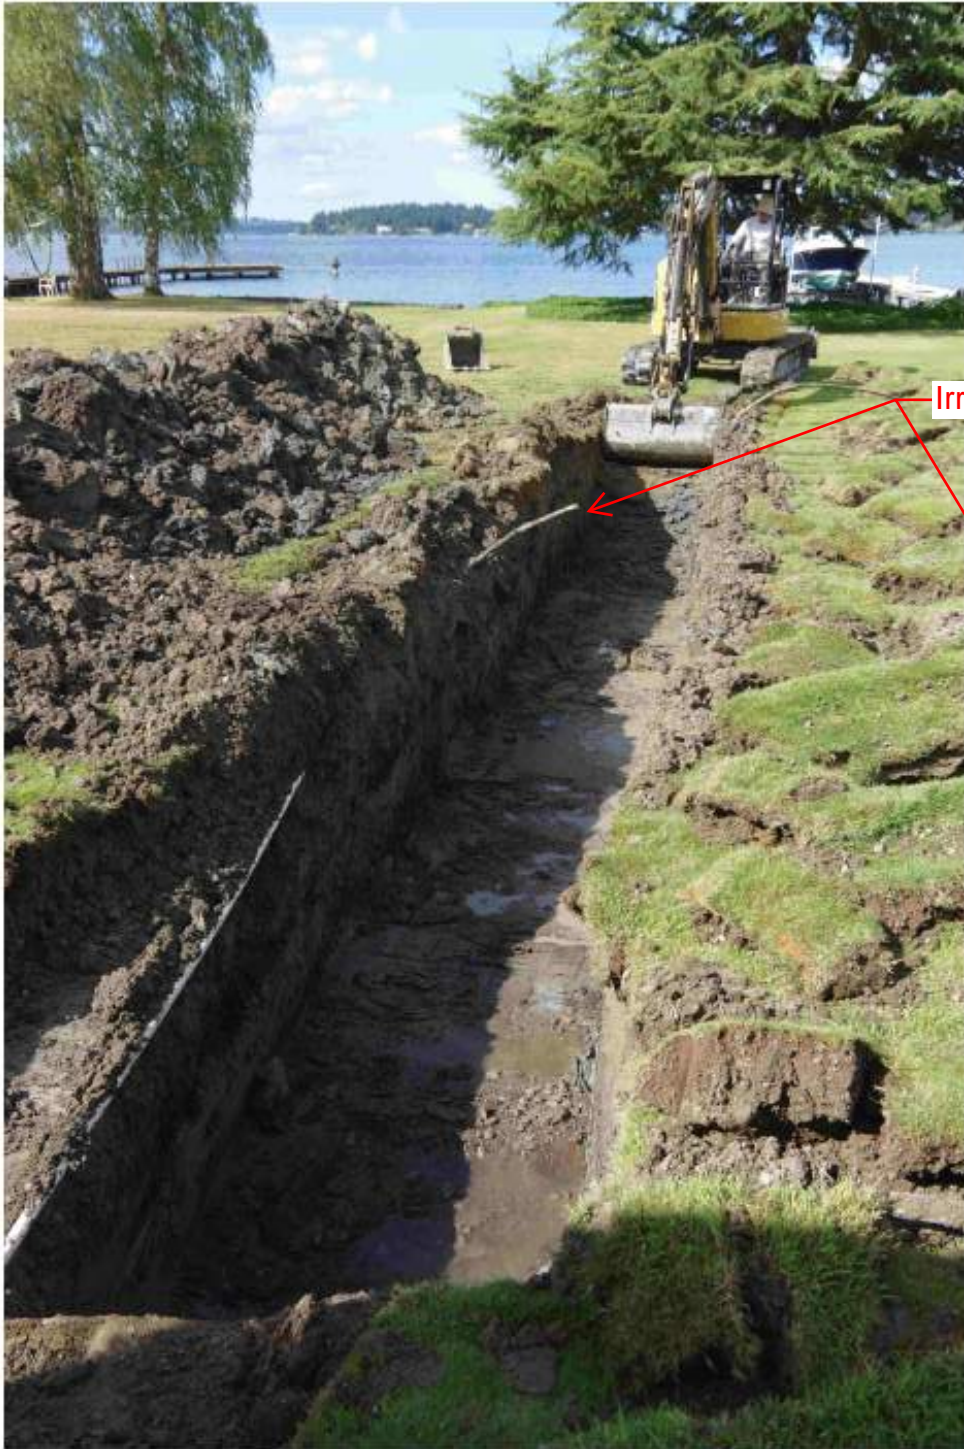
Looking North

One exploratory trench excavation was made from the north side of 8000 out to about 75-feet from the north face of the house off the west corner of the house, did not encounter any other utilities, except private irrigation and control conduit. Once below the topsoil and irrigation piping, the excavation appeared to be going through previously undisturbed soils. This excavation was made to a depth of between 3.5 and 4-feet.

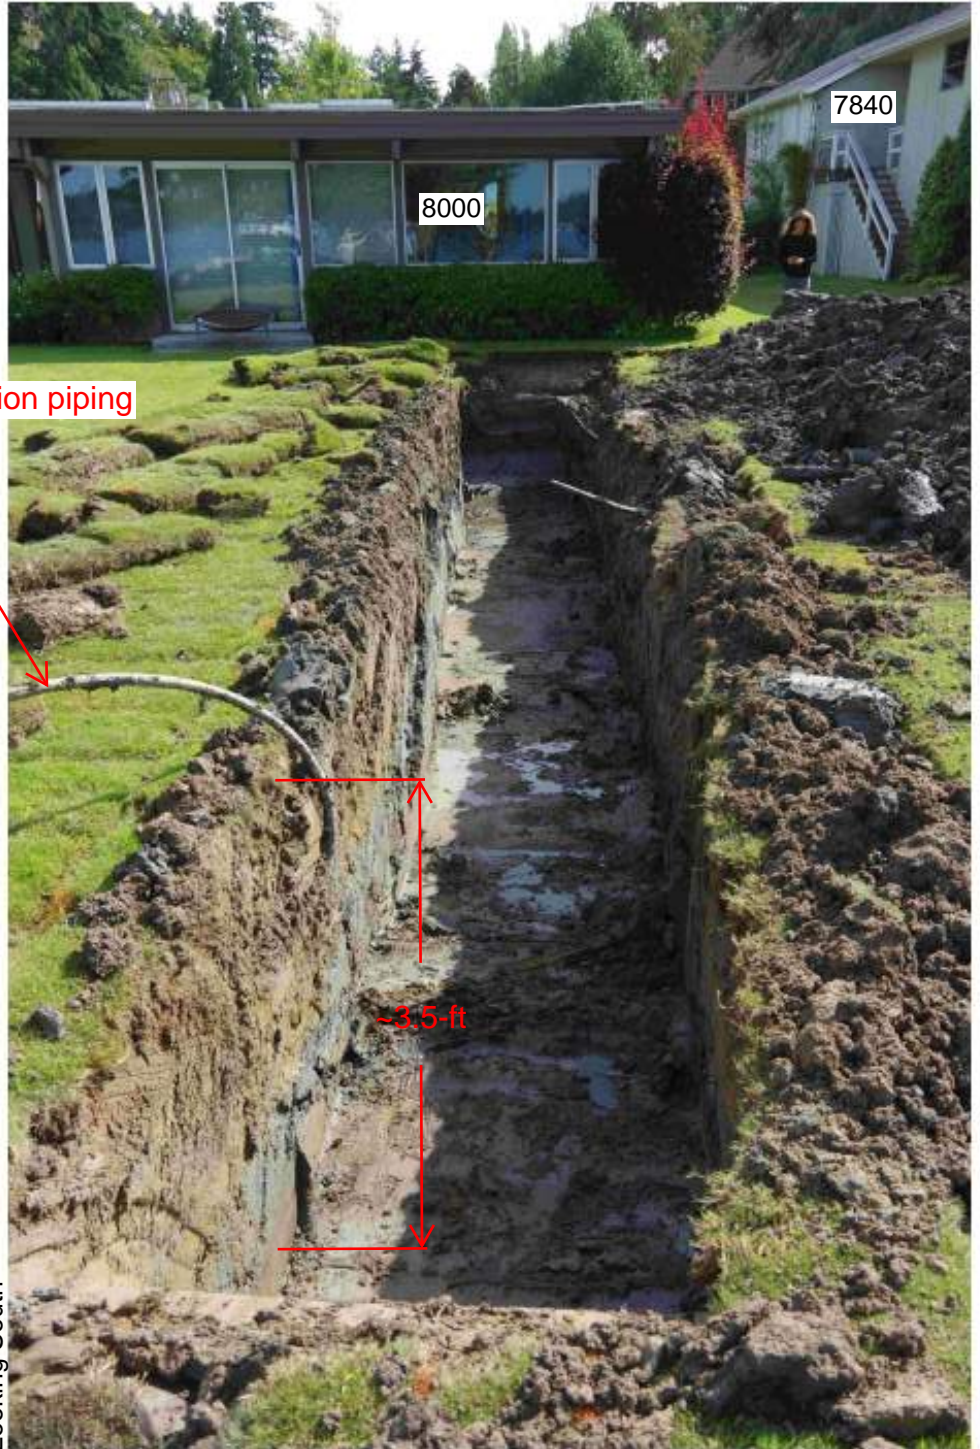
Looking South

Irrigation piping

~3.5 ft

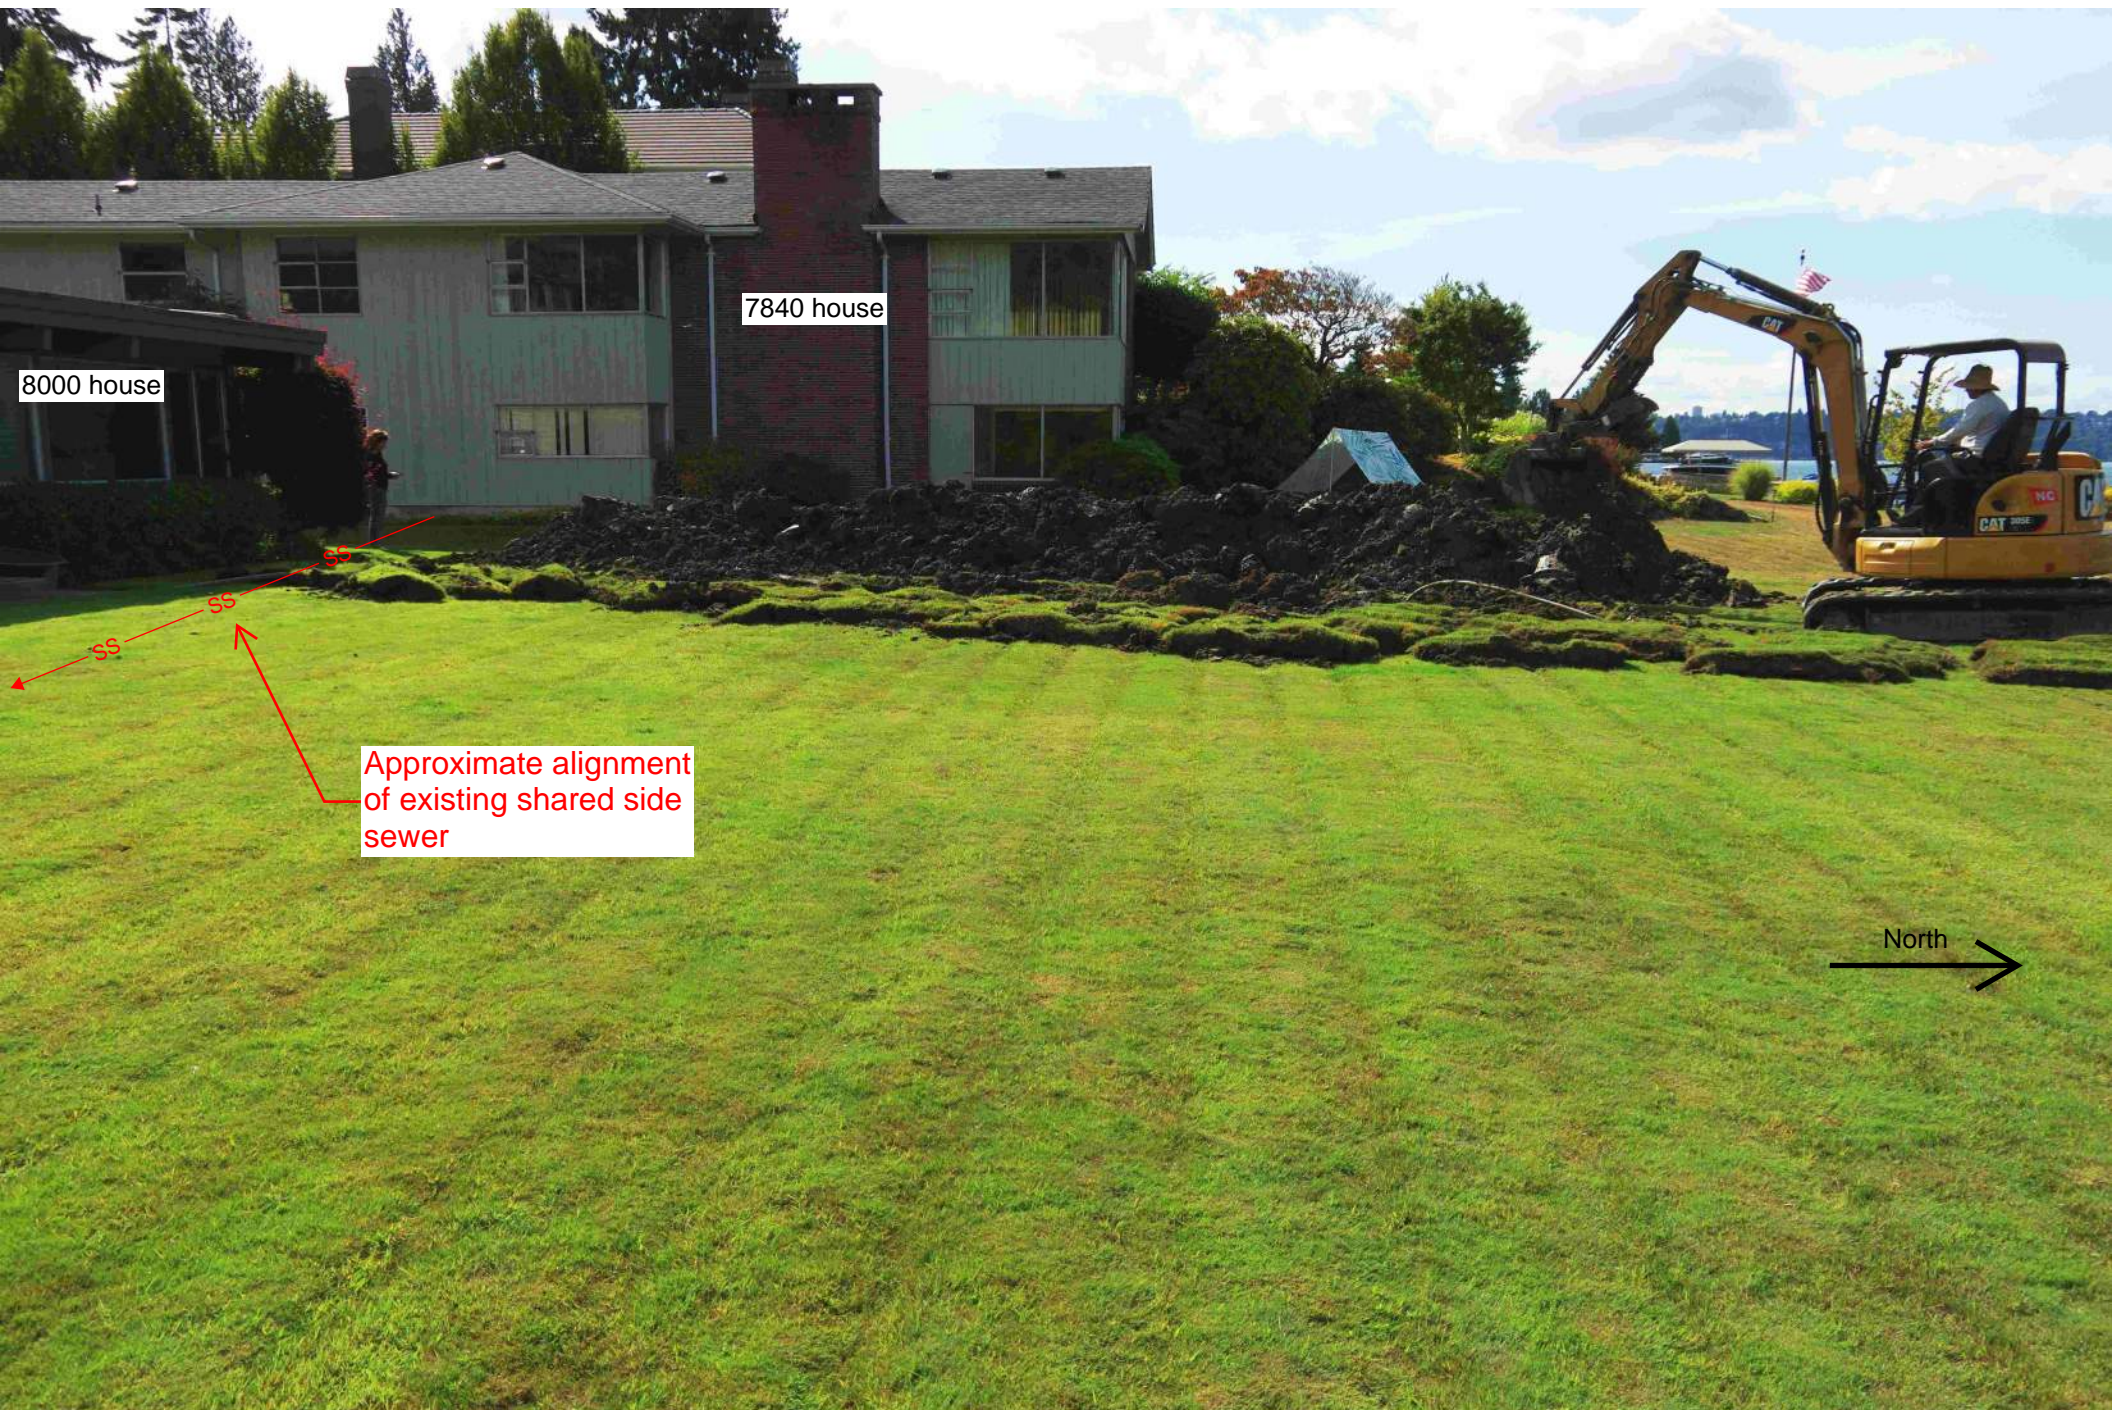
7840 house

8000 house

Approximate alignment
of existing shared side
sewer

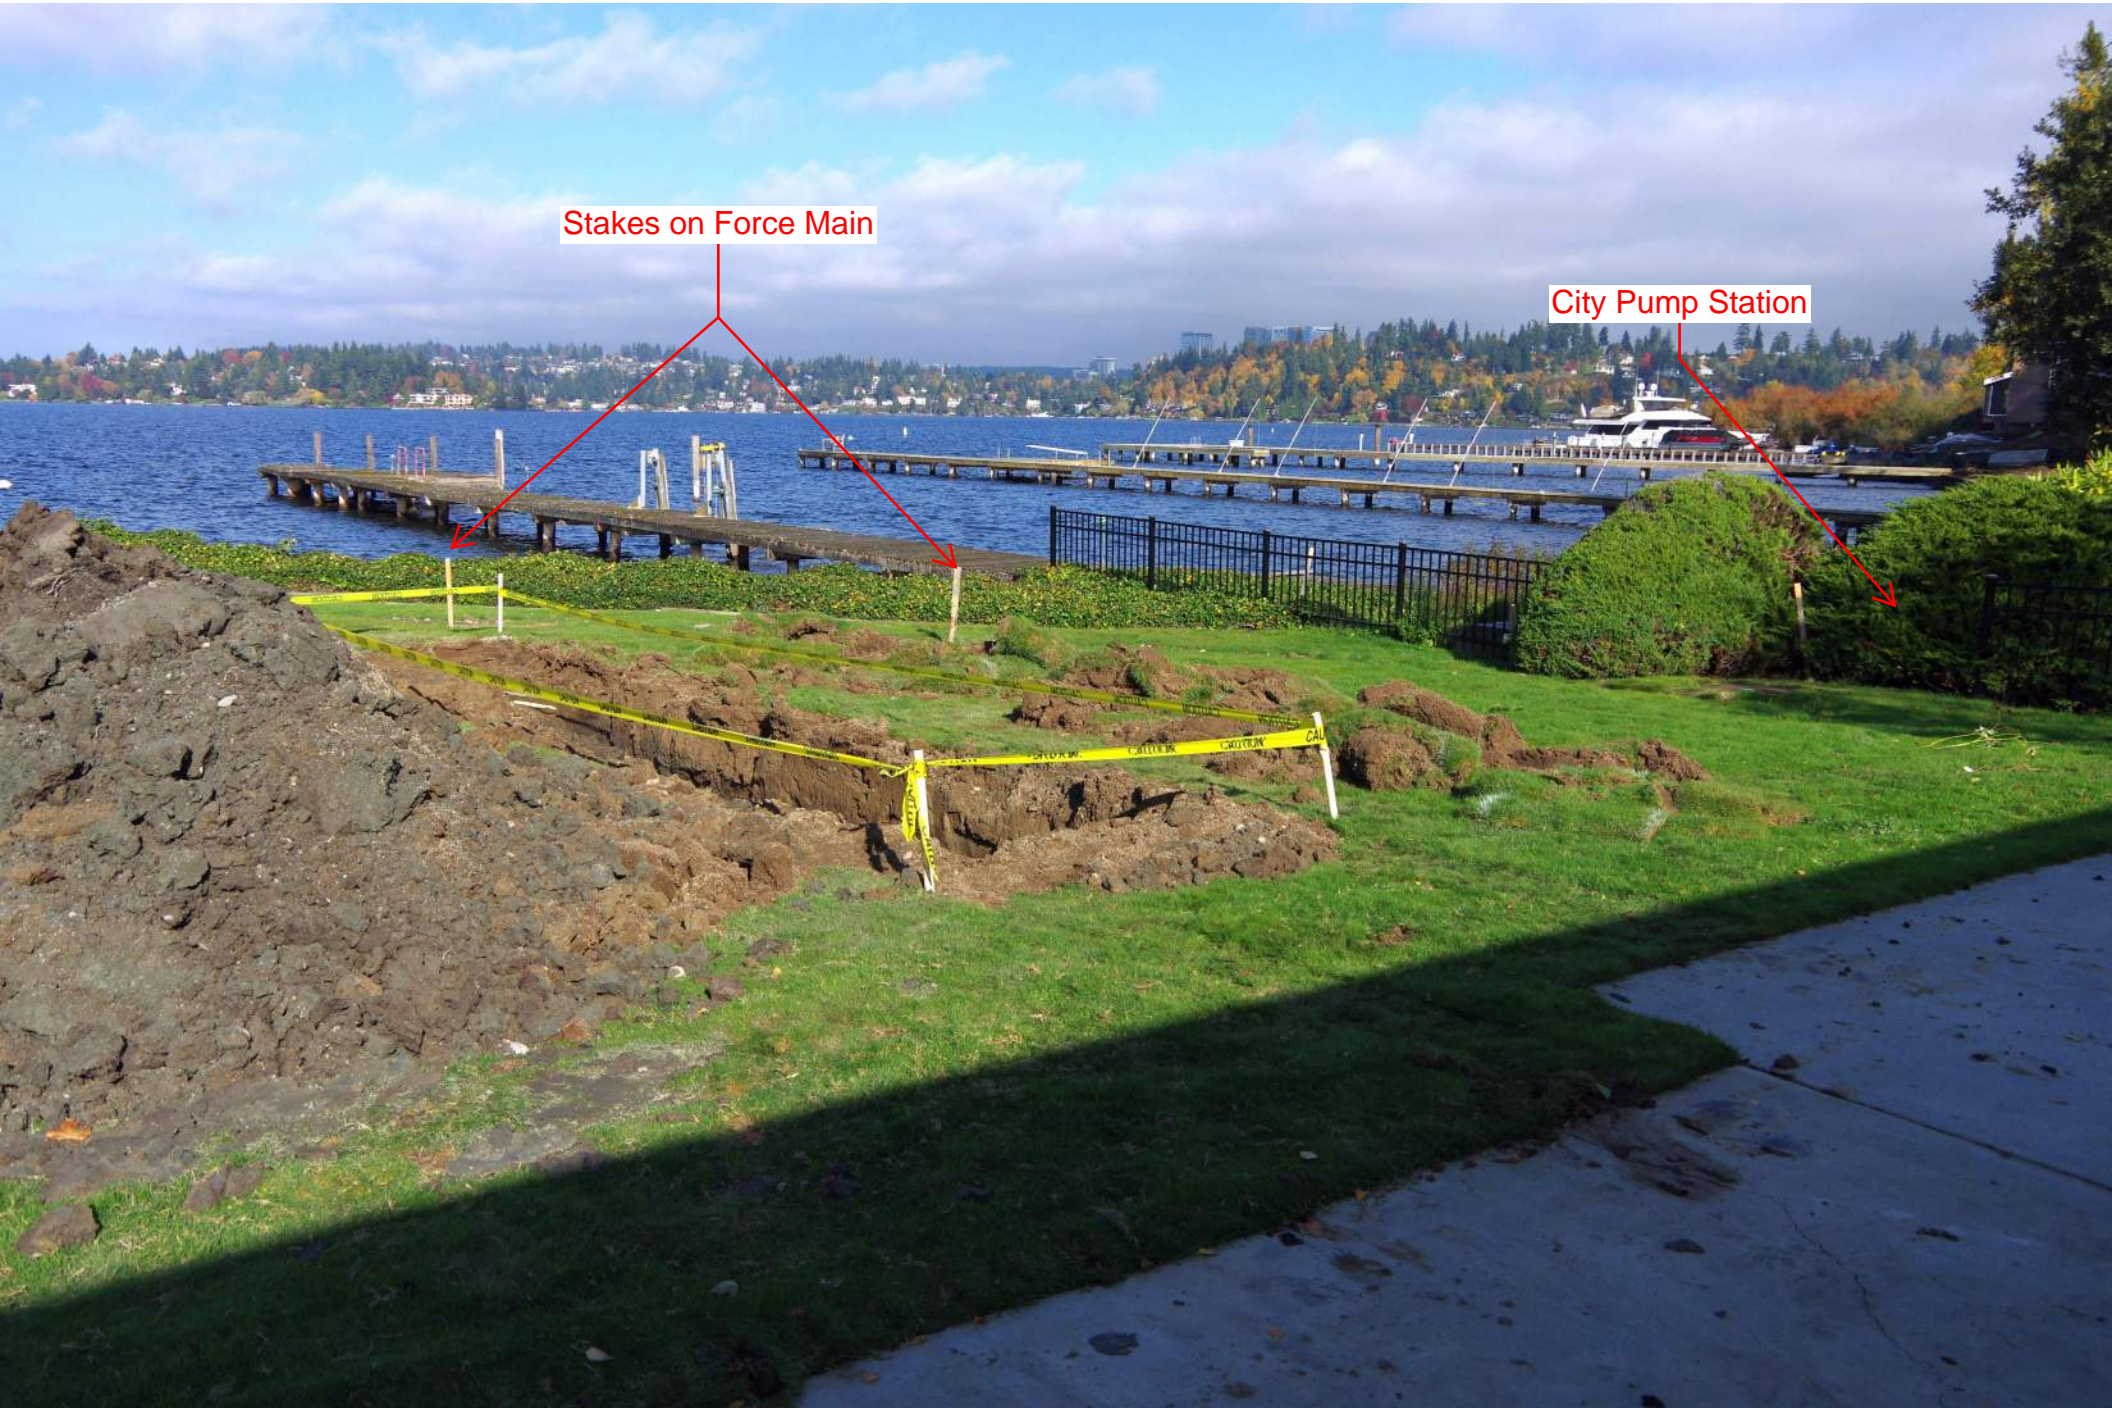
Stakes on Force Main

City Pump Station

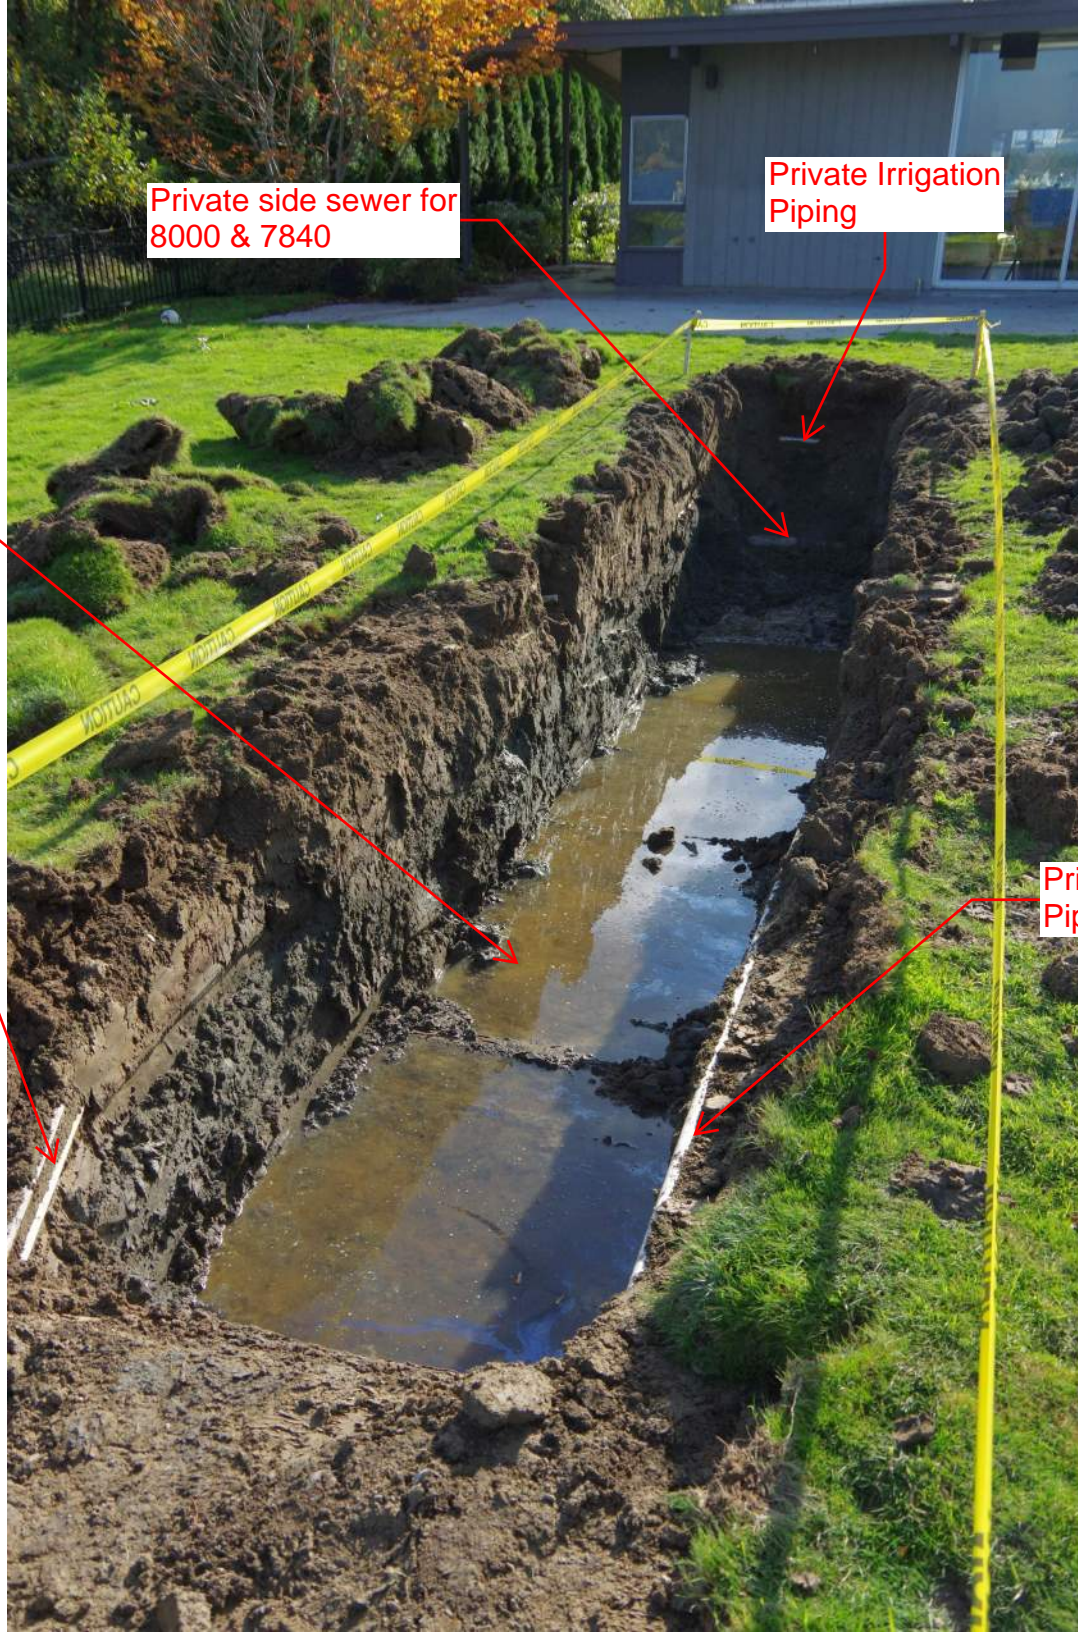
Private side sewer for 8000 & 7840

Private Irrigation Piping

Excavation to 4+ feet deep. This is below lake level and was starting to fill with lake water.

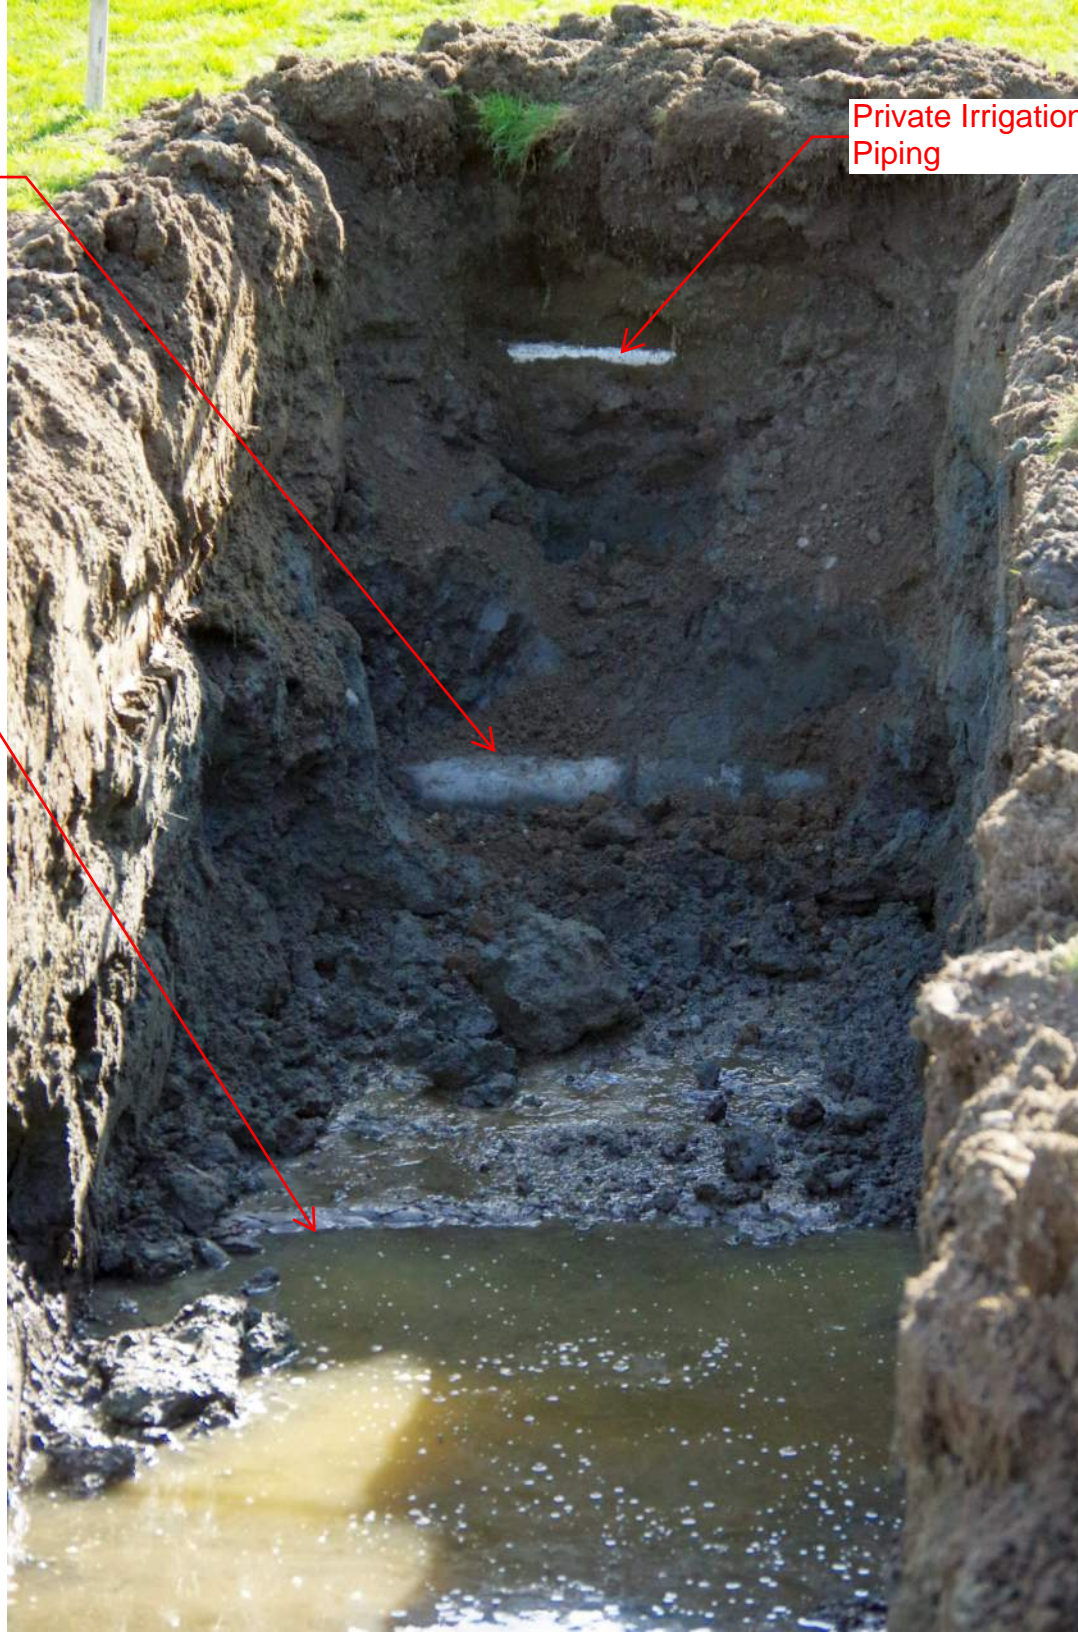
Private side sewer for
8000 & 7840

Private Irrigation
Piping

Excavation to 4+ feet deep.
This is below lake level and
was starting to fill with lake
water.
