Arborist Report

Tree Inventory - March 2023

Davey Resource Group (DRG) was contracted by Chung Ling (Vicky) Ou to inspect and provide an arborist report and tree protection plan for the property 3804 E Mercer Way in Mercer Island, Washington (PIN: 210700-0100). The client intends to develop the property.

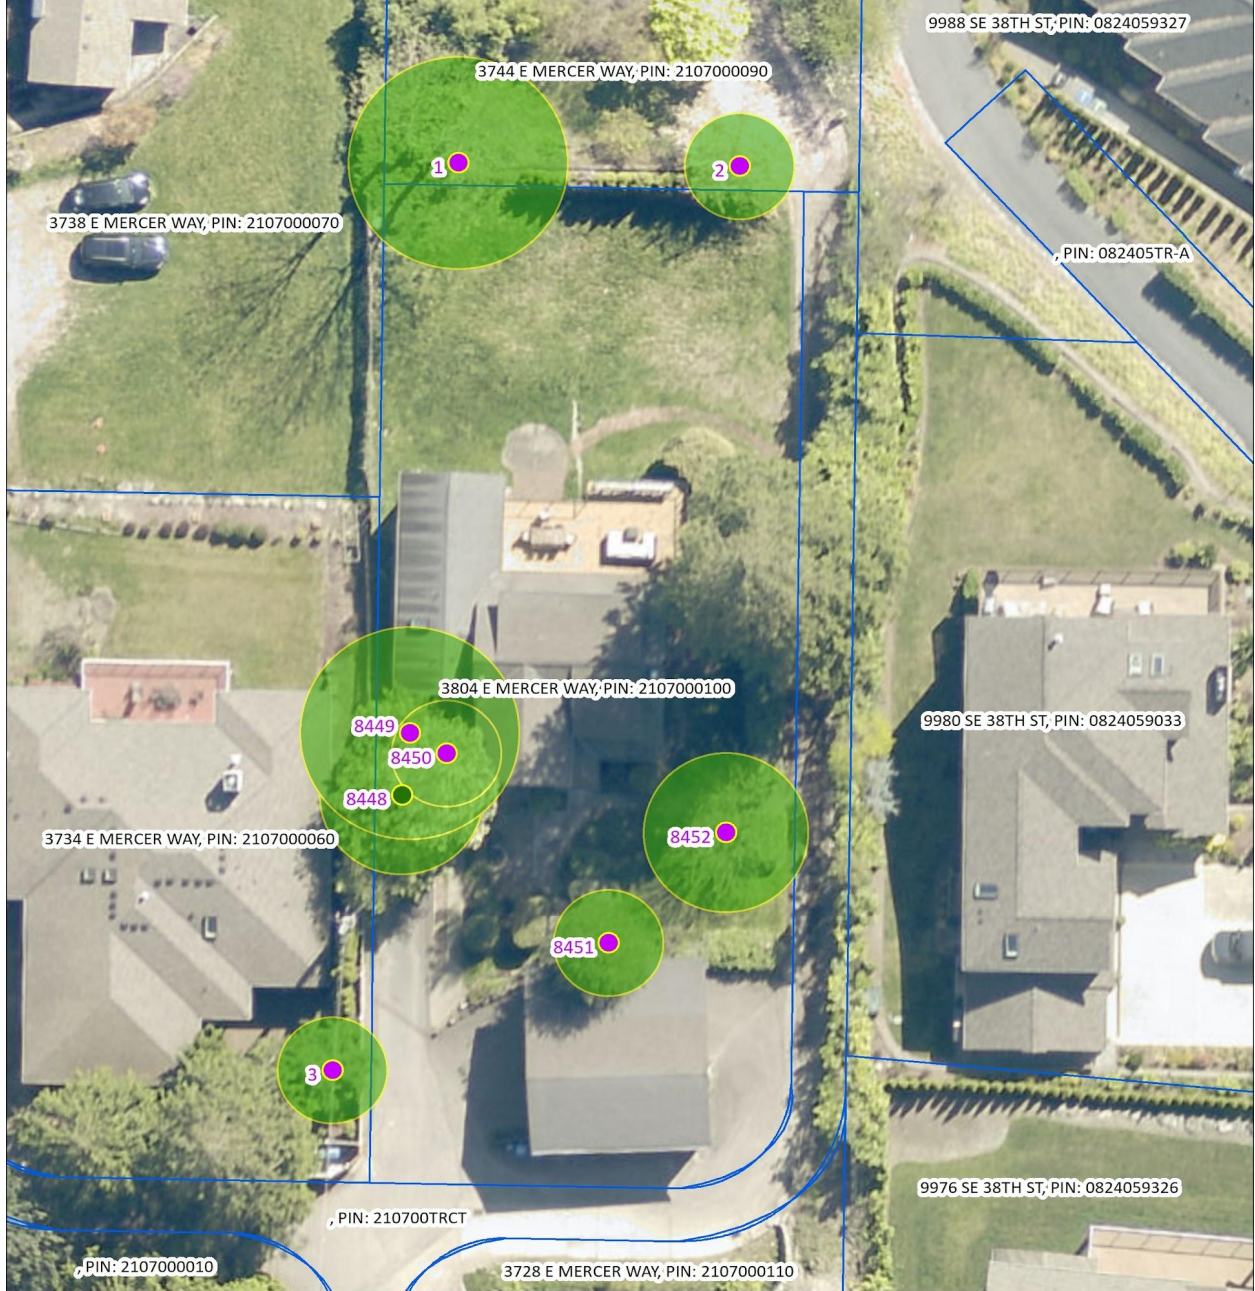
Map 1- Site map overview showing tree ID number. Aerial photos are only used for reference. Map projections may distort tree canopy size and locations.

A total of five (5) trees were inspected at the site and an additional three (3) trees were inspected off-site. The trees on-site are growing in terraced and landscaped areas of the property and appear to have a pruning history. Landscaping trees and shrubs are primarily located on the western side of the property in the front yard. One Cherry laurel tree has a calculated DSH of 24 inches and is considered to be an **Exceptional Tree** per the City of Mercer Island. The lawn in the backyard slopes downhill toward the lakefront neighbor to the east where Tree IDs #1 and #2 are growing. Tree ID# 3 is growing on the property to the north and has limited growing space due to the presence of overhead utilities.

- A total of five (5) trees were inspected at the site. Four (4) trees are in fair condition. One (1) tree is in poor condition.
- One tree (Tree ID #8448) has a DSH of 24 inches and is considered to be an **Exceptional Tree** per the City of Mercer Island.

- A total of three (3) trees were inspected off-site. Two (2) trees are in good condition. One (1) tree is in poor condition.
- Tree ID #1 and #2 are located on the parcel to the east (PIN: 210700-0090).
- Tree ID #3 is located on the parcel to the north (PIN: 210700-0060).

There are three (3) trees identified for removal along with a previously removed western red cedar (see addendum). According to MIMC 19.10.070, replacement trees are required based on tree size. A total of ten (10) replacement trees could be required to mitigate tree removals.

- Tree#8448 (24" DSH) is an **exceptional tree** and will require 3 replacement trees.
- Tree#8449 (11" DSH) is a regulated tree and will require 2 replacement trees.
- Tree #8450 (12" DSH) is a regulated tree and will require 2 replacement trees.
- A western red cedar (Estimated 26" DSH) had been removed from the site at some time in the recent past. This tree will require 3 replacement trees (see addendum).

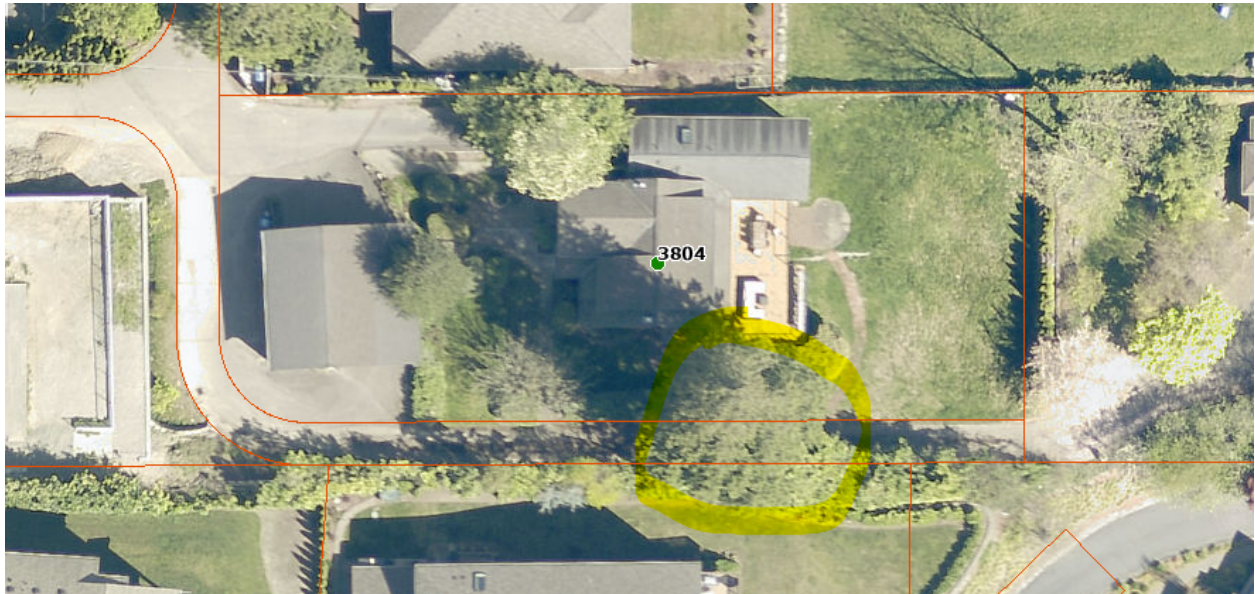
The City of Mercer Island has requested that all previously removed trees from the past five years be accounted for in this report. One tree was possibly removed from the subject property within this timeframe. The tree has been identified and circled in yellow from an image captured on the King County Parcel Map, however, it's unclear when the tree was removed.

Image 2. An overview of the subject parcel with the previously removed tree circled in yellow.

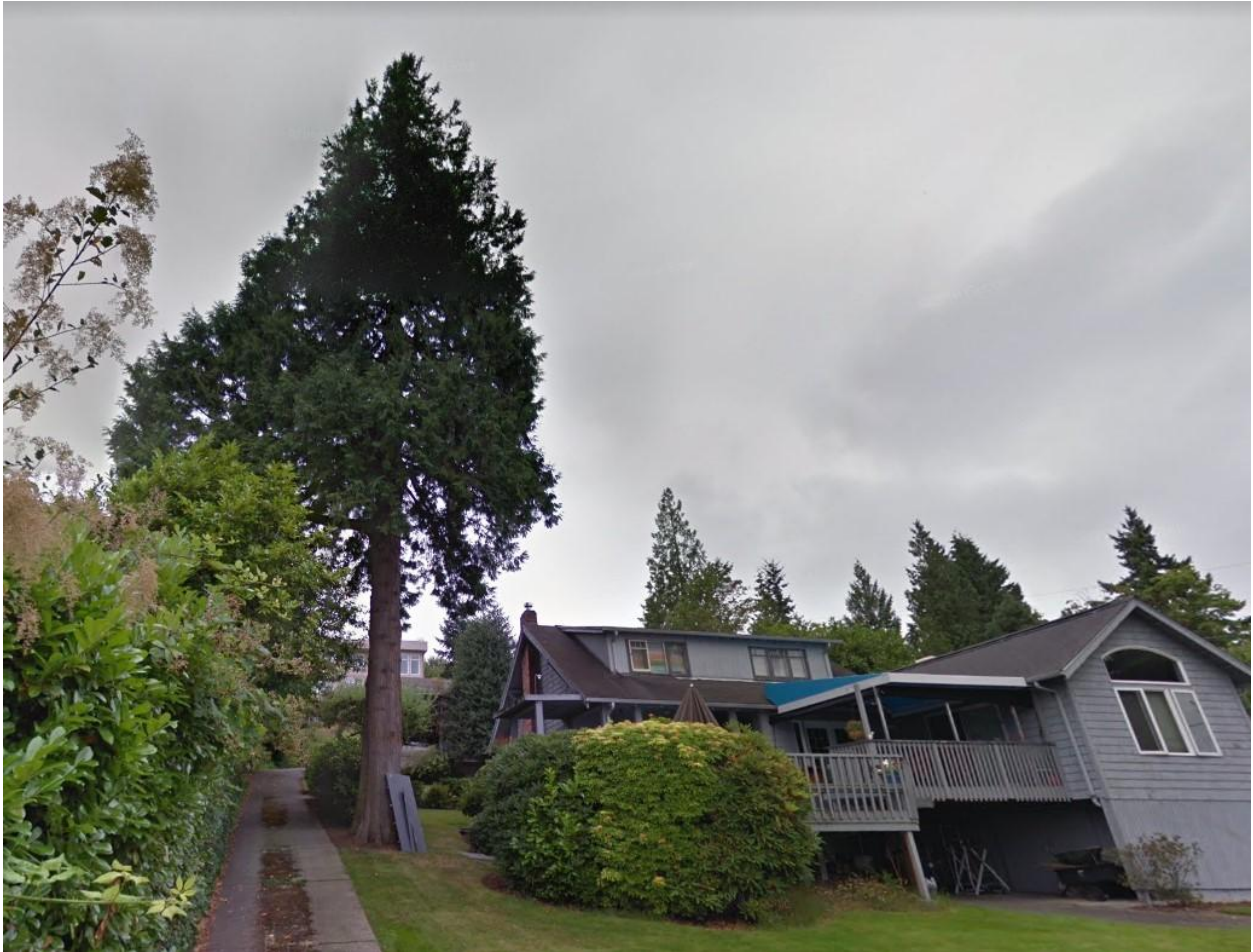
No stump or visible remnants of the trees remained on-site during the field inspection. Google Maps Streetview tool was used in order to determine the approximate size of the tree prior to its removal. The imagery was captured in August 2011. The tree appears to have been a tall-statured Western red cedar (*Thuja plicata*). Using other site objects and features as a reference, the estimated size (DSH) of the tree prior to its removal ranges from 26-30 inches. The image of the tree is included on the next page of the report.

Image 3. Google Maps Streetview imagery of the removed tree dated August 2011.
