EX. 1110
1/11

RE: CITY OF MERCER ISLAND PERMIT APPLICATION NUMBER 1410-199, HILLSIDE GRADING AT 7703 WEST MERCER WAY, MERCER ISLAND, WASHINGTON

GARTZ/HOLT RES.
DRIVEWAY REPAIR

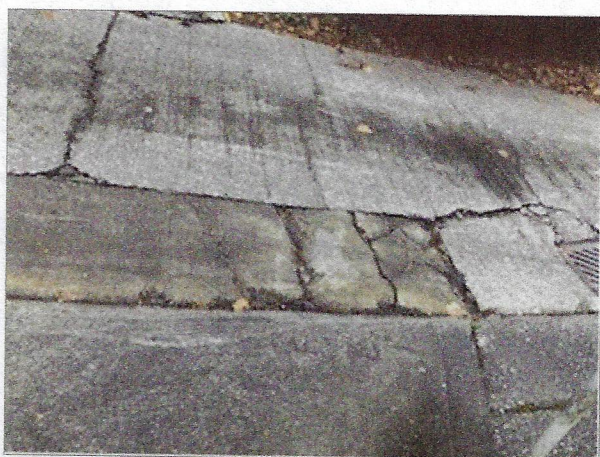
- All work will be on your private property.
- Remove approximately 600 square feet (sf) of distressed portland cement concrete pavement. The following photograph (Exhibit 1) shows pavement distress that was caused by poor pavement reconstruction following a waterline repair performed by the neighbor to the south.

Exhibit 1: Distressed Pavement from Waterline Repair

We observed the driveway and surrounding features on your property during our 2015 study and during site visits we made on January 5, 2019, and January 7, 2020. We did not observe evidence of slope movement in the proposed pavement repair area, adjacent portions of your driveway, and the rockery above the driveway. The pavement patches made by your neighbor are cracked and show evidence of settlement.

The distressed pavement where patched, likely is caused by two factors: poor subgrade preparation and poor portland cement pavement construction. We recommend evaluating the subgrade after removing the distressed pavement. Subgrade areas that are not dense and unyielding should be repaired. Repairs could consist of compacting the soil in place if the depth of poorly compacted or yielding soil is less than 12 inches and the moisture content of the soil is suitable for compaction. Deeper poorly compacted soil and/or soil that has a moisture content that is not suitable for compaction should be overexcavated and replaced with soil compacted in lifts. The thickness of a soil layer before compaction should not exceed 10 inches for heavy equipment compactors or 6 inches for hand-operated mechanical compactors. Before constructing the pavement, the prepared subgrade should be dense and unyielding.

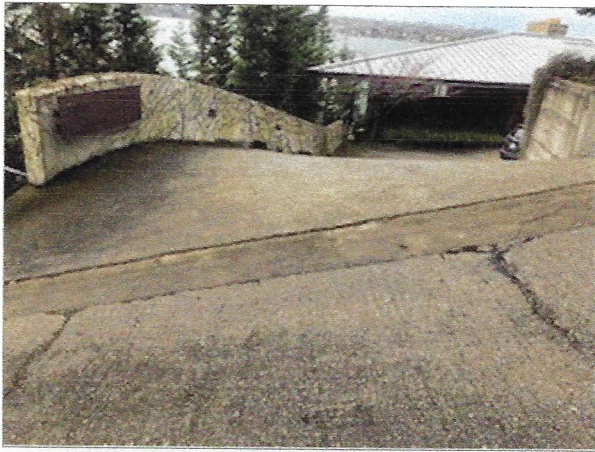
- Regrade approximately 600 sf of the driveway subgrade to remove a dangerous hump from the driveway into the parking apron as shown in the following photograph (Exhibit 2).

Exhibit 2: Driveway to Paring Apron, Note Hump.

Flattening the hump is necessary because numerous vehicles have been high centered when entering the parking area. The proposed regrading will flatten a steeper section and steepen a flatter section. The enclosed Entry Drive Paving Plan shows the proposed new pavement areas. The enclosed Section Looking SW shows the proposed changes in grade, which will be about 2 feet or less.

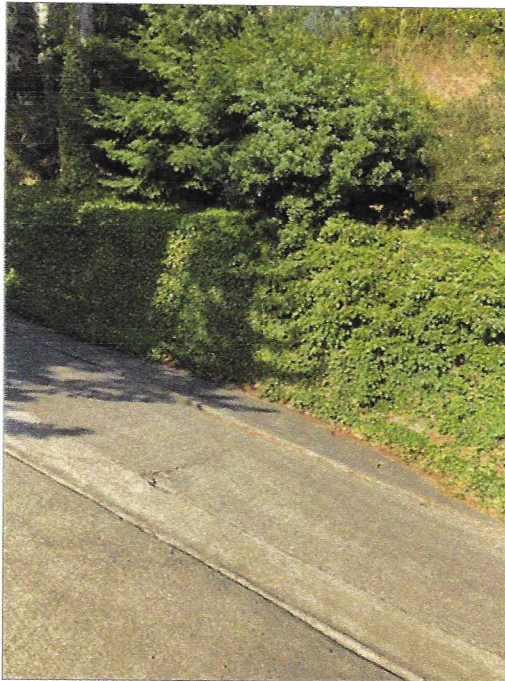
A low rockery covered with ivy is present on the northeast side of the driveway, as shown in the following photograph (Exhibit 3):

Exhibit 3: Ivy-Covered Rockery Northeast of Driveway.

The repaired pavement will remain at the existing grades along the base of the rockery, i.e., the proposed work will not reduce toe support for the rockery.

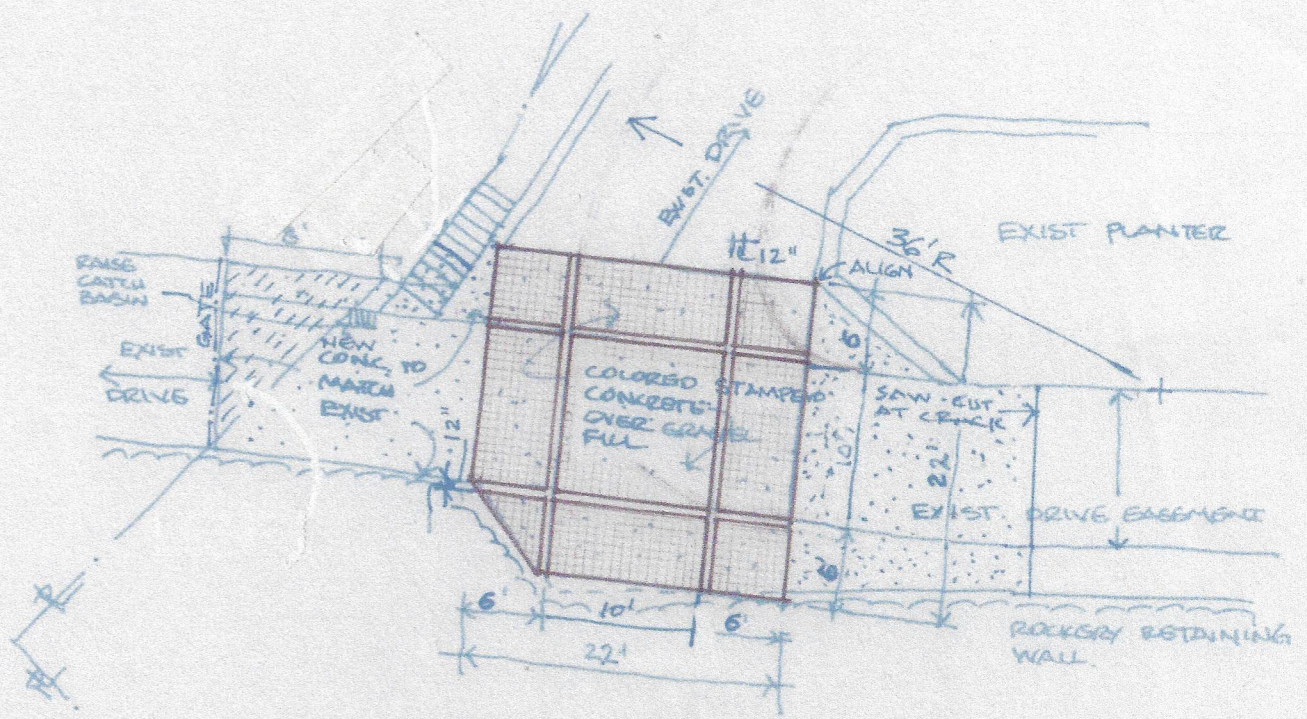
ENTRY DRIVE
PAVING PLAN
FEB 1, 09
REV. OCT 10, 19
REV. OCT 24, 19
1/8" = 1'-0"

The enclosed Entry Drive Paving Plan shows the areas of distressed pavement that will be removed and replaced.
