May 16, 2017

JN 16556

Subject: **Geotechnical Engineering Study**
Proposed Landslide Repair Project
8100 Evergreen Lane
Seattle, Washington

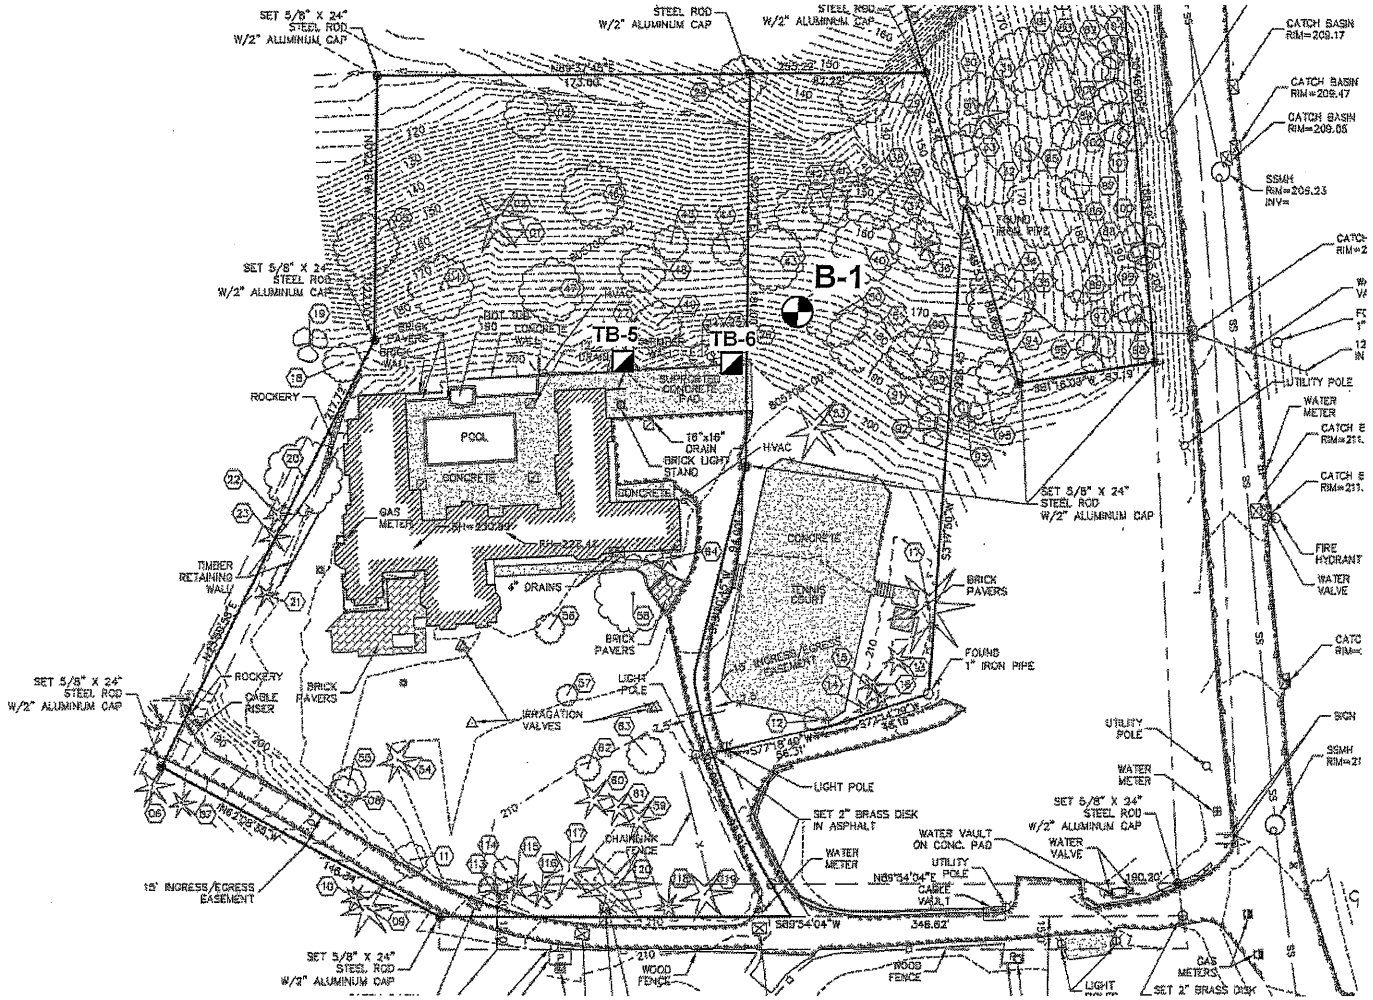
SITE EXPLORATION PLAN
8100 Evergreen Lane
Mercer Island, Washington

The subsurface conditions in the landslide area were recently explored by drilling one test boring at the approximate location shown on the Site Exploration Plan, Plate 2. However, several other test borings were drilled in this area in 1993 prior to the construction of the parking structure; these test borings were contained within a geotechnical engineering study prepared by Terra Associates. Our recent exploration program was based on the proposed construction, anticipated subsurface conditions based on the previous test borings and those encountered during exploration, and the scope of work outlined in our proposal.

The Terra Associate's study indicated that two test borings had been drilled at that time in the area of the parking structure. The location of these test borings is also shown on Plate 2. These test borings indicated that loose fill and native silty soils in the range of 10 to 12 feet were revealed overlying competent, native silty soil. On November 16, 2016, our personnel traversed the landslide area and used a shovel to expose soils in the landslide area near the northern edge of the parking structure. We observed that, in general, there was about 7 feet of loose fill soil overlying about 4 feet of loose/soft native silt soil. More competent silt soil was seen under these upper loose/soft soils; thus, the soils we observed were very similar to the soil conditions noted in the 1993 test borings. The logs of the two notable test borings are included in the Appendix of this study.

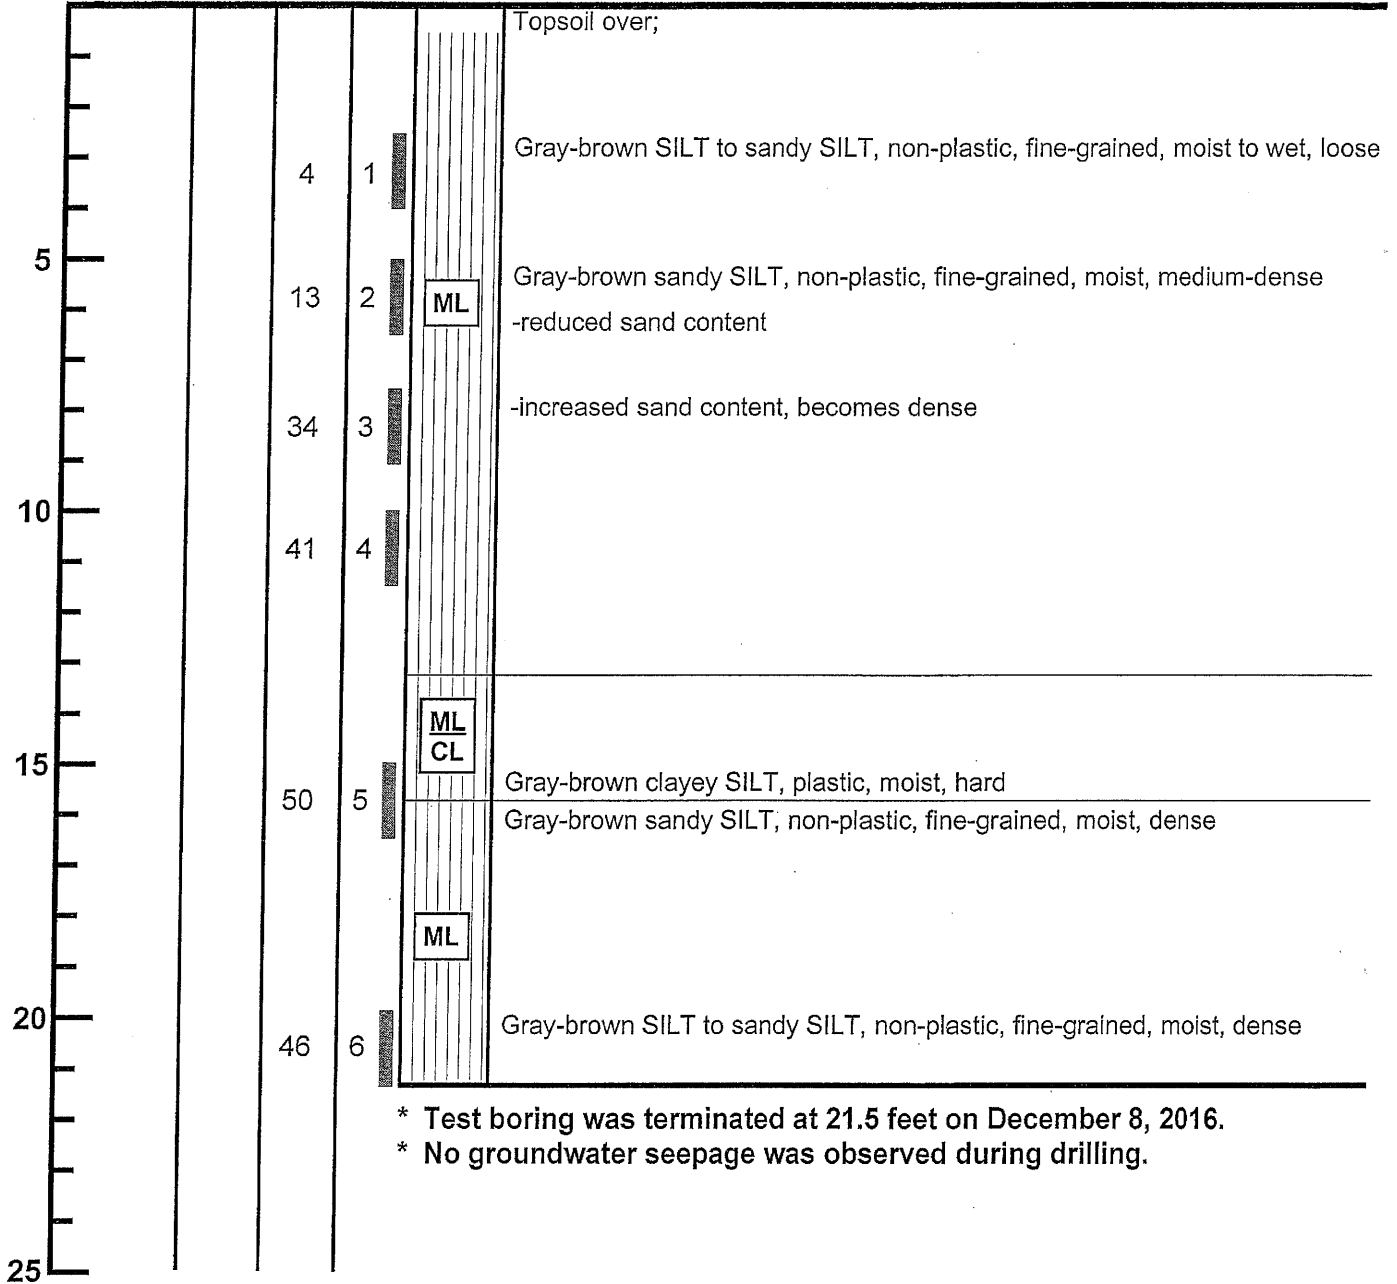
TEST BORING LOG

A recent test boring was drilled on December 8, 2016 using a portable Acker drill -- this drill system utilizes a small, gasoline-powered engine to advance a hollow-stem auger to the sampling depth. Samples were taken at approximate 2.5- to 5-foot intervals with a standard penetration sampler. This split-spoon sampler, which has a 2-inch outside diameter, is driven into the soil with a 140-pound hammer falling 30 inches. The number of blows required to advance the sampler a given distance is an indication of the soil density or consistency. A geotechnical engineer from our staff observed the drilling process, logged the test borings, and obtained representative samples of the soil encountered. The recent Test Boring Log is attached as Plate 2. The test boring was drilled just outside of the eastern edge of the recent landslide (the landslide area was covered in plastic, so we could not drill within the landslide area). The soil revealed in the test boring was quite similar to the 1993 test borings, but not including the upper fill soil; it appears that this portion of the slope did not have fill soil placed on it. The upper, approximate 4 feet of soil revealed in the recent test boring consisted of loose, native, somewhat sandy silt soil. This loose was underlain by medium-dense to dense silt soil to a depth of approximately 13 feet. The silt below this level was either hard or dense to very dense down to a maximum explored depth of 21.5 feet.

Some groundwater could readily be seen on November 16, 2016 in the landslide area flowing beneath the loose/soft soils and perched on the surface of the more competent silt soil. However, no groundwater seepage in the recent test boring drilled on December 8, 2016. Therefore, it appears that the groundwater seepage that perches on the more competent silt soil occurs follows a period(s) of significant rainfall.
