EVALUATION OF TREES AT

**4825 East Mercer Way
Mercer Island, WA 98040**

September 19, 2017

Brian K. Gilles, Consulting Arborist

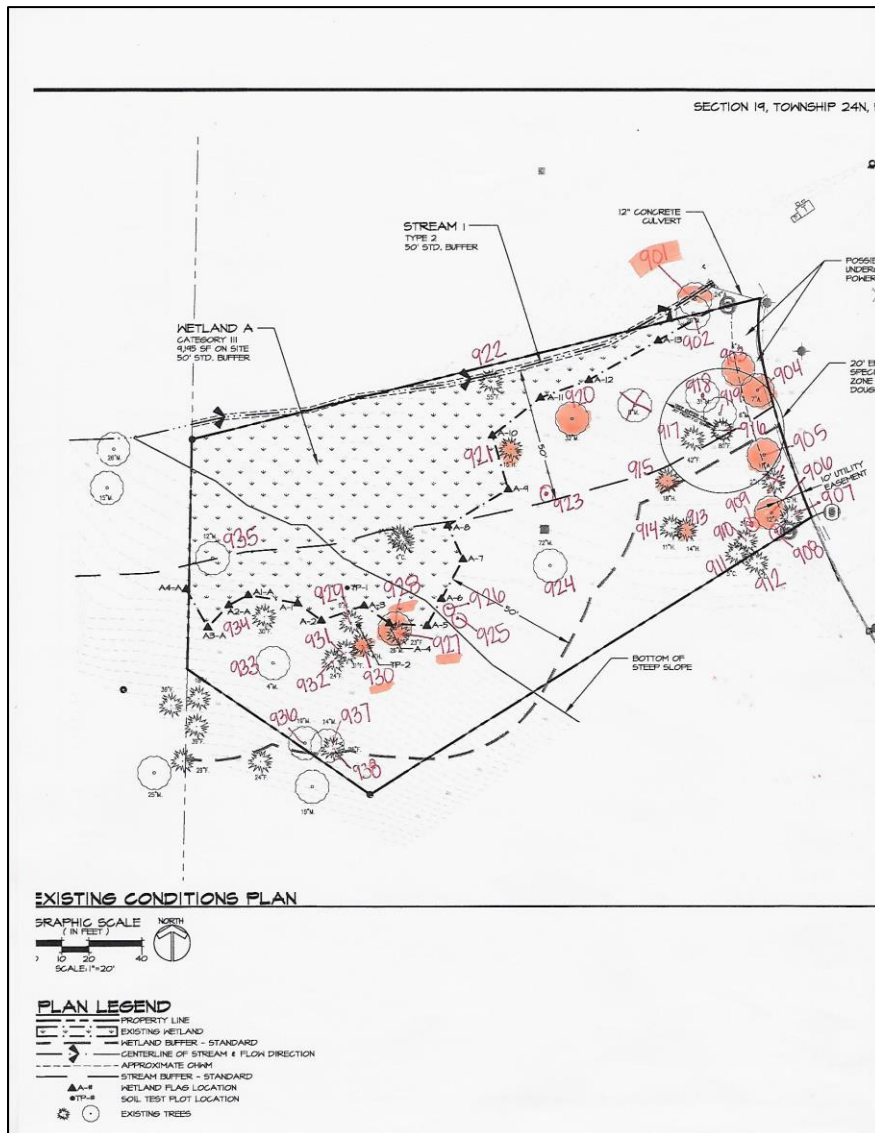
Exhibit # 1: The Existing Conditions Plan from Talasaea Consultants, Inc. showing the eleven *Non-Viable* Trees. It is obvious that many of the trees are within striking distance of the proposed driveway and home. Many of these trees will need to be reduced for safety. Some can be allowed to fall on their own if they do not have a target. Some can be converted into Habitat Trees, Nurse Logs, and Brush Piles to benefit erosion control and desirable urban/suburban wildlife. Please refer to *Attachment 6, Habitat Tree, Nurse Log, and Brush Pile Creation and Benefits* for important information.

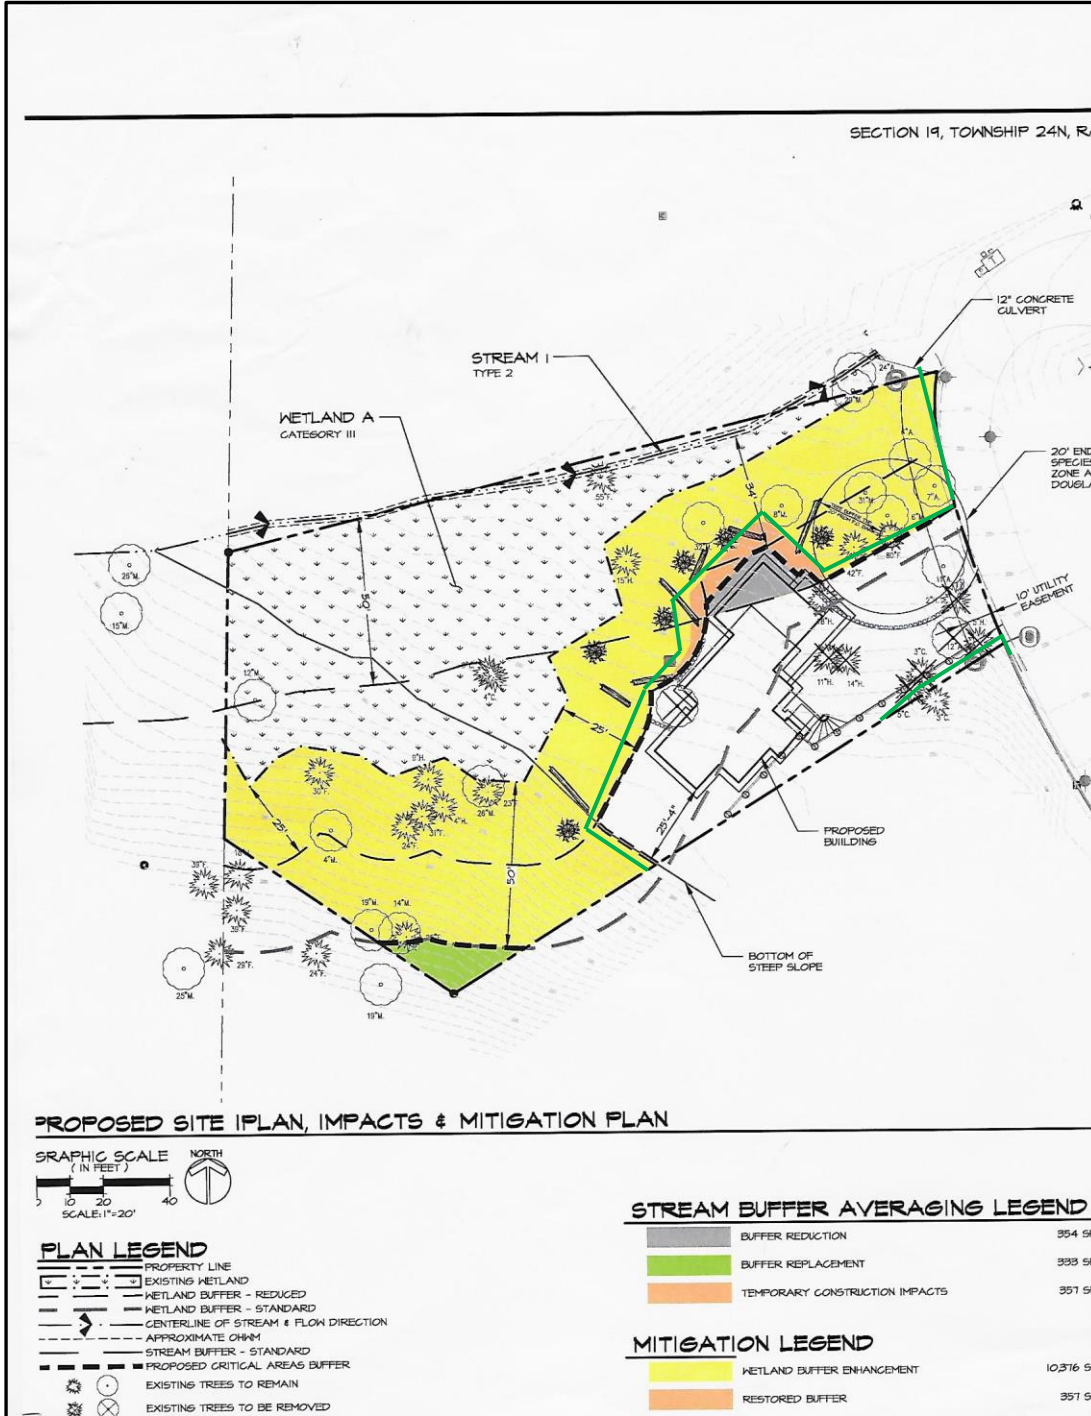
Proposed Site Plan, Impacts, & Mitigation Plan, provided by Talasaea Consultants,
 Approximate locations of *Tree Protection Fences* _____
