On June 29, 2019 Kurt Fickeisen from Symbiosis Tree Care came to the 4825-Property to inspect and evaluate trees.

This report provides information on several 4825-Property trees and evaluates prior assessments by arborists on the property. Recommendations based on observations and findings are provided. Please see Assumptions and Limitations for this report (**Assumptions and Limitations**).

Summary

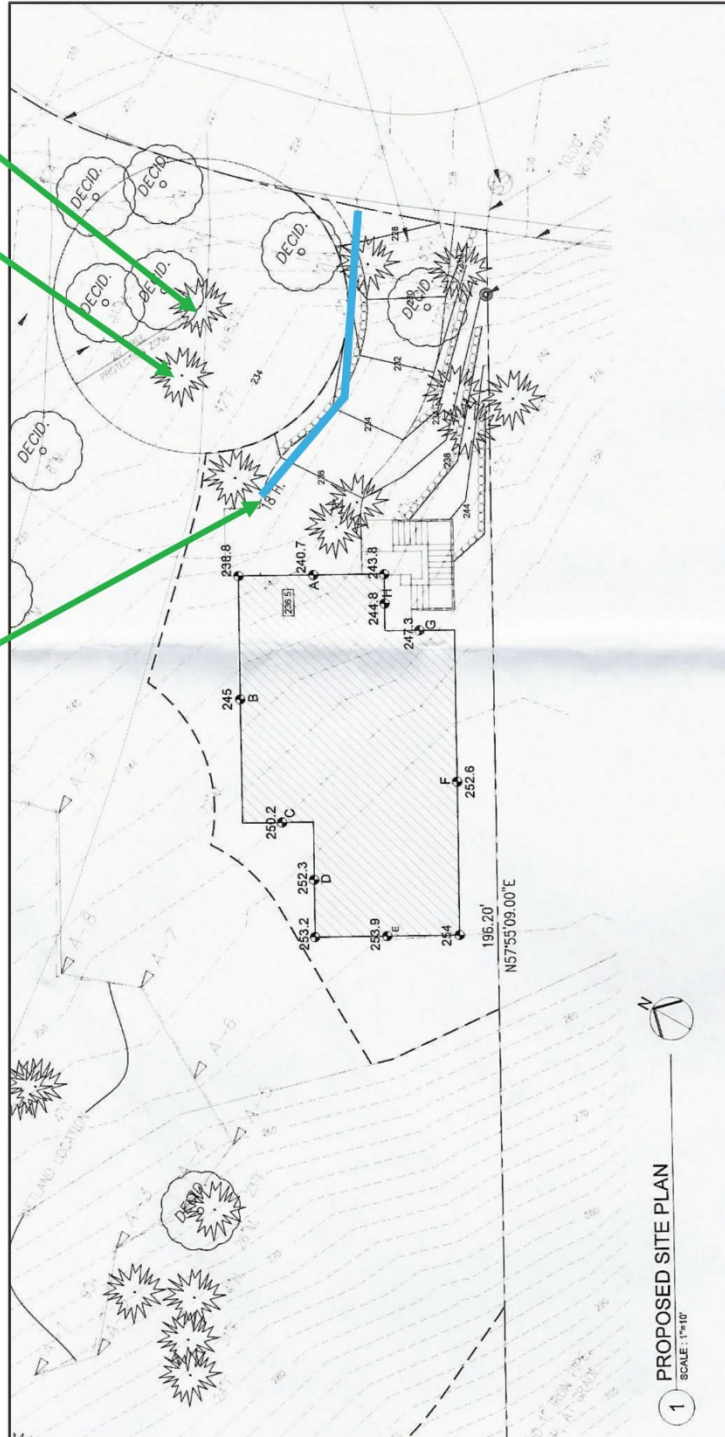
While tree trunks and canopies represent potential obstacles to construction, root growth is a potential conflict and not visible without additional below grade exploration. Both Gilles Consulting and Tree Solutions Inc. explored soil for root growth between the two Douglas firs and the line marked as the, “Approximate location of the air spaded trench” (Figure-2).

Given the species preference for soil free of excessively damp areas, most fir roots grow south and west of trunks. This area is within the area marked as “Approximate location of the air spaded trench,” in Figure-2

Prior to approving placement of a new driveway in the desired location, additional root exploration is recommended due to likely chances of encountering significant roots.

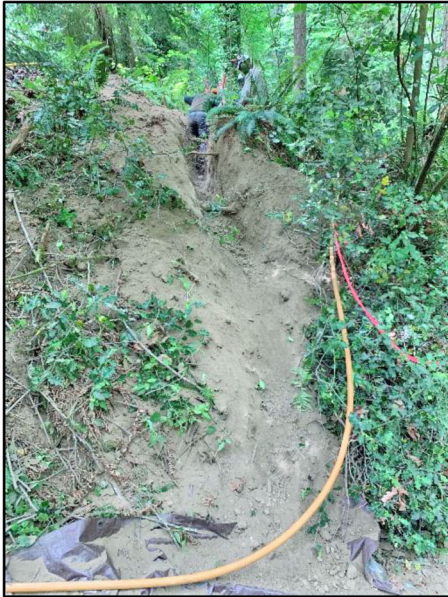
Figure-3

Photo # 2: Looking west from the road at the trench being blown and shoveled. Note the tarp under the soil in the roadside ditch to capture the soil as it moved down. This soil was then put back up into the trench. The roots observed appear to be from the adjacent shrubs.

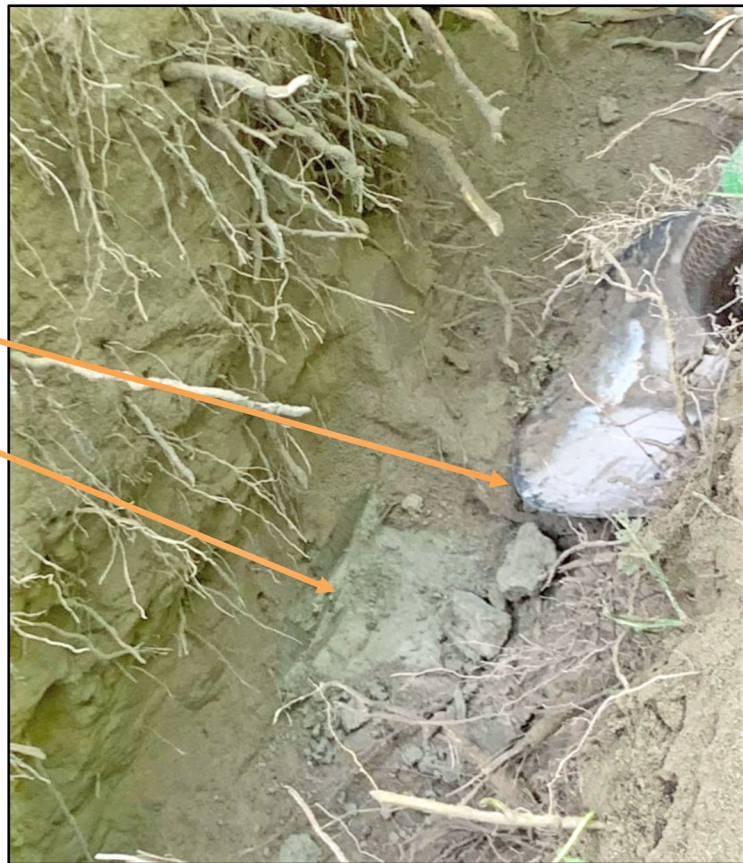
The Gilles Consulting report documents finding clay soil 2 to 3-feet below grade and states, “blue impenetrable soil was encountered at deeper depths.” In at least one case solid clay was encountered when a depth of 40 to 46-inches was reached (Figure-3).

Photo # 3: Looking down into the trench. At approximately 26 to 34 inches below the surface solid blue clay was encountered. In a few random places the operators forced their way into the clay to a depth of 44 to 46 inches. They encountered solid clay at those depths also.

The small roots present are from the invasive English Ivy and ground cover shrubs.

Blue, impenetrable clay layer 26 to 34 inches below the surface.

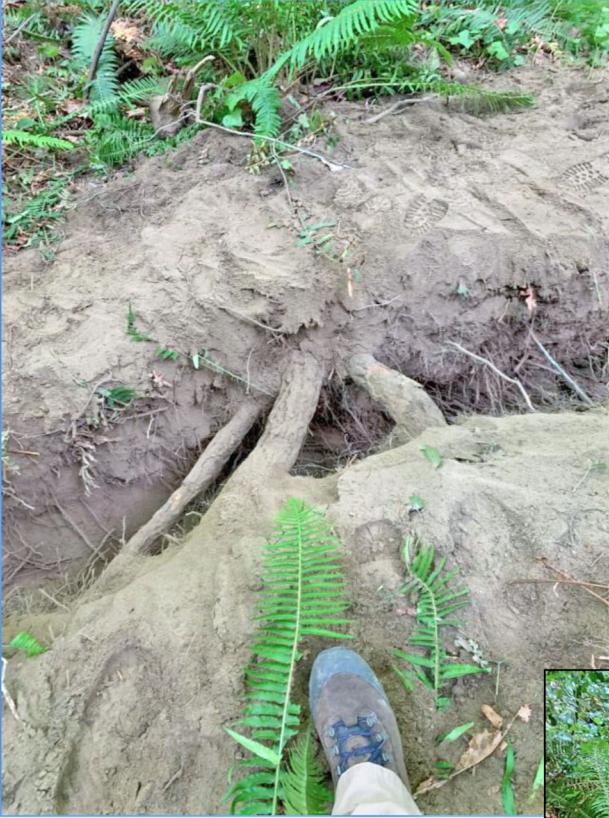
Figure-4

Upslope and west of excavation described above, Gilles Consulting’s root exploration exposed several large diameter roots (Figure-4, Figure-5)

- Expose roots measure between 2.9 and 4.6-inches

Photo # 4: Looking down at the only Douglas Fir tree roots encountered from the two subject trees. A fourth root was encountered at the bottom of the trench at approximately 30 inches of depth. They measured 2.9", 4.6", 3.7", & an estimated 2.5".

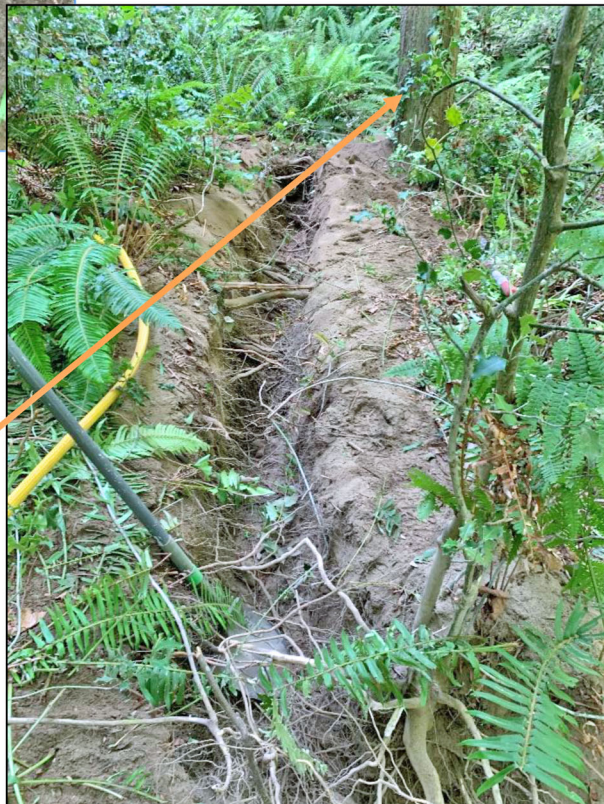
Hemlock Tree

Photo # 5: The last several feet of the trench showing roots of shrubs and the Hemlock in poor condition, but no Fir Roots.

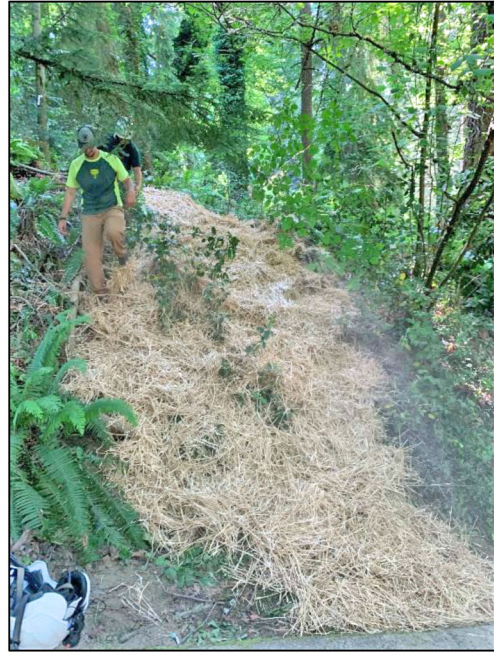
Figure-5

Photo # 6: The crew finishing the day with a bale of straw covering the open soil to minimize erosion.

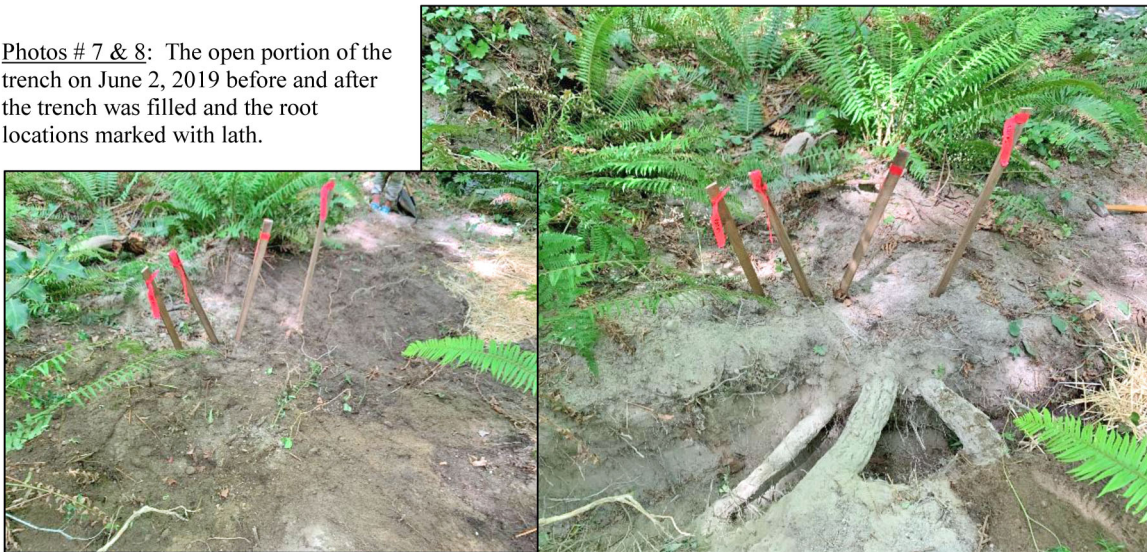
The Four Douglas Fir Tree Roots

City Staff requested that we clearly mark the location of the only four roots that were encountered from trees # 916 & 917. Therefore, on May 30, a small length of the trench was left open where these four roots are. I returned on June 4, 2019 and put in four pieces of lath with the roots numbered. Then I refilled the trench.

Photos # 7 & 8: The open portion of the trench on June 2, 2019 before and after the trench was filled and the root locations marked with lath.

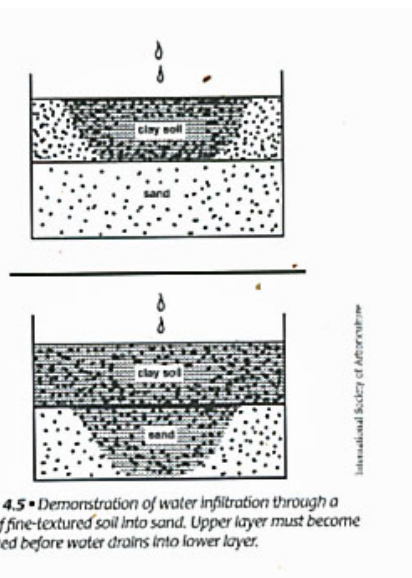
Figure-7

While tree roots typically grow in the upper 2-feet of soil, **roots may reach greater depths if permeable soil is present, and or if layers of clay soil reside above sandy textured soil (Figure-7).**

Figure 4.5 • Demonstration of water infiltration through a layer of fine-textured soil into sand. Upper layer must become saturated before water drains into lower layer.

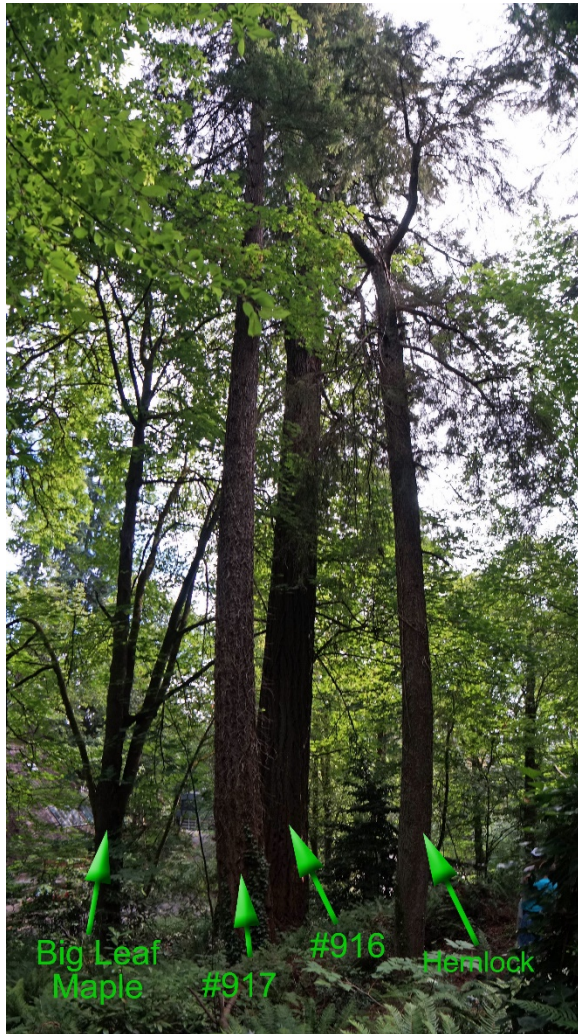
Photo-1

The 4825-Property contains a parcel of undeveloped land adjacent to several single-family homes. Mature trees on the property include a big leaf maple (*Acer macrophyllum*), a western hemlock (*Tsuga heterophylla*), and two Douglas firs (*Pseudotsuga menziesii*) numbered 916 and 917 (**Photo-1**).

The big leaf maple and both Douglas show signs of good structural condition and the western hemlock shows signs of fair to poor structural condition.

#916 & #917 are Douglas fir
