Consulting Arborists

Memo

TO: Mr. Gerry Kaelin
JOB SITE: Lot at 4825 East Mercer Way
FROM: Scott D. Baker, Registered Consulting Arborist
DATE: 2-28-08
SUBJECT: 2-27-08 site visit to observe Eagle tree and observe air excavation South of tree.

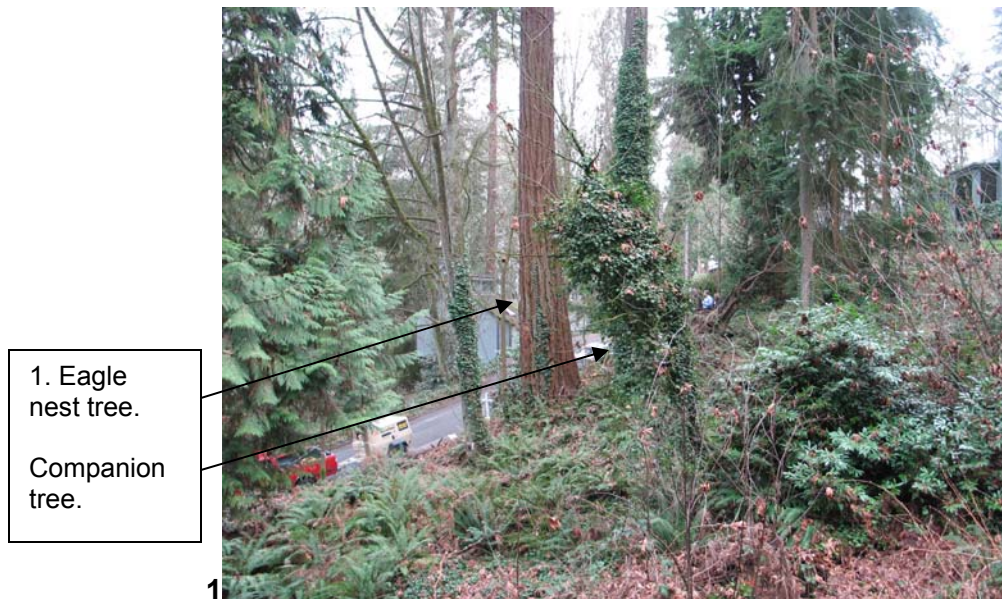
The large Douglas-fir tree (eagle tree) is shown in several documents as measuring 80" in diameter. I measured it as 72" in diameter at 4.5' or standard height (DSH). The tree is a remnant of the forest present on Mercer Island prior to recent settlement. I measured the tree height using a laser hypsometer as 188.3'. The large tree has a companion Douglas-fir tree that is 42" DSH growing a few feet to the West. The two trees compose a shared canopy. Based on my knowledge, the two trees are likely grafted together within their root systems. When trying to preserve trees with grafted root systems, my experience is that they should be considered as one tree.

I used a steel soil probe and determined that I could probe easily to 40" depth in the area immediate to the eagle tree and its companion. In my experience this generally indicates a sandy soil.

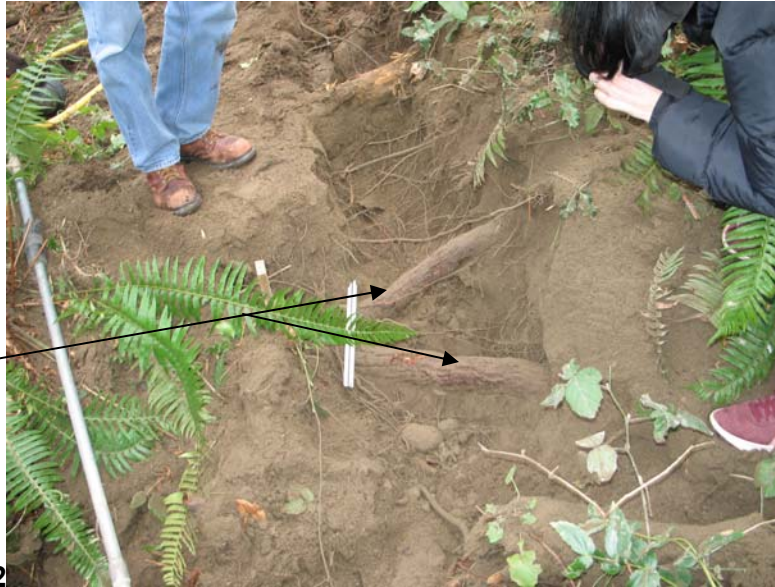
Mr. See used his air tool to dig a narrow trench just beyond the 20' circle around the eagle tree. He exposed dead and decayed roots of a hemlock tree that has fallen on the site. Also exposed were three significant (2.5"-4" diameter) Douglas-fir roots along with a number of smaller (≤ 1 ") fir roots and many fine fibrous fir roots. The fine roots were most dense in the top 12" of soil, however, as is typical in sandy soils, fine roots were present deeper in the exposed soil.

2.
Excavation
with two fir
roots in
view.

The soil exposed by the excavation was sandy loam. A small lens of silt clay was also encountered. I was able to insert my probe another 36" from the bottom of the excavation without much force, indicating that the sandy well drained soils continue in this area. Given the soil conditions on the site it would not surprise me to find more roots of significant size growing at a greater depth than was exposed during this investigation.
