SHOFFNER CONSULTING

RE: Tree Inventory - 8430 SE 47th Pl., Mercer Island.

TREE INVENTORY MAP
8430 SE 47TH PL. MERCER ISLAND, WA

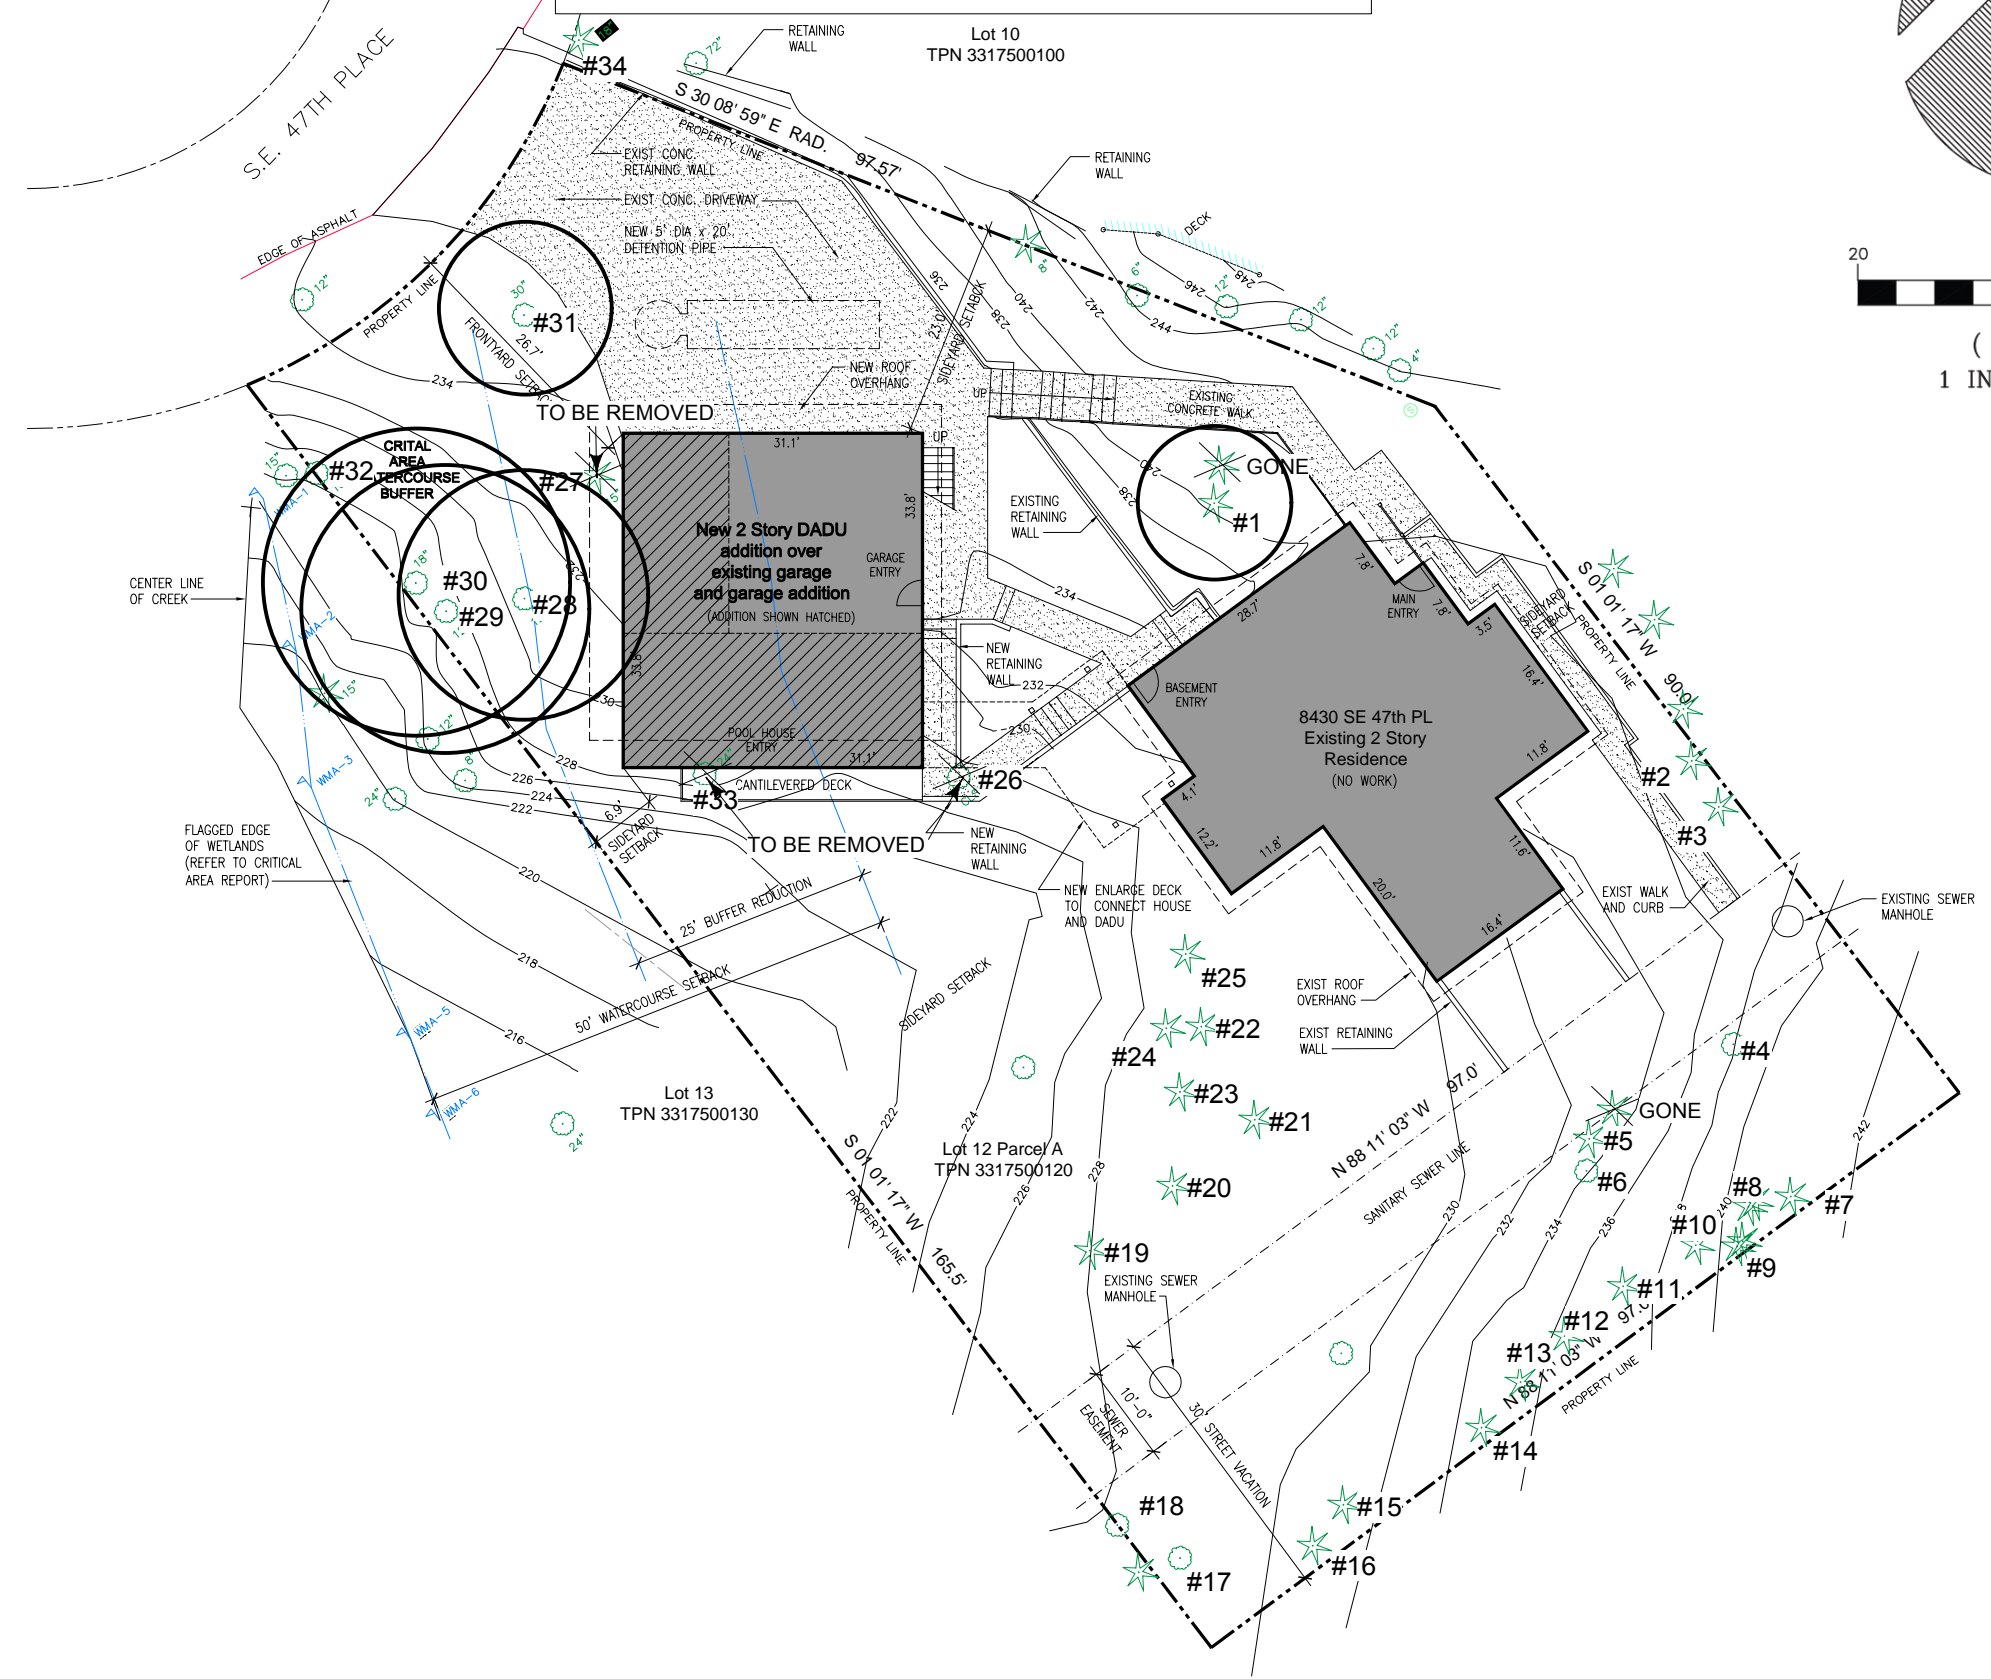
This report is provided to address the recent inventory I conducted of the trees on the property at the address of 8430 SE 47th Pl. in Mercer Island. The tree retention and replacement requirements for developing lots are specified in the revised section 19.10 of the Mercer Island City Code (MICC). Please see the accompanying tree evaluation data spreadsheet and tree inventory map for reference to this report. The inventory map shows the driplines of the trees near to the proposed development.

The proposed development is to expand the existing detached garage to the south and west. This will result in significant root damage and loss to three trees requiring their removal. These trees are numbers 26, 27 and 33. Number 26 is an exceptional tree, however it large, old and multi-trunked with a moderate amount of dieback in the upper crown. Based on its condition and age, in my opinion, this tree does not meet the criteria of *trees that are healthy and have a greater likelihood of longevity.*

There are five trees within the vicinity of the new development that are proposed to be retained. The new building will encroach slightly into the dripline of one of the retained trees, tree #28. The nearest impact to this tree will be no closer than 10 feet from the tree, far enough to maintain sufficient root area.

General tree protection standards are specified in section 19.10.080 of the MICC. Tree protection fencing is to be installed around the trees adjacent to the proposed development prior to beginning any construction, including clearing, and is to remain throughout development.

For trees with proposed impacts within their driplines, the fencing is to be placed at the dripline until work within the dripline is necessary. At that point, the fencing is to be moved only as far as possible to accommodate the development.
