SHOFFNER CONSULTING

November 27, 2017

RE: Tree Inventory - 8430 SE 47th Pl., Mercer Island.

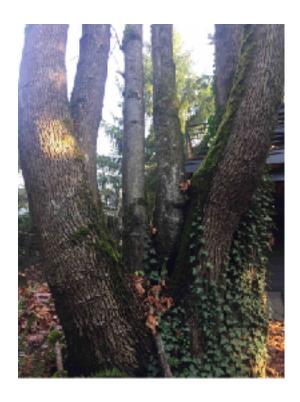
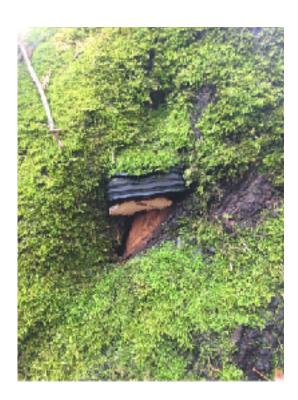
There is a total of 32 trees on the property ranging in size from 6" to 30" in diameter. Trees #6 and 26 meet the threshold diameter criteria to be classified as exceptional. Tree #26 is a multi-trunked big-leaf maple that has a moderate amount of dieback in the upper crown. As the following photos show, the tree has multiple trunks at the base with very tight, v-shaped crotches and included bark between the leaders. The second photo is of a fruiting body at the base indicating decay within. One of the leaders in the center of the cluster has considerable decay up its bole.

The fruiting body and the decaying lead are certain signs that there is decay within the trunk and spreading up into the leads. While it may not be showing symptoms in the crown at this time, the already weak big-leaf maple wood is weakened further with the presence of decay. At to that the included bark between the codominant lead putting pressure on their connections, the failure potential of any of them warrants a high classification.

exceptional tree, however it large, old and multi-trunked with a moderate amount of dieback in the upper crown, decay in the trunk and the leaders. Based on its condition and age, in my opinion, this tree does not meet the criteria of *trees that are healthy and have a greater likelihood of longevity*. This tree has a risk rating of high.

The proposed development is to expand the existing detached garage to the south and west. This will result in significant root damage and loss to three trees requiring their removal. These trees are numbers 26, 27 and 33. Number 26 is an
