Project/Parcel Number: P192405-9077

Jake Zhen Lin Li & Moon Yanci Wu 5660 E Mercer Way Mercer Island, WA 98040

Date: 5/15/18

**Objective:** To assess tree impacts by the recent construction of retaining walls in the backyard of residential property.

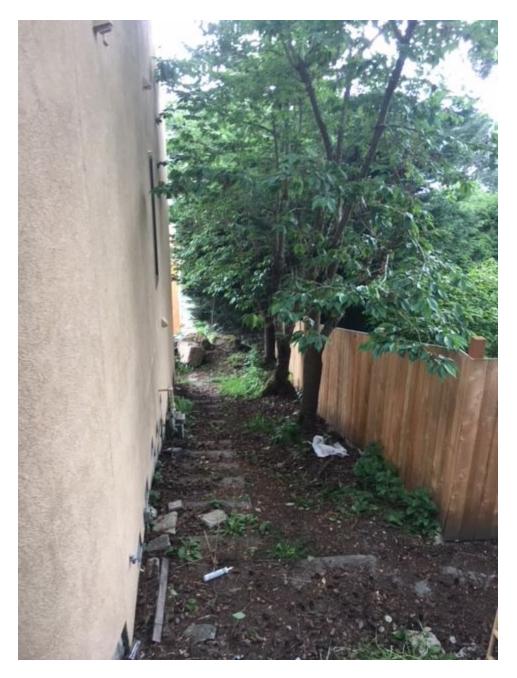
| Tree # | Botanical Name | Common Name | DBH Size<br>(Inches) | Dripline<br>radius<br>(Feet) | Condition | Comments |
|---|---|---|---|---|---|---|
| 3 | Prunus serrulata | Japanese<br>Flowering Cherry | 14" | ~12' | Good | Some foot traffic over roots, growing very close to fence |
| 4 | Prunus serrulata | Japanese<br>Flowering Cherry | 12" | ~12' | Good | Some foot traffic over roots, growing very close to fence |
| 5 | Prunus serrulata | Japanese<br>Flowering Cherry | 12" | ~12' | Good | Some foot traffic over roots, growing very close to fence |

South side of house (side yard/backyard access) looking at trees #3, #4 and #5, Prunus sp.

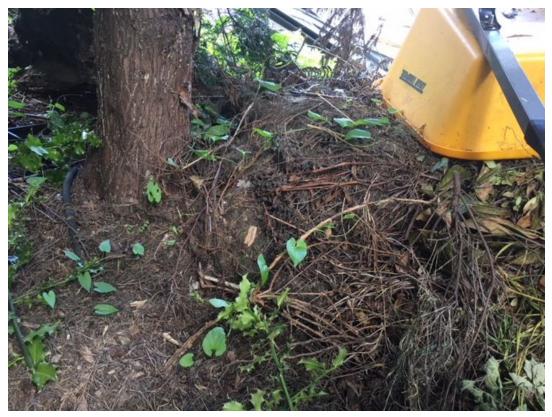
| Tree # | Botanical Name | Common Name | DBH Size<br>(Inches) | Dripline<br>radius<br>(Feet) | Condition | Comments |
|---|---|---|---|---|---|---|
| 2 | Thuja plicata | Western Red<br>Cedar | 12" | ~12' | Poor | Topped tree, debris/fill<br>placed over tree roots |

Photo of tree #2, Western Red Cedar, with fill material placed over root zone.

To avoid further construction impacts, I recommend removing debris/fill material placed over tree roots as well as placing barrier fencing beyond the tree's protected root zone as described here:

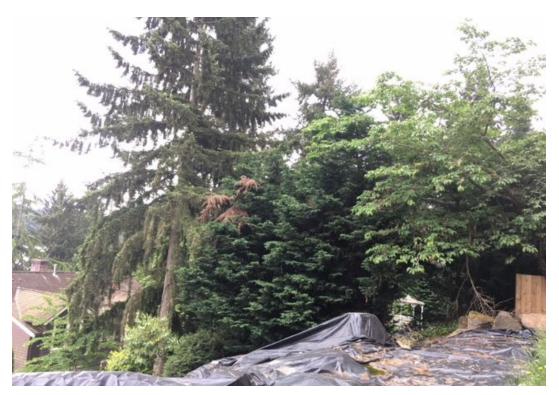
Photo taken on north side of backyard looking south toward small and large trees along edge of property

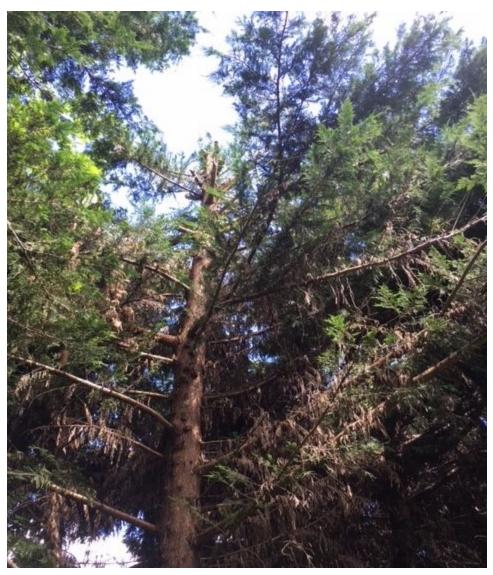
One of these trees (12" Cedar) has been topped and is considered a removed tree per MICC 19.10.020. Per MICC 19.10.070, loss of this tree shall be mitigated for on site. The other tree (22" Douglas Fir) has no visible damage to tree roots, trunk, branches or crown, however, debris/fill material was observed over roots of tree, which if not removed in a timely manner, will potentially cause health decline.

Photo of crown damage and topping central leader of Western Red Cedar

In addition, since the backyard is on a steep slope, approximately 2:1, I recommend restoring with a native and site appropriate plant palette that will provide slope stabilization and aesthetic appeal for the homeowner. Impacts to existing site trees will be mitigated per MICC 19.10.070. Tree replacement ratios are as follows:
