Project No. 1961.01
June 19, 2018

Subject: Geotechnical Report
 Dawn Drive Landslide Stabilization
 Tract A, Parcel No. 192300TR-A
 Mercer Island, Washington

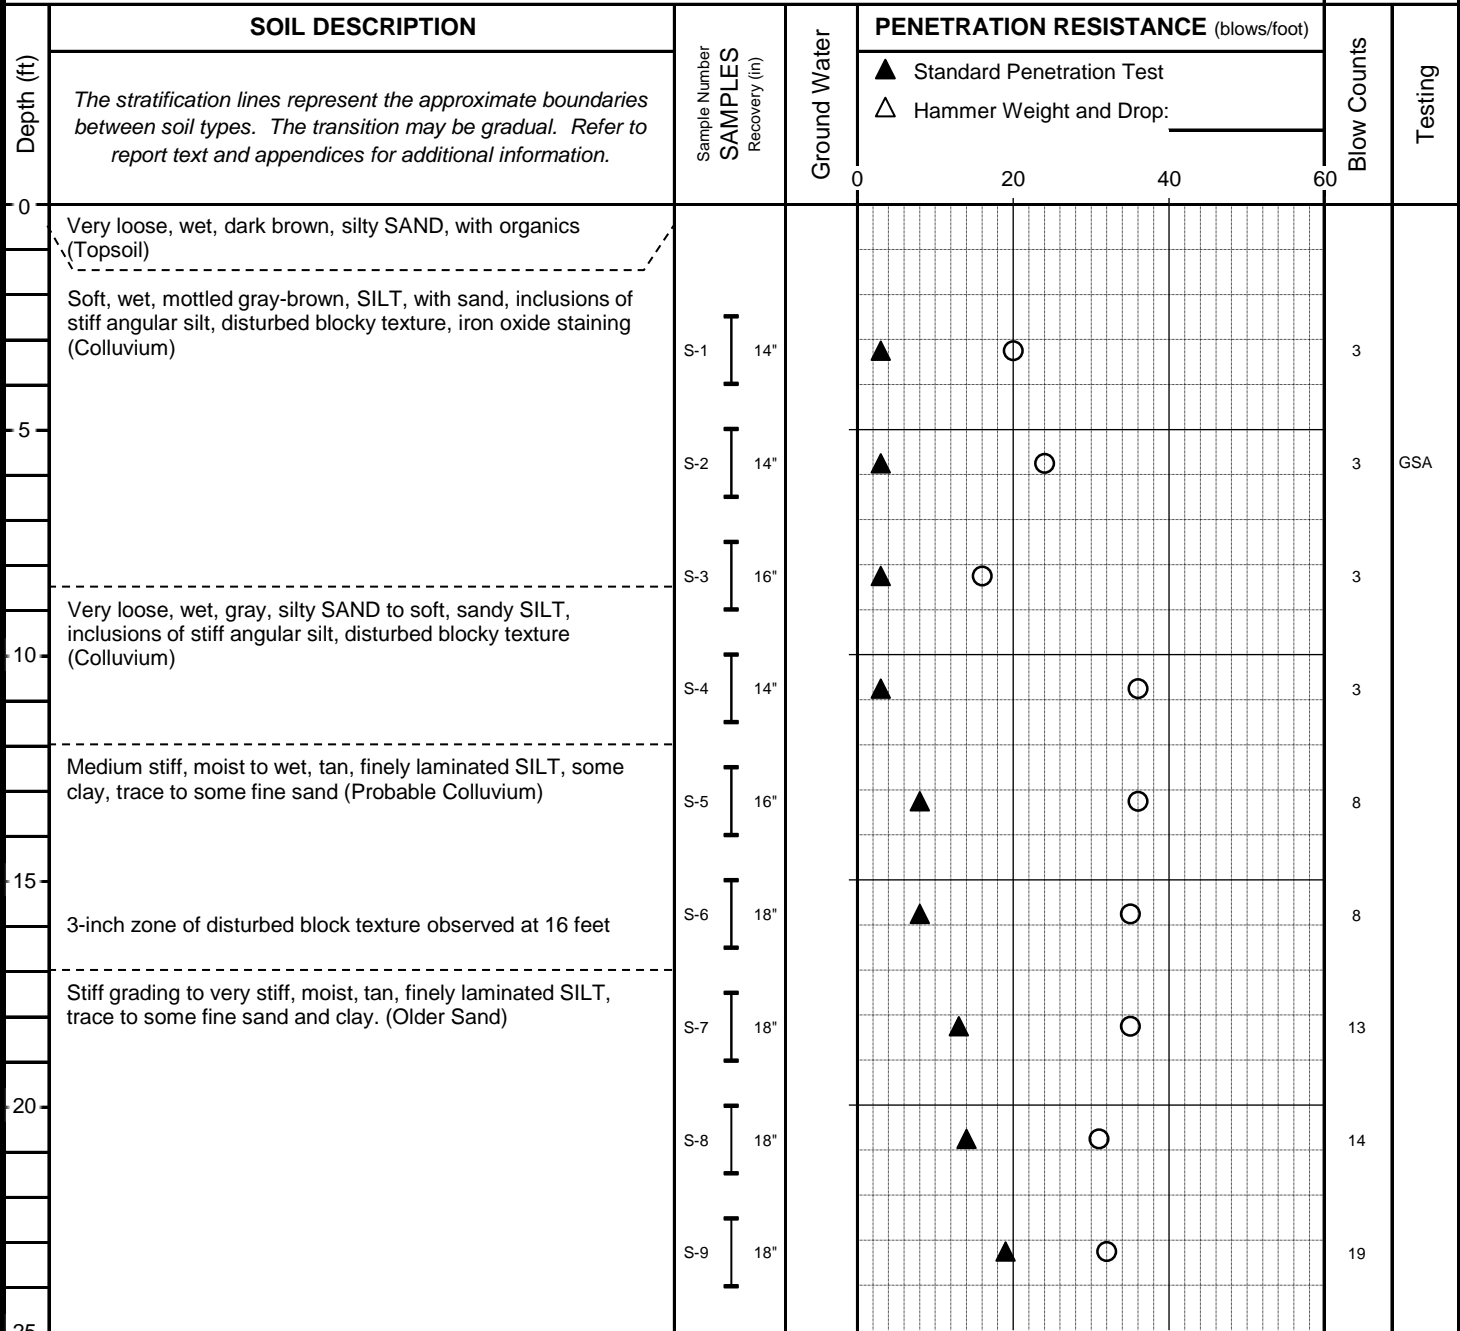
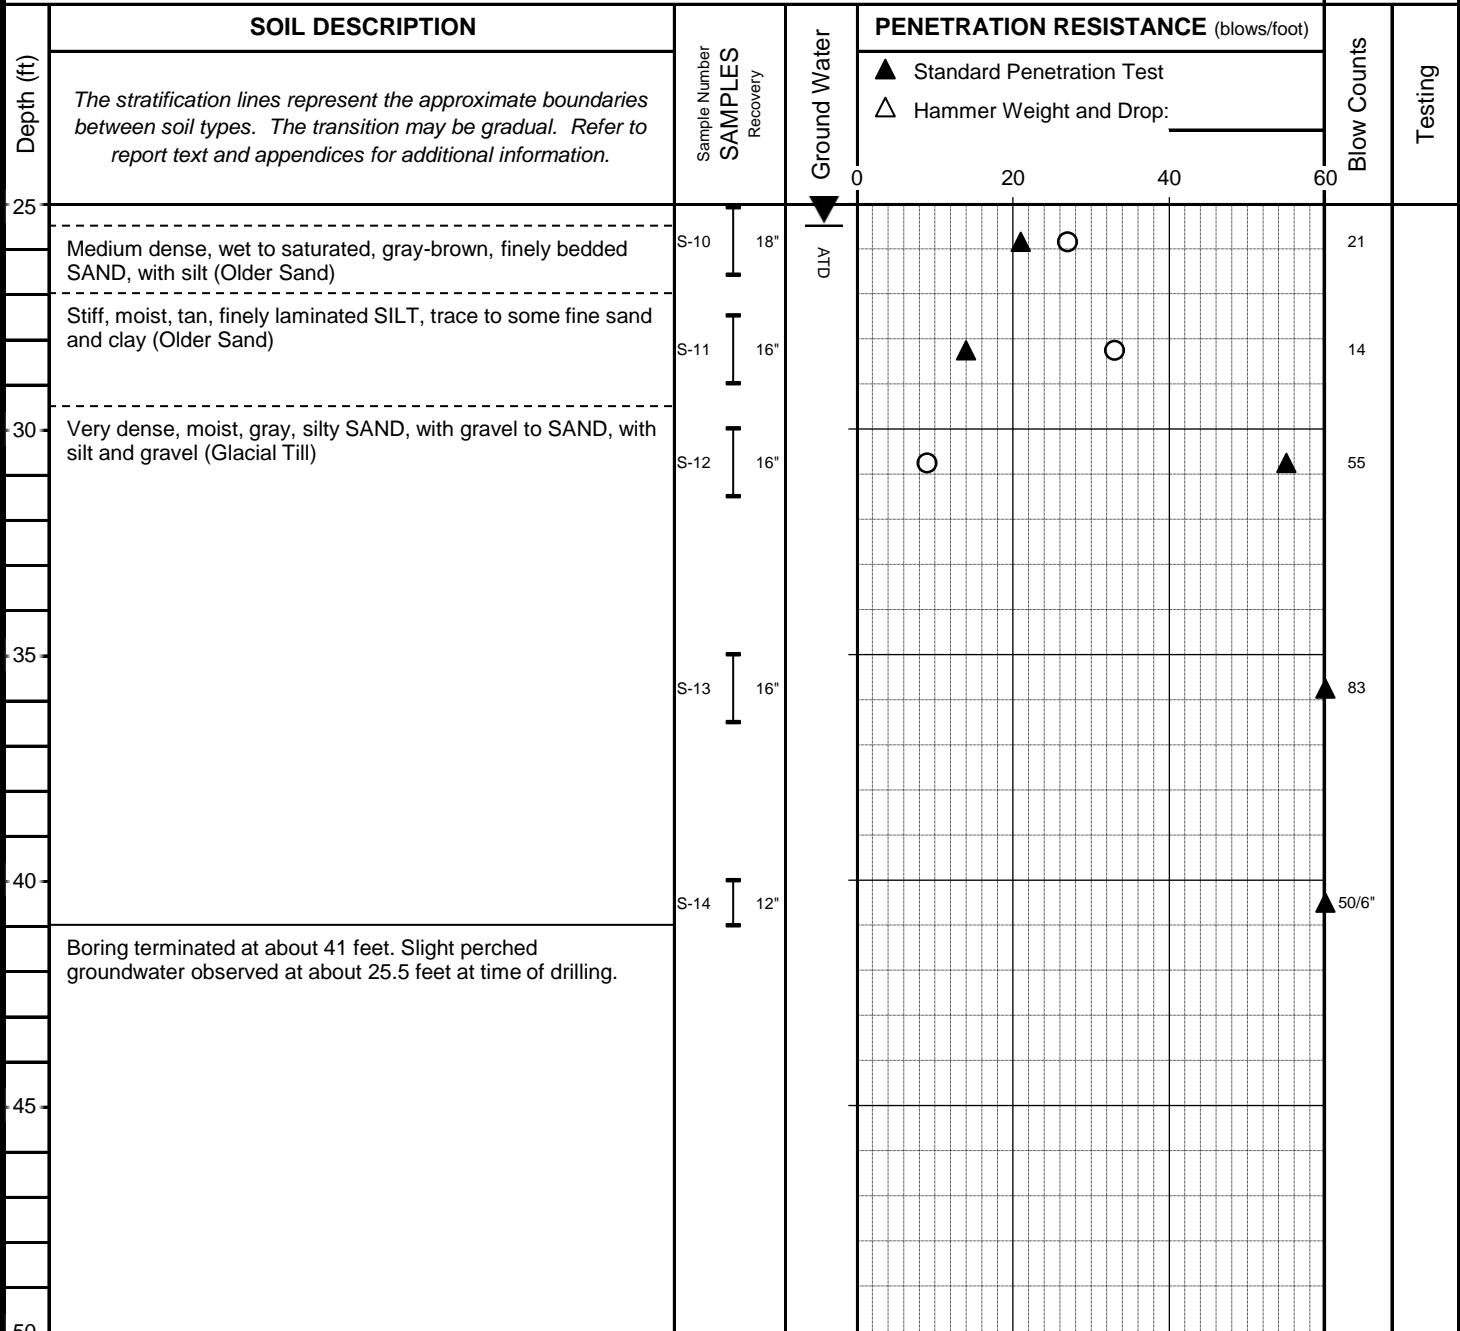
BORING LOG: B-1

Boring B-1 was completed near the south edge of the landslide head scarp. Subsurface soil conditions observed in boring B-1 generally consisted of soft to medium stiff silt and very loose silty sand (colluvium) extending from the ground surface to about 17 feet below existing site grade. Below the colluvium, the boring encountered stiff to very stiff, finely bedded/laminated silt (older sand) extending to about 30 feet below existing site grade. Below the older sand, the boring encountered very dense, silty sand (glacial till) extending to the completion depth of about 41 feet below existing site grade.

Slight, perched groundwater was observed at about 25.5 feet below existing grade in boring B-1 at the time of drilling. No groundwater was observed in boring B-2 at the time of drilling. Slight, perched groundwater was observed at about 9 feet below existing site grade in boring B-3 at the time of drilling. Fluctuations in groundwater levels will likely occur due to seasonal variations in the amount of rainfall, runoff and other factors not evident at the time the explorations were performed. Therefore, groundwater levels during construction or at other times in the life of the structure may be higher than indicated on the logs.

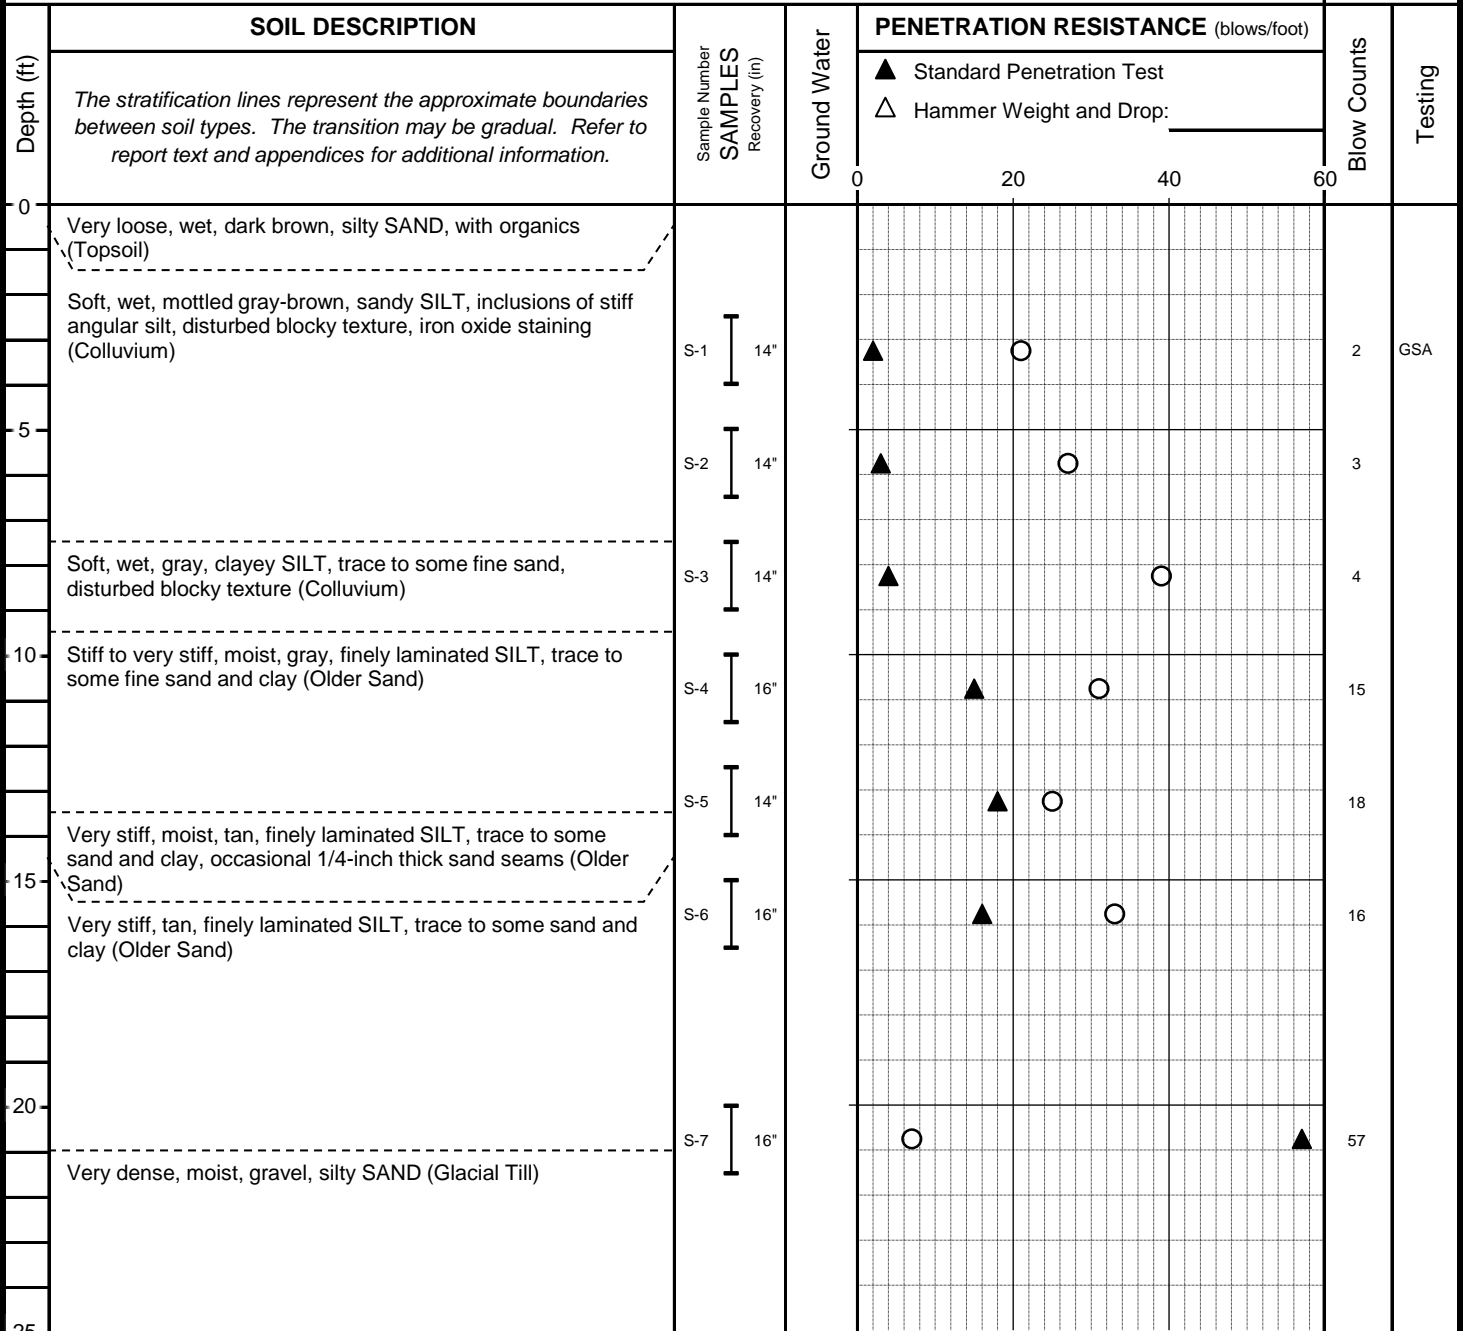
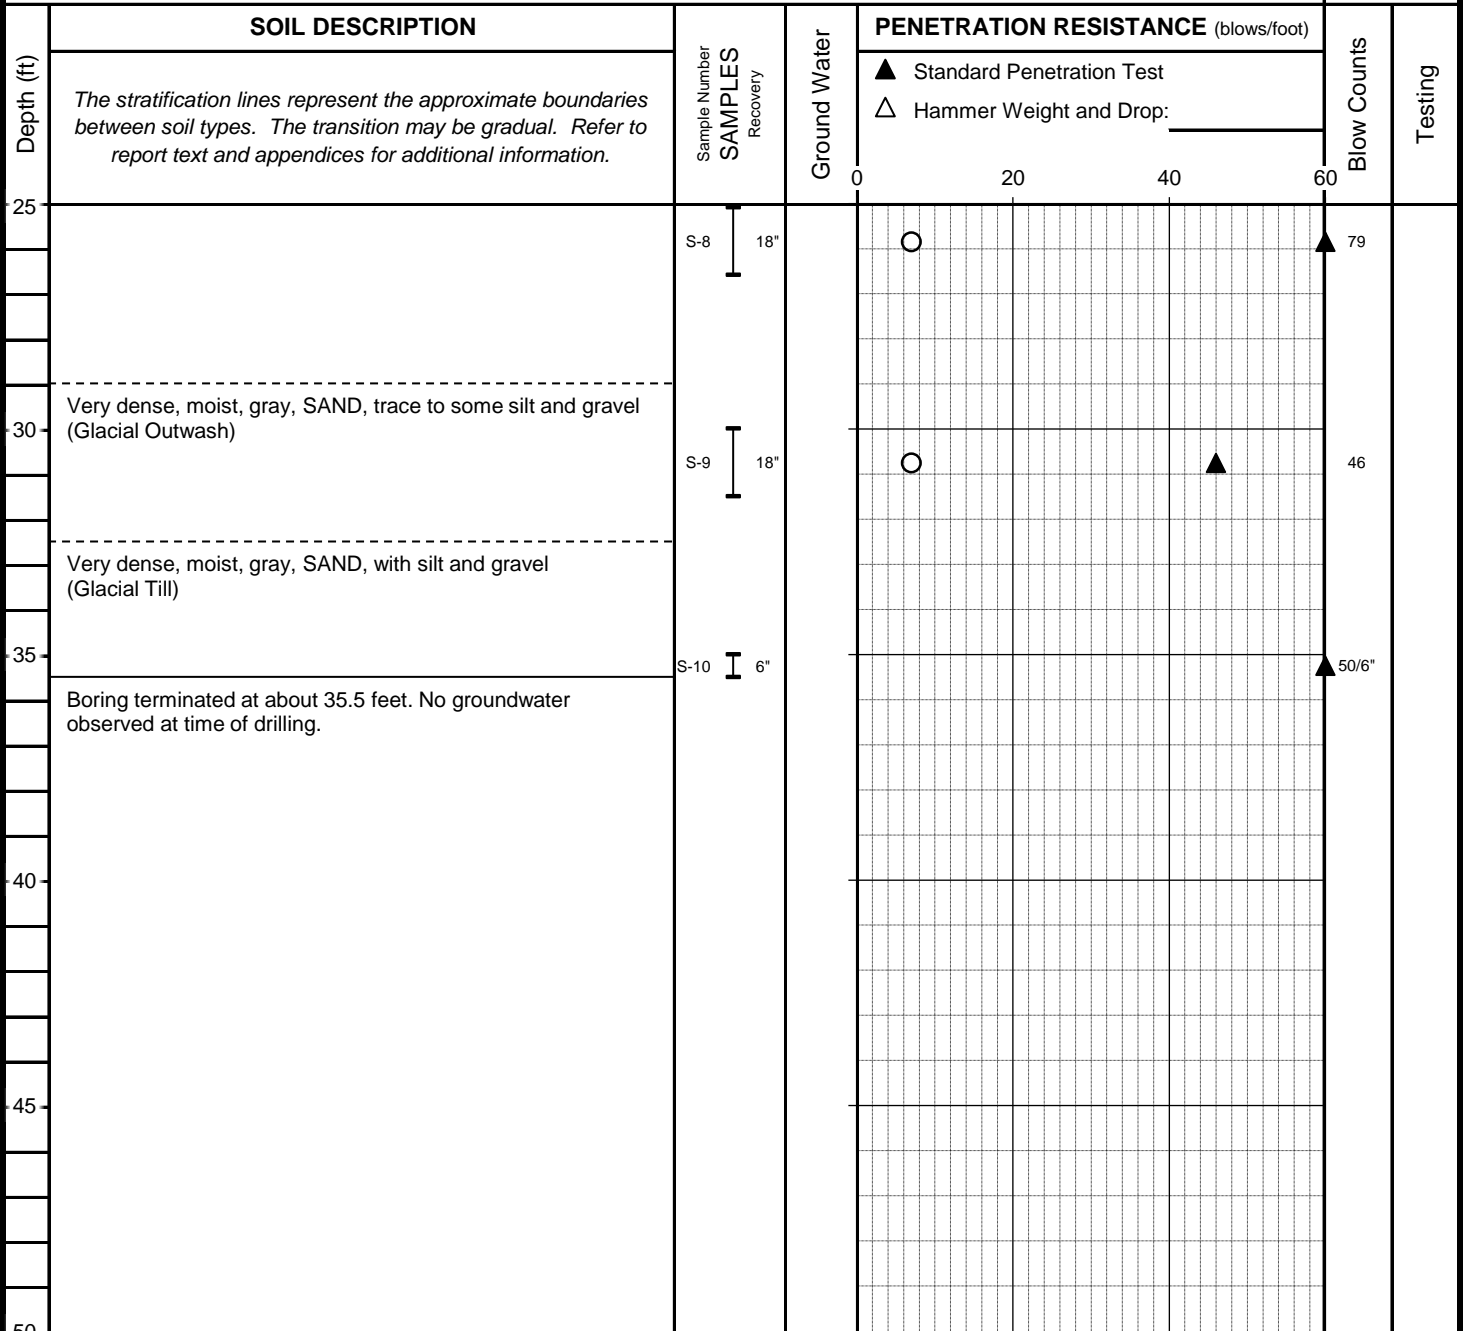
BORING LOG: B-2

Boring B-2 was completed near the north edge of the landslide head scarp. The stratigraphic sequence observed in boring B-2 was similar to that of boring B-1 with the colluvium extending to about 13.5 feet below existing site grade; older sand below the colluvium extending to about 21 feet; and glacial till below the older sand extending to the completion depth of about 35.5 feet below existing site grade.

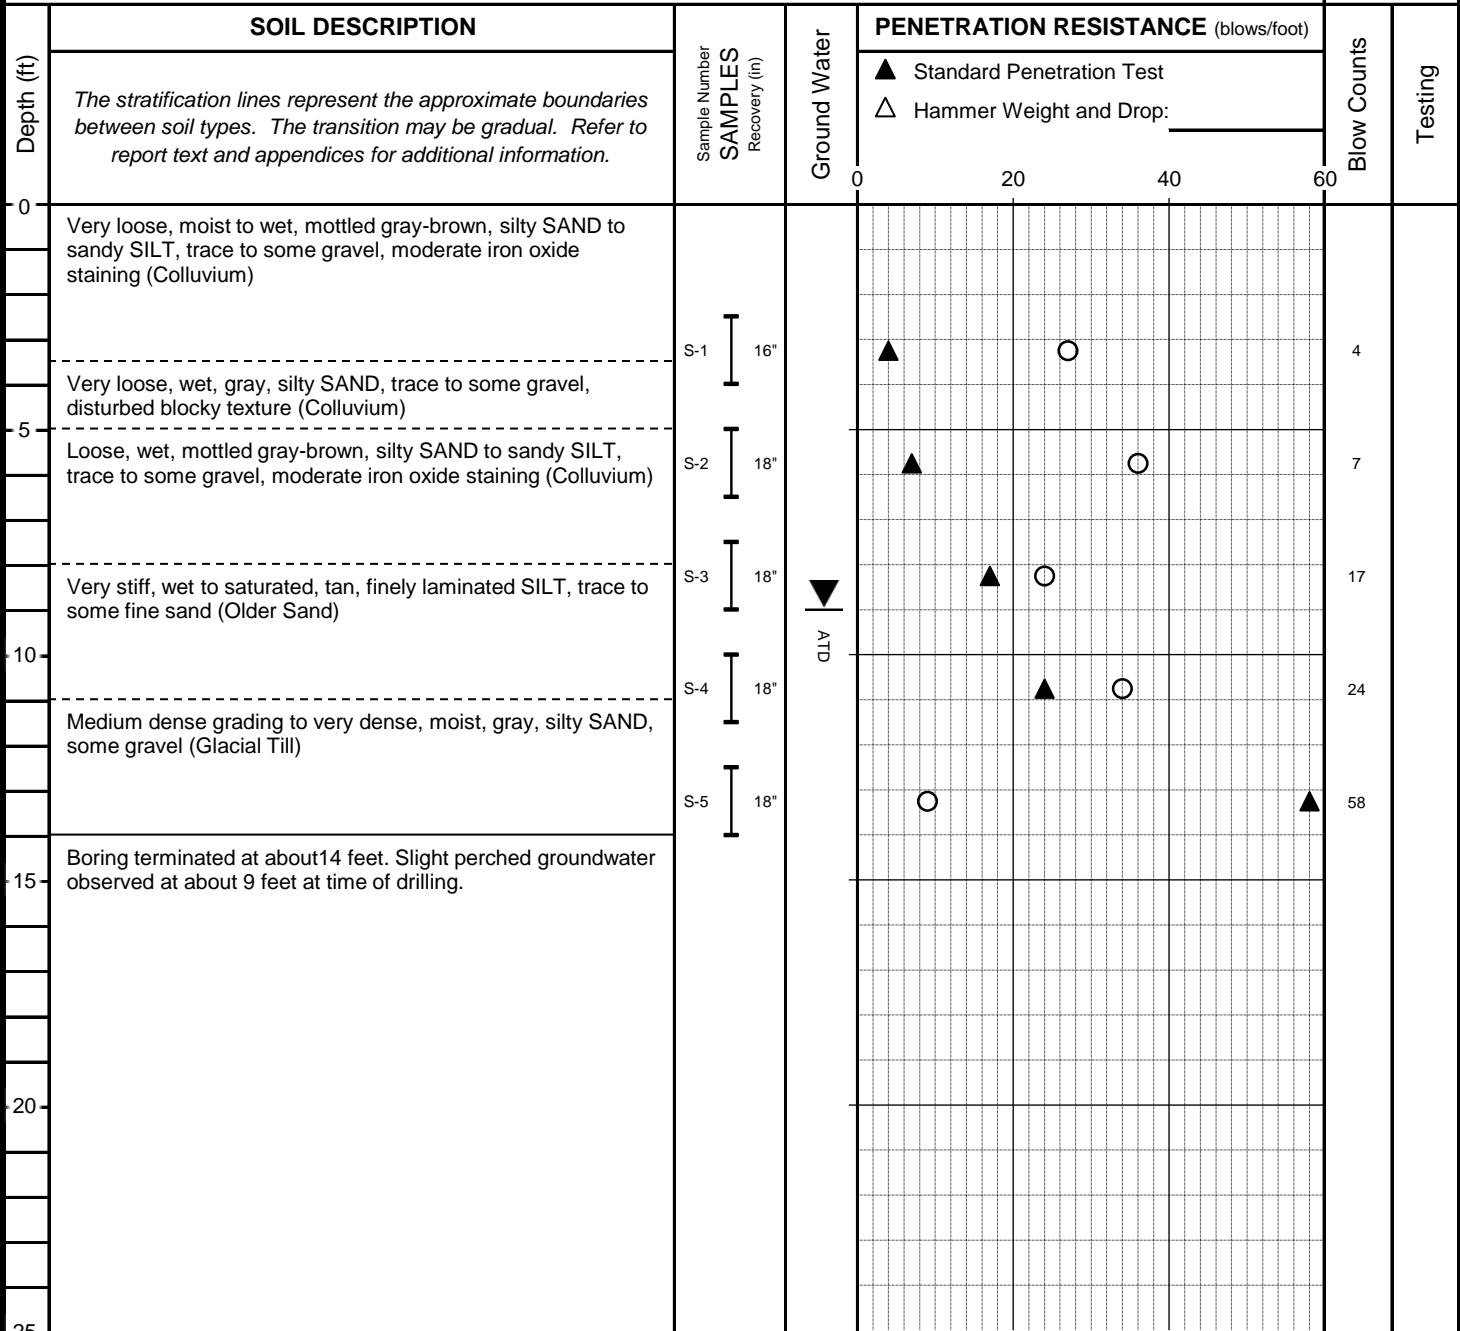
BORING LOG: B-3

Boring B-3 was completed down-slope from the head scarp, near the north center of the main body of the landslide. The stratigraphic sequence observed in boring B-3 was similar to that of boring B-1 with the colluvium extending to about 8 feet below existing site grade; older sand below the colluvium extending to about 11 feet; and glacial till below the older sand extending to the completion depth of about 14 feet below existing site grade.

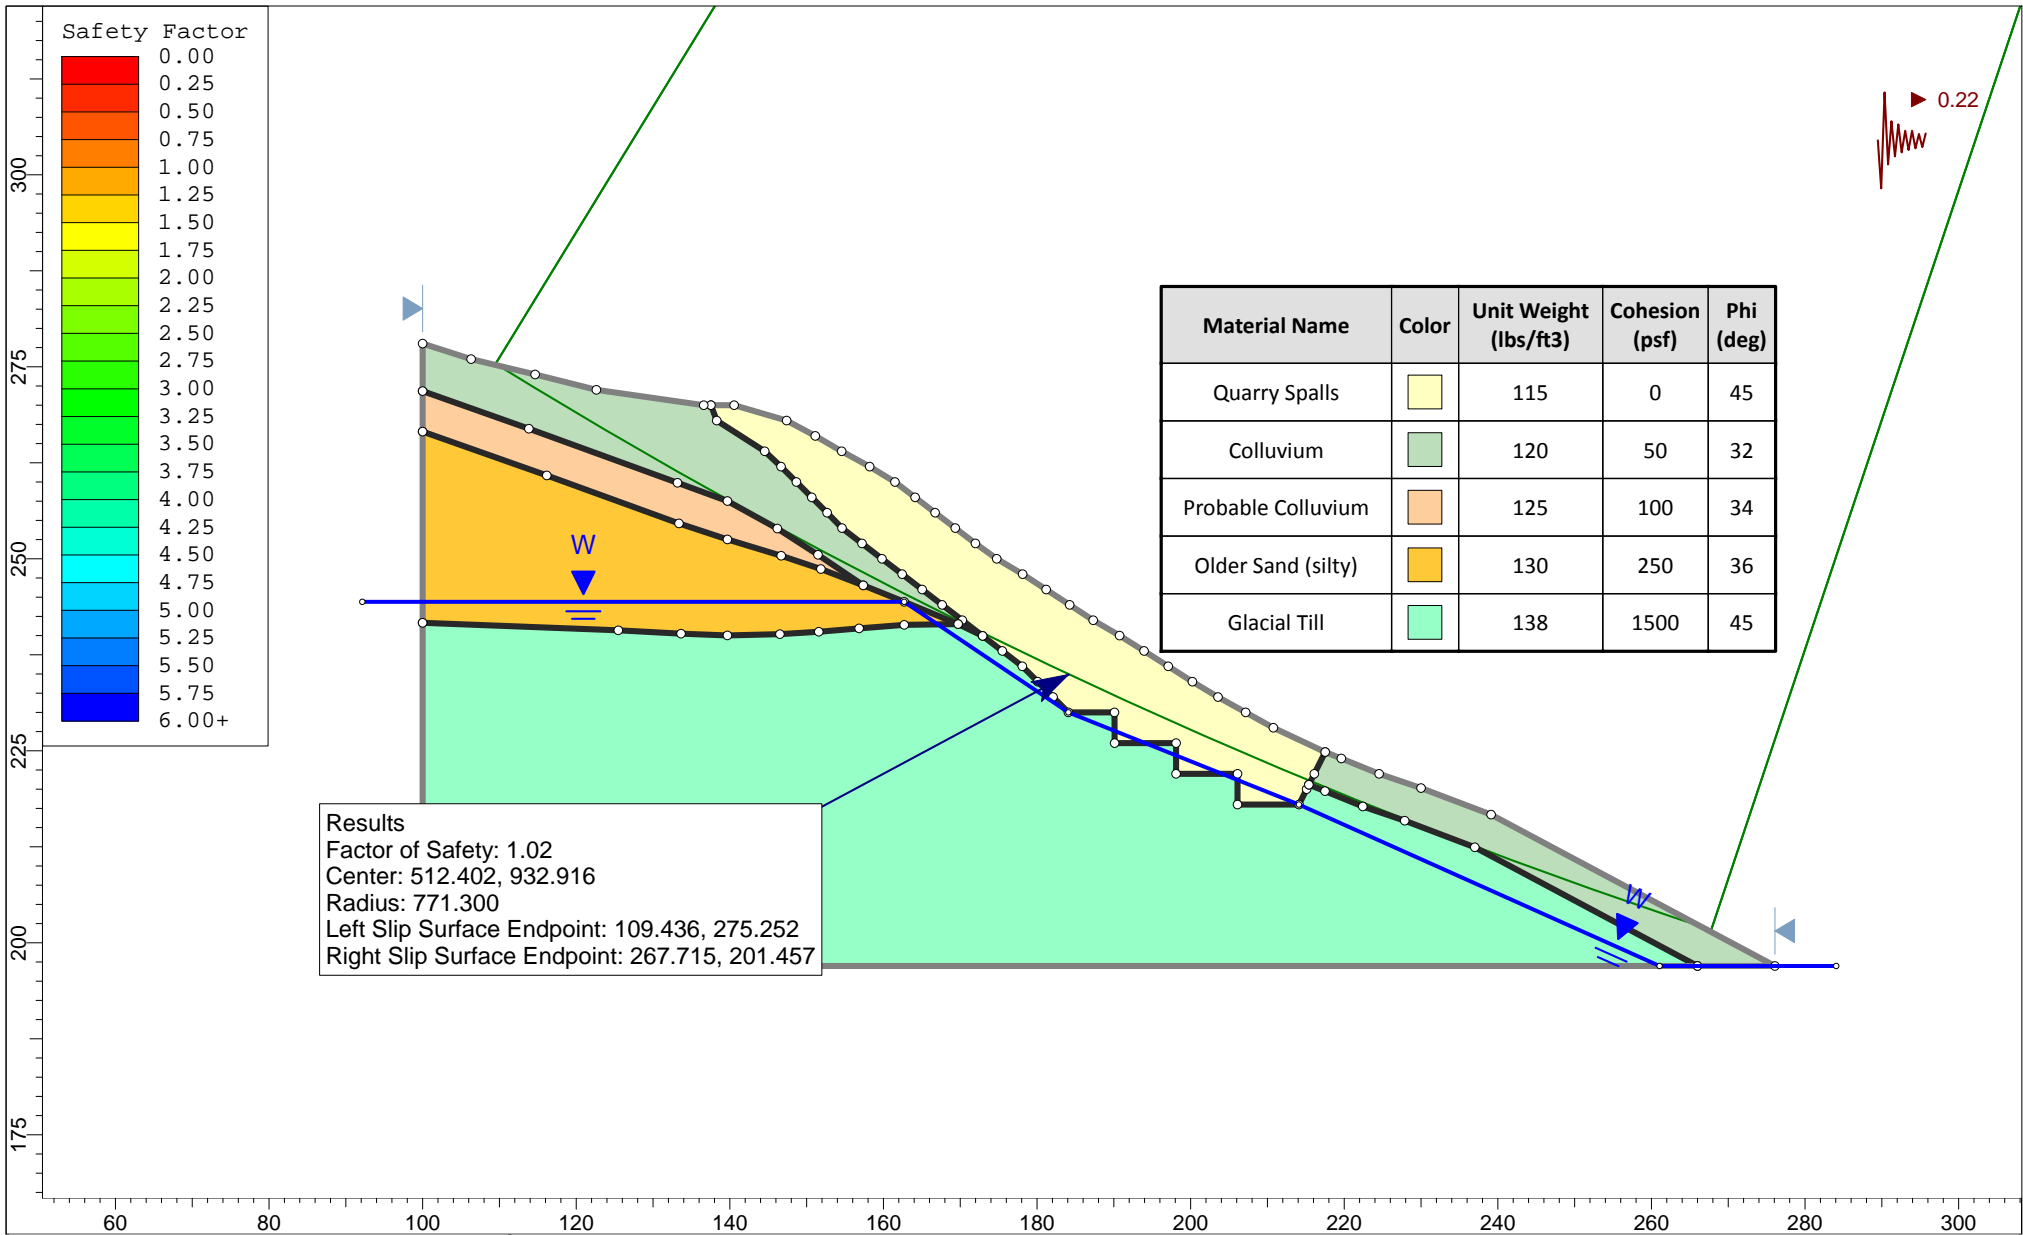
<i>Project</i>				Dawn Drive Landslide Stabilization	
<i>Analysis Description</i>				Seismic Yield Acceleration Determination	
<i>Drawn By</i>	RAR	<i>Scale</i>	1:300	<i>Company</i>	ZGA
<i>Date</i>	4/27/2018, 11:57:44 AM			<i>File Name</i>	SLIDE RAR.slim

- Seismic:
 - Per USGS for site latitude and longitude assuming AASHTO LRFD Bridge Design Manual as code reference, $A_s = 0.47g$, $M=7.5$
 - Calculated yield acceleration, $k_y = 0.22g$

- Per Newmark Displacement Charts assuming $a_{max} = 0.47g$ and $k_y = 0.22g$, estimated seismic lateral displacement is approximately 2 inches. Which is acceptable for this slope.

Results
 Factor of Safety: 1.02
 Center: 512.402, 932.916
 Radius: 771.300
 Left Slip Surface Endpoint: 109.436, 275.252
 Right Slip Surface Endpoint: 267.715, 201.457
