REFERENCE: Regulated Tree Inventory

SITE ADDRESS: 3611 W Mercer Way, Mercer Island

DATE: February 13, 2019

PREPARED BY: Favero Greenforest, ISA Certified Arborist # PN -0143A
ISA Tree Risk Assessment Qualified
ASCA Registered Consulting Arborist® #379

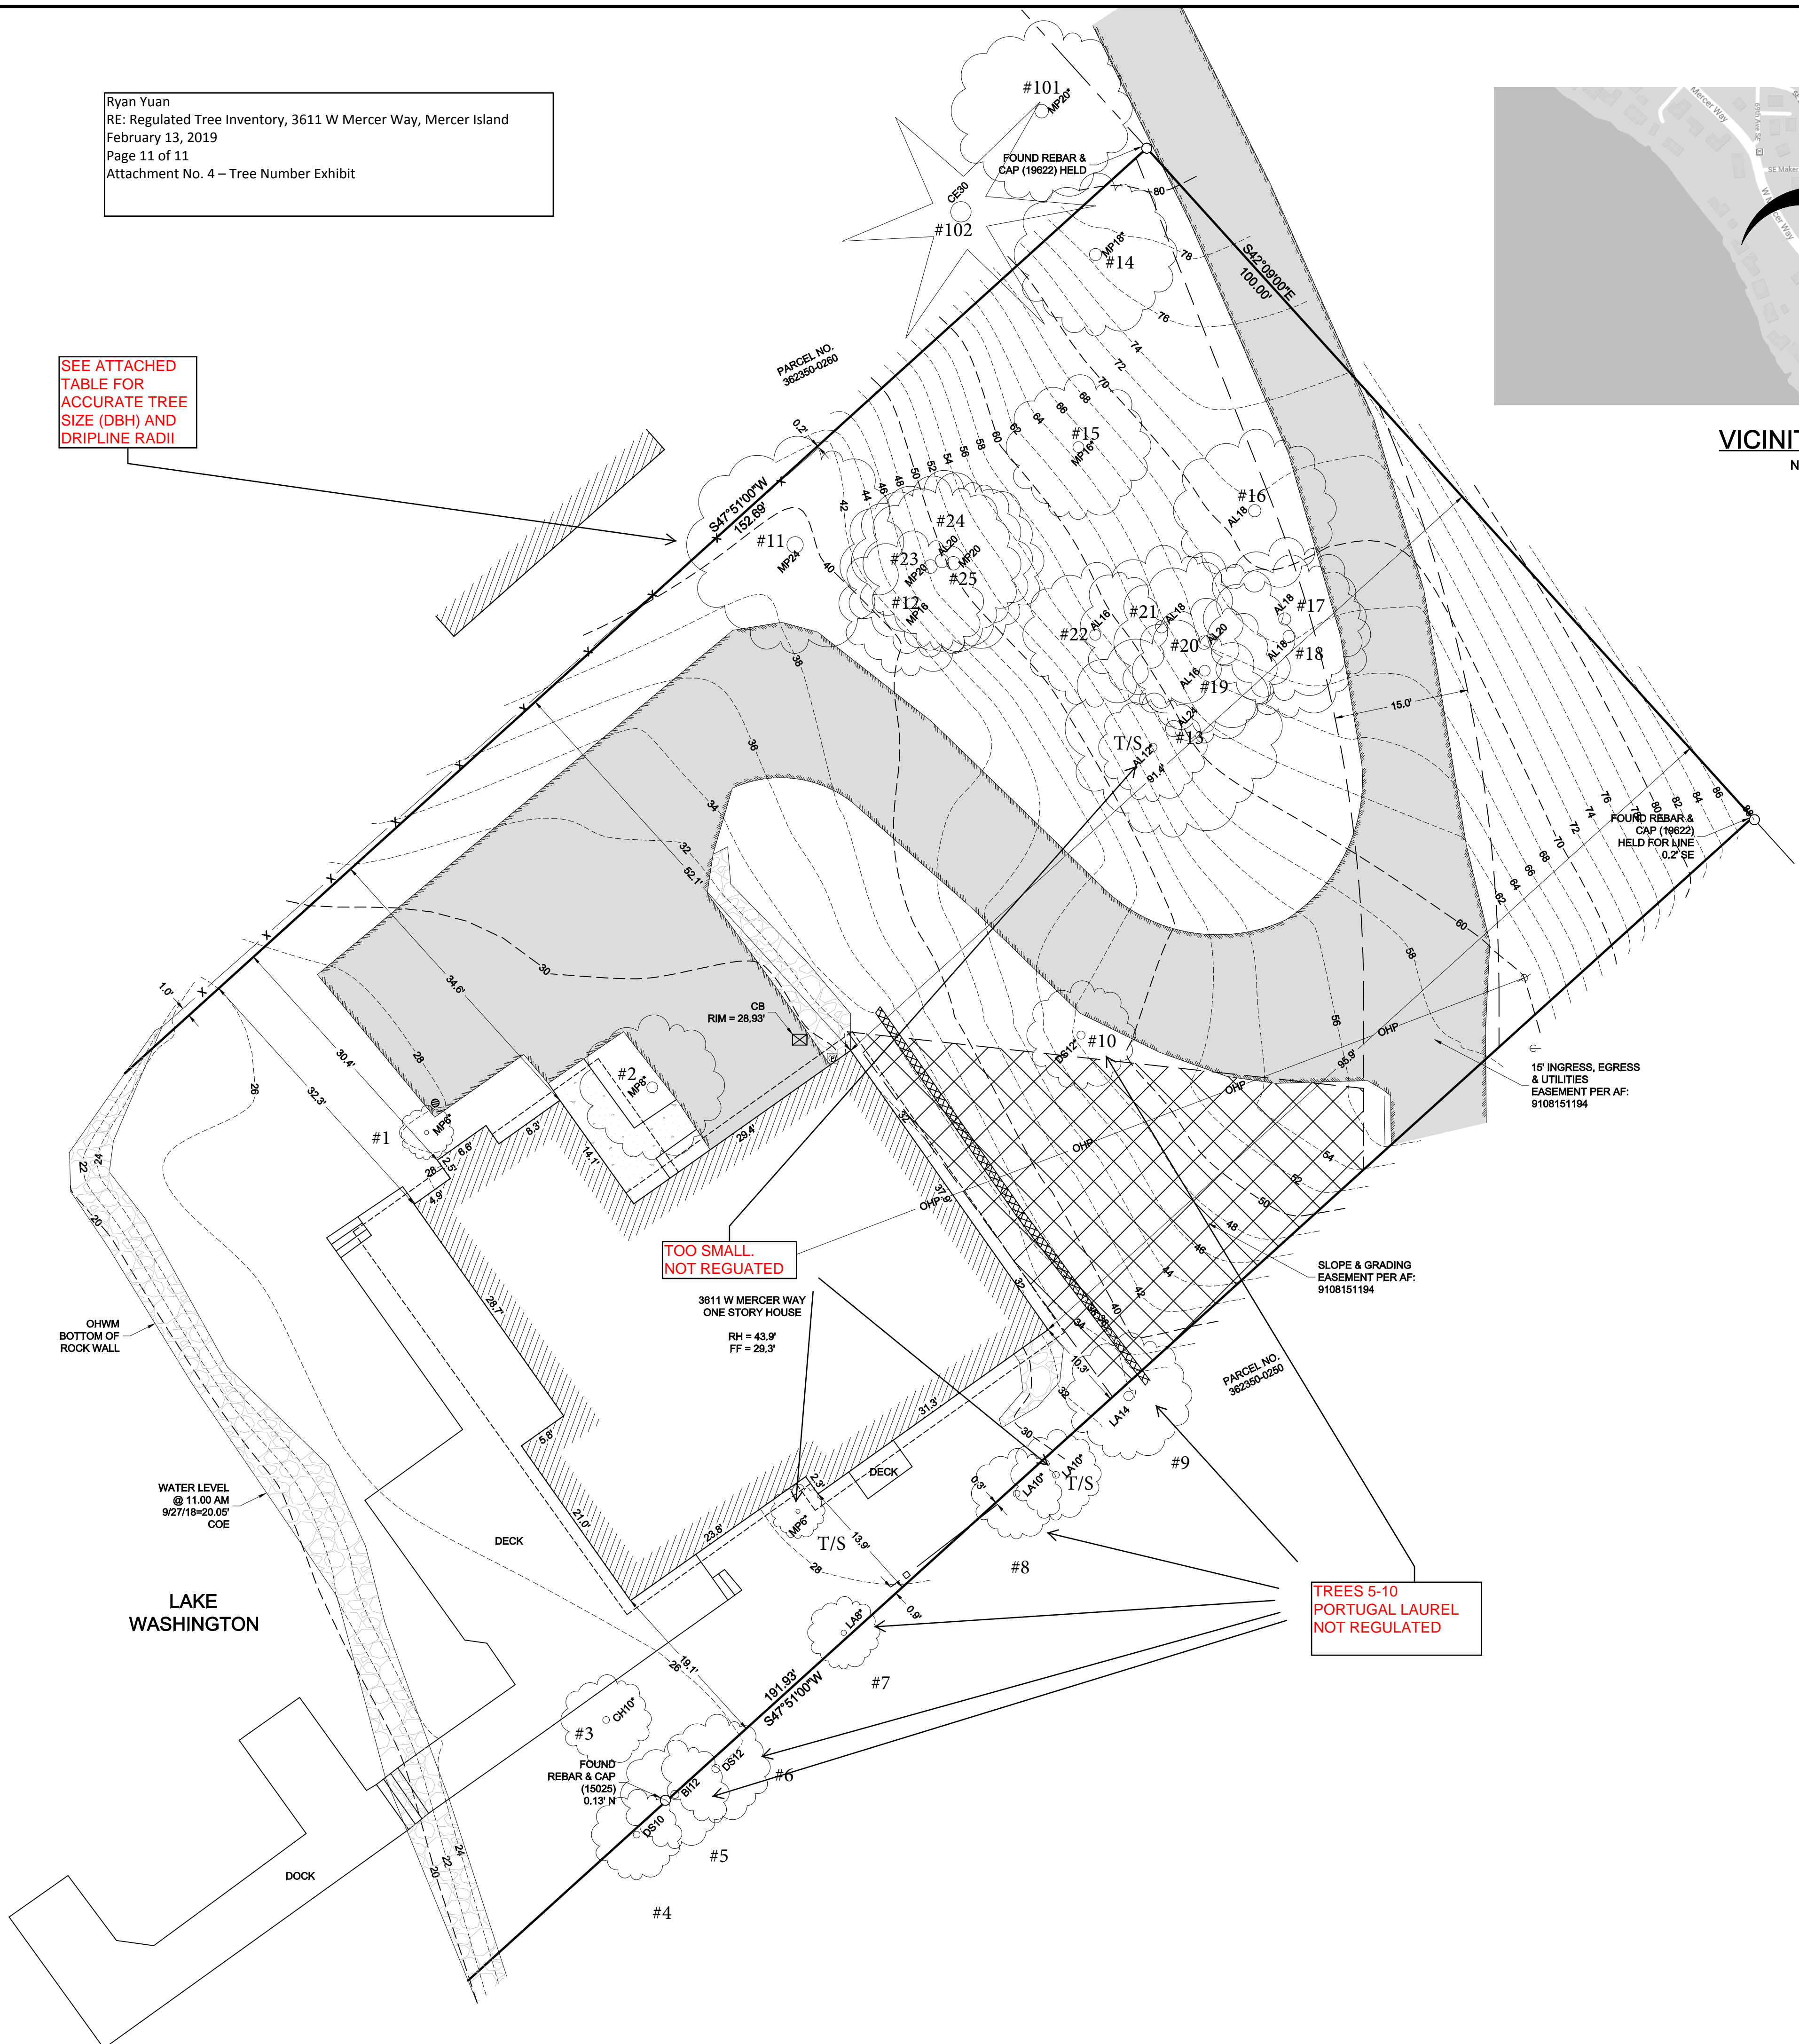
Ryan Yuan
 RE: Regulated Tree Inventory, 3611 W Mercer Way, Mercer Island
 February 13, 2019
 Page 11 of 11
 Attachment No. 4 – Tree Number Exhibit

The attached survey is for tree number reference only: not all tree sizes and dripline measurements are accurate as shown on this exhibit. Please refer to the inventory above for accurate tree attributes.

SEE ATTACHED TABLE FOR ACCURATE TREE SIZE (DBH) AND DRILINE RADI!
