# LAYTON TREE CONSULTING, LLC

## ARBORIST REPORT/TREE PLAN

7216 93<sup>rd</sup> AVE SE  
Mercer Island, WA

**October 29, 2019**

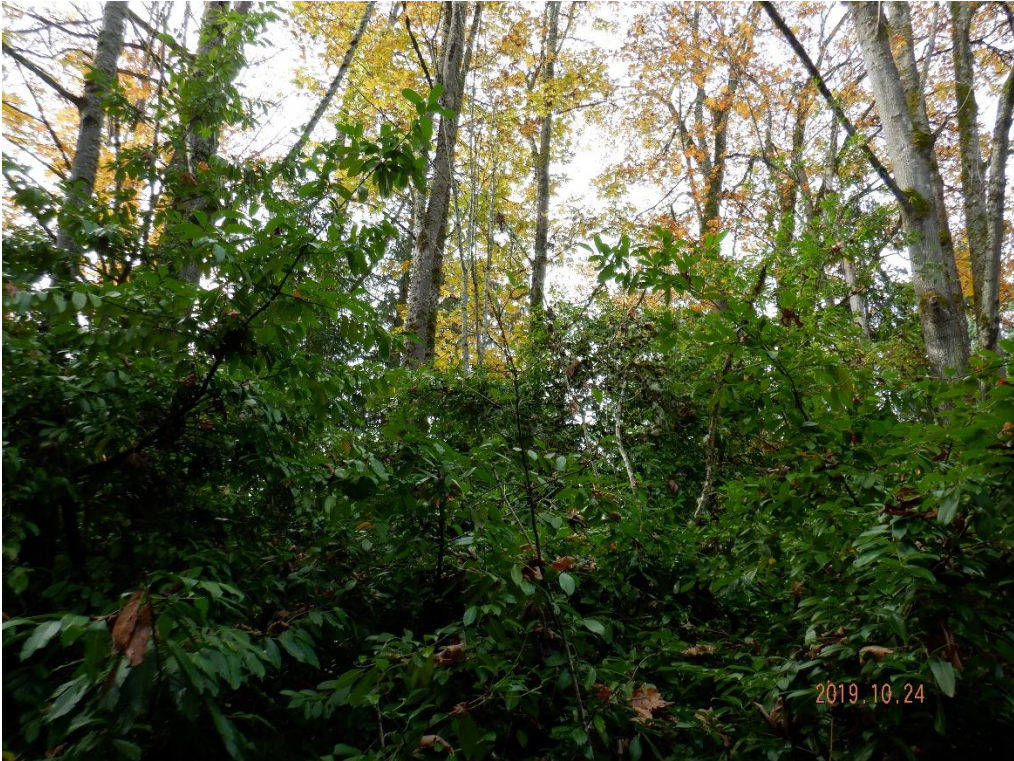
The property has a major infestation of English laurel, which is found throughout. It is quite dense in places. There is also a moderate component of invasive English holly and a minor component of Himalayan blackberry. Most of the native vegetation is found in the southeast portion of the property. Here there are minor to moderate components of sword fern, Oregon grape, beaked hazelnut and oceanspray.

Middle portion of property, dense English laurel

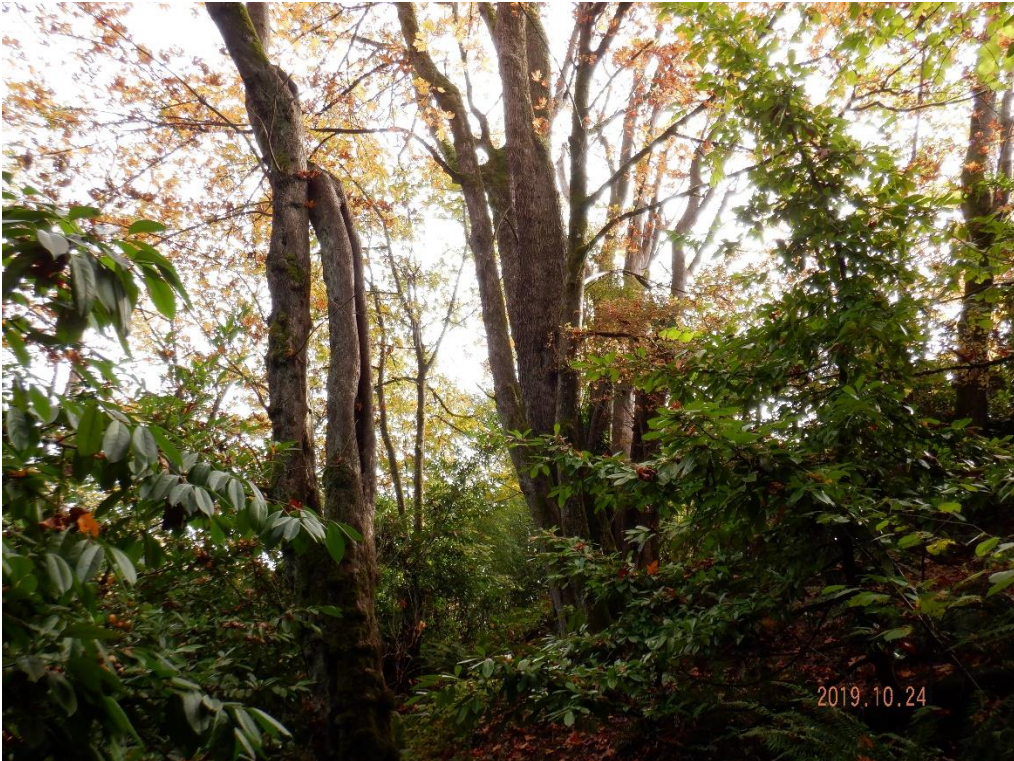
The grove of trees within the southeast portion of the site will be retained. Some of these are in poor condition with a high potential for failure in the future. However, there are few targets in the area. Trees parts are likely to fall into the wooded areas. The retention of the poor condition trees is feasible at this time.

Maples in southeast portion of property

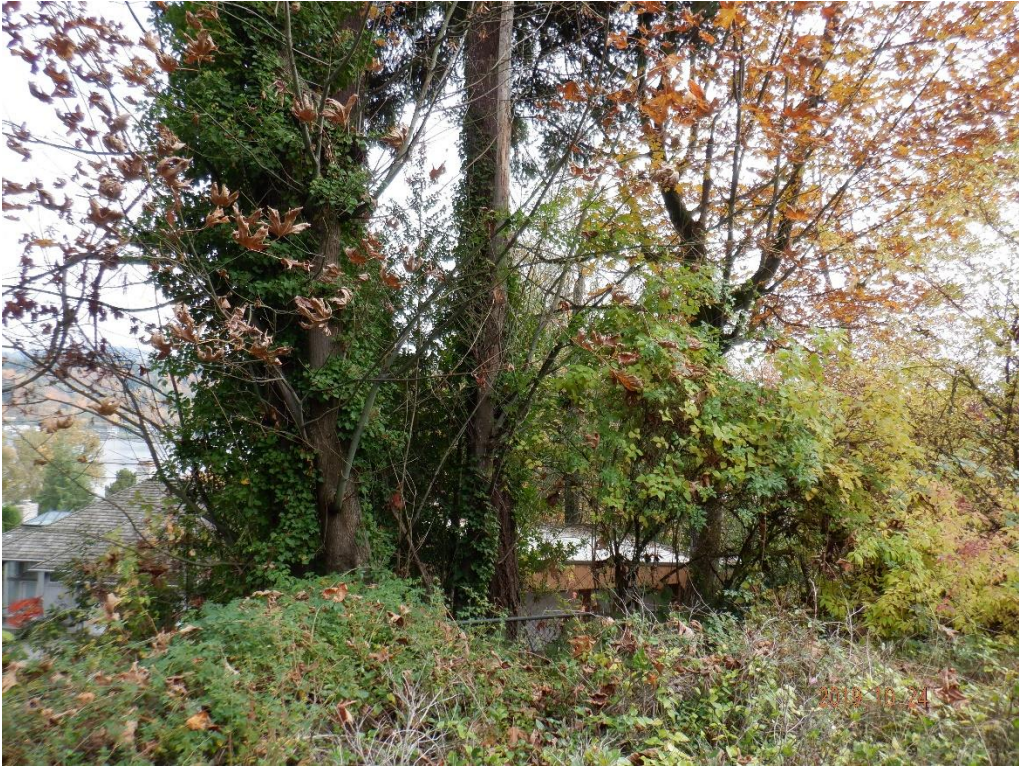
Neighboring trees #101, #102 and #103

Trees #101, #102 and #103 are located on the neighboring property to the north. #101 and #102 are approximately 10-feet off of the property line and not likely to be impacted by re-development of the property. Tree #103 which is located closest to the property line is in poor condition. This is a semi-mature bigleaf maple cluster in ultimate decline. The tops have broken out in the past.

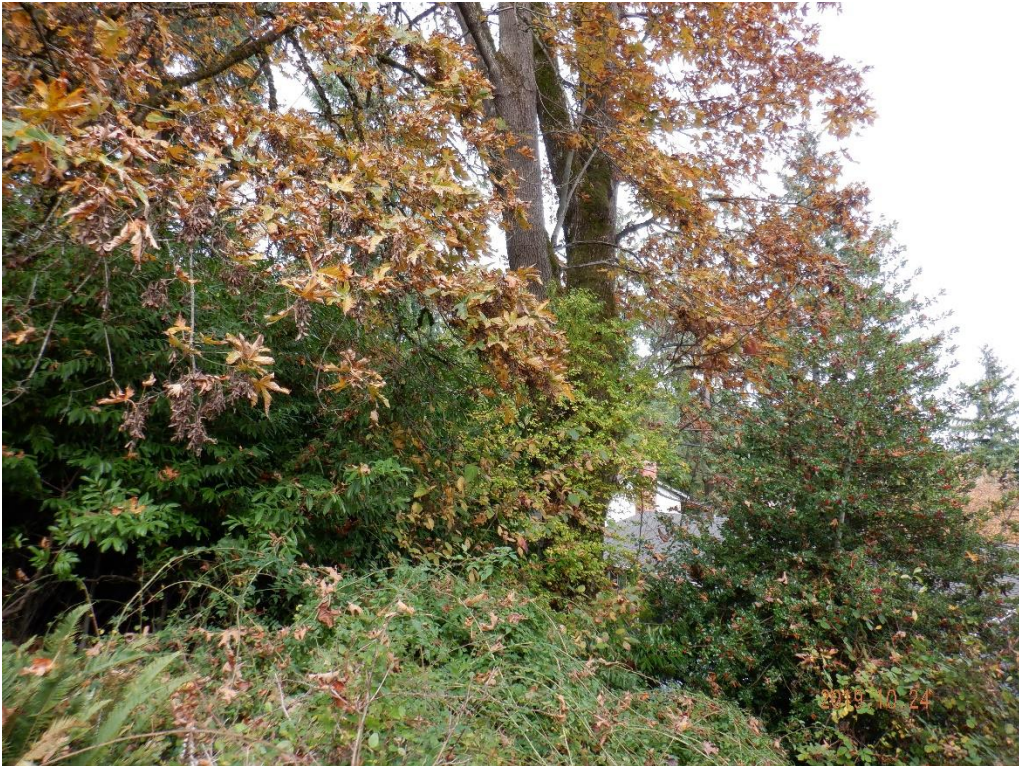
Neighboring tree #104

Neighboring trees #104, #105, #106 and #107 are located on the neighboring property to the north. #104 is a mature bigleaf maple. This exceptional tree has developed good form and is of good vigor. #105 is a mature European white birch. It is of fairly good vigor. Only minor top decline was observed. #106 is an exceptional Japanese maple in good condition. #107 is a cluster of English holly near the northwest property corner. It has developed typical form and is in fair condition.

In order to adequately protect neighboring Trees #105 and #106, provide a 10-foot protection zone from the property line. #106 is 'exceptional' and warrants protection. Tree #104 is not likely to be impacted because of existing steep slopes. If the slope is landscaped in the future, all work shall be done by hand within the driplines of retained on and off-site trees. Soils shall not be significantly disturbed. No grading is allowed within the LOD.
