Arborist Report

TO: David Yeh
SITE: 7239 SE 27th Street, Mercer Island, WA
RE: Inventory report
DATE: August 31, 2016
PROJECT ARBORIST: Katherine Taylor,
ISA Certified Arborist #PN-8022A
ISA Qualified Tree Risk Assessor

Summary

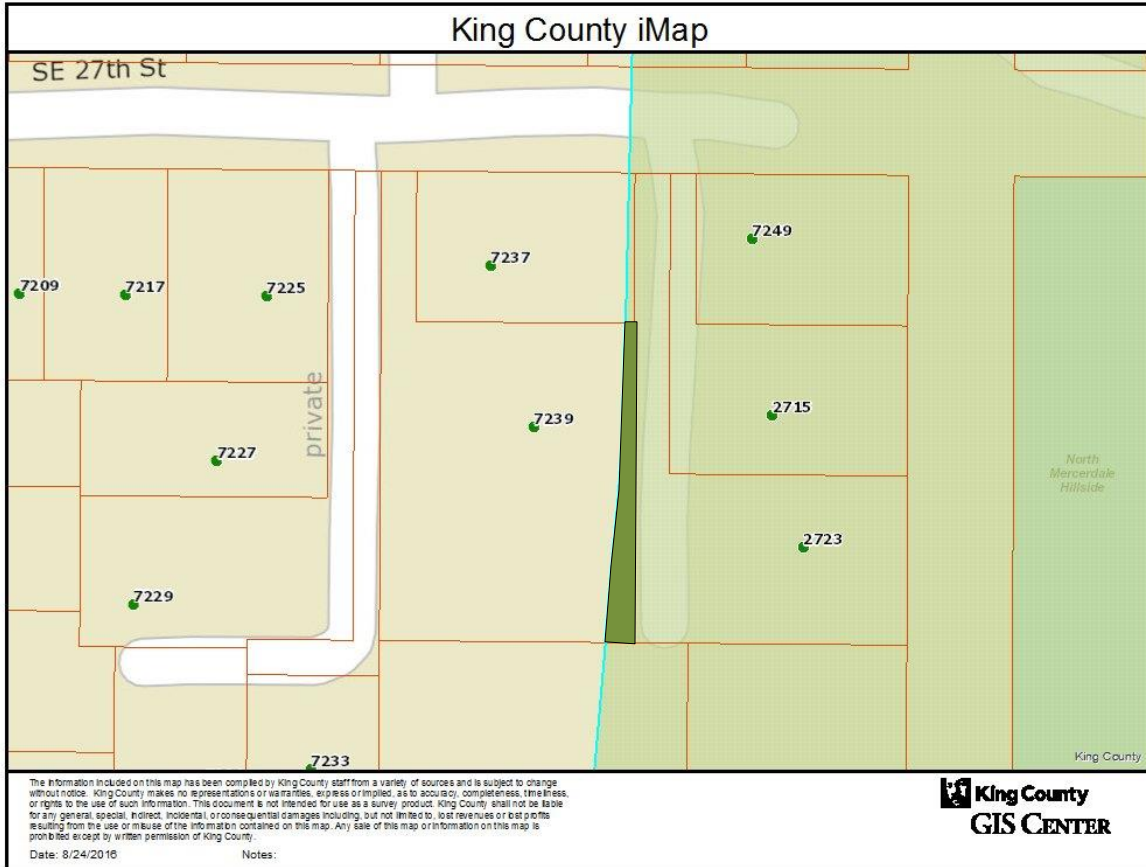
The ESA for erosion hazard on the east side of the property includes trees 16, 17, 19, 20, 29, and 30. This area is designated by King County to define areas where soils may experience severe soil erosion (see [Figure 1](#)).

Figure 1: Site Map with erosion hazard area outlined (The dark green shaded area shows property that is inside the erosion hazard area).

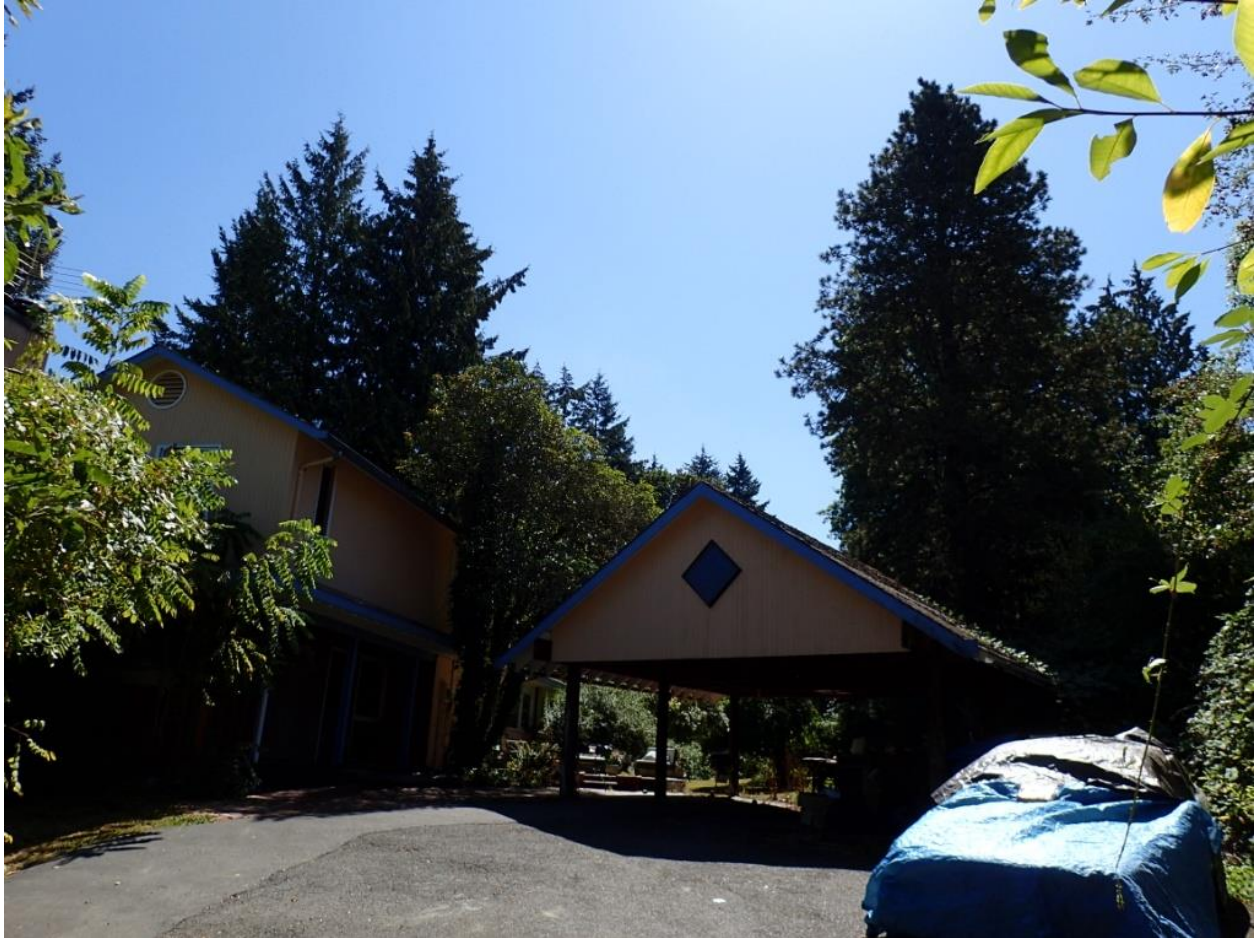
There are several large coniferous trees in good health and structural condition onsite, including trees 13, 20, and 23 through 29. The DSH of these trees range from 18.4 inches to 35.8 inches and species include western redcedar, Douglas-fir, and ponderosa pine (see [Photo 1](#)).

Photo 1: A view of some of the large coniferous trees found on site.

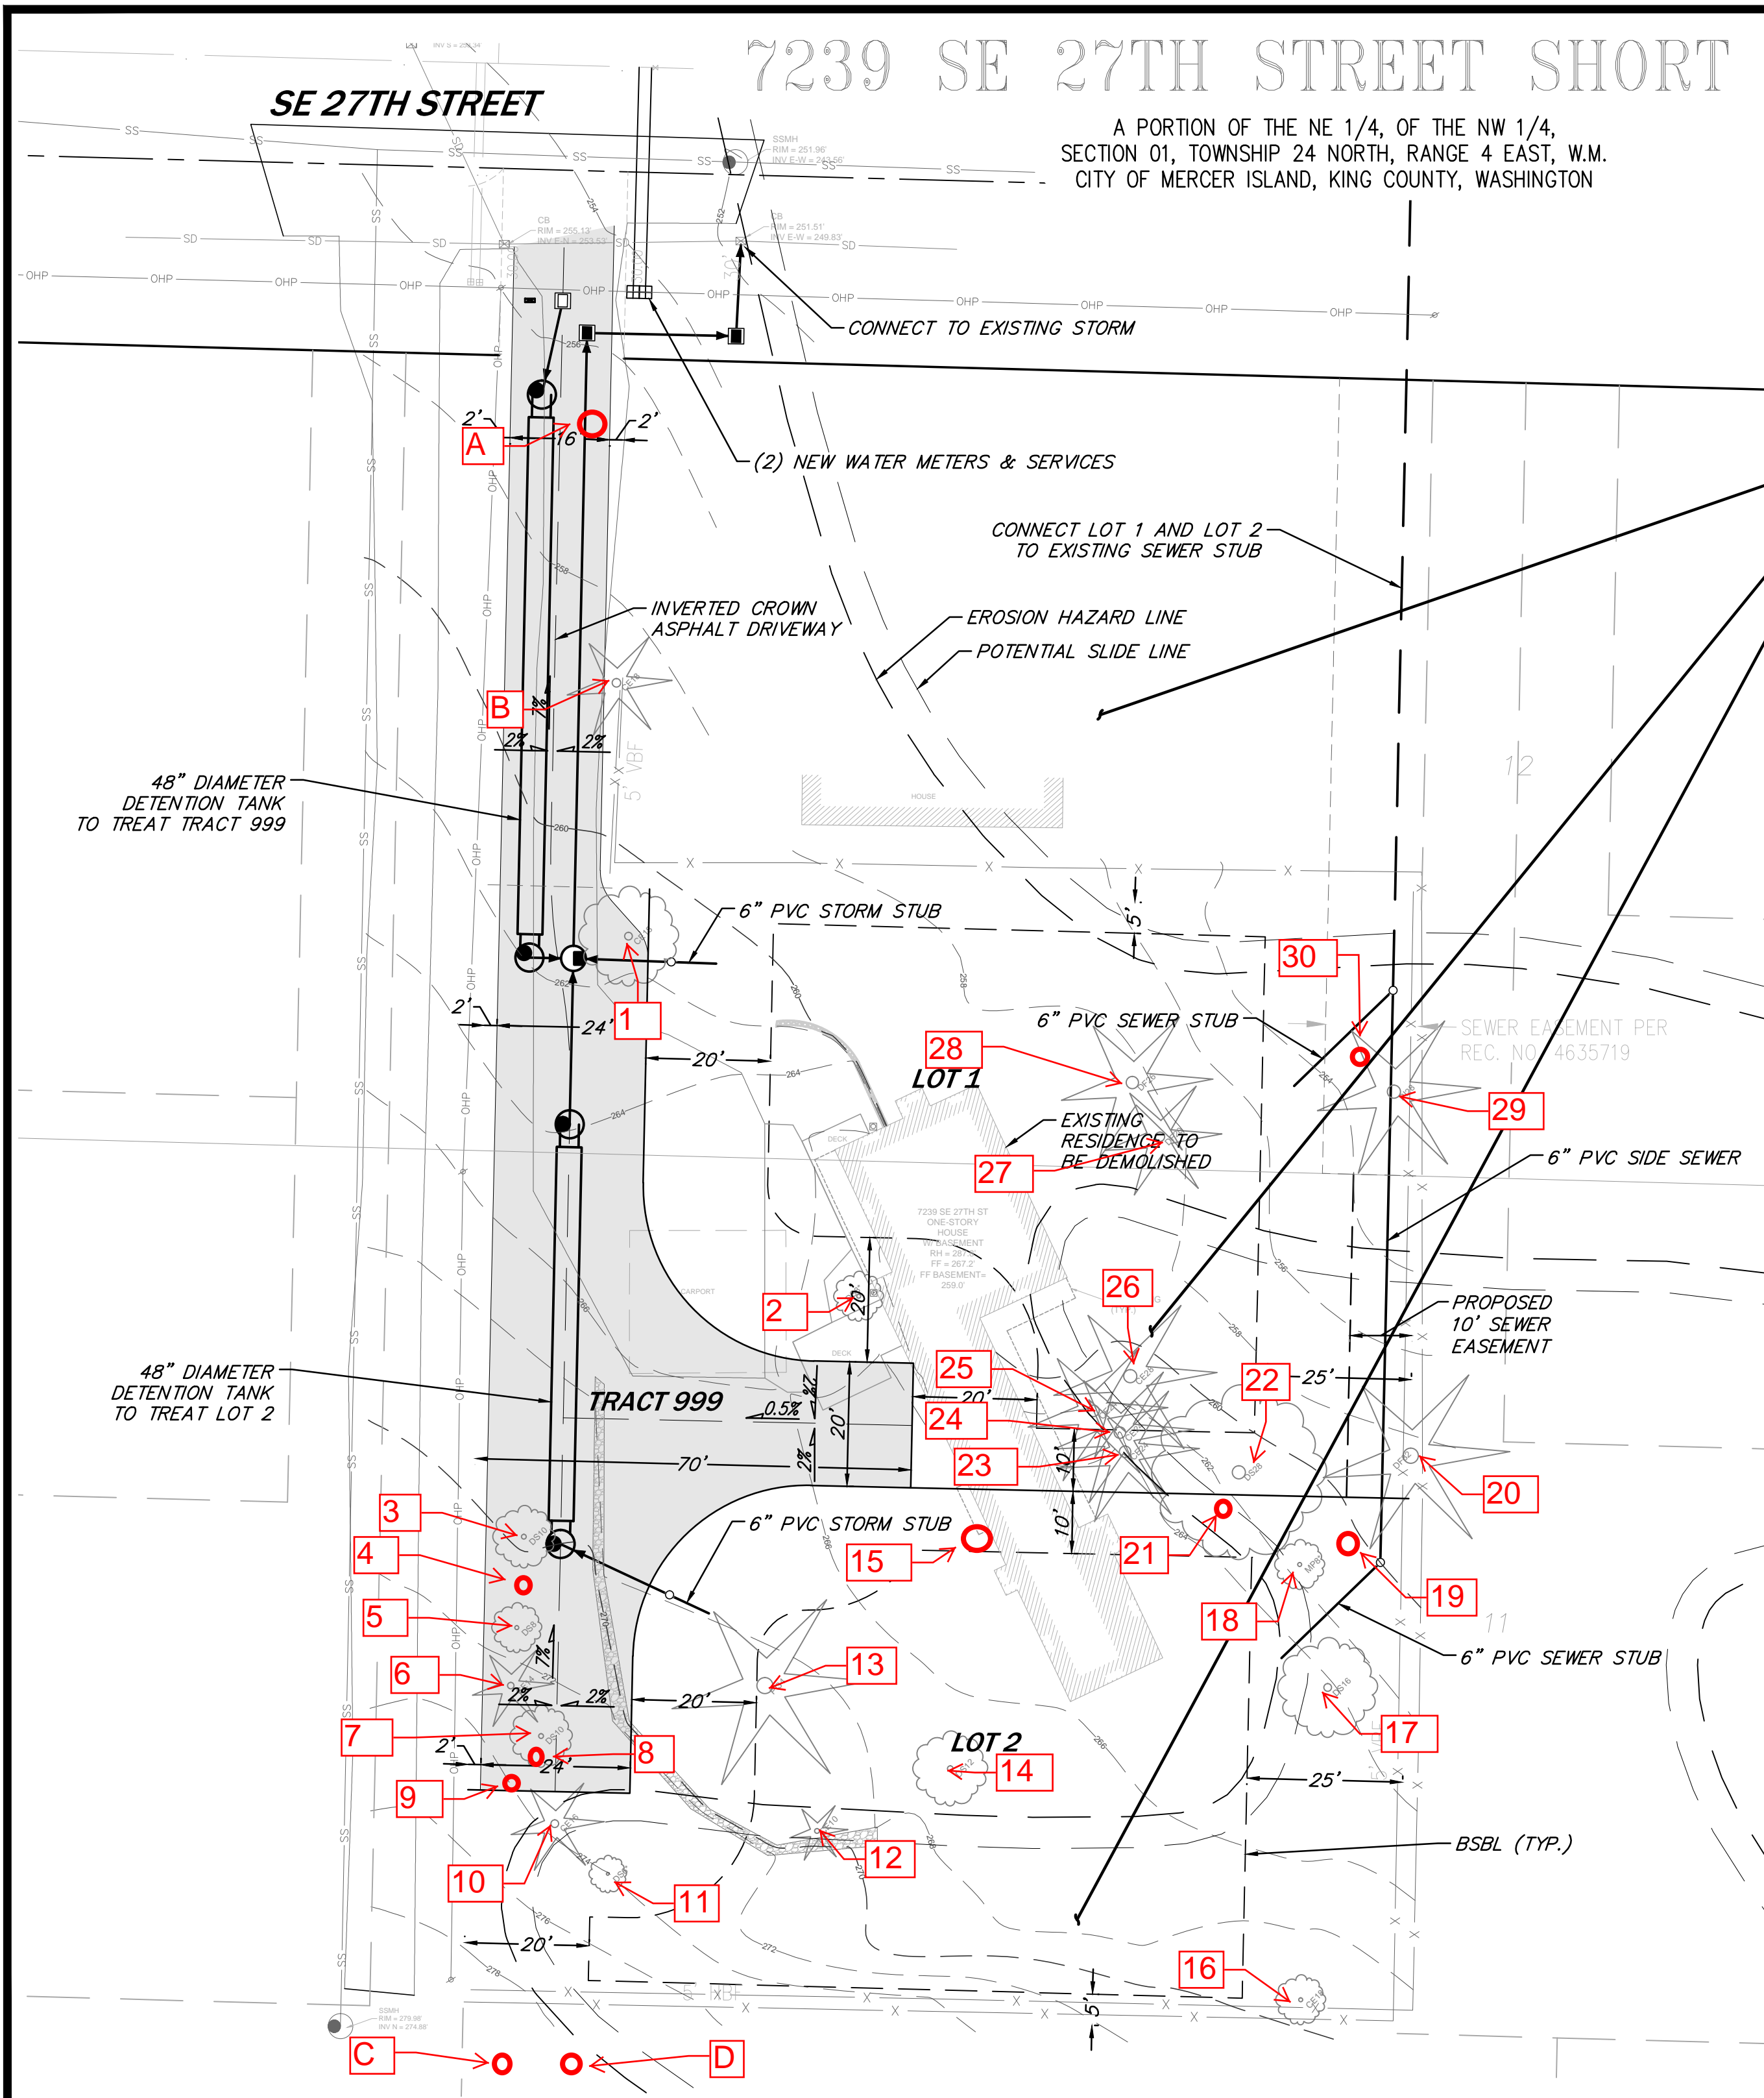
THESE 3 LOTS ARE IN THE EROSION/SLIDE HAZARD AREA. WE NEED TO DETERMINE IF THESE LOTS CAN BE EXCLUDED FROM THOSE HAZARD ZONES
