**ARBORIST REPORT
FOR
3675 W Mercer Way
Mercer Island, WA**

**August 16th, 2016
Revised January 12th, 2018
Updated February 6, 2019**

American Forest Management, Inc. has been asked to compile an ‘Arborist Report’ for a proposed two lot short plat located within the City of Mercer Island, WA.

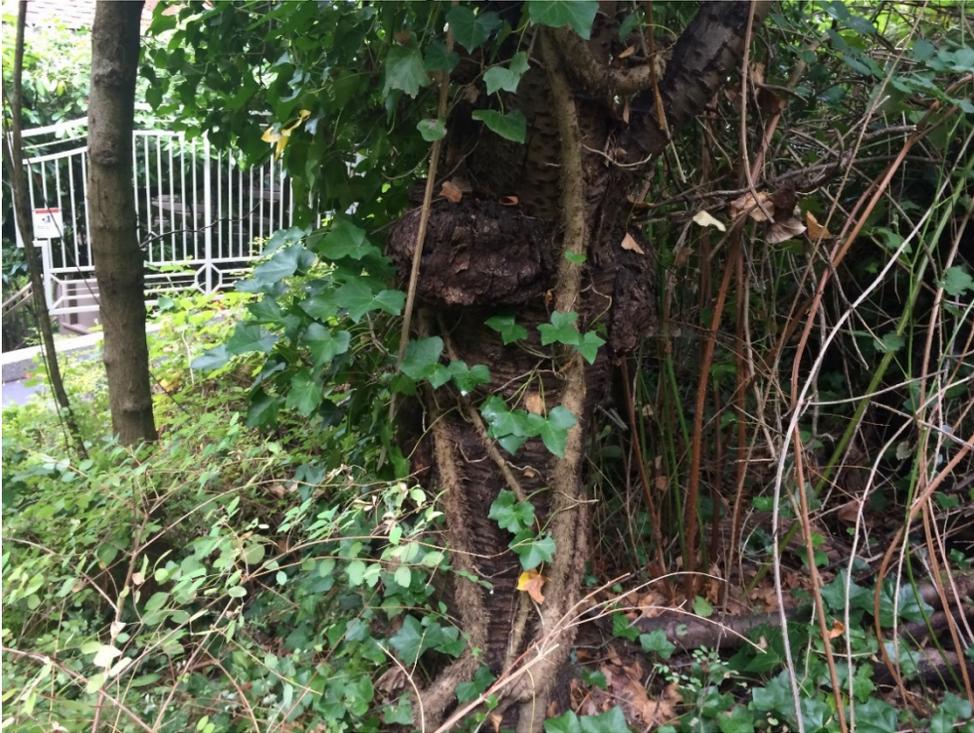
Tree #102 – bitter cherry with large ivy stems and burls

For the majority of the property, ivy was killed and removed from trees in the past. There is still ivy covering the trunks of many trees. This threatens the long term health and viability of the trees. It also impeded visual assessments of tree trunks. The remaining ivy should be killed and removed from trees.

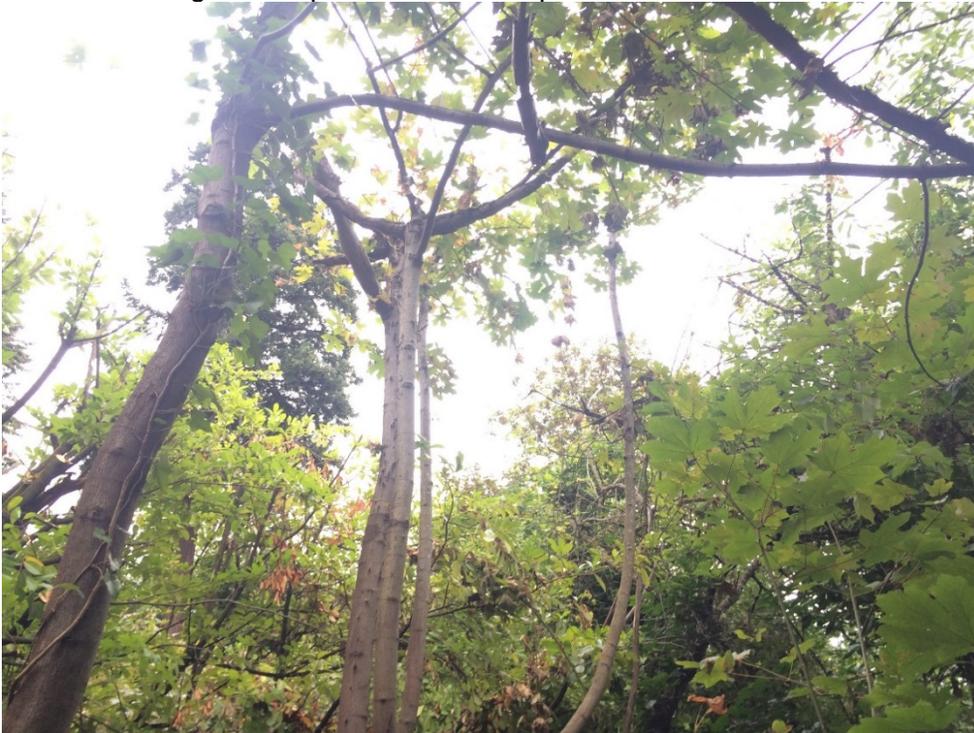
Big leaf maple trees are dispersed throughout the steep slope above the home. The big leaf maple range in age and condition. One big leaf maple, #103 has a broken top and is in poor condition. This is the only significant, non-viable big leaf maple on the subject property. Common defects include forked trunks, self-corrected leans.

Tree #103 – big leaf maple with broken top

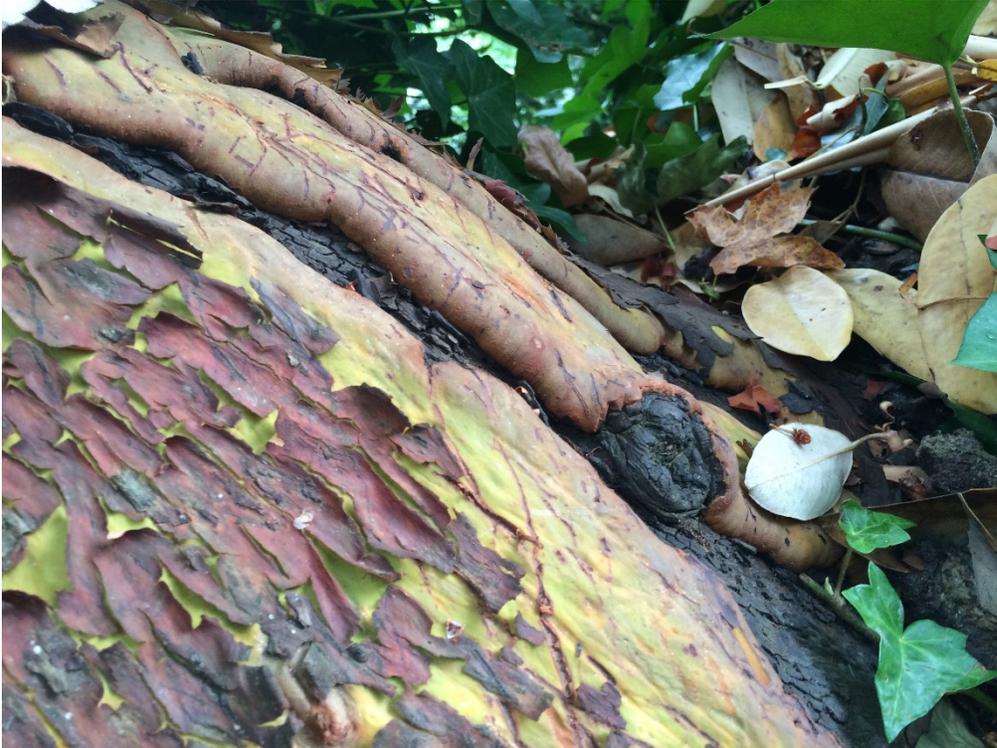
Tree #121 – Pacific madrone with cankers caused by *Nattrassia mangiferae*

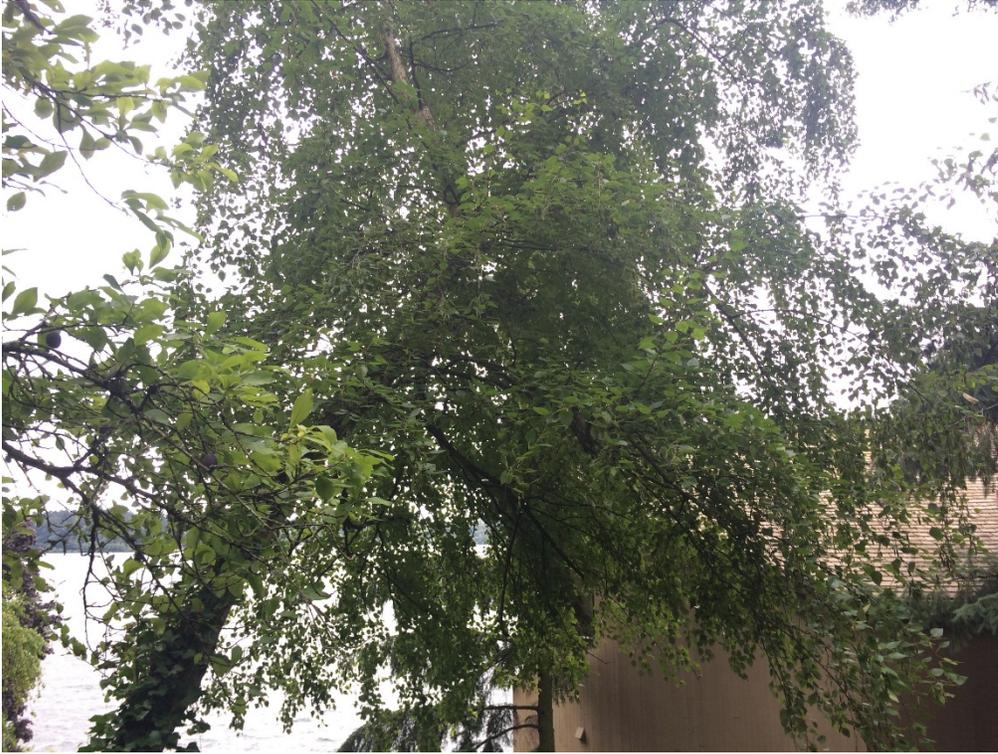
Tree #123 – paper birch leaning west, ivy on the trunk

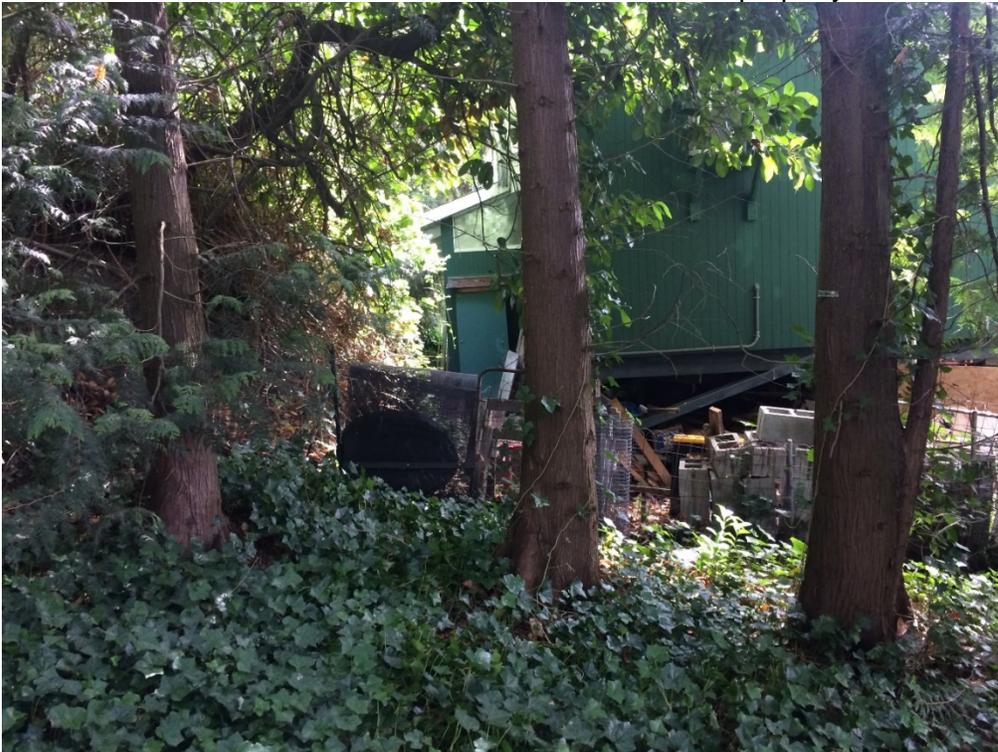
Tree #131 - #133 – western red cedars on the southeast property line

The cluster of western red cedar trees on the south property line are close to the preliminary new home and deck location. Western red cedar trees are intolerant of root damage and fill. Changes in water table and soil moisture can severely impact their viability. Careful tree protection measures will be necessary to protect these trees. All eight trees (#131 - #138) will be retained as a group to minimize future wind impacts.

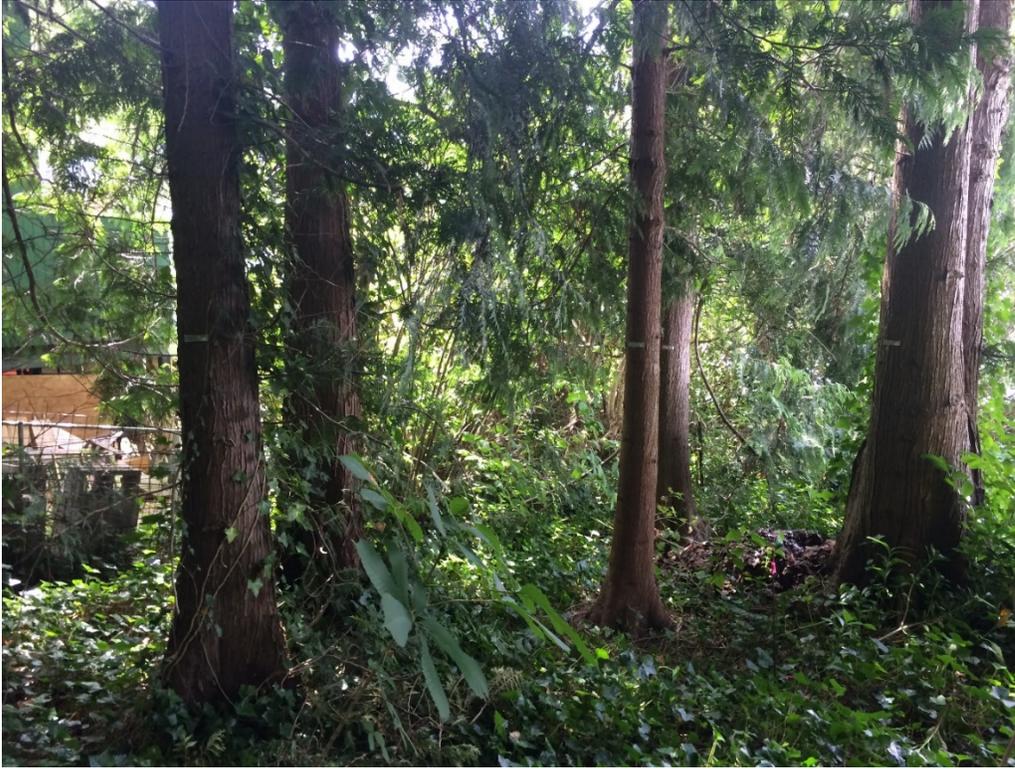
Western red cedar trees on the southeast property line

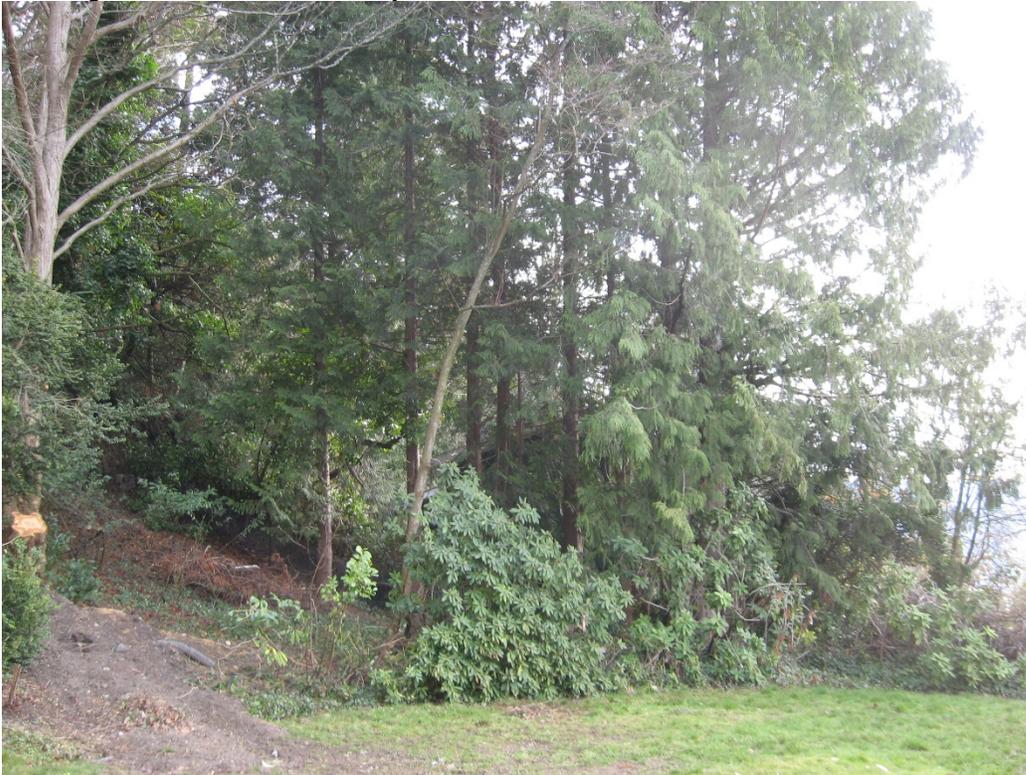
Same grove as above, January 2019

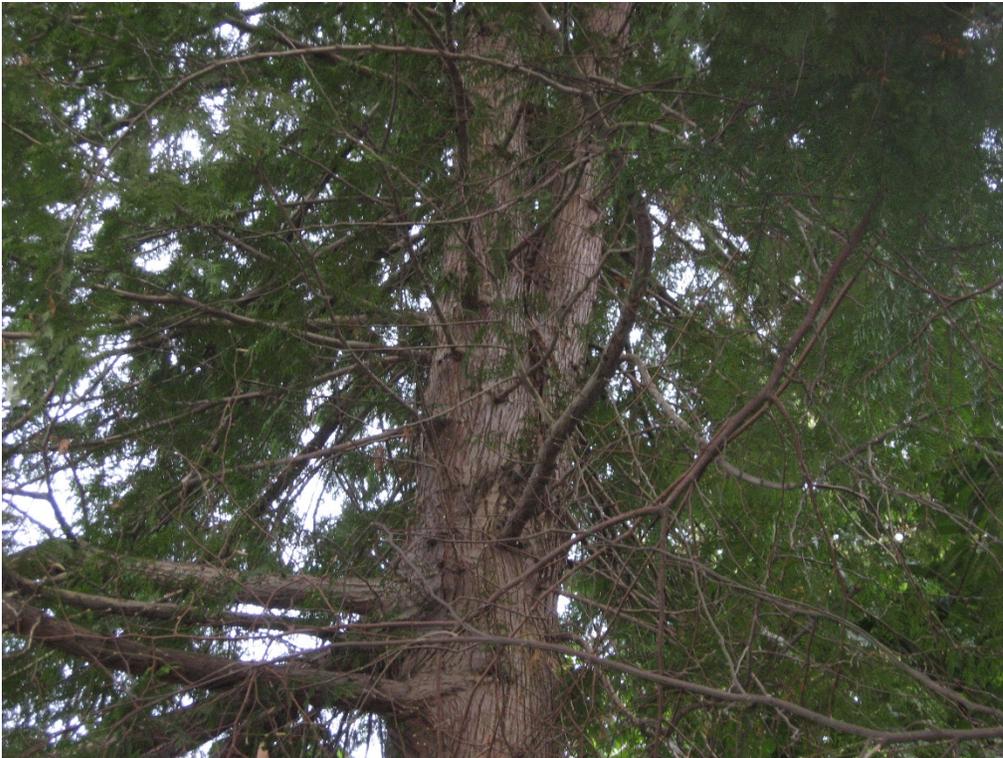
Tree #114, east forked stem susceptible to failure
