DRAINAGE MEMORANDUM

TO: City of Mercer Island
 FROM: Ben Iddins, P.E.
 DATE: May 10, 2019
 RE: 3440 97th Ave SE, Mercer Island, WA
 On-site Drainage System Design Summary

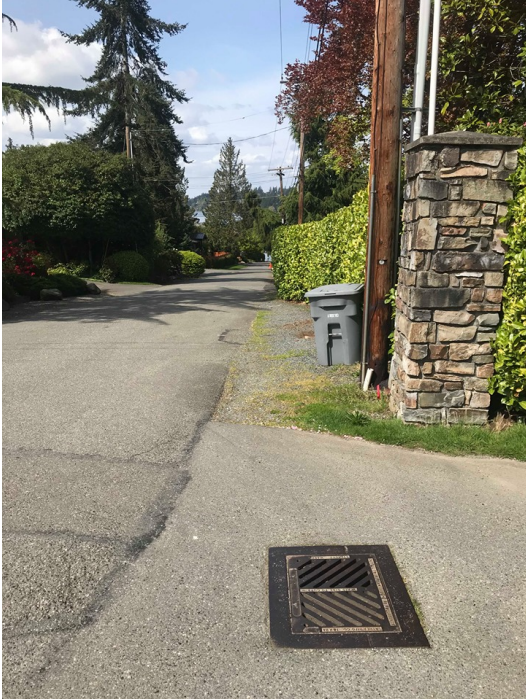
Photo 1 (looking N): Type 1 Catch basin (#1). 12" concrete inlet from the south and 8" corrugated inlet from the southwest. This CB will be receiving runoff from the project development.

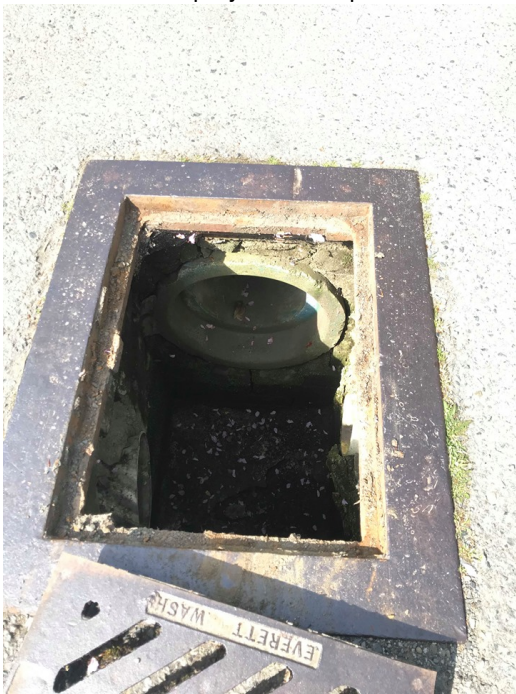
Photo 3 (looking into CB #1): Type 1 Catch basin (#1). 12" concrete pipe outlet flowing N.

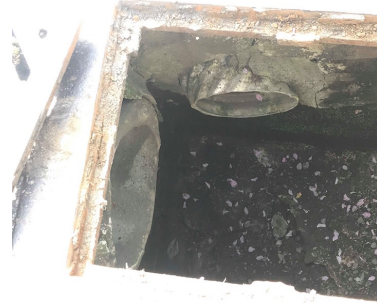
Photo 2 (looking into CB #1): 12" concrete inlet from the south and 8" corrugated inlet from the

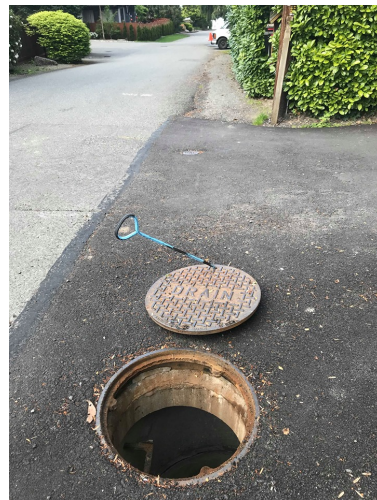
Photo 4 (looking N): Type 2 MH (#2). Inlet from 8" corrugated pipe.

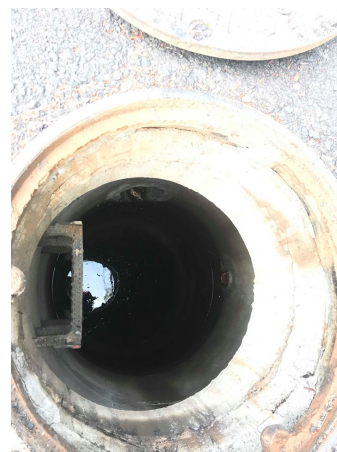
Photo 5 (looking into MH #2): Type 2 Manhole (#2). 12" concrete pipe outlet flowing N.

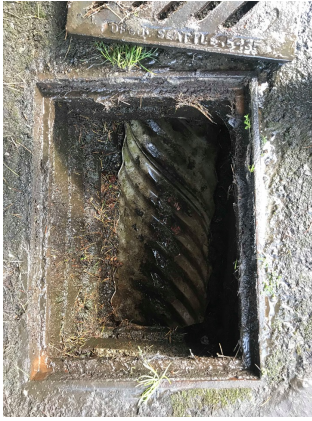
Photo 6 (looking into CB #3): Type 1 Catch Basin (#3). 12" concrete outlet flowing N.

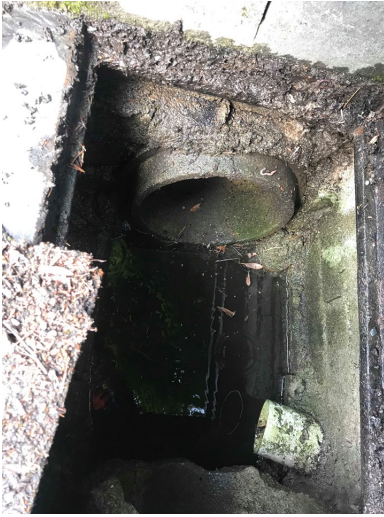
Photo 8 (looking into CB #4): Type 1 Catch Basin (#4). 12" concrete outlet flowing N.

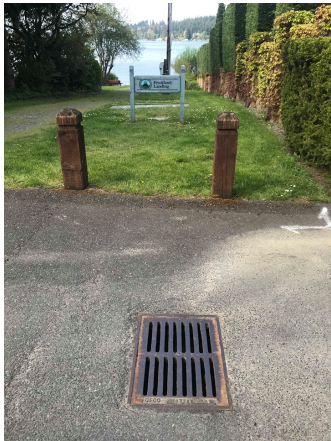
Photo 10 (looking N): Type 1 Catch Basin (#6). 12" concrete inlet.

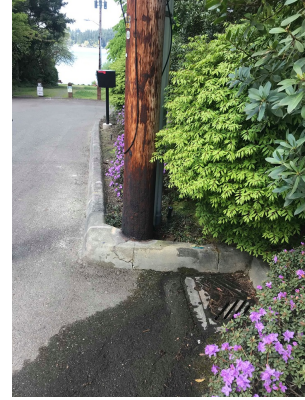
Photo 7 (looking N): Type 1 Catch Basin (#4). 12" concrete inlet.

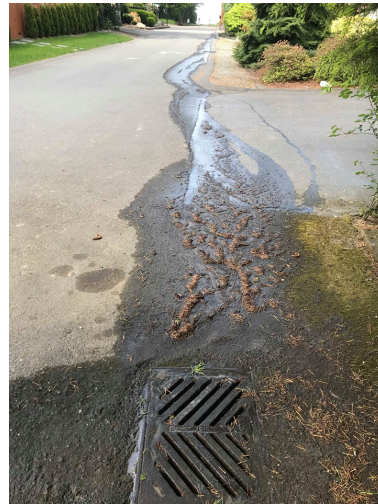
Photo 9 (looking N): Type 1 Catch Basin (#5). 12" concrete inlet according to GIS, but appears to be 6".

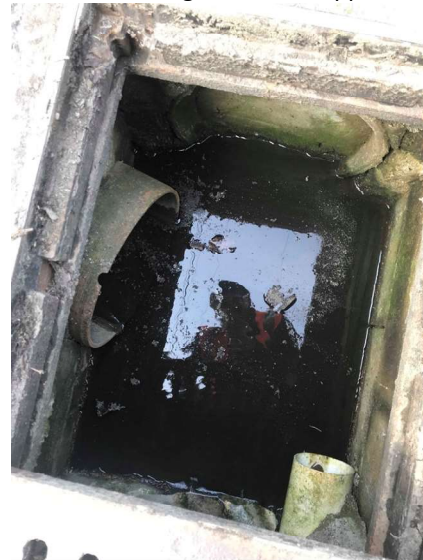
Photo 11 (looking into CB #6): 12" concrete outlet flowing W.

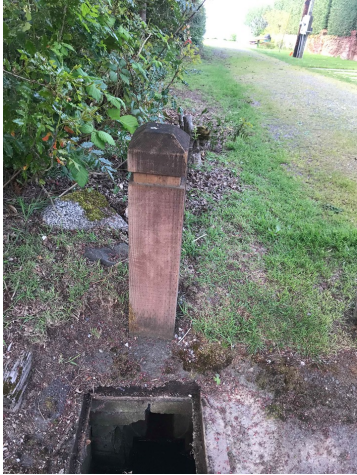
Photo 12 (looking into CB #7): 12" concrete outlet flowing N.

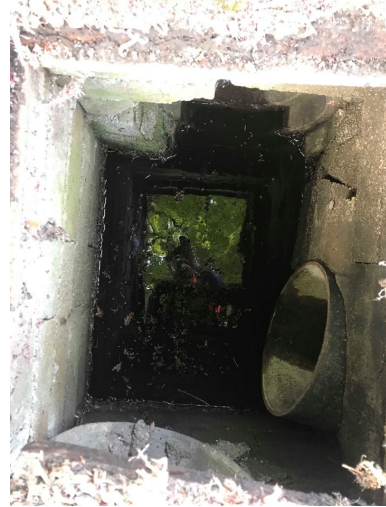
Photo 13 (looking N): Type 1 Catch Basin (#7). 12" concrete inlet.

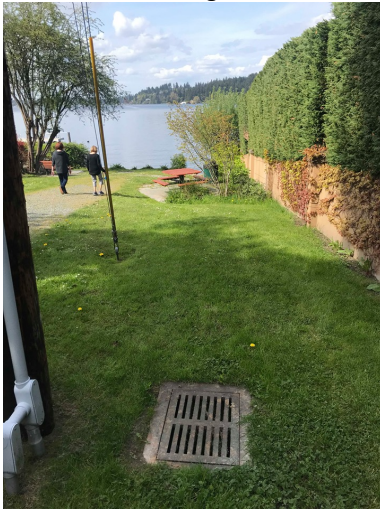
Photo 14 (looking into CB #8): Type 1 Catch Basin (#8). 12" concrete pipe outlet flowing NW.

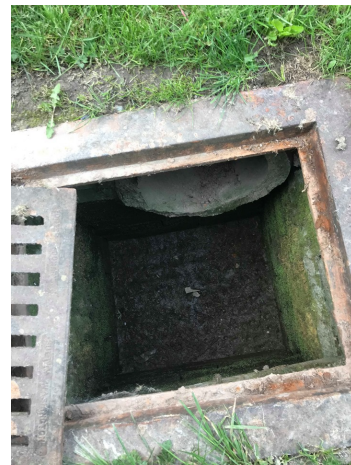
Photo 15 (Looking N): Type 1 Catch Basin (#8). 12" concrete inlet.

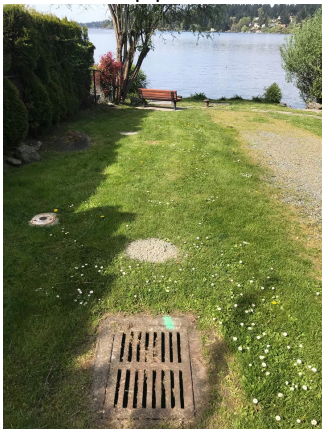
Photo 16 (looking N): Type 1 Catch Basin (#9). 12" concrete inlet.

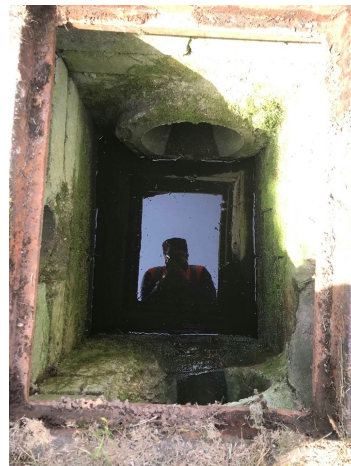
Photo 17 (looking into CB#9): Type 1 CB (#9). 12" concrete pipe outlet flowing north.

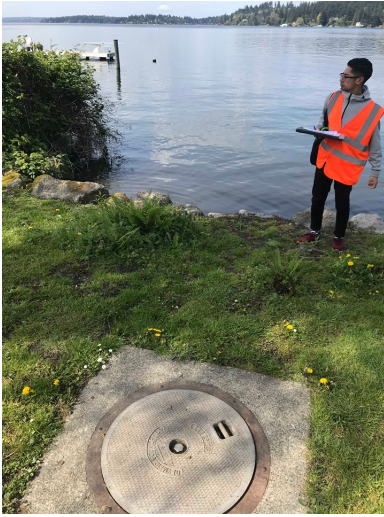
Photo 18 (looking N): Manhole (#10) that outflows into Lake Washington.
