Development Tree Plan – Valentin Residence

February 23, 2019

Arborist Report

Dated: January 19, 2019 Revised February 23, 2019

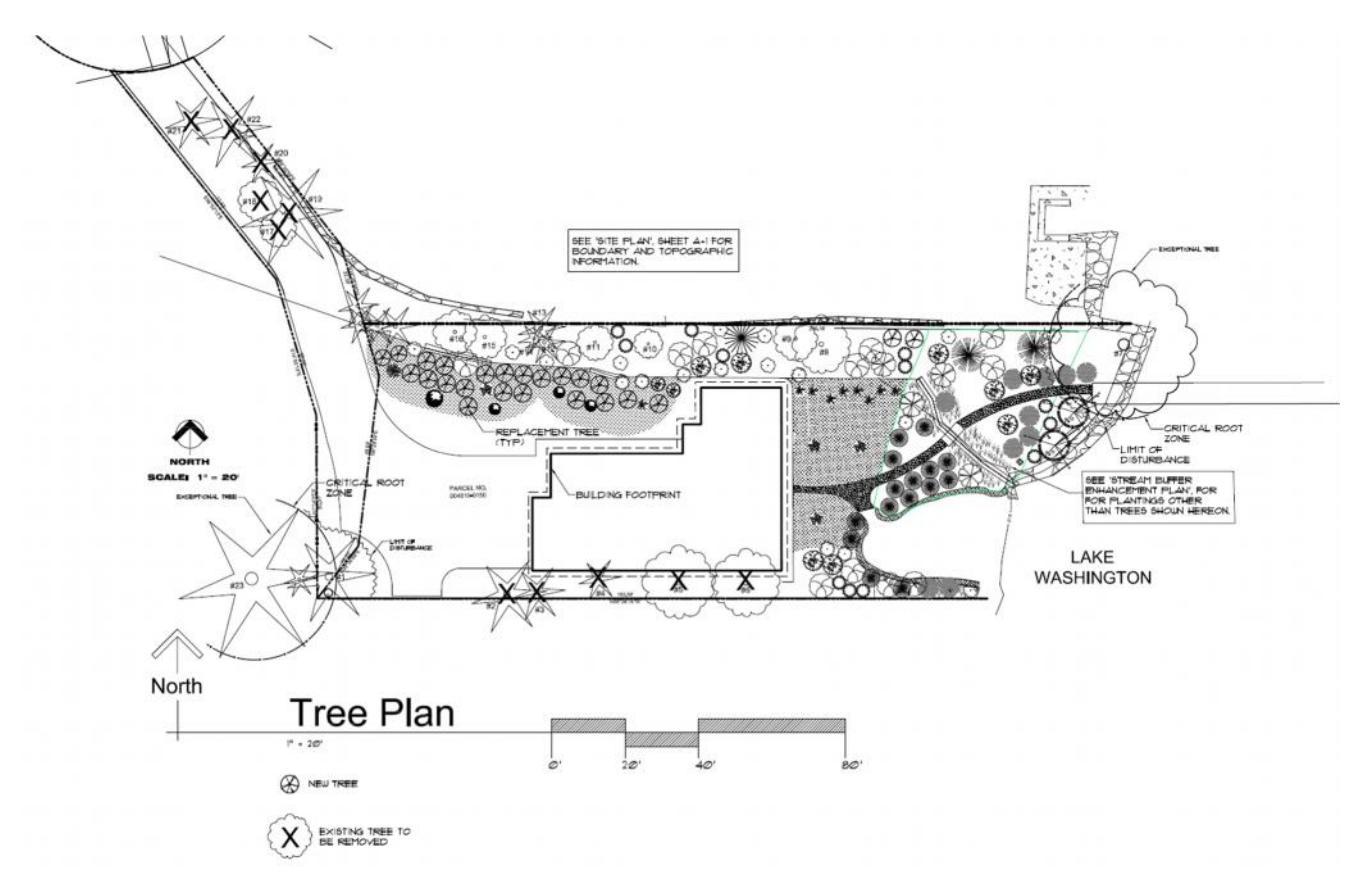
Tree Retention and Replacement Plan:

The eastern part of the parcel hosts one Western Red Cedar (1). The neighboring property to the East hosts one exceptional Coast Redwood (23) that will be within safe distance from any excavation. I recommend that these trees be further protected by a clearly marked limit of disturbance and associated tree protection fencing during construction. The Birch trees (8,9) on the north side have English Ivy growing up the trunks. The Birch trees appear to be healthy. I recommend removal of the ivy from the entire trunk to encourage the trees to thrive in the future as the ivy adds unnecessary weight to the trees which could lead to premature trunk failure.

property line, within the existing utility/sewer easement, there are two over-mature Poplars (5,6) and three Pines (2,3,4).

- Poplars are a very fast-growing species with a short life span. Consistent with MICC 19.10.060(A), the two Poplars (5,6) should be removed as they are considered hazardous. Trees of this size and age constantly shed spear-like branches and pose a safety and liability issue to both this property and neighbors. I recommend these for removal. They would be replaced per the replacement ratio in MICC 19.10.070.
-) There are three Pines (2,3,4) on the south side of the property, one with trunk lean and growing into the southern neighbor's property. They are less than 24" and are growing within the existing utility/sewer easement which make them lesser of a priority than the other trees on the property. I consider the pines on the south side a potential hazard to the proposed residence. The root system would be damaged by foundation and connection to the sewer would likely require them to be removed. For these reasons, I recommend removing the pines. They would be replaced per the replacement ratio in MICC 19.10.070.

The replacement trees will be located in proximity to the other native trees to form a grove of trees. See the tree retention and replacement plan below.
