ARBORIST REPORT

October 9, 2020

9820 SE 35th Place
Mercer Island, WA

Tom Quigley
ISA Certified Arborist, PN-655A
Tree Risk Assessment Qualified (TRAQ)

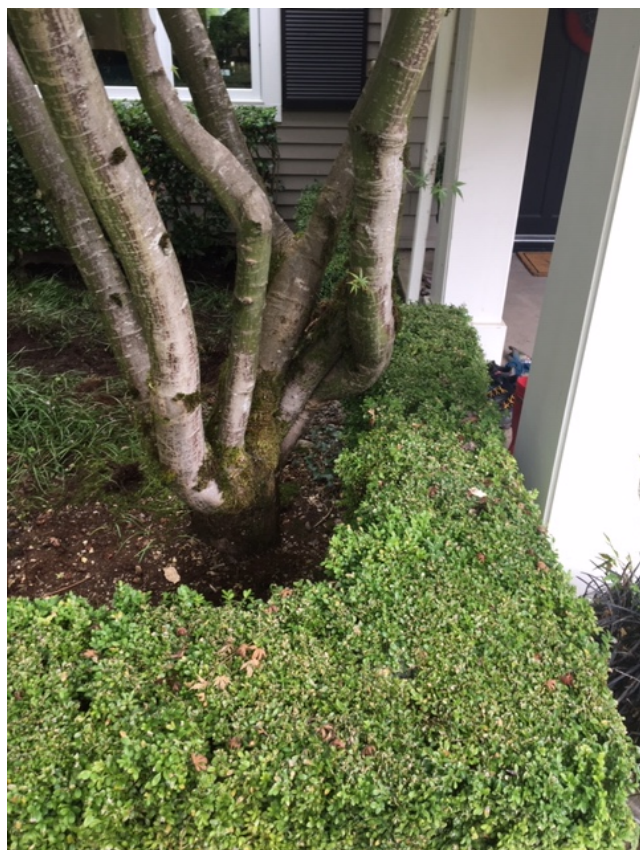
There are three areas of the proposed construction that may impact root systems of nearby trees. Tree #5 is a Japanese maple that is located 30" away from the exiting front porch wood

pillar. Your plans detail that the porch will be extended in this area. Tree #5 will need to be removed. See Photo below.

Photo below is Tree #5, located 30" away from existing porch pillar. Tree to be removed.

Tree #5 will be removed so there is no need for additional assessment or comment.

I have completed the Tree Inventory & Replacement Submittal Information sheet as required by the City of Mercer Island. You propose to remove only one (1) tree. You will be required to plant two (2) trees as mitigation for the removal of Tree #5. **The above referenced site plan details the planting locations for the replacement/mitigation trees. (need to see revised site plan)**
