# ARBORIST REPORT

December 14, 2020

9820 SE 35<sup>th</sup> Place  
Mercer Island, WA

Tom Quigley  
ISA Certified Arborist, PN-655A  
Tree Risk Assessment Qualified (TRAQ)

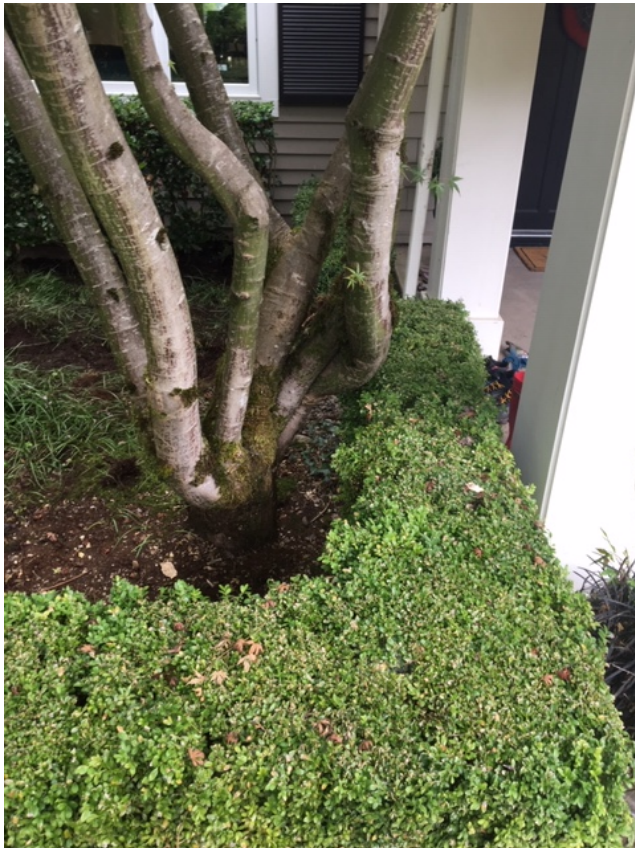
There are three areas of the proposed construction that may impact root systems of nearby trees. Tree #5 is a Japanese maple that is located 30" away from the exiting front porch wood

pillar. Your plans detail that the porch will be extended in this area. Tree #5 will need to be removed. See Photo below.

Photo below is Tree #5, located 30" away from existing porch pillar. Tree to be removed.

Tree #5 will be removed so there is no need for additional assessment or comment.

I have completed the Tree Inventory & Replacement Submittal Information sheet as required by the City of Mercer Island. You propose to remove only one (1) tree. You will be required to plant two (2) trees as mitigation for the removal of Tree #5.
