ARBORIST REPORT/TREE PLAN

4245 90th AVE SE
Mercer Island, WA

October 12, 2020
Updated 12-8-2020

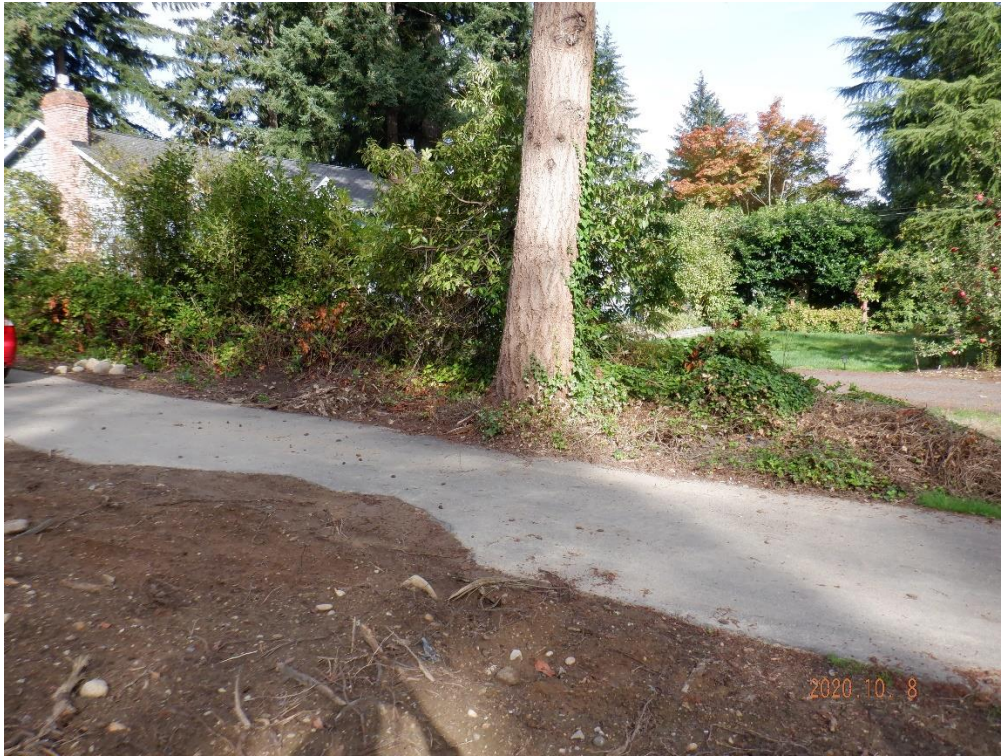
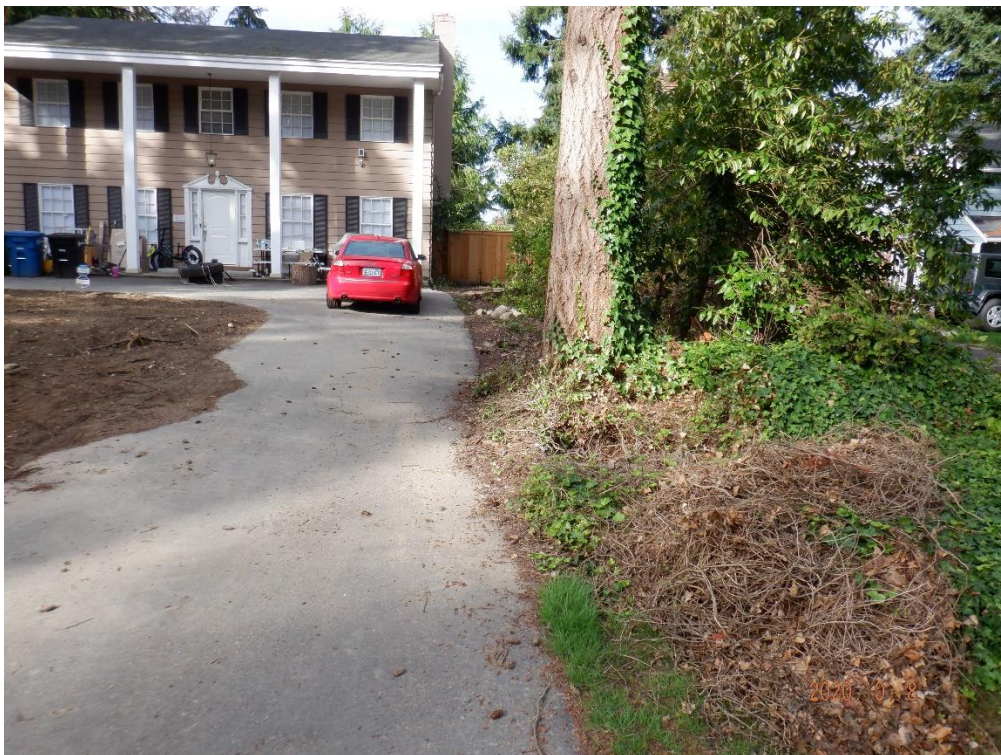
Tree #1 – lower trunk

Tree #1 is located near the northeast corner. This is a semi-mature Douglas fir. It has developed good structural form. Vigor is good. The crown is somewhat asymmetric to the south. Trees were recently removed on the north side. The lower trunk is sound with no outward indicators of any internal decay issues. Condition is rated ‘good’.

No further tree removal is proposed. All of the subject trees will be retained. Tree #1 has been recently exposed or isolated by the removal of trees to the south. This tree should be periodically monitored, particularly after strong wind events. Monitor for changes in lean or ground movement around the base of tree. If any conditions of concern arise, have the tree assessed for risk immediately.

If the existing asphalt driveway is to remain undisturbed adjacent to Tree #1, there should be no impact to the tree. If the driveway is to be replaced, work within the dripline shall be accomplished using hand-labor only. Care shall be taken to preserve any roots that exist underneath the existing pavement. Position a tree protection barrier as shown on the attached map to protect the trunk and soils to the east and west. New pavement placed south of the existing driveway is not expected to have any adverse impacts on the tree.

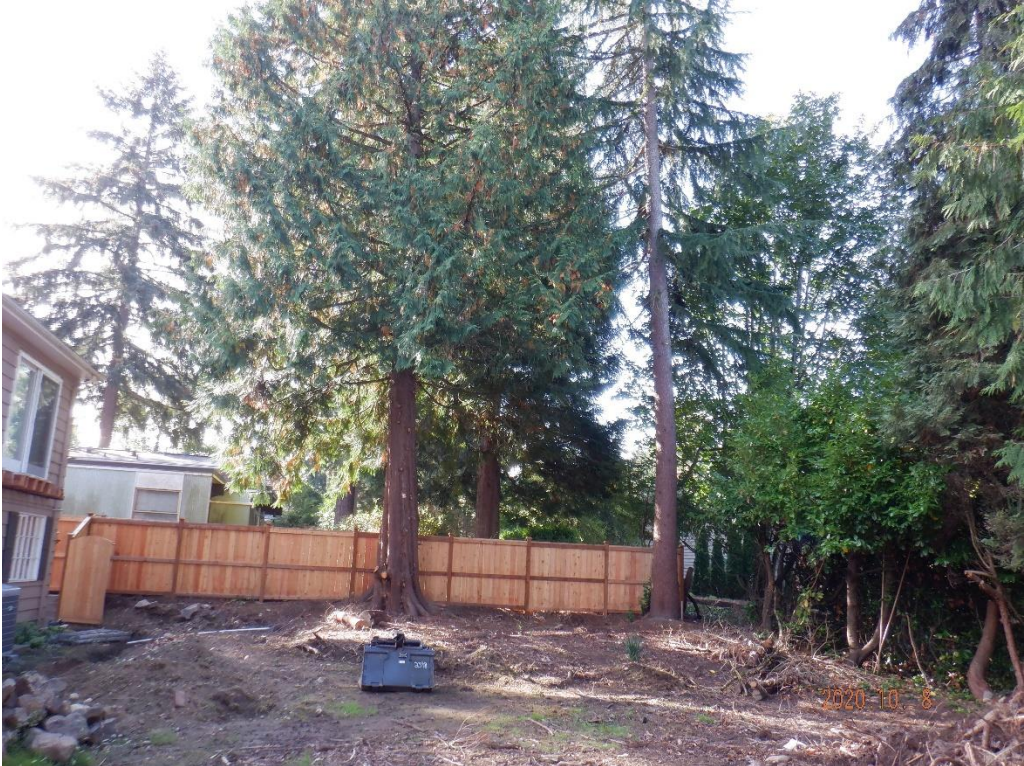
Trees #2 and #3

Tree #2 is a semi-mature Western red cedar. It has recently been crown-raised. Vigor is good. Soils and surface roots have been recently disturbed on the north and northeast sides during vegetation removal. The lower trunk is sound with no outward indicators of any internal decay issues. Condition is rated ‘good’. Tree #2 is ‘exceptional’ under City code.

Tree #3 is a semi-mature deodar cedar. Vigor is good. Soils and surface roots have been recently disturbed on the north and northeast sides during vegetation removal. The lower trunk is sound with no outward indicators of any internal decay issues. Condition is rated 'good'.

No work is proposed in the backyard other than landscaping. A significant amount of vegetation was recently removed from backyard of the subject property. The grubbing of vegetation and stumps has disturbed soils and surface roots within the driplines of subject trees. Any further work within the driplines shall be accomplished by hand-labor only. Hand rake soils to establish finish grades. To maintain these trees in the best condition possible, simply finish the landscape within the driplines of

subject trees by placing a 3 to 4-inch layer of organic mulch. Avoid large plantings, the construction of hardscapes and irrigation trenching within the driplines of subject trees. Ensure trees are provided supplemental irrigation during the dry months of June through September.

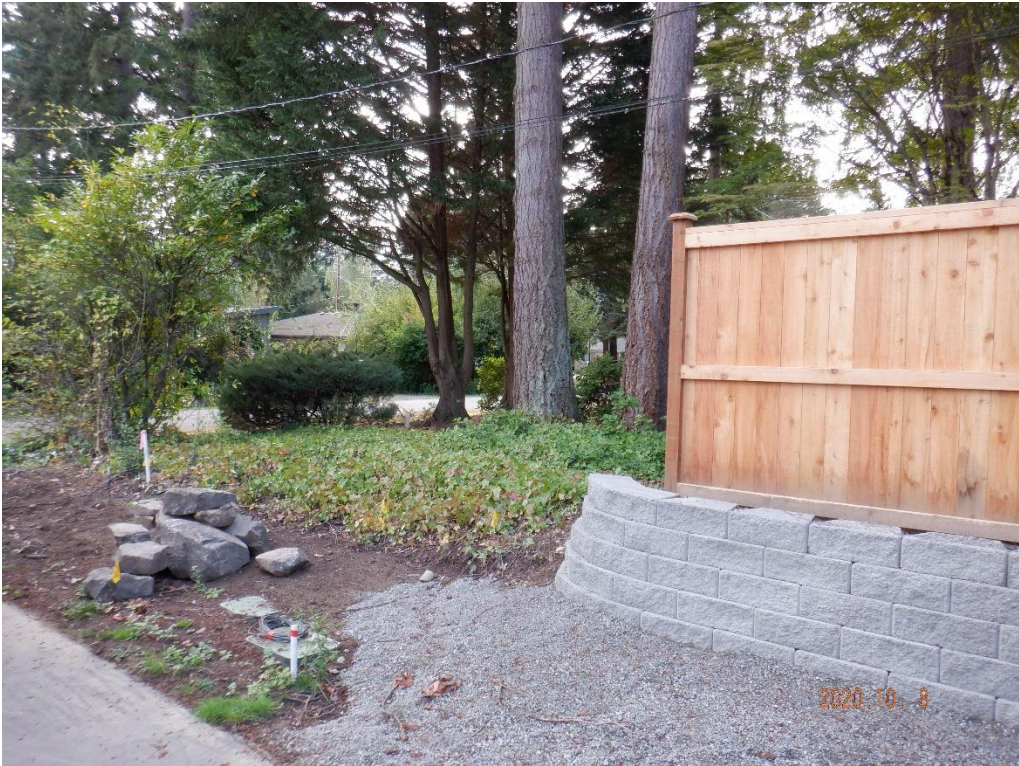
Trees #101 and #102 are semi-mature Douglas fir, located roughly 16-feet off of the property line on the neighboring property to the south. No concerning defects were observed from the subject property. Both are of good vigor and in 'good' condition.

Neighboring trees #101 and #102 are situated several feet (+/- 16-feet) off of the property line. These will not be impacted by the proposal. Work up to the property line is acceptable. Place the tree protection barrier at the property line to ensure no impacts.
