## Memorandum

To: Luigi Pontes c/o Gary Upper  
Site: Parcel 5315100417 Mercer Island, WA 98040  
Re: Feasibility Assessment  
Date: October 14, 2020  
Project Arborists: Sean Dugan, Registered Consulting Arborist # 457  
ISA Board Certified Master Arborist #PN-5459B  
ISA Qualified Tree Risk Assessor  
Tyler Bunton  
ISA Certified Arborist #PN-8715A  
ISA Qualified Tree Risk Assessor  
Attachments: Tree Site Map  
Table of Trees

**Tree Inventory Map**  
October 14, 2020

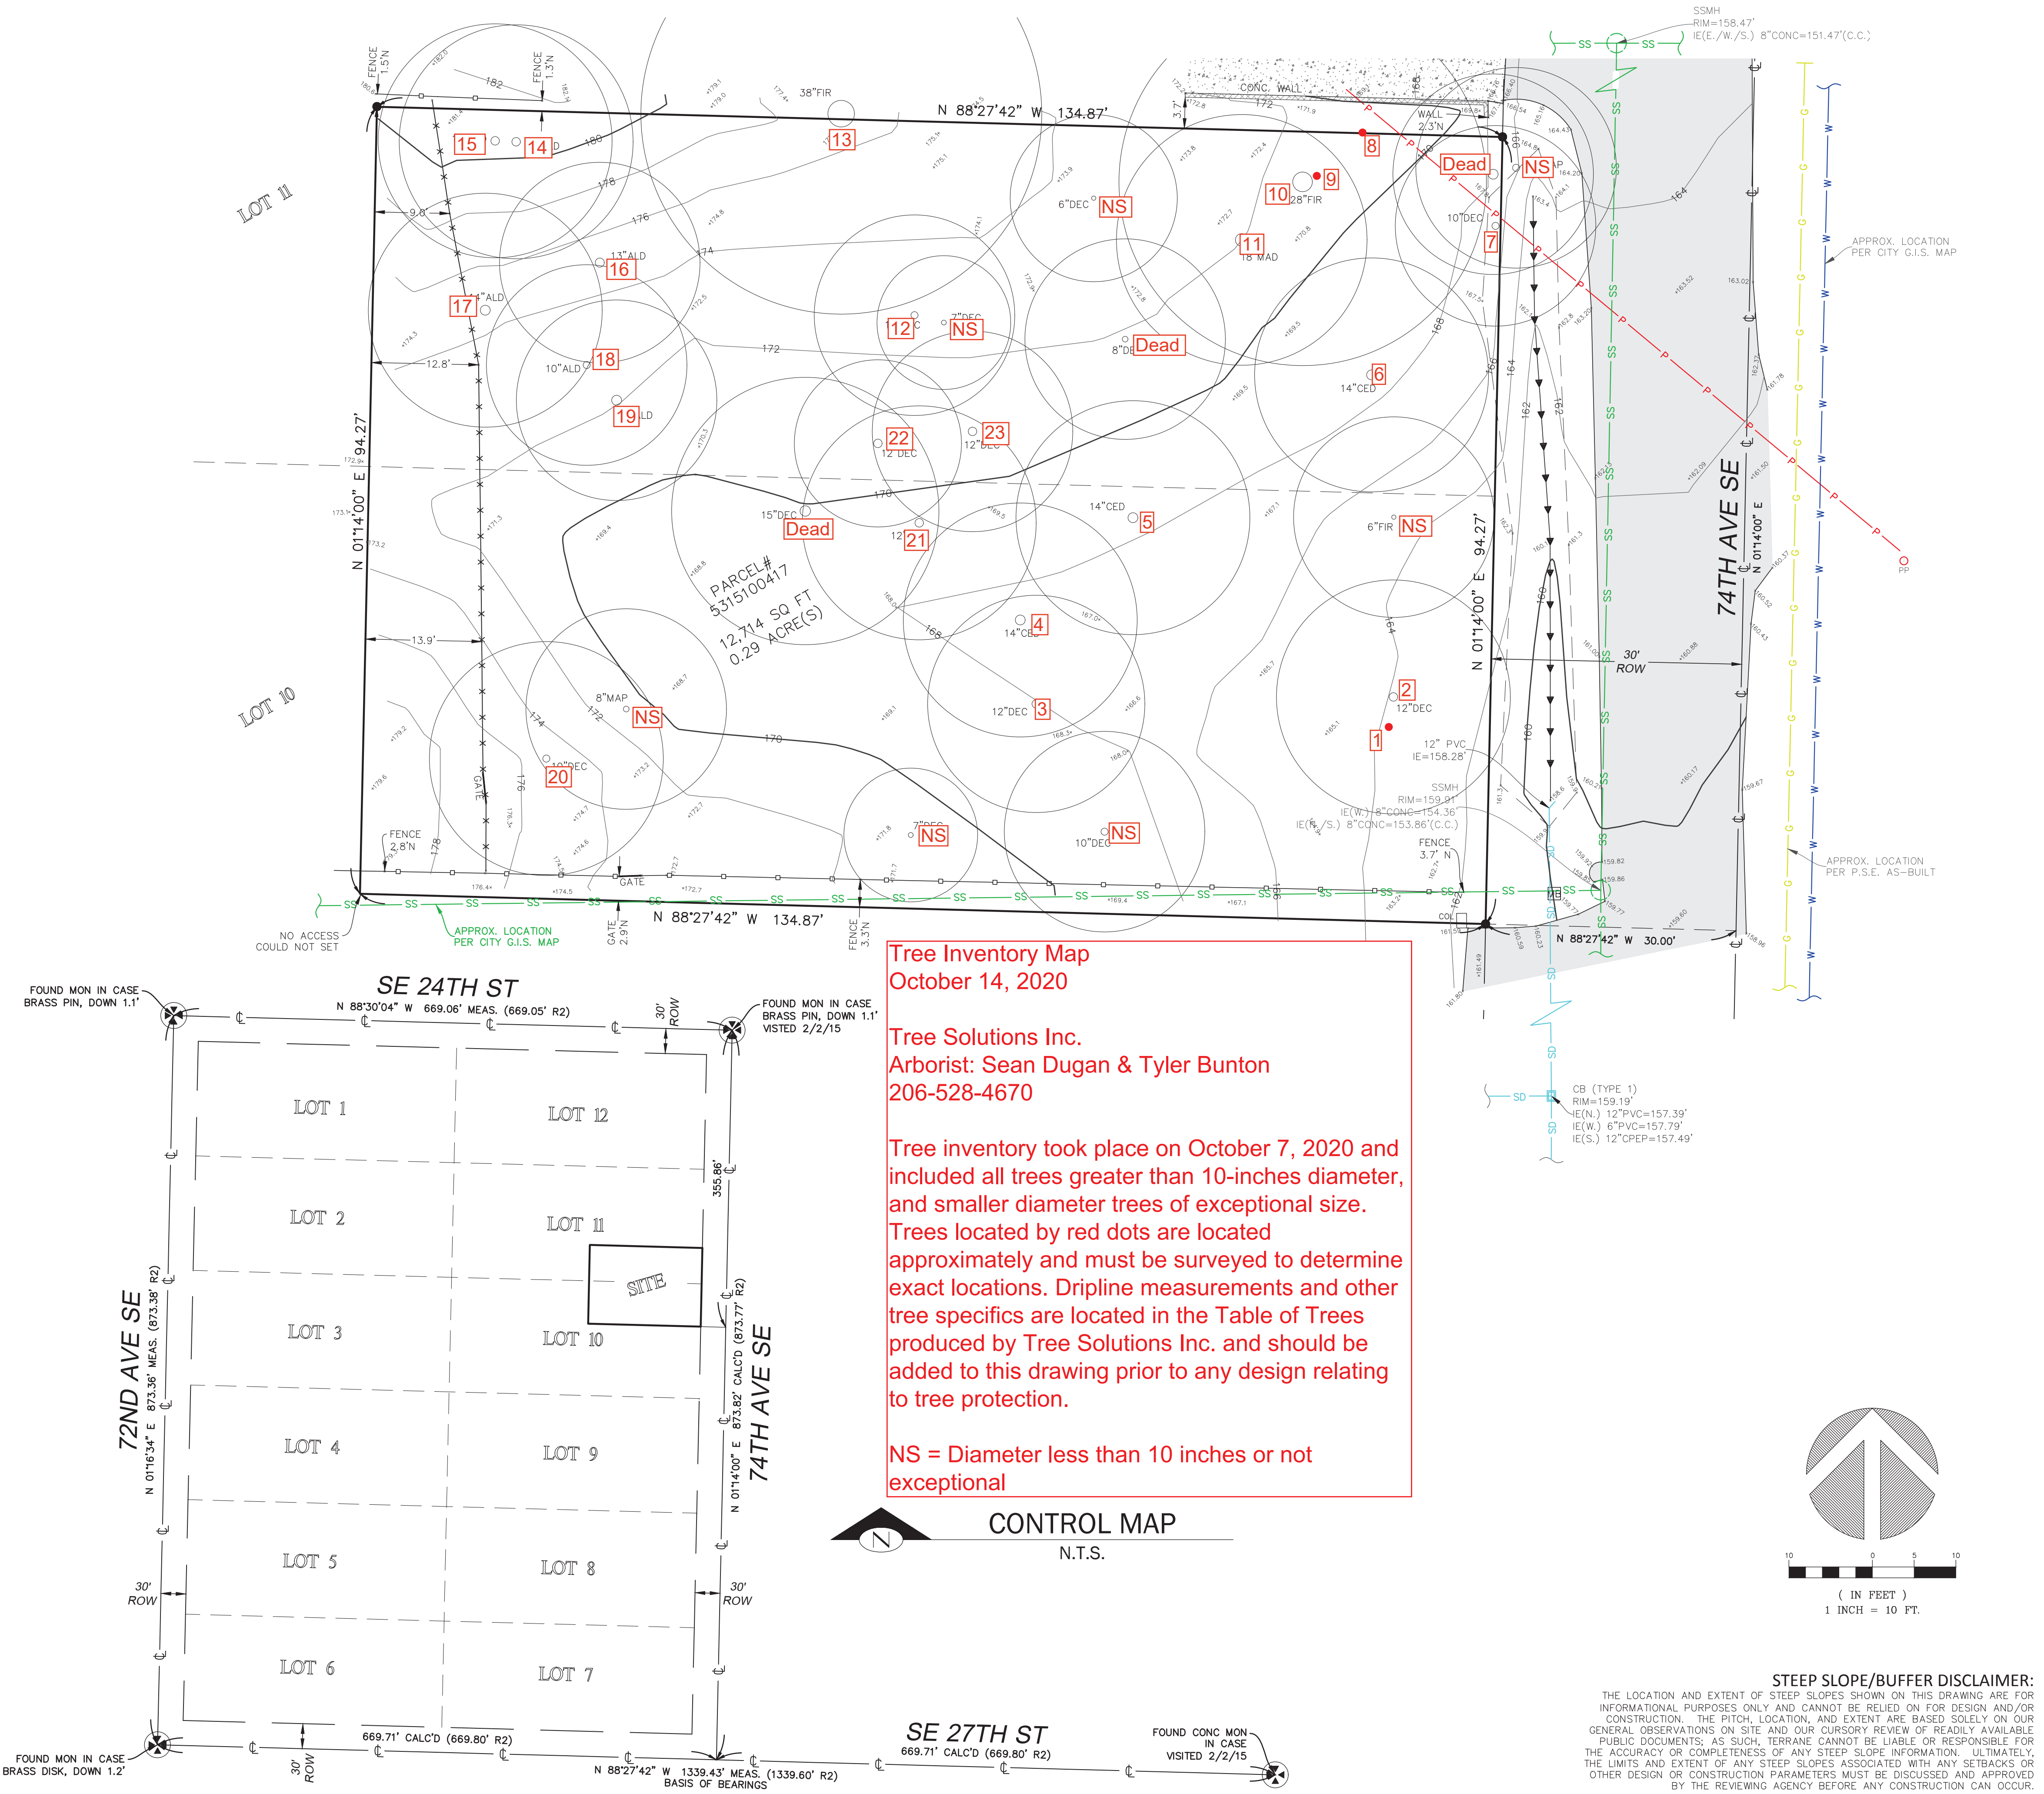
Tree inventory took place on October 7, 2020 and included all trees greater than 10-inches diameter, and smaller diameter trees of exceptional size. Trees located by red dots are located approximately and must be surveyed to determine exact locations. Dripline measurements and other tree specifics are located in the Table of Trees produced by Tree Solutions Inc. and should be added to this drawing prior to any design relating to tree protection.
