Arborist Report

TO: Rouslana & Leonid Yaroslavsky
SITE: 9319 SE 43rd Street, Mercer Island, WA 98040
DATE: March 31, 2021
PROJECT ARBORISTS: Joseph Sutton-Holcomb
ISA Certified Arborist #PN- 8397A
ISA Qualified Tree Risk Assessor

REFERENCED PLANS: "Combined Permit Set" Métrica LLC, dated 03.31.2021
ATTACHED: Table of Trees, Annotated Survey

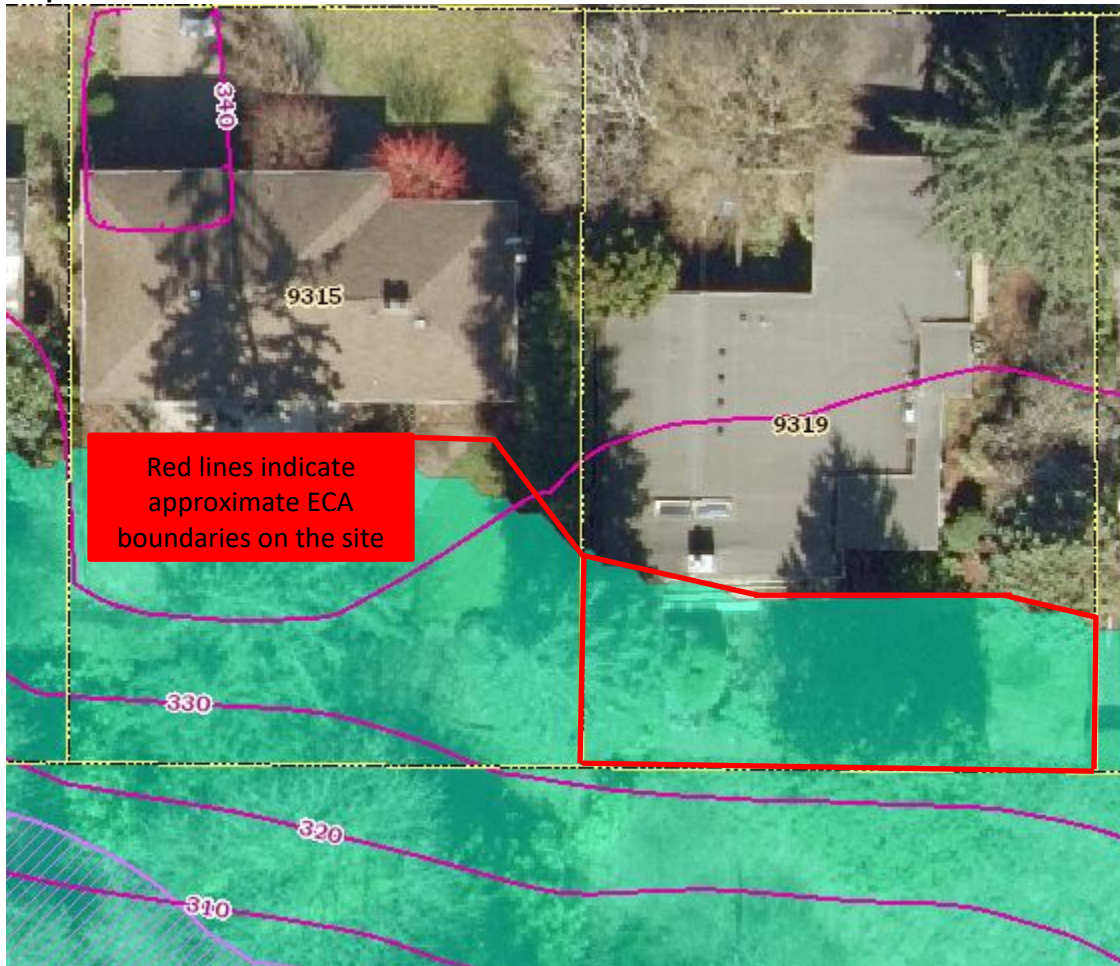
The south end of the parcel abuts a steeply sloping ravine full of Himalayan blackberry (*Rubus bifrons*). The southern portion of this lot is considered an Environmentally Critical Area and is protected under Mercer Island City Code (Figure 1).

Figure 1. A map of the site with property lines and ECA boundaries shown in green.
(source: City of Mercer Island) Red lines and call out added by Tree Solutions for clarity.

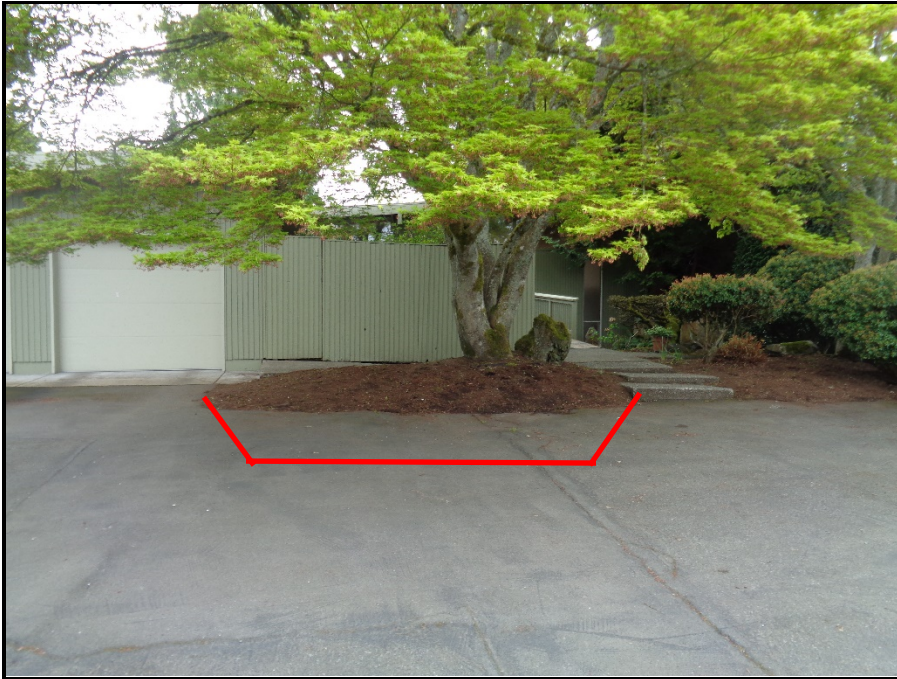
Tree 617 is a Japanese maple (*Acer palmatum*) of unusual size. It is Exceptional by size under Mercer Island City Code and is likely one of the largest of its species growing on the island. The tree is growing in a small planting strip surrounded by impervious concrete and asphalt. I observed buckling of the asphalt, suggesting it is being lifted by the tree's large structural roots. I observed compacted soil and landscape fabric near the base of the tree and noted impervious surface in the form of asphalt and concrete well within the dripline.

Photo 1: Exceptional Japanese maple tree 617. Red lines indicate area of asphalt which should be removed and converted to an expanded tree well area. This will allow more space for root growth and allow air and water into the soil in the tree's critical root zone.

Removal of any hardscape within the dripline of this tree must be done with extreme care to avoid damaging the roots of the tree. The plans I have reviewed show removal of existing asphalt and installation of a hardscape path in close proximity to the tree.

At the conclusion of the project, I recommend creating a large planting "island" of hardscape free rooting area for the tree by removing as much of the asphalt as possible within the limits of disturbance. An expanded "island" mulched with coarse woody material will allow greater amounts of air and water into the root zone, which can help ensure the health and longevity of this impressive specimen.

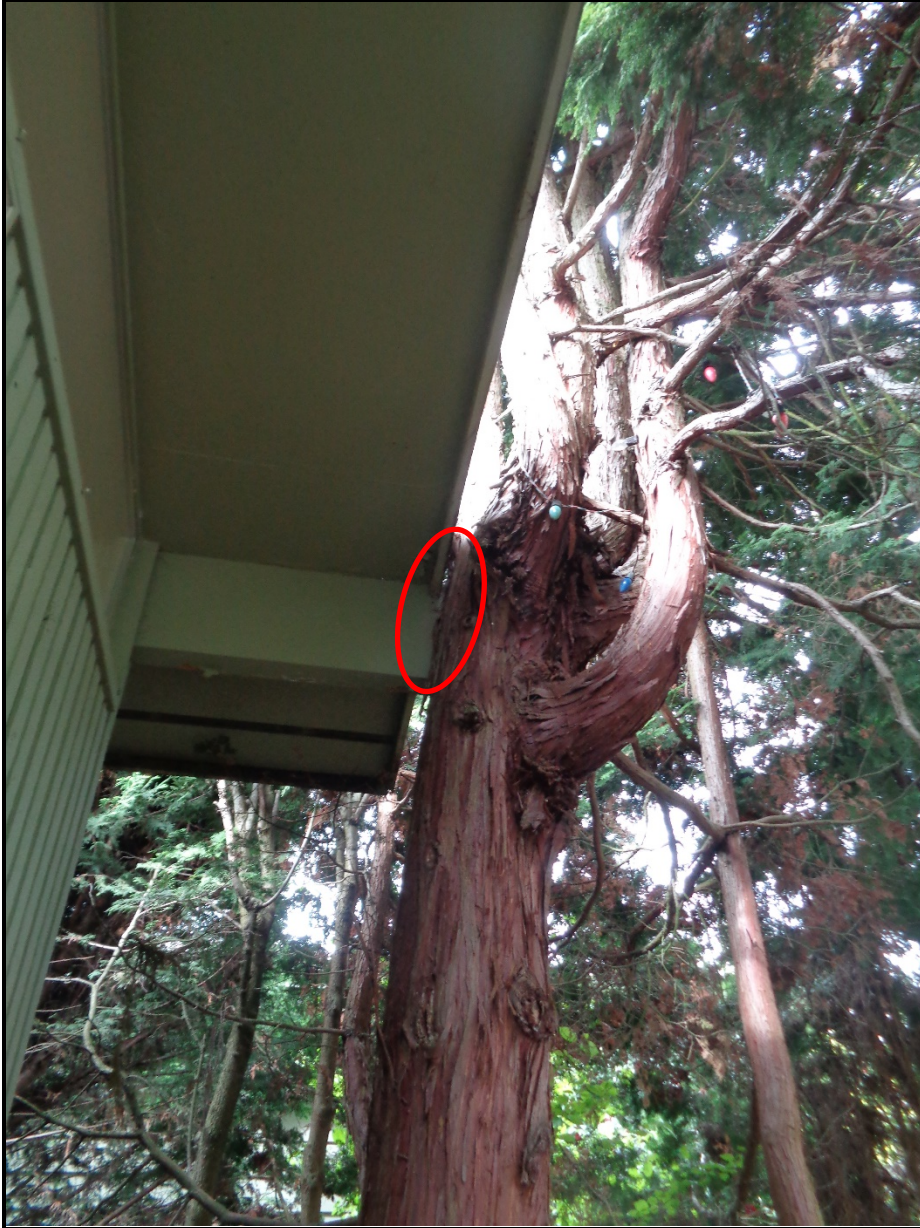
Tree 619 is a Hinoki cypress (*Chamaecyparis obtusa*) growing approximately two feet from the foundation of the existing house. The trunk is currently impacting the roof of the house. The City of Mercer Island granted a permit to remove the tree, and it has since been removed.

Photo 2: Tree 619, a Hinoki cypress impacting the roof of the house. The red circle indicates the area of contact. This tree was permitted for removal and has been removed.

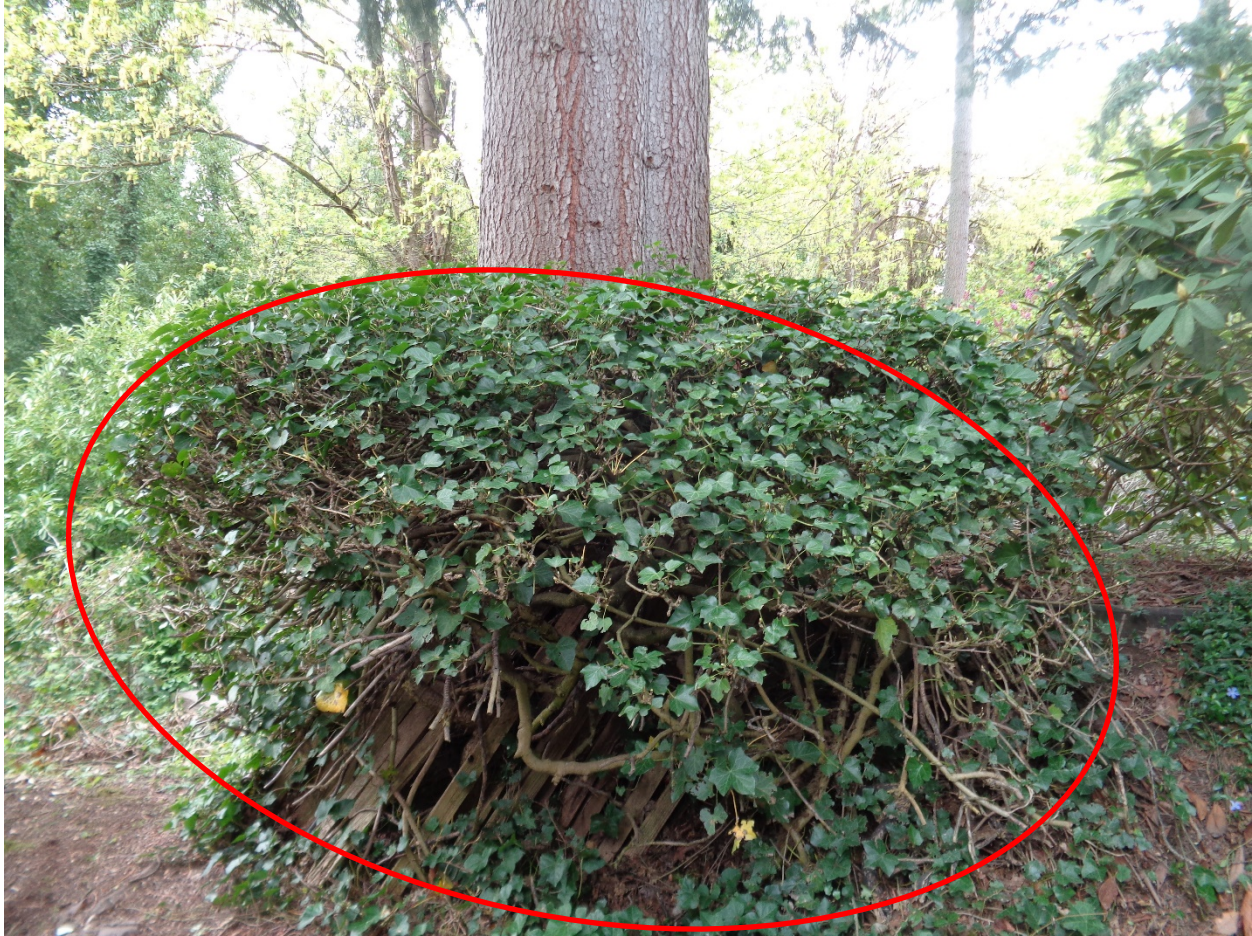
Tree 625 is an Exceptional Grand fir (*Abies grandis*) in the southwestern corner of the property. I assigned it a health and structural rating of Excellent. I observed fencing and ivy surrounding the base of the tree. There also appeared to be good extension of new shoots throughout the tree's canopy, which is an indicator of good vigor. It has a live crown ratio of approximately 85%, suggesting that it has not had its crown significantly raised via pruning.

Photo 3. The base of Grand fir tree 625. The red circle indicates a mass of old fencing material and ivy which should be removed from the base of the tree as soon as possible.

At the time of my inspection, Ivy and the fencing material were present around the base of this tree. These must be removed prior to construction. These materials prevent air circulation around the base of the trunk, cause chronic stress which can make the tree more vulnerable to insects and pathogens.

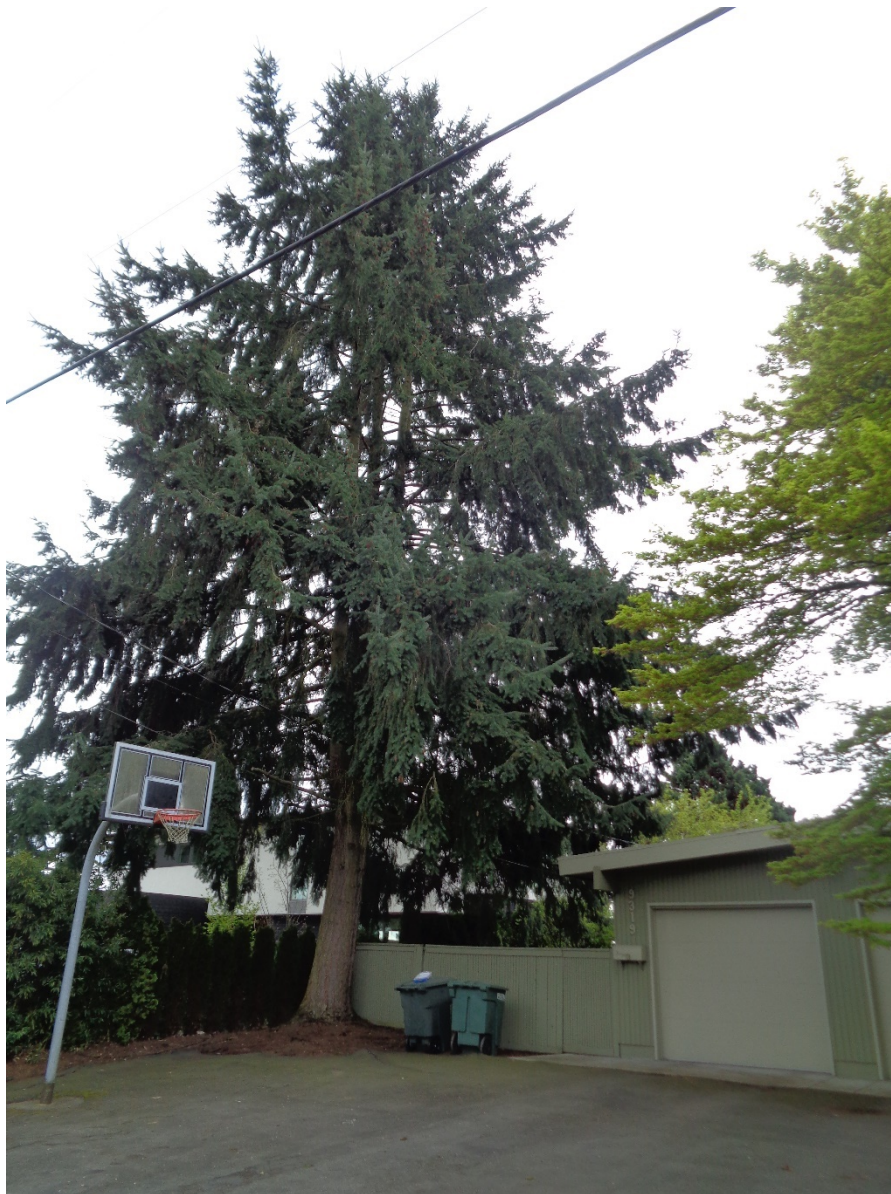
Tree 631 is a semi-mature Douglas-fir (*Pseudotsuga menziesii*) growing on the northeast corner of the parcel. It is 17.5 feet to the east of the existing house. The main trunk divides into three codominant stems at approximately 13 feet above the base. I observed cracking and lifting of asphalt near the tree's basal root flare, which is likely caused by large structural roots lifting the pavement as they grow in diameter over time.

Photo 4. Tree 631, a semi-mature Douglas-fir proposed for removal.
