**SONDERGAARD GEOSCIENCE, PLLC**  
13012 65<sup>TH</sup> Avenue SE  
Snohomish, Washington 98296

Subject: Critical Area Report

7216 93<sup>rd</sup> Avenue SE

Mercer Island, Washington

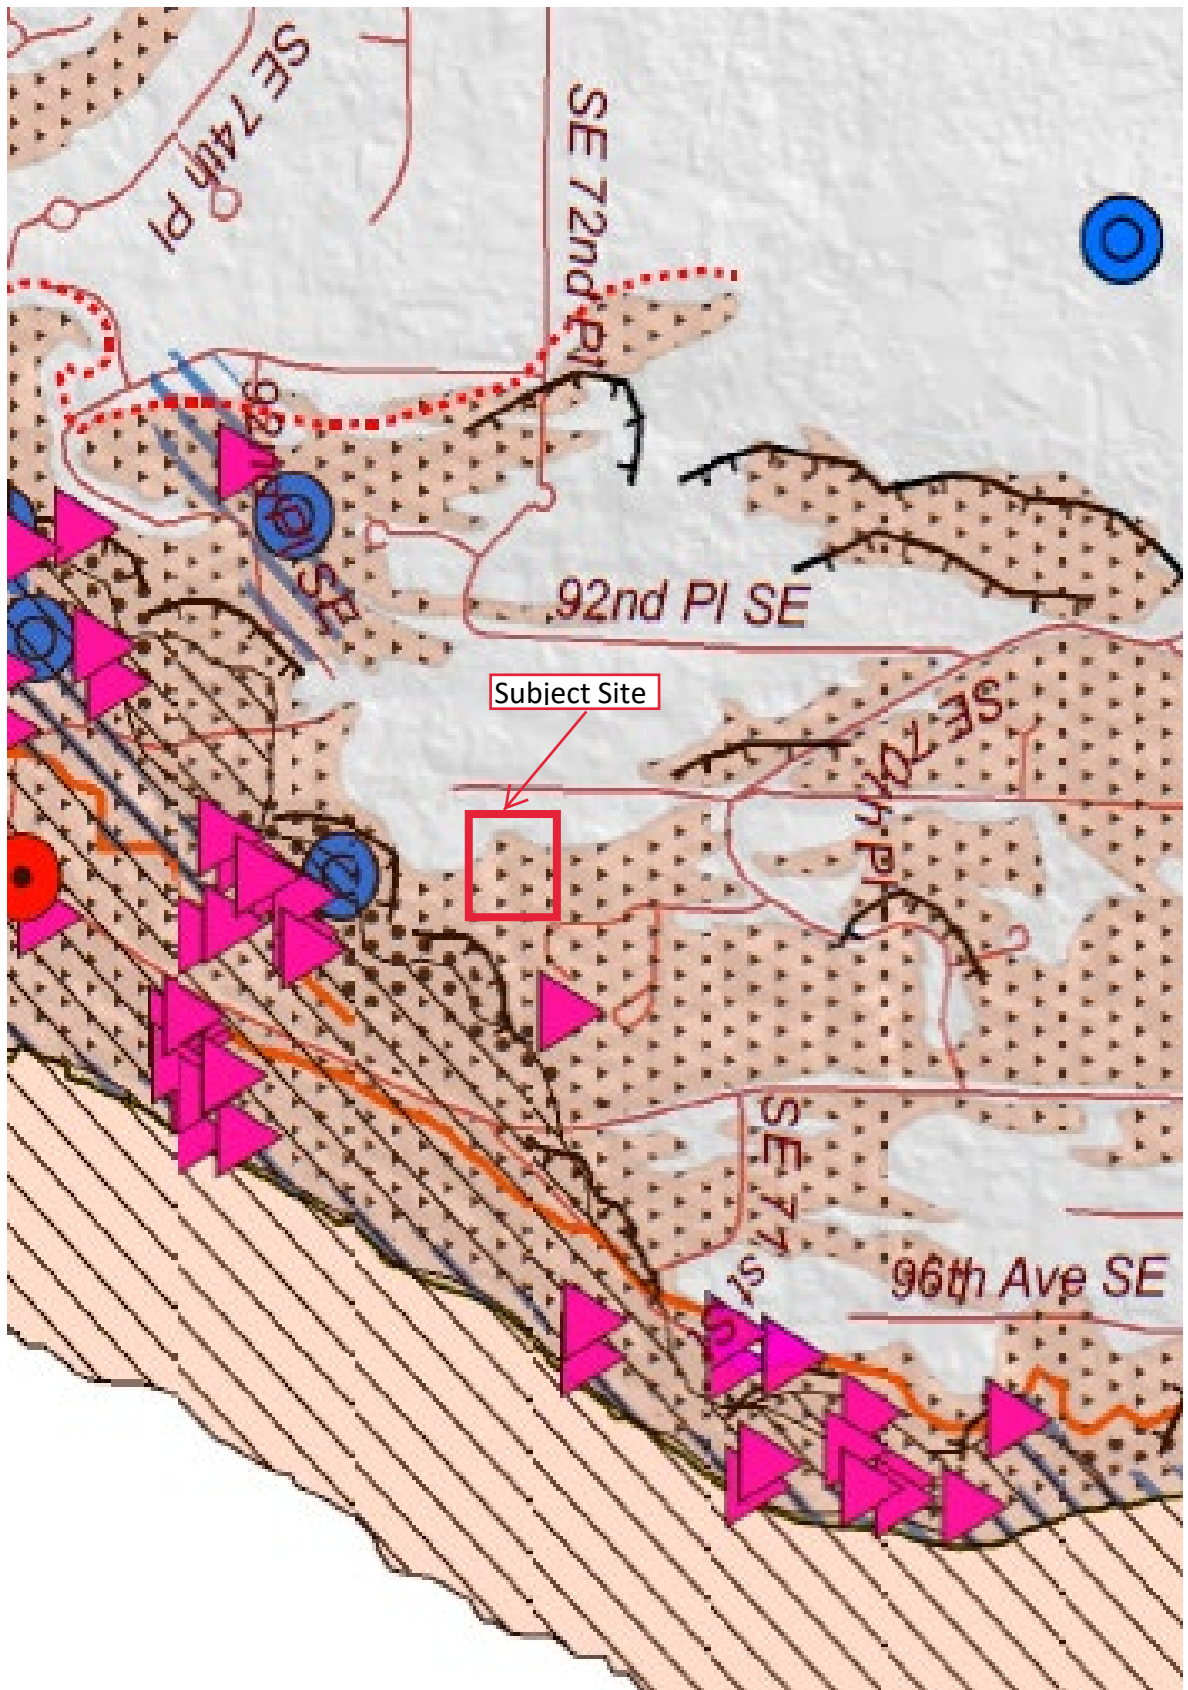
**J-0165 FIGURE 5**

**MERCER ISLAND LANDSLIDE HAZARD MAP  
7216 93RD AVENUE SE  
MERCER ISLAND, WASHINGTON**

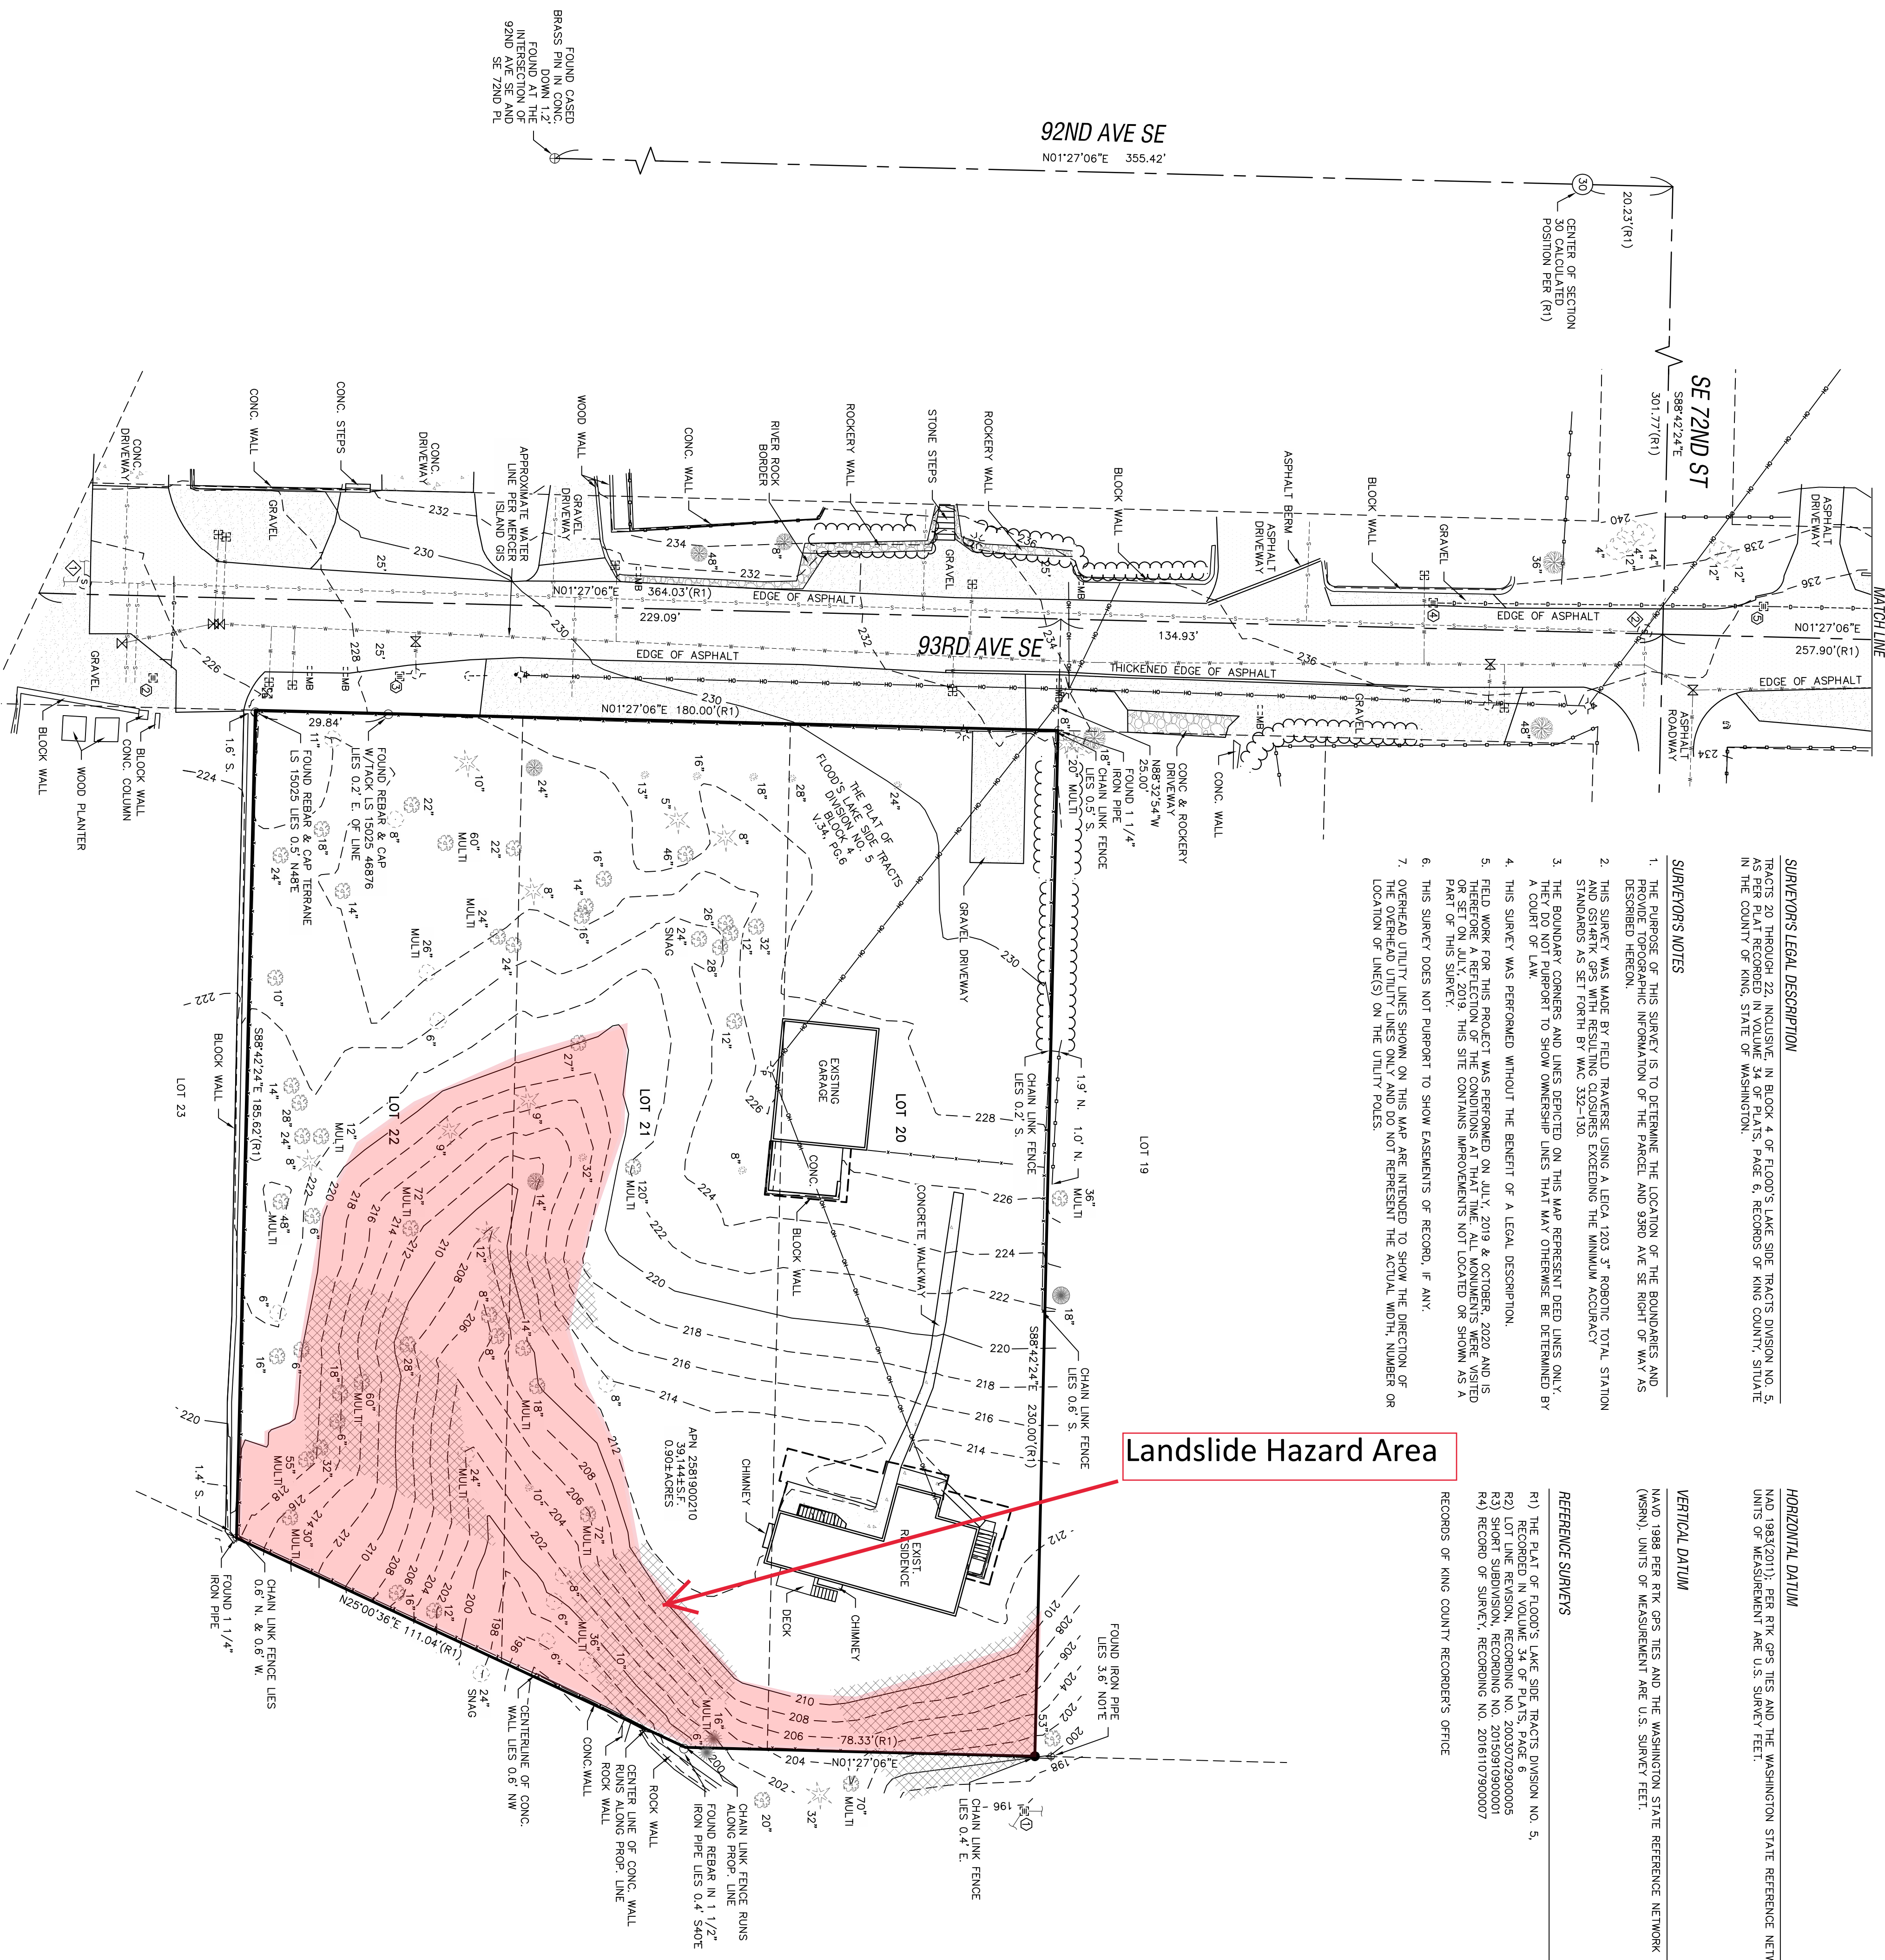
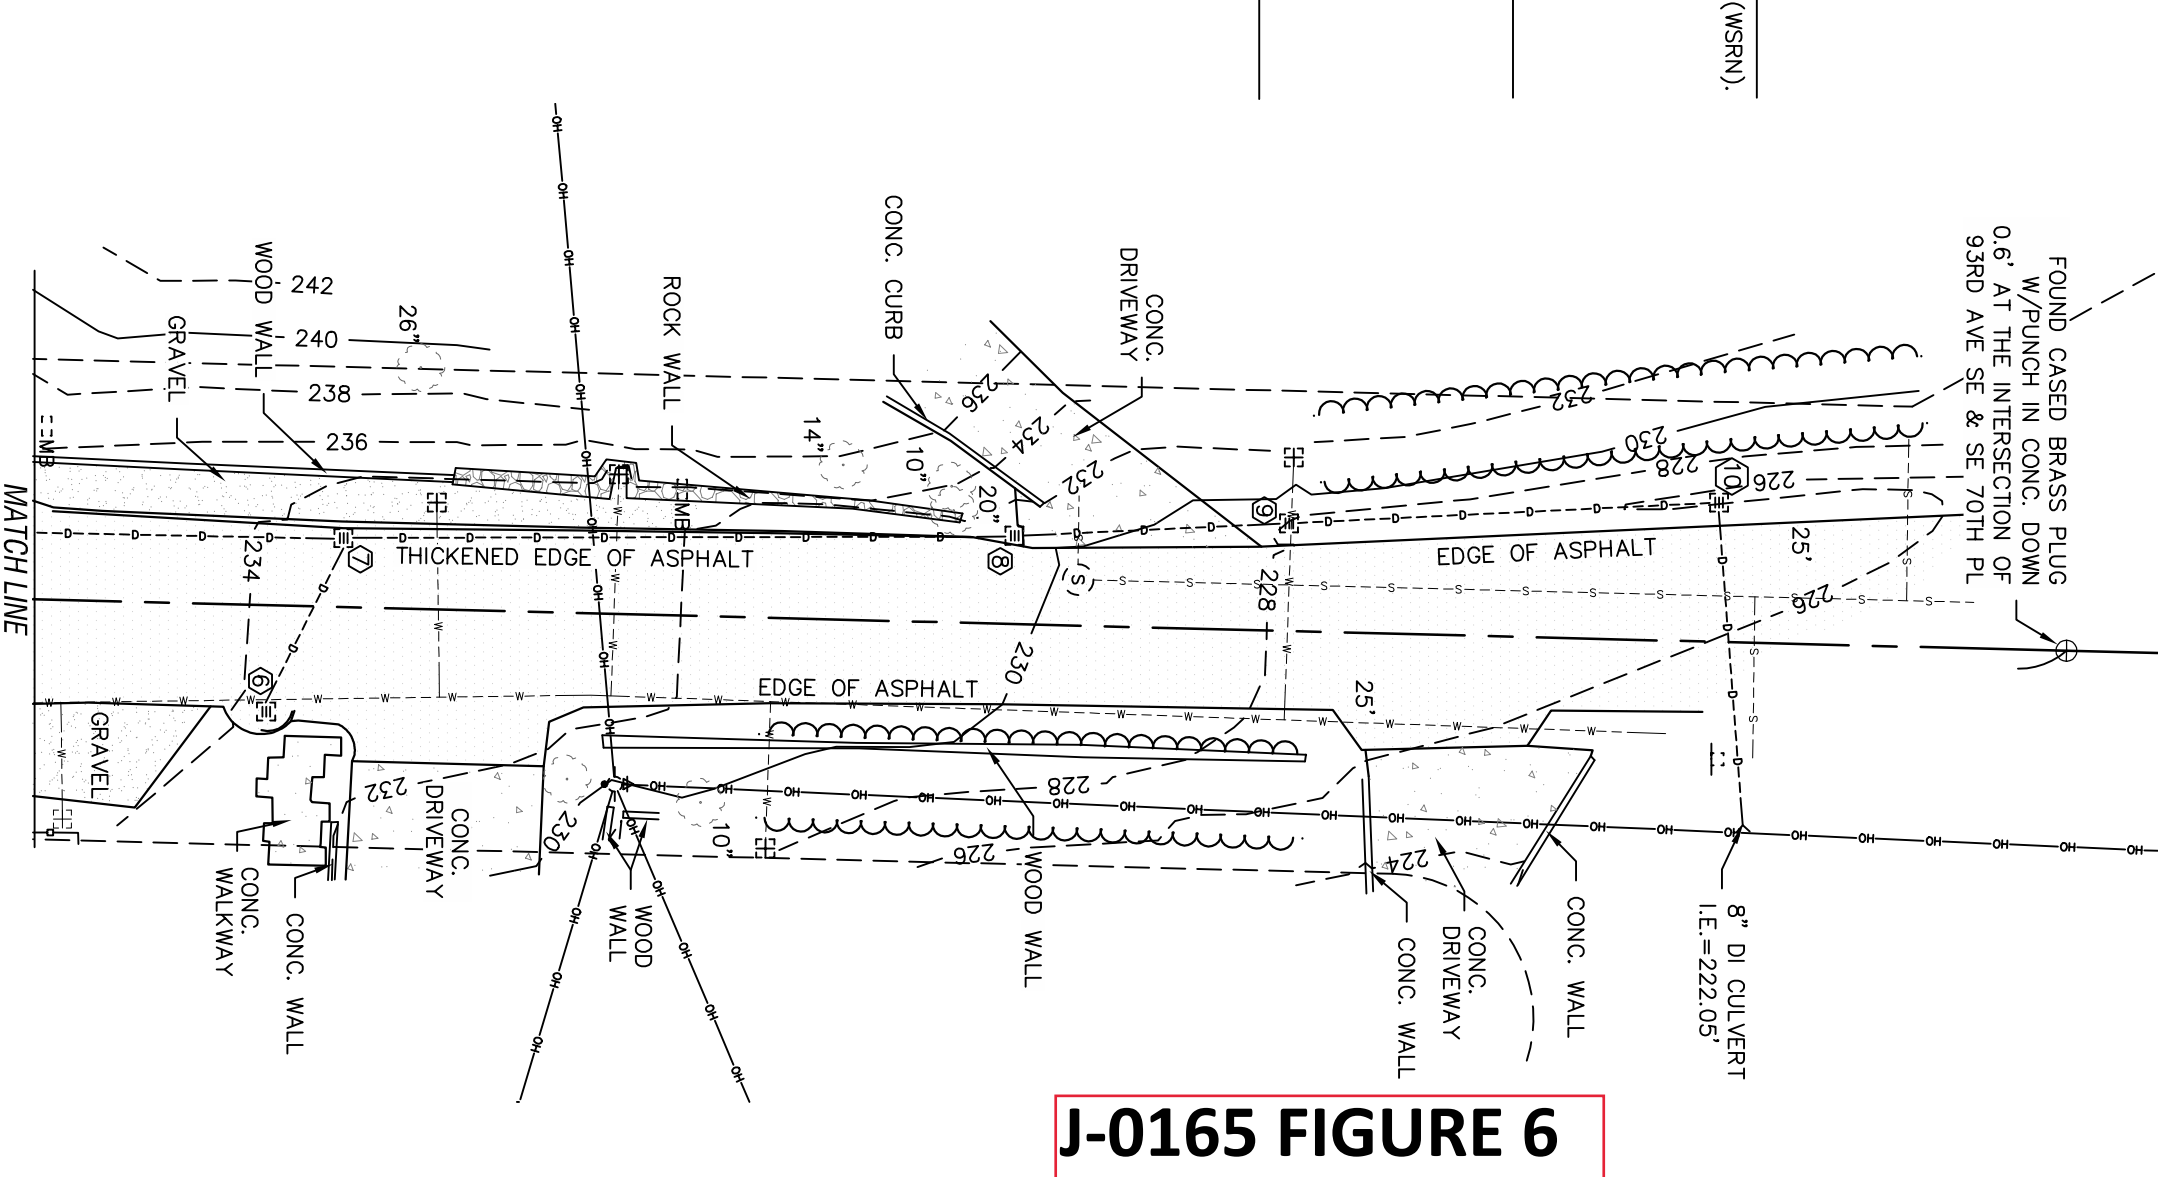
**J-0165 FIGURE 6**

The site is characterized by a slight slope down to the east on the west half of the property and on most of the northeast portion of the property. A gully runs along the southeast portion of the lot and along the east property line (Figure 4). Review of the Mercer Island Landslide Hazard map (K.G. Troost and A.P. Wisher (2009), Mercer Island Landslide Hazard Assessment prepared for Geomap Northwest and the City of Mercer Island indicates the east portion of the property contains slopes greater than 15 percent inclination (Figure 5). The topographic survey of the property shows that the slopes along the gully range height from about 8 to 20 feet with slope inclinations ranging from approximately 38 to 53 percent. According to MIMC Title 19, Chapter 19.16, Section 19.16.010(L) the gully slopes meet the definition of a landslide hazard area by having slope inclinations greater than 40 percent over a horizontal distance of 30 feet or greater (Figure 6). Based upon observation of the existing site conditions, including the large trees that remain on the site, in our opinion, there is no obvious evidence of past or present shallow or deep landslide movement at the site.

**SITE SPECIFIC LANDSLIDE HAZARD AREA**  
 7216 93RD AVENUE SE  
 MERCER ISLAND, WASHIGTON

1. Restrict development of the site within the designated landslide hazard area except those portions that meet the requirements of MIMC Title 19, Chapter 19.07, Section 19.07.160(B)(2). The current plan for Lots 2 and 3 shows that the southeast corner of the new home for Lot 2 extends into the buffer approximately 20 feet and the northeast corner of the new home for Lot 3 extends into the buffer about 10 feet. The proposed new home for Lot 1 does not intrude into the buffer. As per the geotechnical recommendations provided by Pride (RM Pride, 2020), foundations that protrude into the buffer should be extended to a minimum depth of 3 feet to reduce potential loads on the slope. An analysis of site specific geologic and topographic conditions indicate that the subject property has not experienced landsliding in the past and the development has been designed so that the risk to the site and adjacent property is mitigated such that the site is determined to be safe.

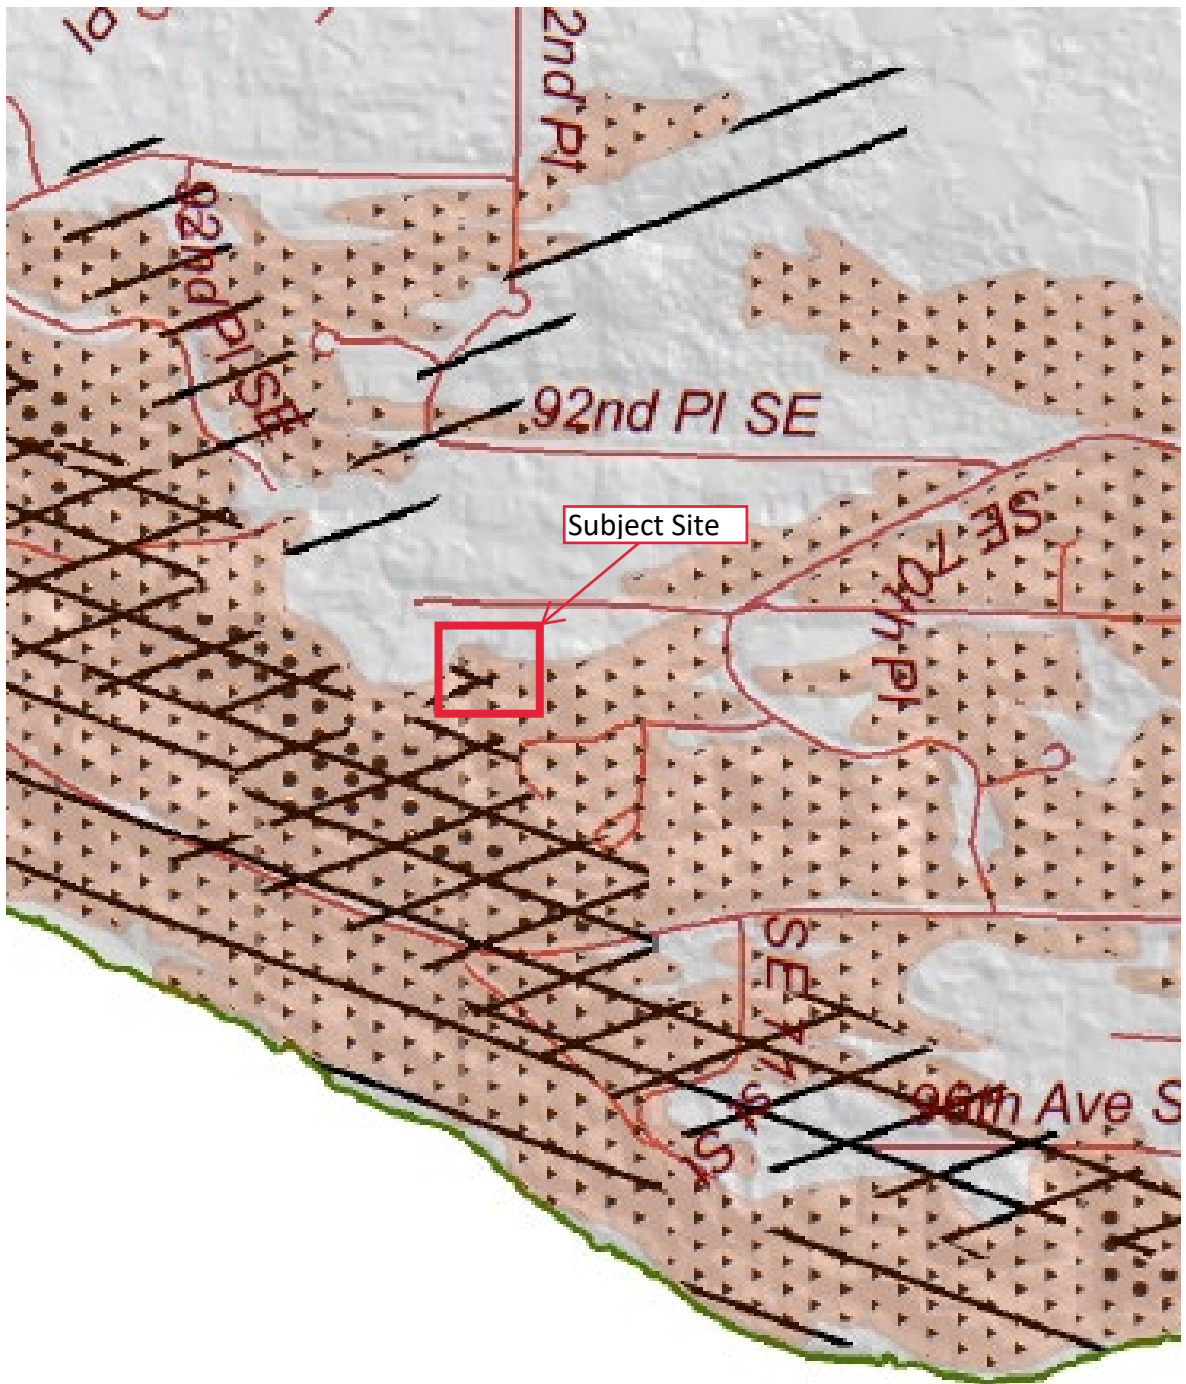
MERCER ISLAND EROSION HAZARD AREA MAP  
7216 93RD AVENUE SE  
MERCER ISLAND, WASHINGTON

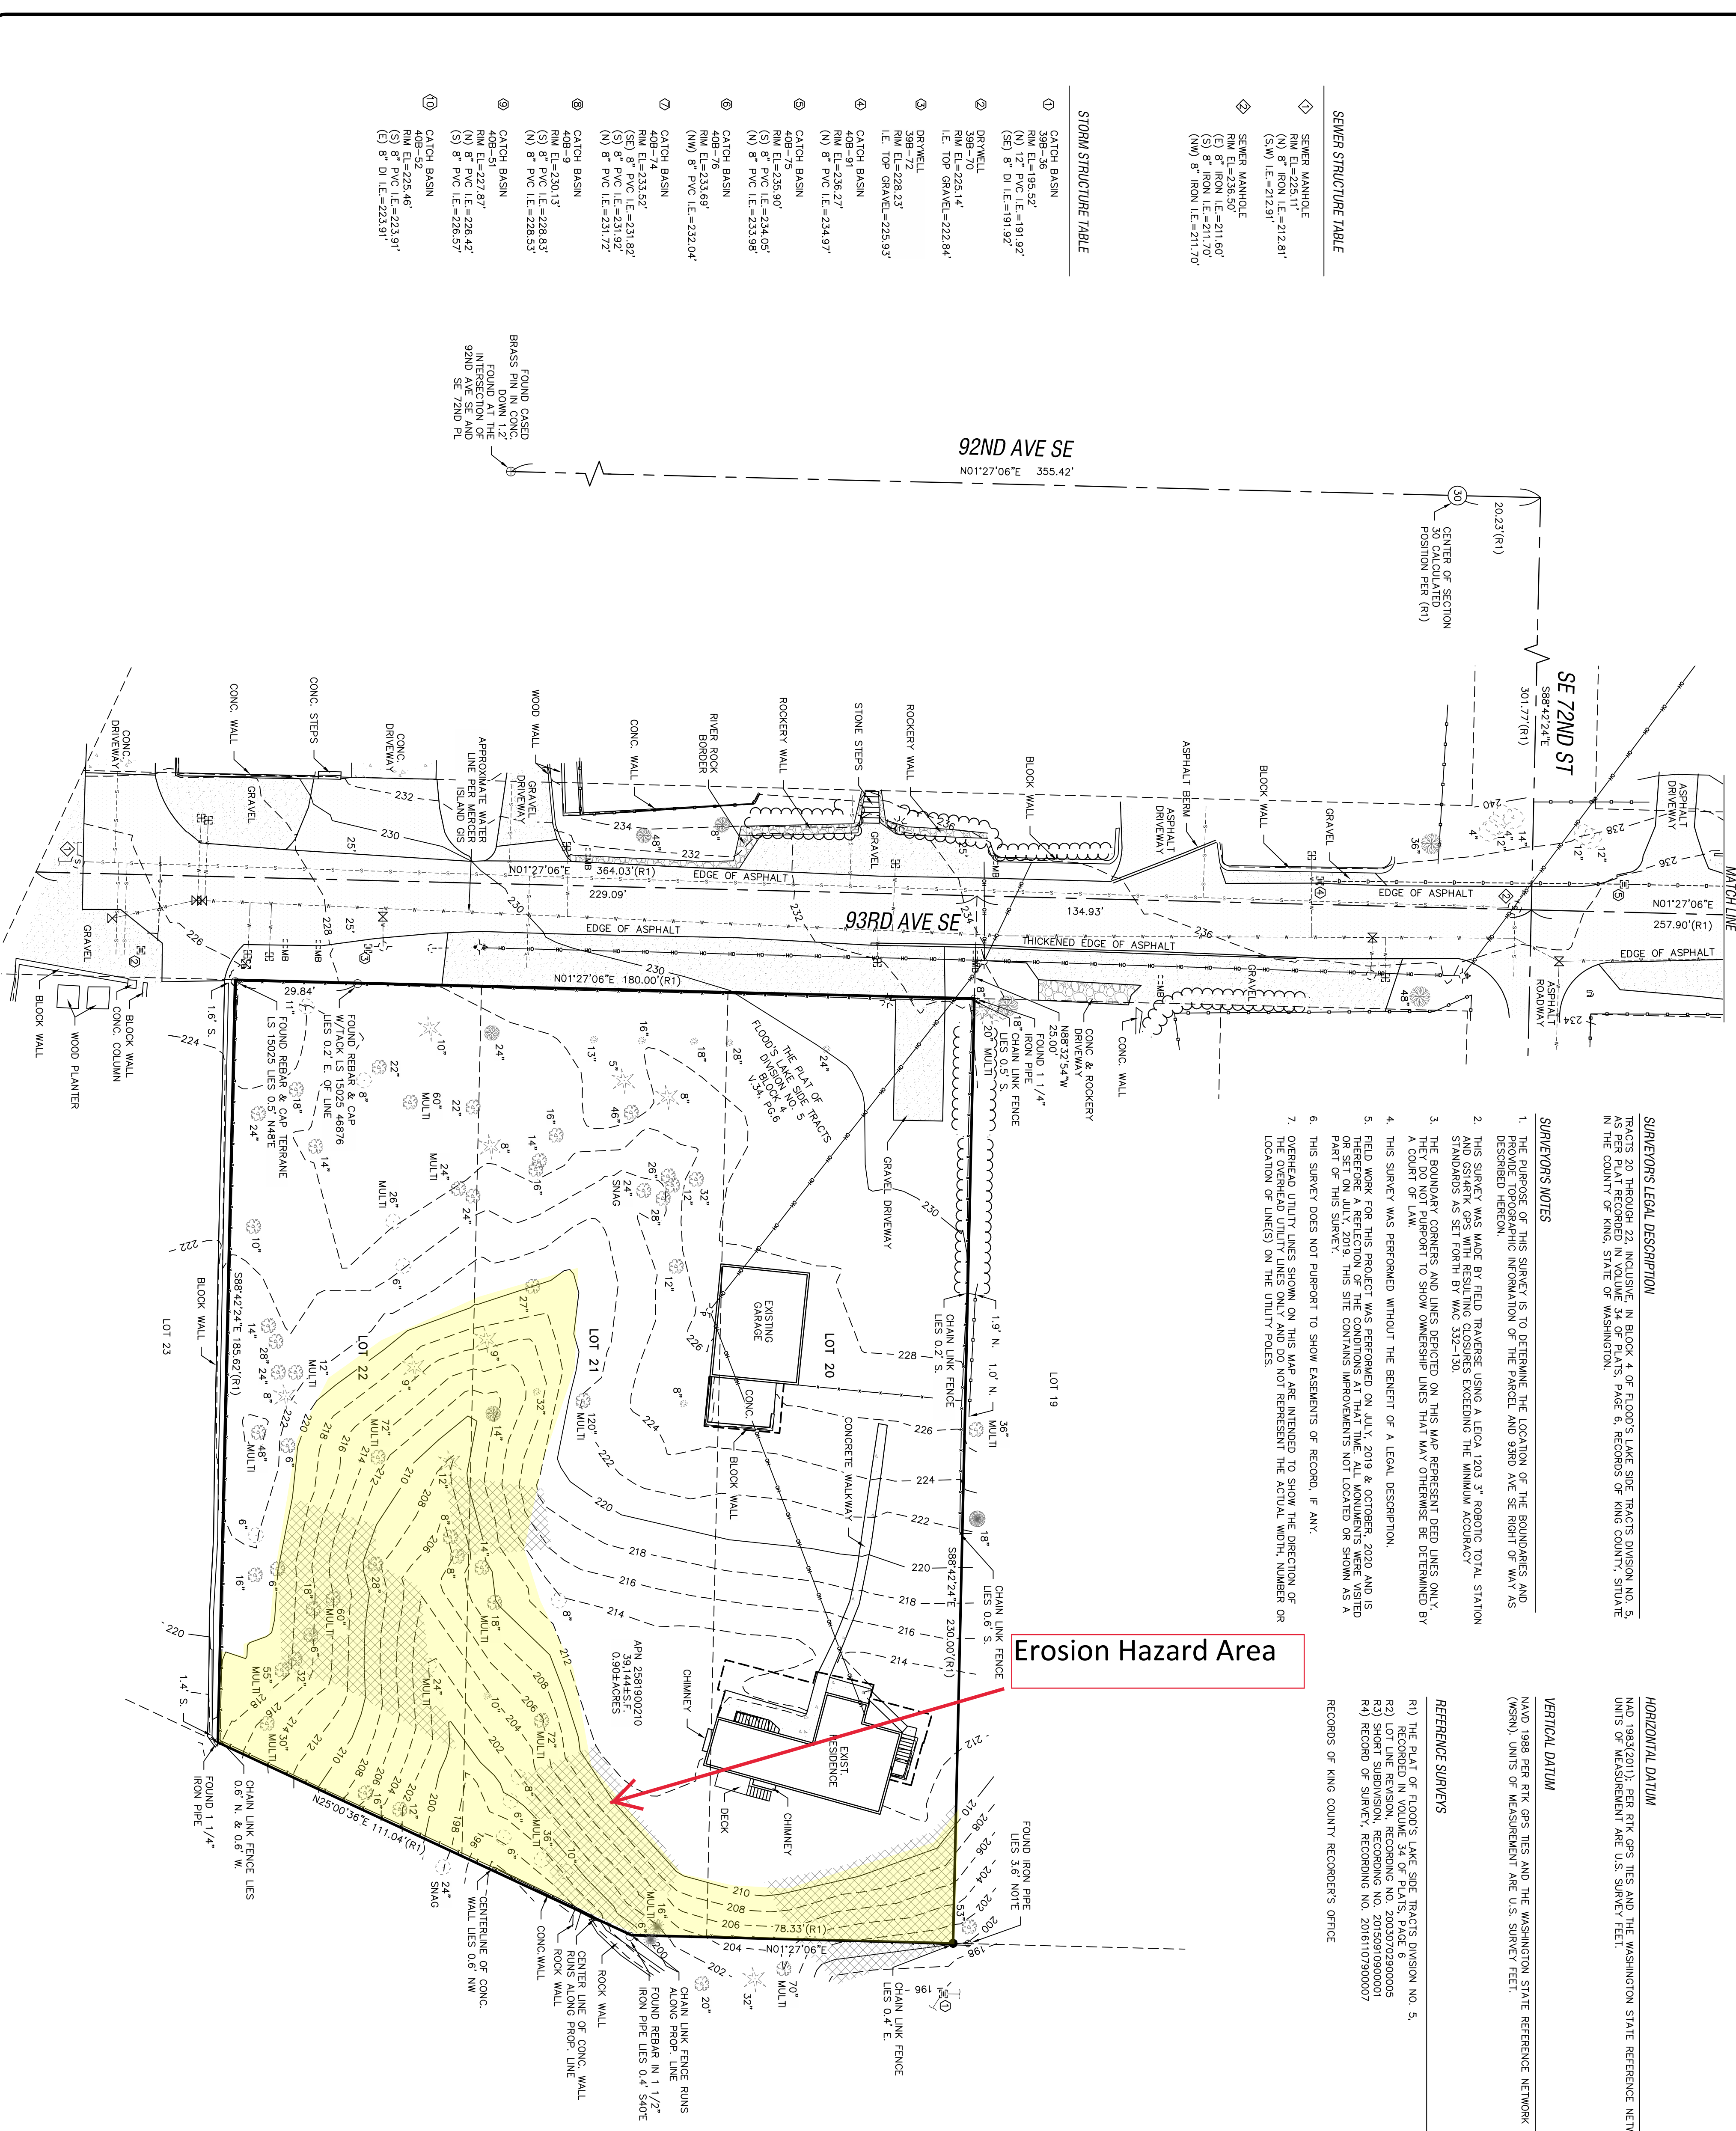
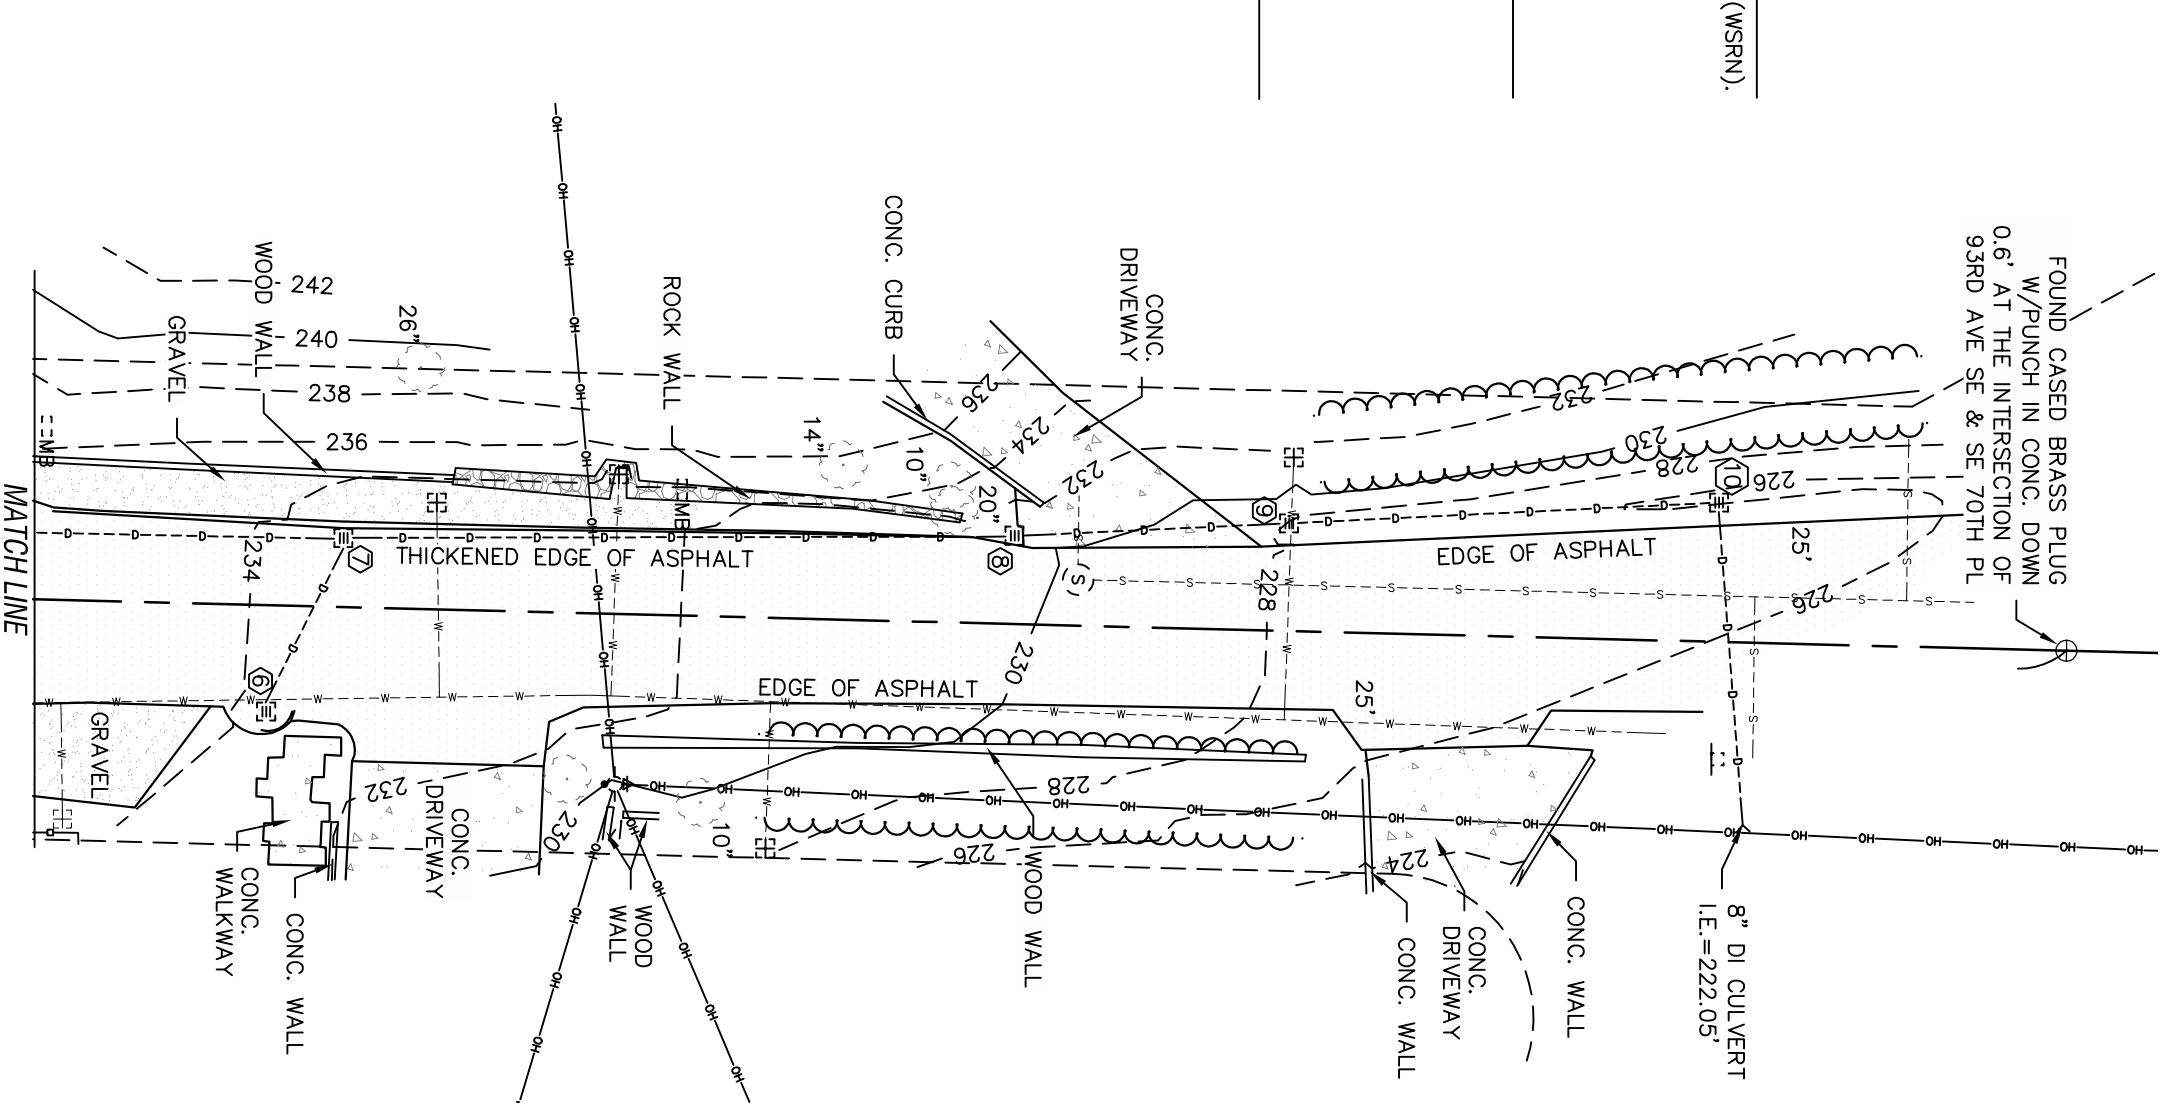
J-0165 FIGURE 10

Review of the Mercer Island Erosion Hazard map (K.G. Troost and A.P. Wisher (2009c) indicates that east portion of the subject property is located within an Erosion Hazard Area (Figure 8). MIMC Title 19, Chapter 19.16, Section 19.16.010(E) defines erosion hazard areas as those areas with slopes having inclinations greater than 15 percent including those areas underlain by soils with a severe or very severe rill and inter-rill erosion hazard. Review of the USDA Soil Survey (Web Soil Survey, 2021) of the site indicates the site is underlain by Everett-Alderwood gravelly, sandy loams on 6 to 15 percent slopes (Figure 9). According to the USDA, these soils exhibit a moderate erosion hazard. The steep slope area of the site exceeds inclination of 15 percent and are classified as an erosion hazard area (Figure 10).

**SITE SPECIFIC EROSION HAZARD AREA MAP**  
 7216 93RD AVENUE SE  
 MERCER ISLAND, WASHINGTON

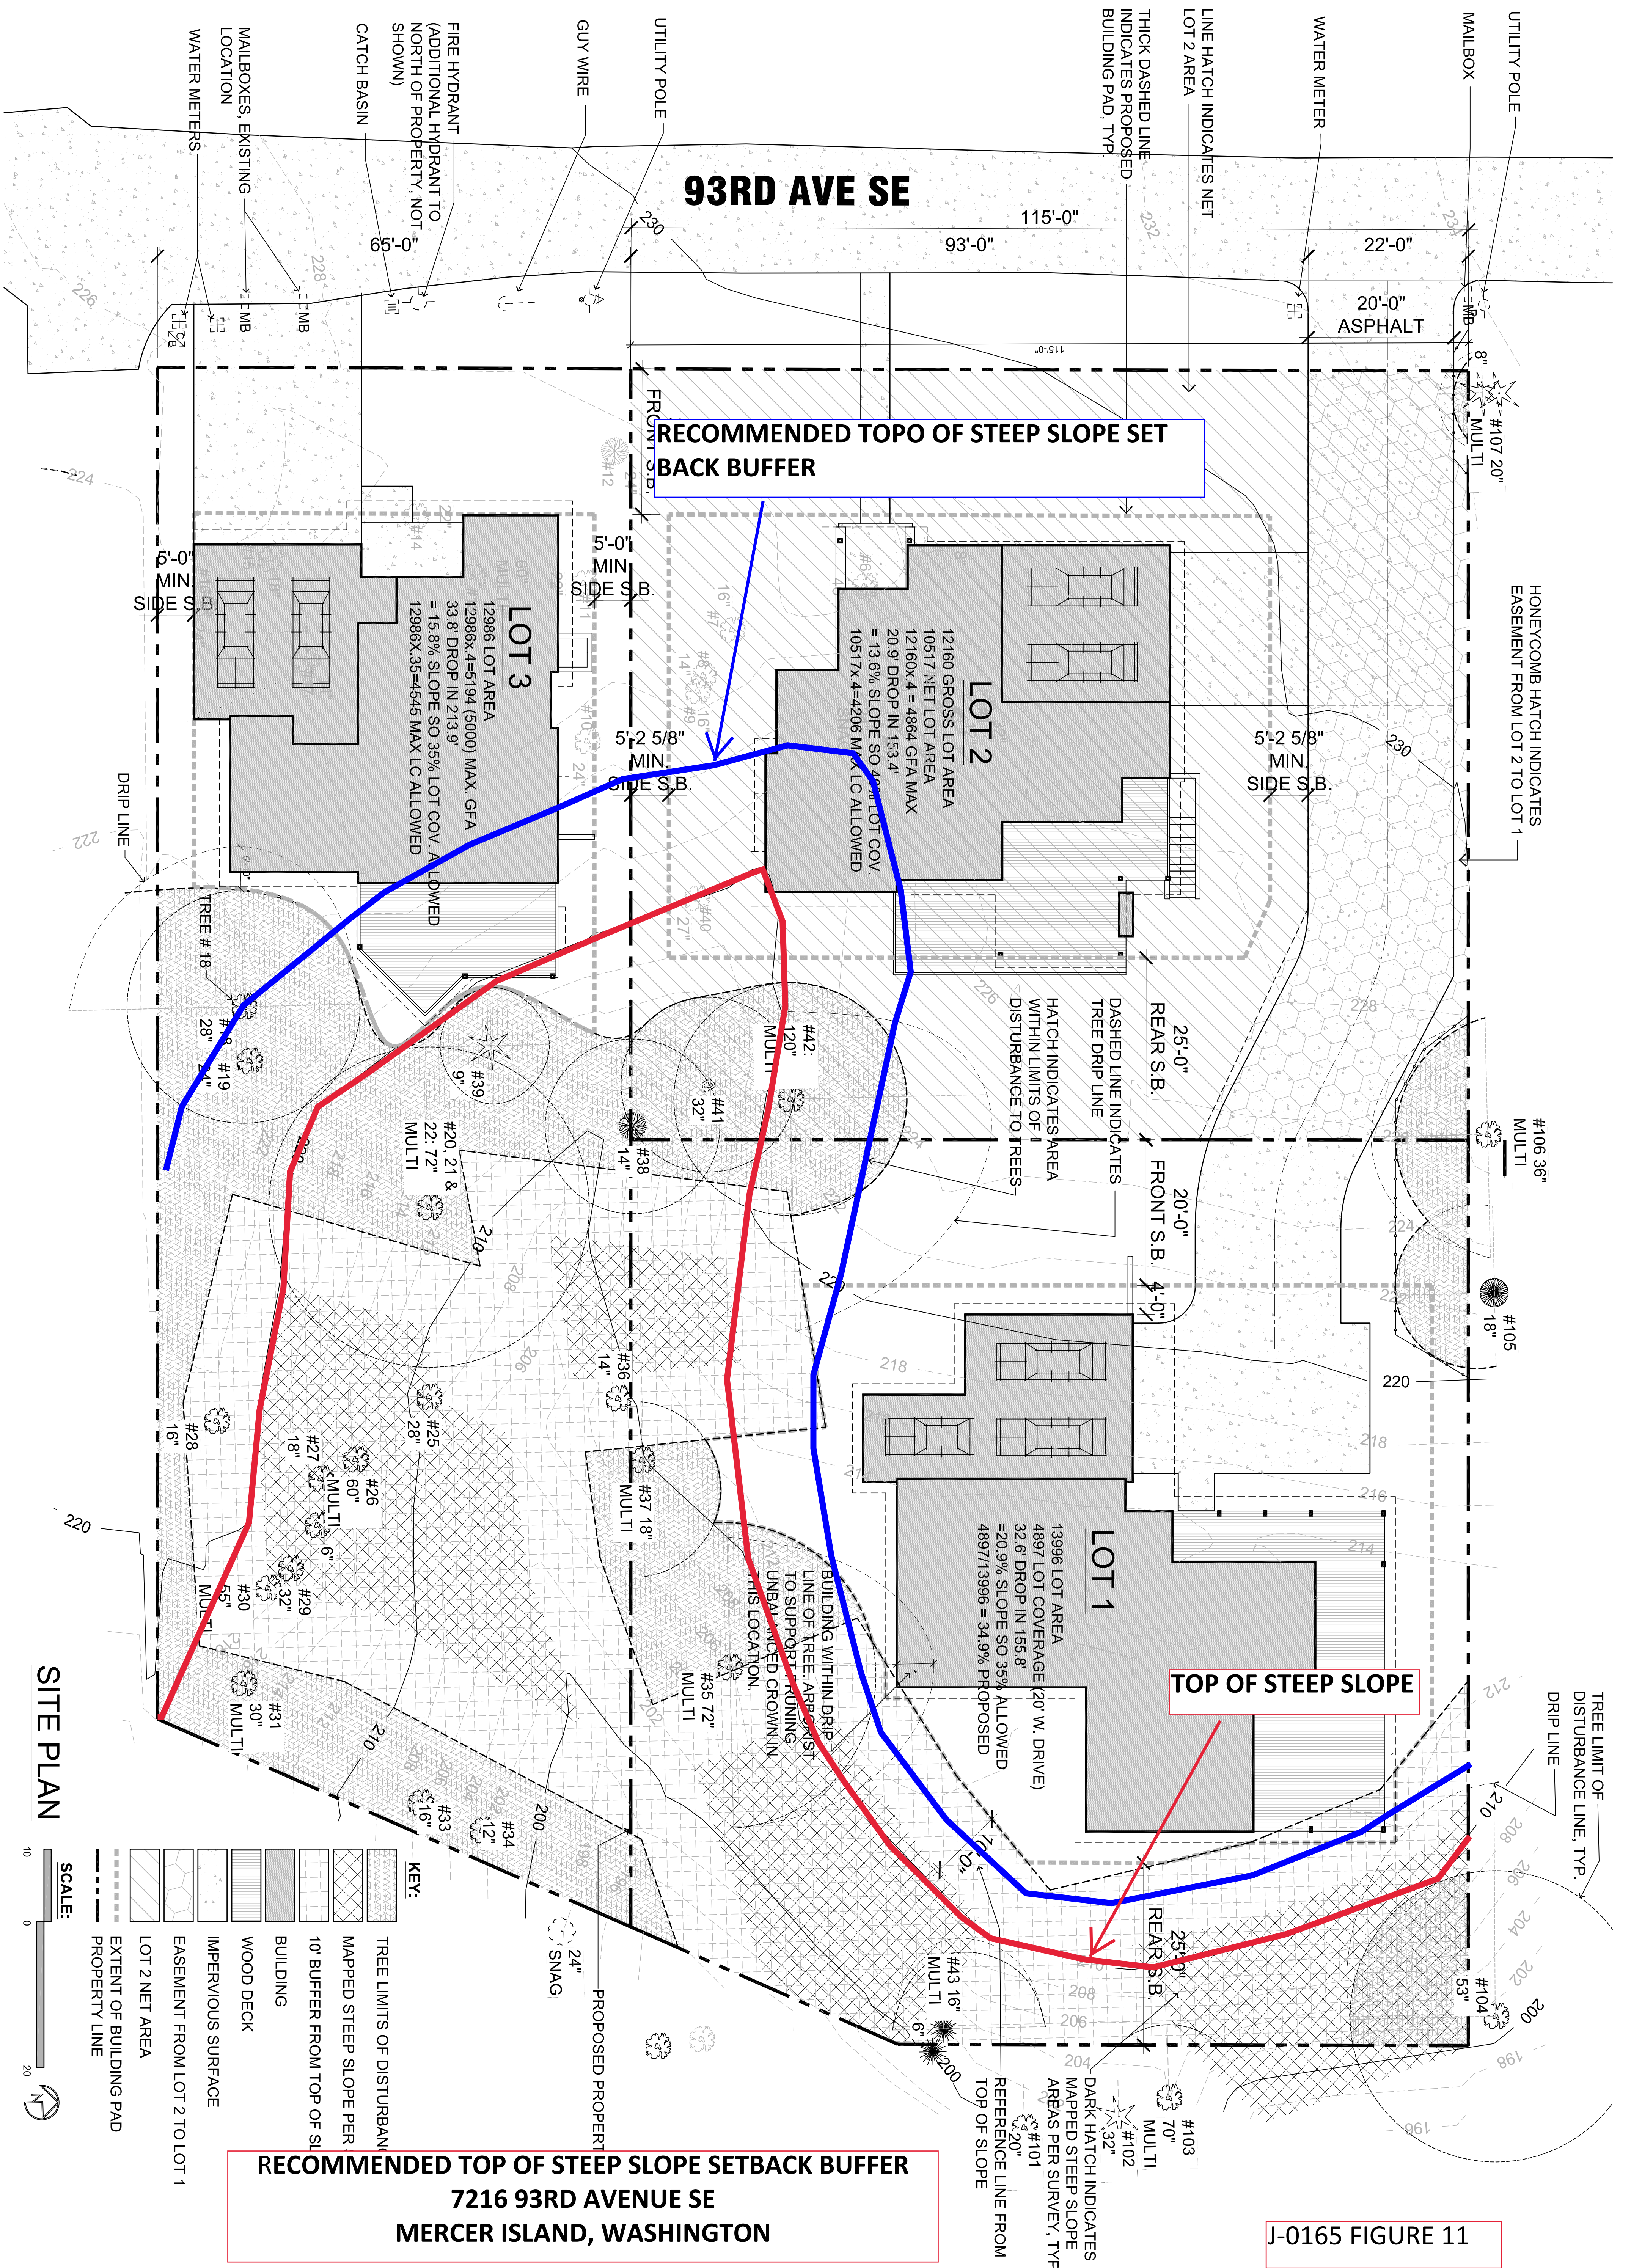
**J-0165 FIGURE 11**

**RECOMMENDED TOP OF STEEP SLOPE SETBACK BUFFER**  
**7216 93RD AVENUE SE**  
**MERCER ISLAND, WASHINGTON**

2. Provide a top of steep slope set back consistent with MIMC Title 19, Chapter 19.07, Section 19.07.160(C)(2)(a) that is equal to the height of the slope (Figure 11). In this case the set-backs would range from approximately 8 to 20 feet as the slope height changes across the site.

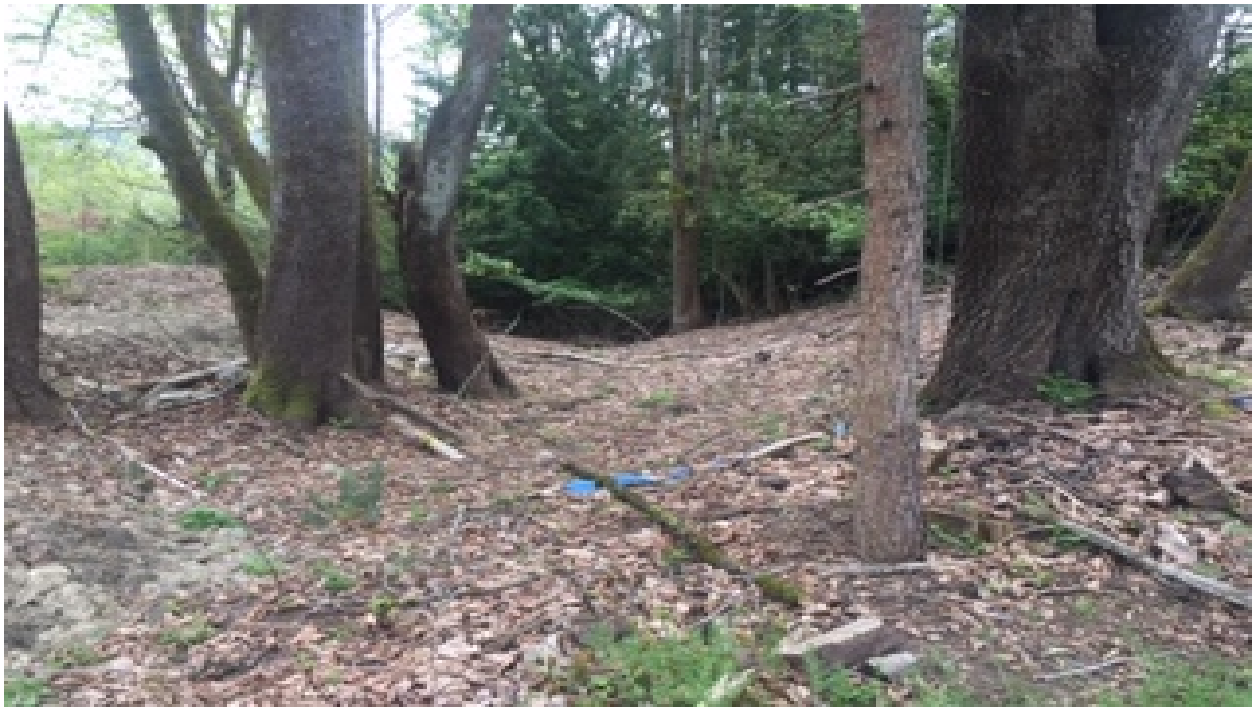
Photo 2: Looking east toward the southeast at the head of small gully that runs along the south side of the property.

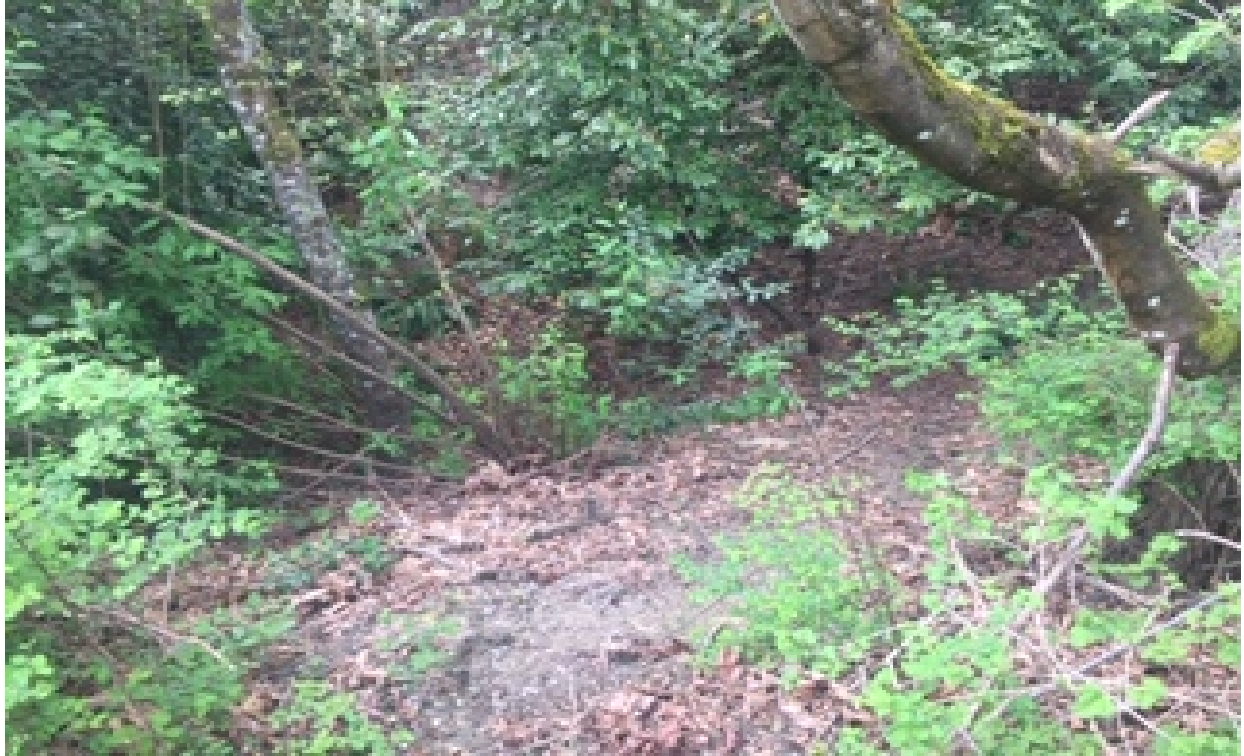
Photo 3: Looking south down slope of small gully on the south side of the property.
