**Preliminary Arborist Report
DRAFT**

To: JMK Homes c/o Jed Murphy
Site: 6610 E Mercer Way, Mercer Island, WA
Re: Tree inventory
Date: July 13th, 2022
Project Arborist: George White,
ISA Certified Arborist #PN-8908A
ISA Qualified Tree Risk Assessor
Reviewed By: Joseph Sutton-Holcomb
ISA Certified Arborist #PN-8397AM
Municipal Specialist, ISA Qualified Tree Risk Assessor
Referenced Documents: Topographic Survey (Pace Engineers, 6.6.2018)
Koneru Short Plat (Pace Engineers, Revised 4.12.2022)
Attached: Table of Trees
Tree Site Map

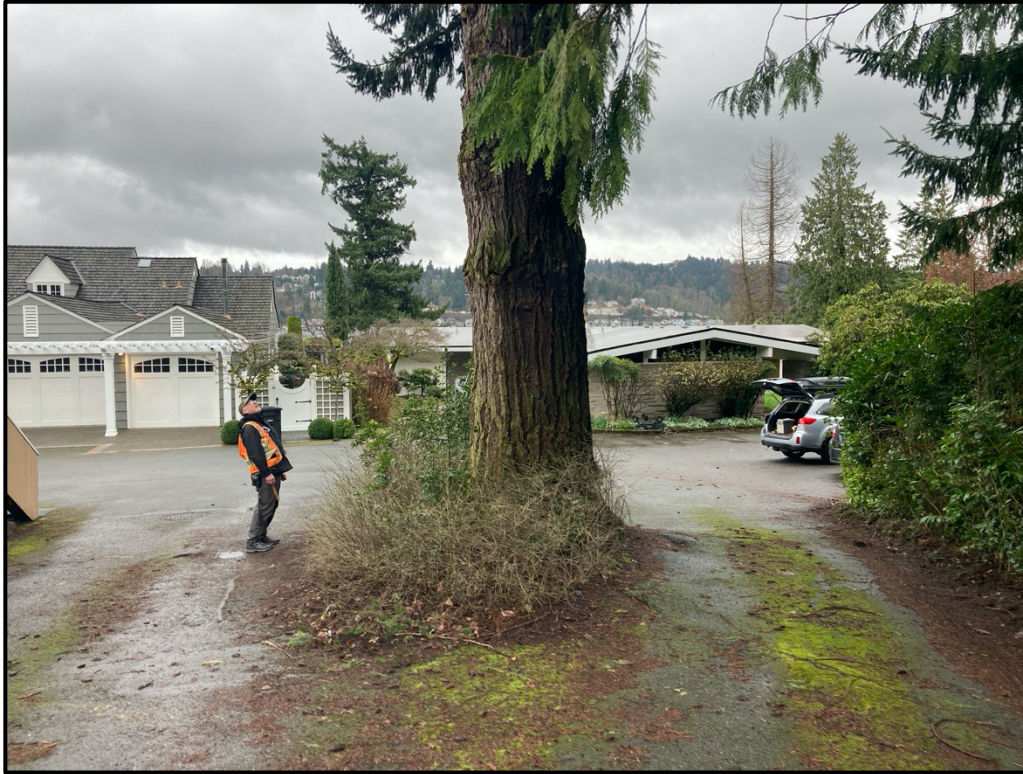
Tree 573 is an exceptional Douglas-fir (*Pseudotsuga menziesii*) that is located in the middle of the driveway easement in the northwest corner of the property. (See photo 1.) This tree is currently proposed for removal. This tree conflicts with the construction of a driveway that would allow for emergency vehicle egress. It also conflicts with plans to install a required fire hydrant and accompanying 6" water line. Therefore, retention of this tree would result in an "unavoidable hazardous situation" as described in MICC 19.10.060.3. if the driveway and fire hydrant are installed at the proposed locations. Therefore, this tree is exempt from the restriction on the removal of exceptional trees.

Photograph 1. Tree 573, An exceptional Douglas-fir in the NW corner of the lot. This tree conflicts with required driveway improvements and new fire-hydrant.

If permitted for removal, the stump of tree 573 should be ground in place, not ripped out to avoid root damage to adjacent trees. Six replacement trees will be required for this tree in accordance with the standards outlined in MICC 19.10.070.

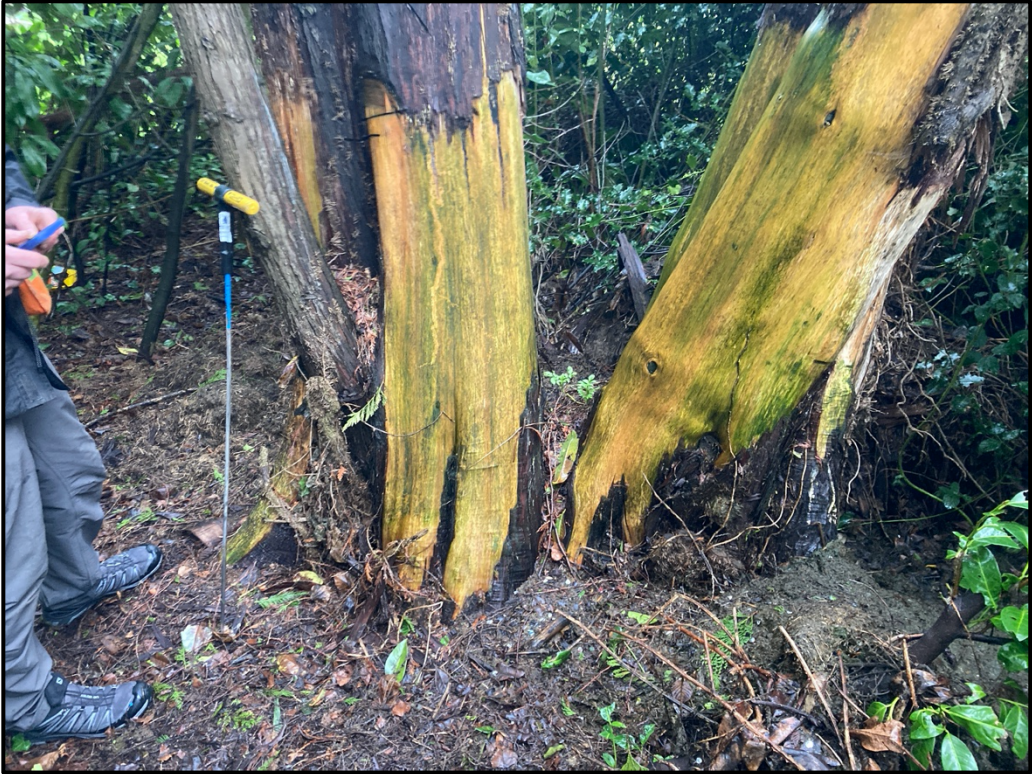
Additionally, we surveyed one dead tree of exceptional size that appeared to have been intentionally girdled by the previous property owners. We observed several trees (some over 10 inches in diameter)

that appeared to have been killed intentionally in this manner. In one case, a dead tree had a funnel protruding from a drilled port that was presumably used to inject herbicide. (See photos 2 and 3.)

Dead tree 1 was an exceptional western redcedar that was killed by the previous property owner. Because this tree was exceptional it would have been required to be retained and not damaged by development in the tree protection zone. The only proposed structure that encroaches on the minimum limits of disturbance is a deck which is to be constructed on piles. In my professional opinion, the impacts from this deck would have been manageable should the tree be alive and required for retention.

The most recent plans show a storm drain and catch basin located within the MLOD of dead tree 1. Retention of the tree would not be possible if it were alive under the current design. The storm drain and catch basin should be moved to the north (under the deck) outside of the MLOD for this tree. Moving the storm drain to this location would also reduce the impacts to tree 576.

Photograph 2. Dead tree 1, An exceptional western redcedar that appeared to have been girdled by the previous property owner.

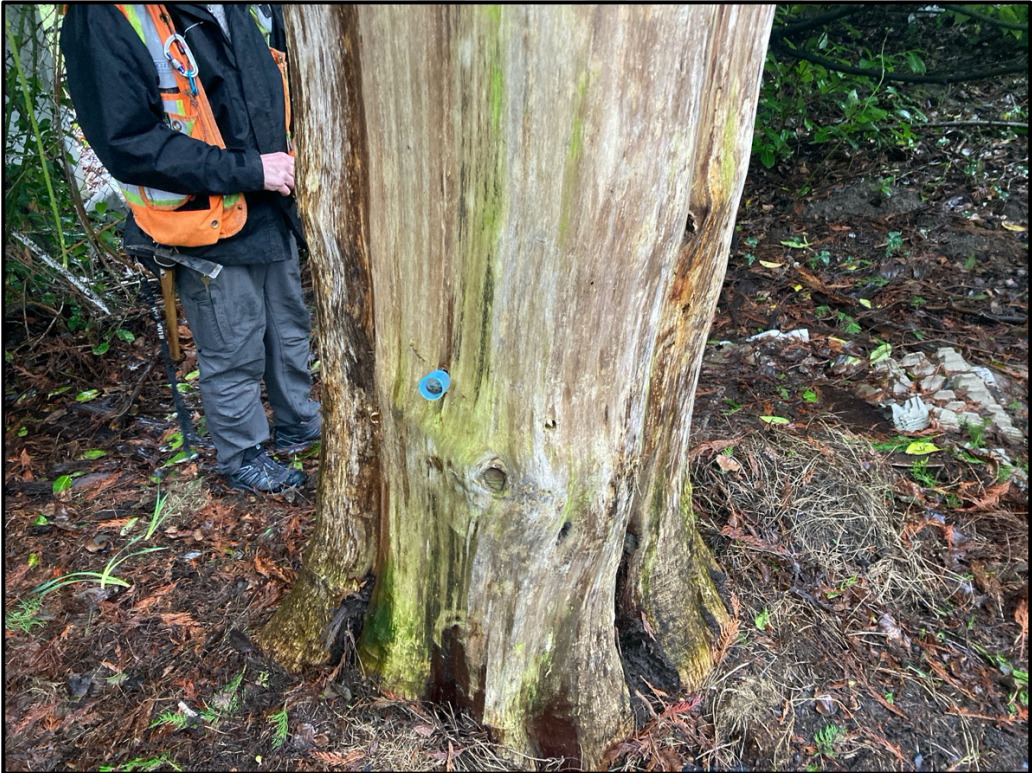
Photograph 3. Dead tree 2, a dead western redcedar with funnel and signs of intentional girdling.

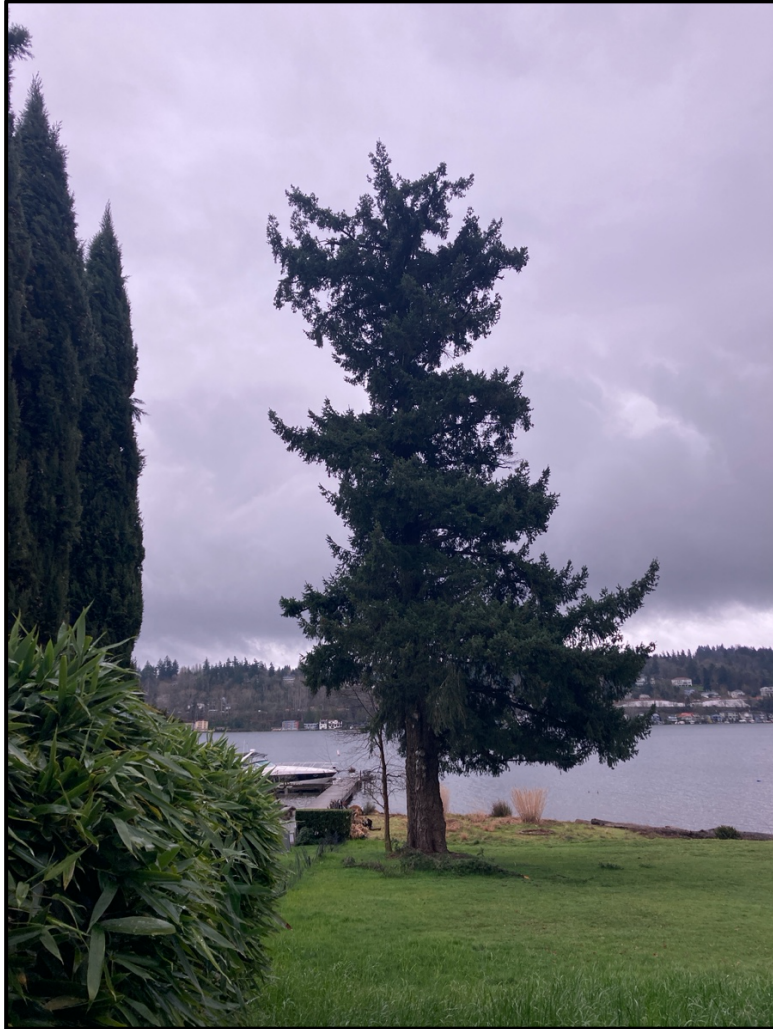
Tree 575 is an exceptional Douglas fir that is located in the northeast quadrant of the lot. (See photo 4.) This tree must be protected with tree protection fencing at the Recommended Limits of Disturbance (RLOD) listed in the attached table of trees using the specifications provided in appendix F. No machine access, or materials storage will be permitted within the RLOD. All erosion and runoff control (e.g., silt-fencing) must be surface mounted within the RLOD. Any excavation within the RLOD must be monitored by the project arborist.

Tree 575 is an exceptional Douglas-fir located north of the proposed structure. There is currently a proposed storm drain 10 feet from the base of this tree which is within the MLOD. This storm drain must be moved to 16 feet to be outside of the MLOD of this tree.

Photograph 4. Tree 275, an exceptional Douglas-fir with windblown canopy that is proposed for retention.

The most recent plans show a proposed storm drain located approximately 12 feet south of tree 575. The edge of this trench must excavate carefully under the supervision of the project arborist and any exposed roots must be cut cleanly and immediately backfilled.

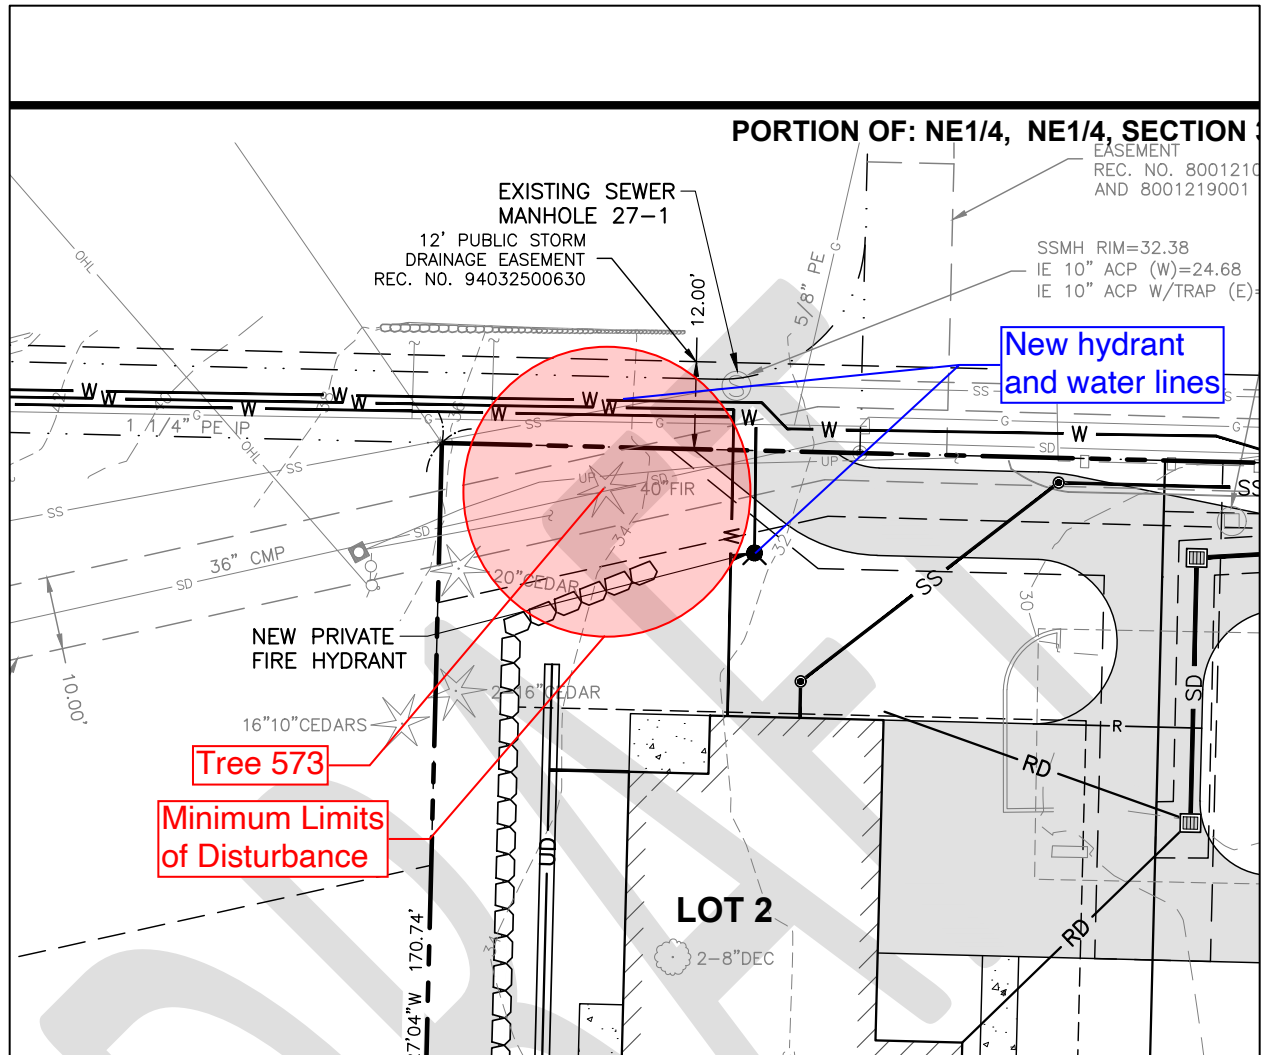
Tree 573 is an exceptional Douglas fir located in the middle of the existing driveway. This tree is currently proposed for removal because it conflicts with the installation of the required fire hydrant. Although the fire hydrant itself is outside of the MLOD, it is required to be hooked up to a new 6-inch water line which parallels the existing driveway. A 6-inch waterline will require a minimum 4-foot trench. There is no way to install this water line without routing it through the MLOD of tree 573 (See Figure 1).

Figure 1. An excerpt from Composite Utility Plan C3.0 (7.20.2021) indicating the location of the new fire hydrant and water lines in relation to tree 573
