Preliminary Arborist Report

To: JMK Homes c/o Jed Murphy
Site: 6610 E Mercer Way, Mercer Island, WA
Re: Tree inventory
Date: November 4, 2022
Project Arborist: George White,
ISA Certified Arborist #PN-8908A
ISA Qualified Tree Risk Assessor
Reviewed By: Joseph Sutton-Holcomb
ISA Certified Arborist #PN-8397AM
Municipal Specialist, ISA Qualified Tree Risk Assessor
Referenced Documents: Topographic Survey (Pace Engineers, 6.6.2018)
Koneru Building Permit (Pace Engineers, Revised 11.4.2022)
Attached: Table of Trees
Tree Site Map

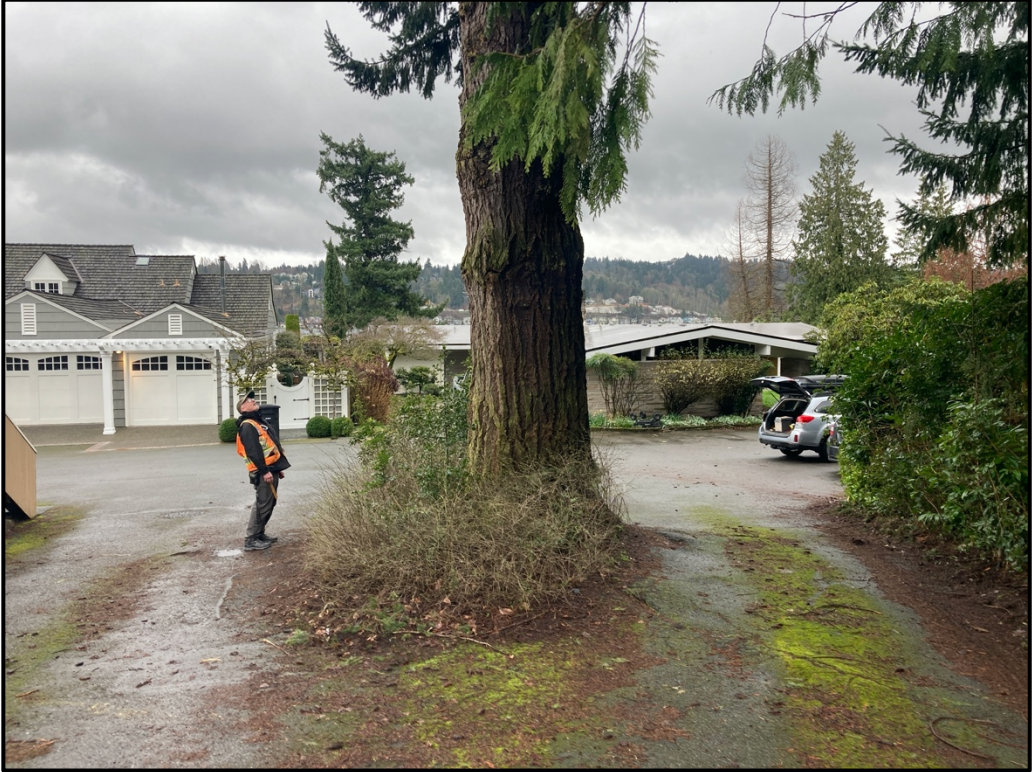
Tree 573 is an exceptional Douglas-fir (*Pseudotsuga menziesii*) that is located in the middle of the driveway easement in the northwest corner of the property. (See photo 1.) This tree is currently proposed for removal. This tree conflicts with the construction of a driveway that would allow for emergency vehicle egress. It also conflicts with plans to install a required fire hydrant and accompanying 6" water line. Therefore, retention of this tree would result in an "unavoidable hazardous situation" as described in MICC 19.10.060.3. if the driveway and fire hydrant are installed at the proposed locations. Therefore, this tree is exempt from the restriction on the removal of exceptional trees.

Photograph 1. Tree 573, An exceptional Douglas-fir in the NW corner of the lot. This tree conflicts with required driveway improvements and new fire-hydrant.

The stump of tree 573 should be ground in place, not ripped out to avoid root damage to adjacent trees. Six replacement trees will be required for this tree in accordance with the standards outlined in MICC 19.10.070.

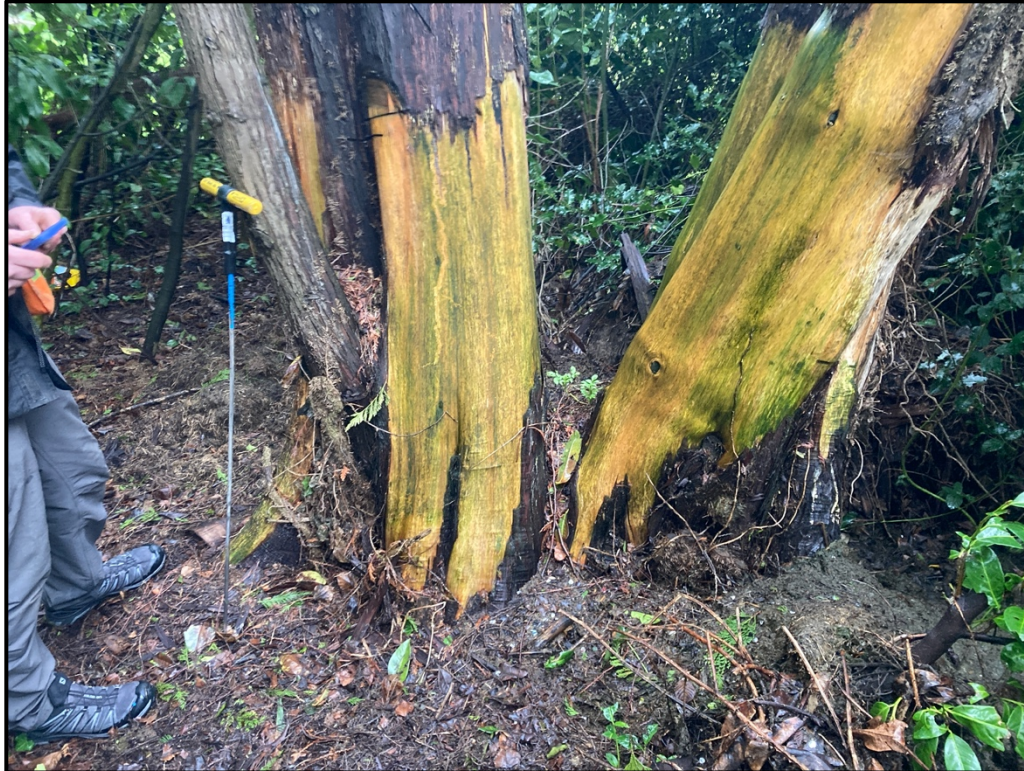
Additionally, we surveyed one dead tree of exceptional size that appeared to have been intentionally girdled by the previous property owners. We observed several trees (some over 10 inches in diameter)

Dead tree 1 was an exceptional western redcedar that was killed by the previous property owner. Because this tree was exceptional it would have been required to be retained and not damaged by development in the tree protection zone. The only proposed structure that encroaches on the minimum limits of disturbance is a deck which is to be constructed on piles. In my professional opinion, the impacts from this deck would have been manageable should the tree be alive and required for retention.

Photograph 2. Dead tree 1, An exceptional western redcedar that appeared to have been girdled by the previous property owner.

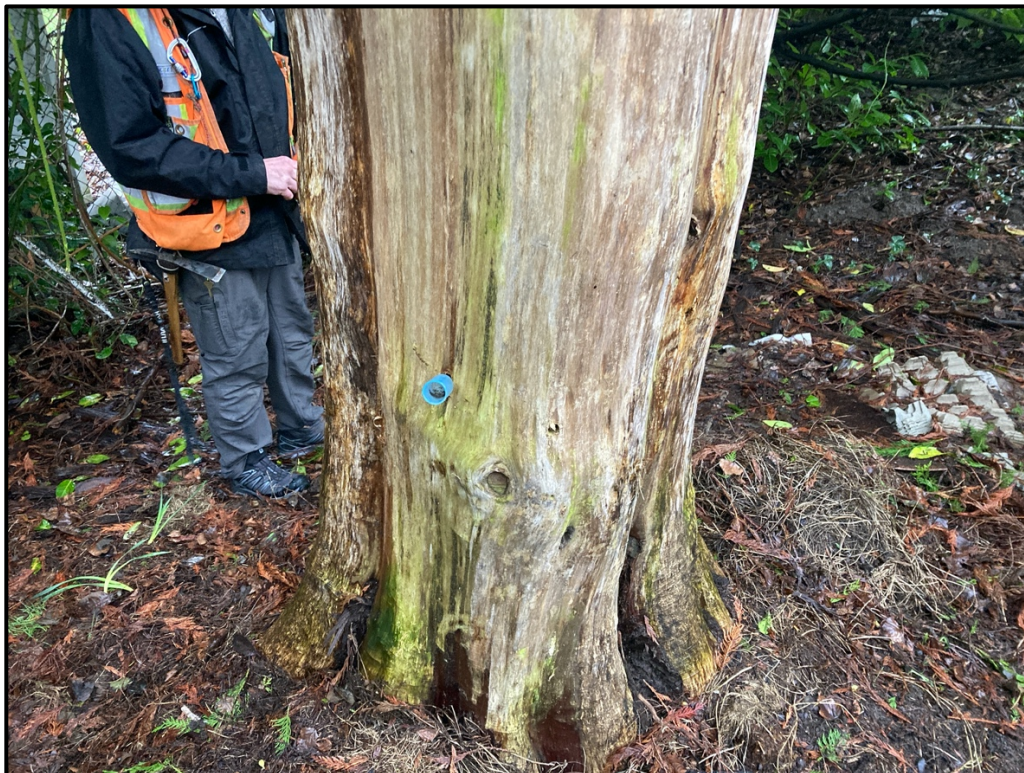
that appeared to have been killed intentionally in this manner. In one case, a dead tree had a funnel protruding from a drilled port that was presumably used to inject herbicide. (See photos 2 and 3.)

Photograph 3. Dead tree 2, a dead western redcedar with funnel and signs of intentional girdling.

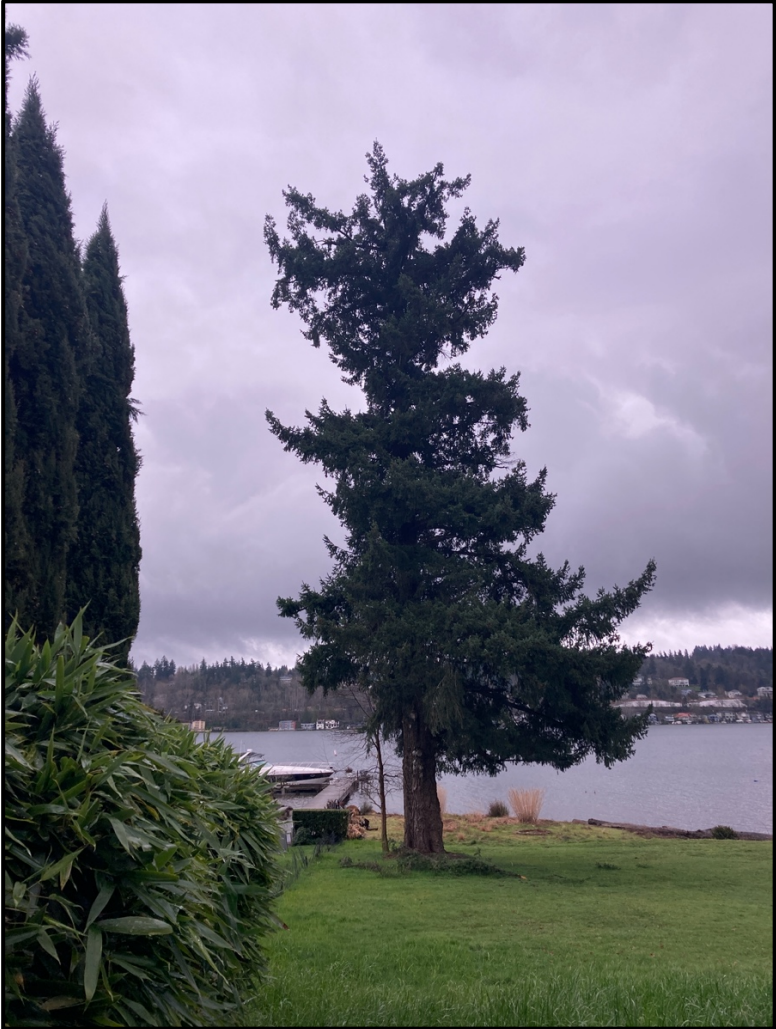
Tree 575 is an exceptional Douglas fir that is located in the northeast quadrant of the lot. (See photo 4.) This tree must be protected with tree protection fencing at the Recommended Limits of Disturbance (RLOD) listed in the attached table of trees using the specifications provided in appendix F. No machine access, or materials storage will be permitted within the RLOD. All erosion and runoff control (e.g., silt-fencing) must be surface mounted within the RLOD. Any excavation within the RLOD must be monitored by the project arborist.

Photograph 4. Tree 275, and exceptional Douglas-fir with windblown canopy that is proposed for retention.

The most recent plans show a proposed storm drain located approximately 20 feet south of tree 575. The edge of this trench must be excavated carefully under the supervision of the project arborist and any exposed roots must be cut cleanly and immediately backfilled.

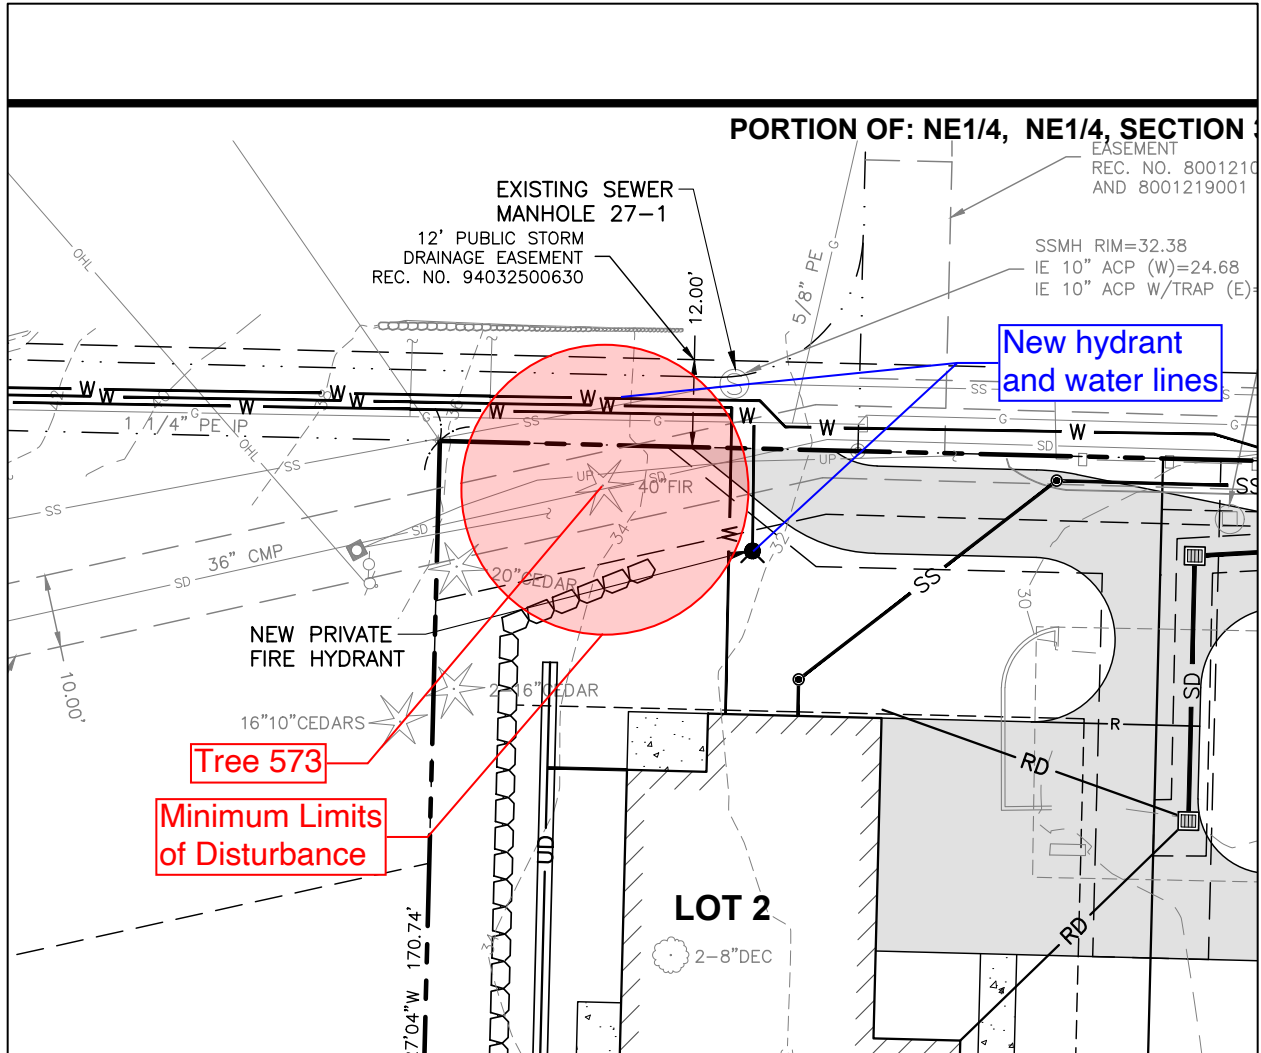
Tree 573 is an exceptional Douglas fir located in the middle of the existing driveway. This tree is currently proposed for removal because it conflicts with the installation of the required fire hydrant. Although the fire hydrant itself is outside of the MLOD, it is required to be hooked up to a new 6-inch water line which parallels the existing driveway. A 6-inch waterline will require a minimum 4-foot

trench. There is no way to install this water line without routing it through the MLOD of tree 573 (See Figure 1).

Figure 1. An excerpt from Composite Utility Plan C3.0 (7.20.2021) indicating the location of the new fire hydrant and water lines in relation to tree 573
