**Stormwater Drainage Report  
3745 77<sup>th</sup> Avenue SE  
Mercer Island, Washington  
KC Tax Parcel #545880-0500**

February 10, 2022

**Offe Engineers, PLLC  
Darrell Offe, P.E.  
13932 SE 159<sup>th</sup> Place  
Renton, Washington 98058  
425-260-3412  
[Darrell.Offe@comcast.net](mailto:Darrell.Offe@comcast.net)**

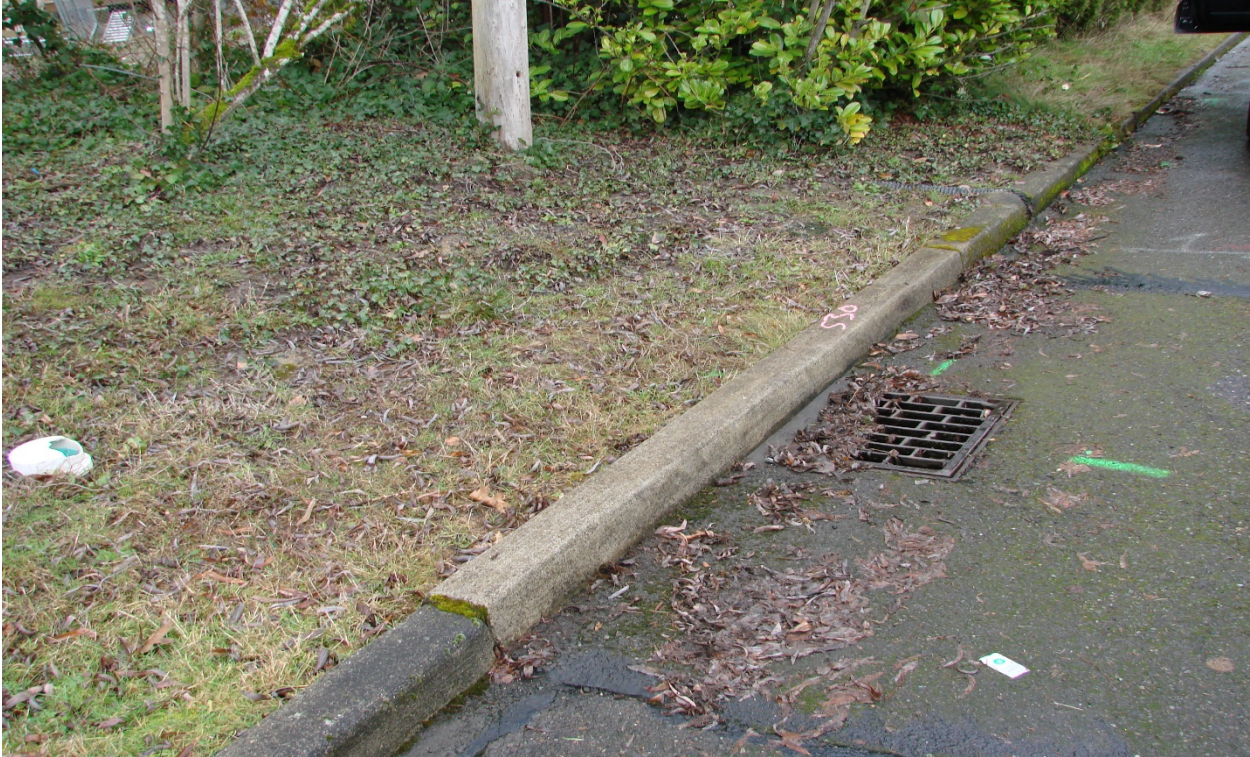
**Photo #5 – CB#10-543**

CB#10-543 - inlet partially blocked, was flowing water -sump full of debris, needs maintenance

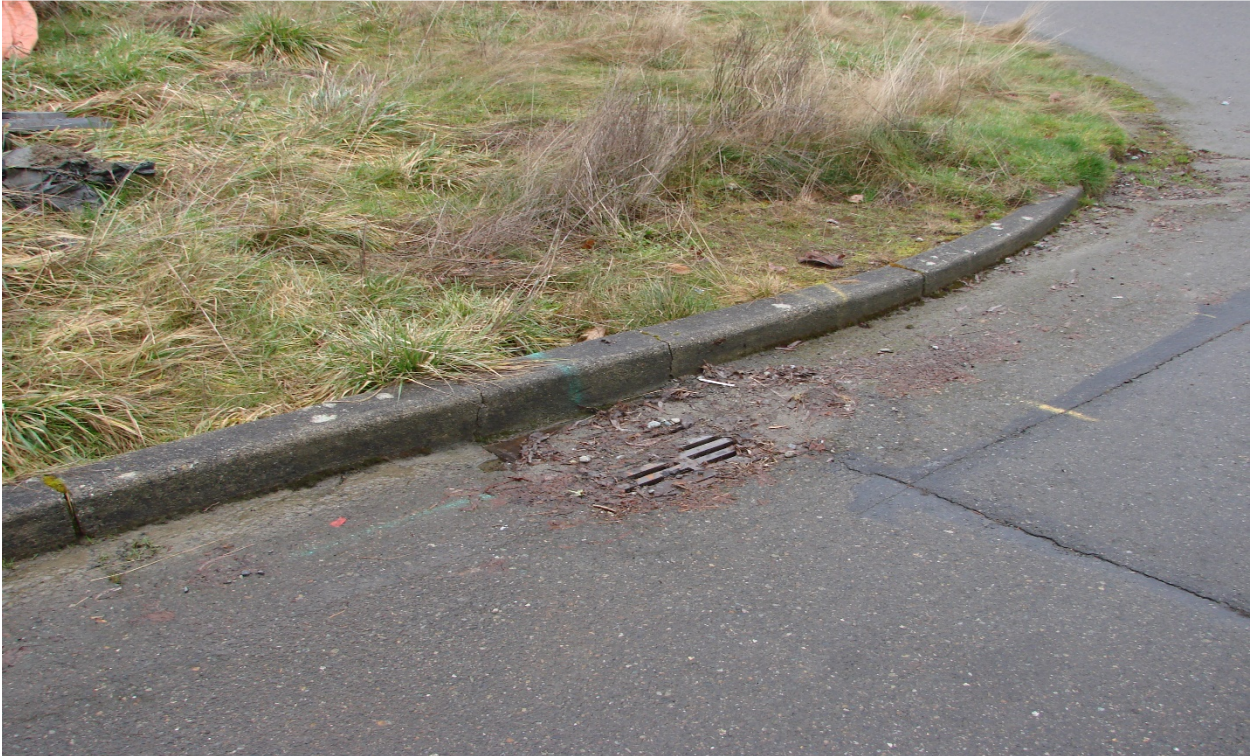
**Photo #6 – CB#10-545**

CB#10-545 - filter sock prevented access; inlet blocked – needs maintenance

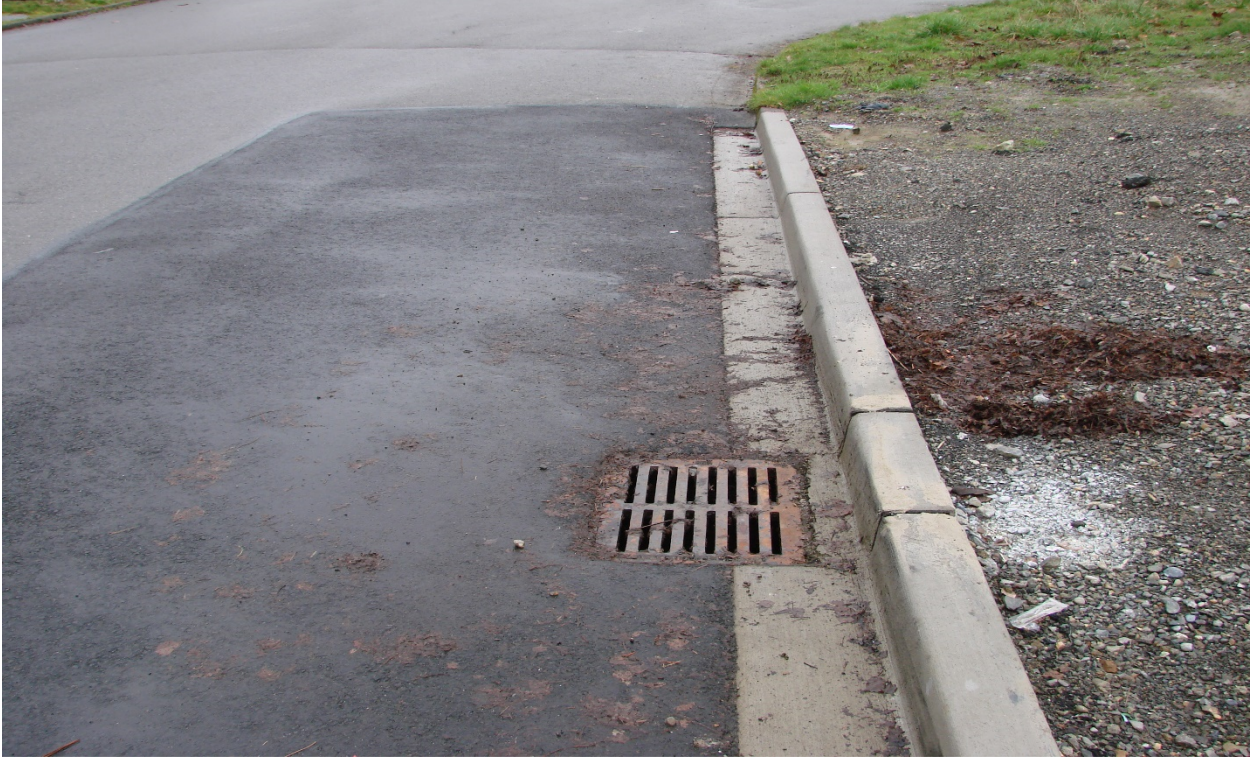
**Photo #8 – CB#10-546**

CB#10-546 – filter sock prevented access; inlet clean

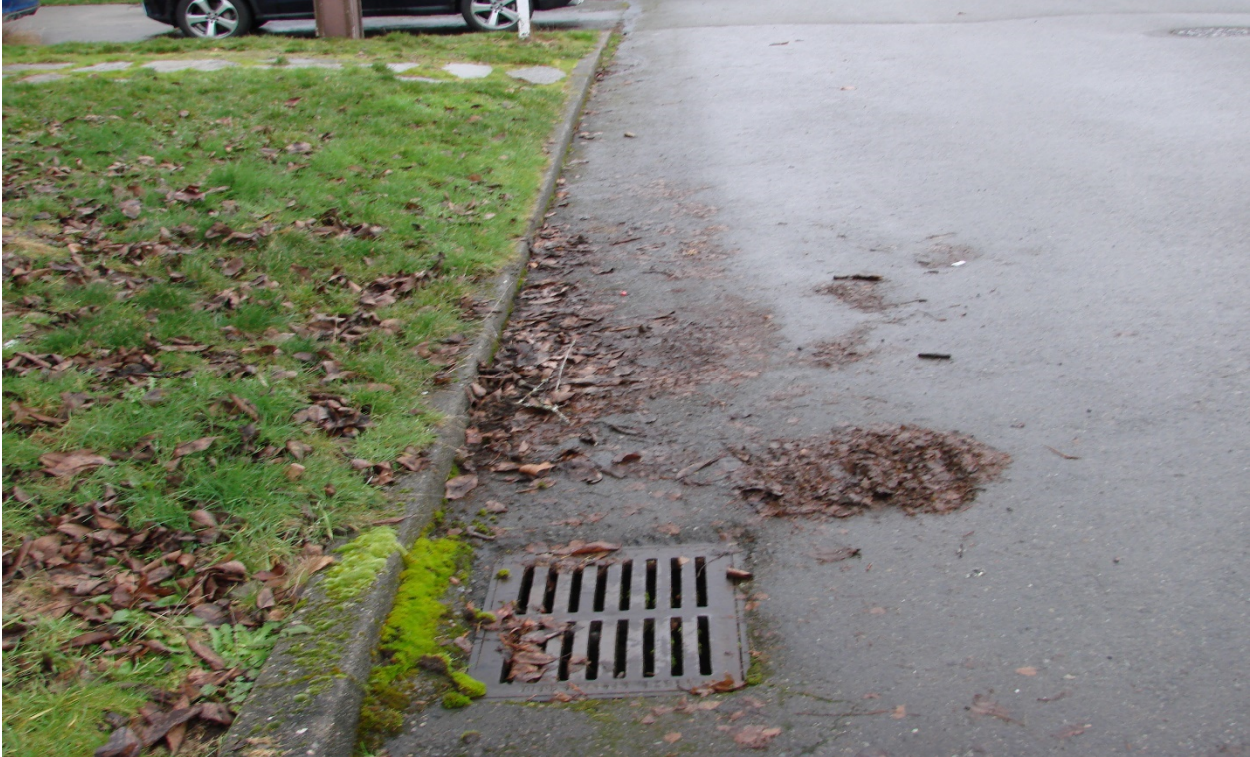
**Photo #9 – CB#10-47**

CB#10-47 – flowing water, sump full of debris – needs maintenance

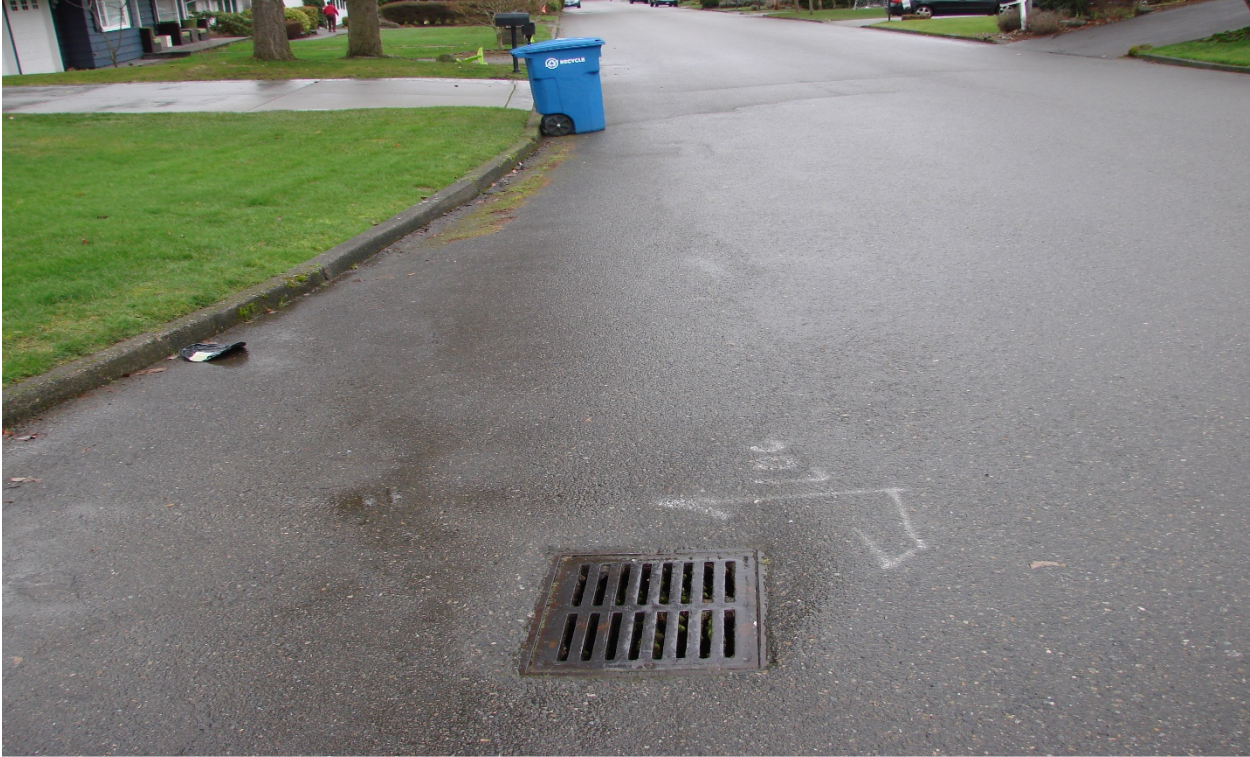
**Photo #10 – CB#10-446**

CB#10-446 – flowing water, inlet clean, sump full – needs maintenance

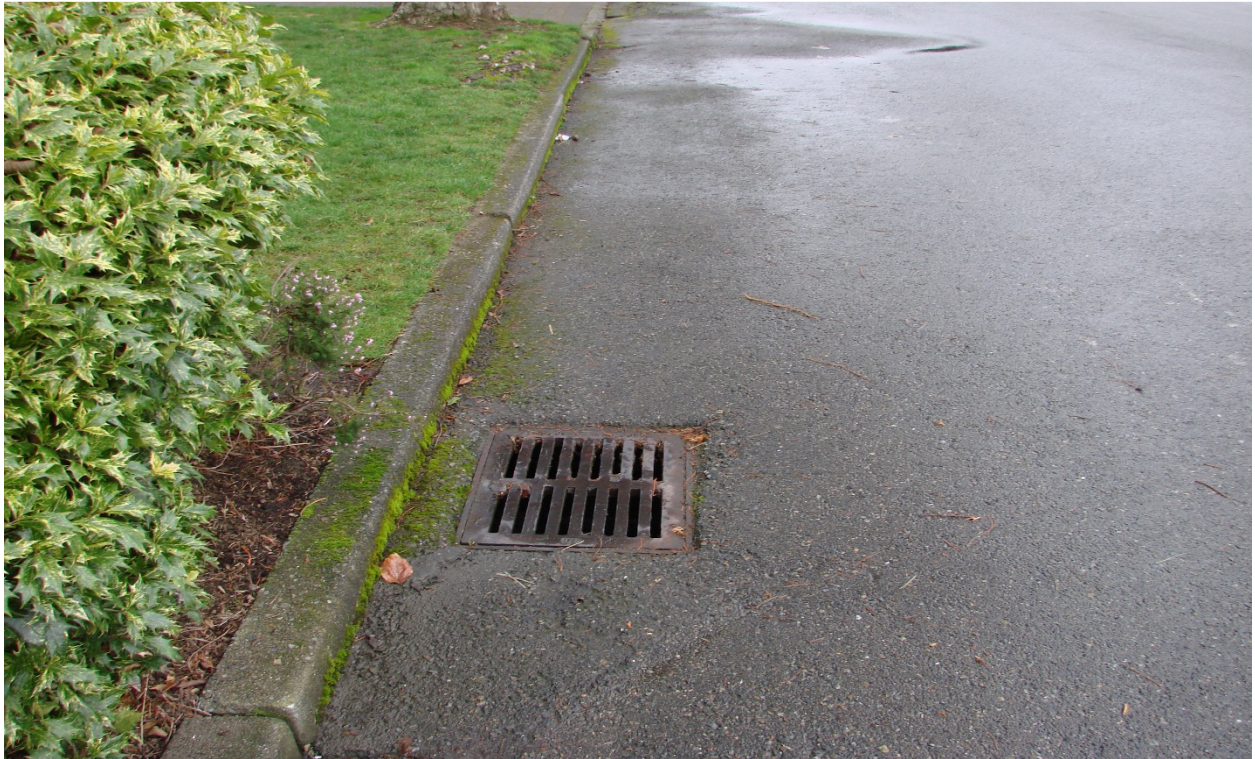
**Photo #11 – CB#10-897**

CB#10-897 – flowing water, inlet clean, sump partially full of debris – needs maintenance

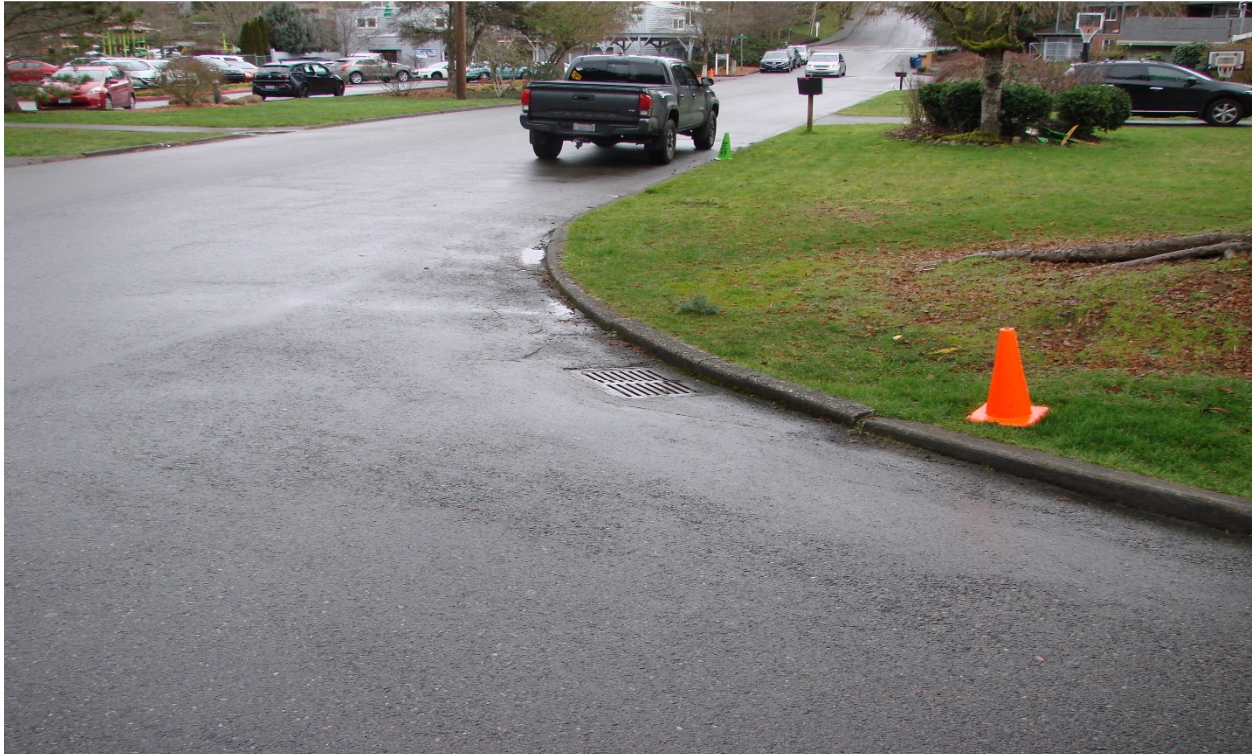
**Photo #12 – CB#10-561**

CB#10-561 – flowing water, inlet clean, sump partially full – need maintenance
