Arborist Report

To: Sturman Architects c/o Logan Gaylan
Site: 6454 E Mercer Way, Mercer Island, WA
Re: Tree Inventory and Assessment
Date: December 1, 2022
Project Arborist: George White,
ISA Certified Arborist #PN-8908A
ISA Qualified Tree Risk Assessor
Reviewed By: Connor McDermott,
ISA Certified Arborist #PN- 8704A
ISA Qualified Tree Risk Assessor
Referenced Documents: Site Plan A1.1 (Sturman Architects, 11/22/2022)
Attached: Table of Trees
Tree Site Map

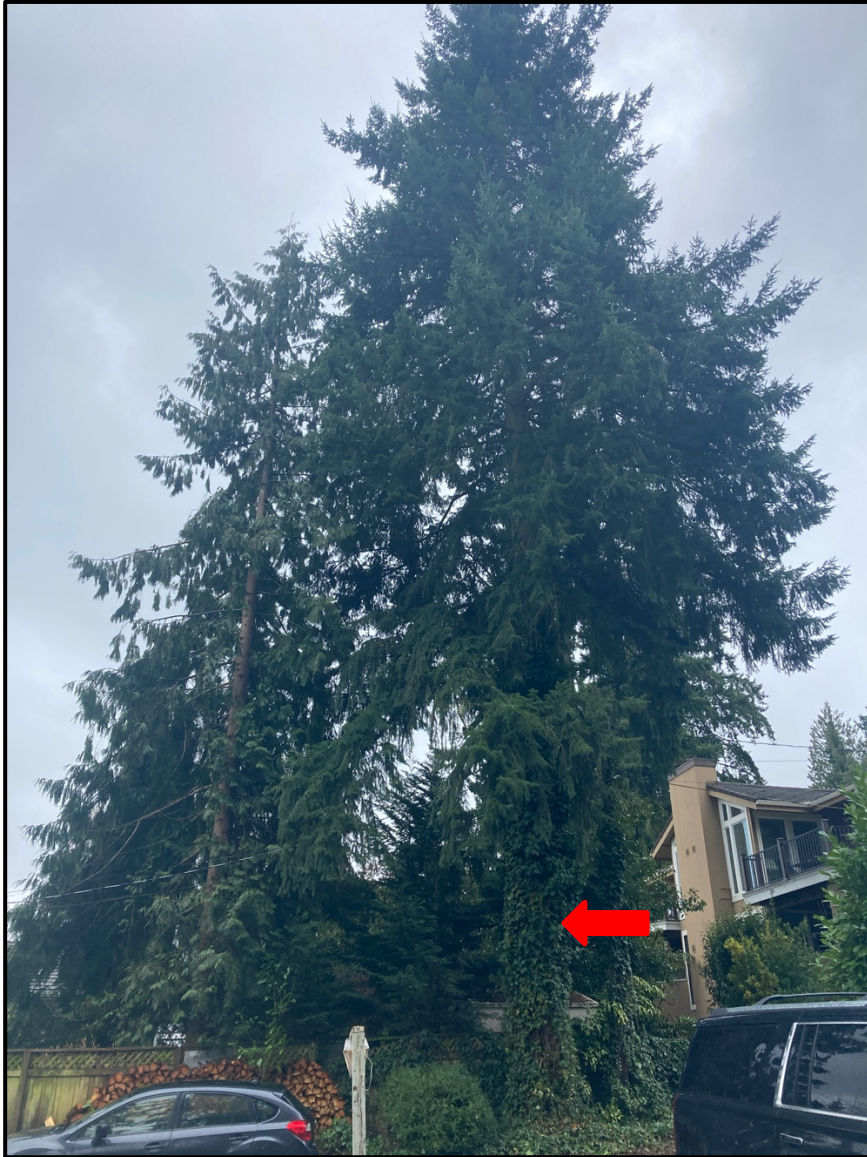
Tree 72 is an exceptional Douglas-fir the southwest corner of the lot that is currently proposed for retention (Photo1). A significant portion of the root zone of this tree lies beneath the existing driveway. This tree can be protected at the edge of the existing hardscape provided that the existing driveway is resurfaced without demolishing the existing surface.

Photograph 1. Tree 72, an exceptional Douglas-fir (Indicated with red arrow) in the southwest corner of the lot. This tree can be protected at the edge of the existing hardscapes. The English ivy should be removed from the trunk.

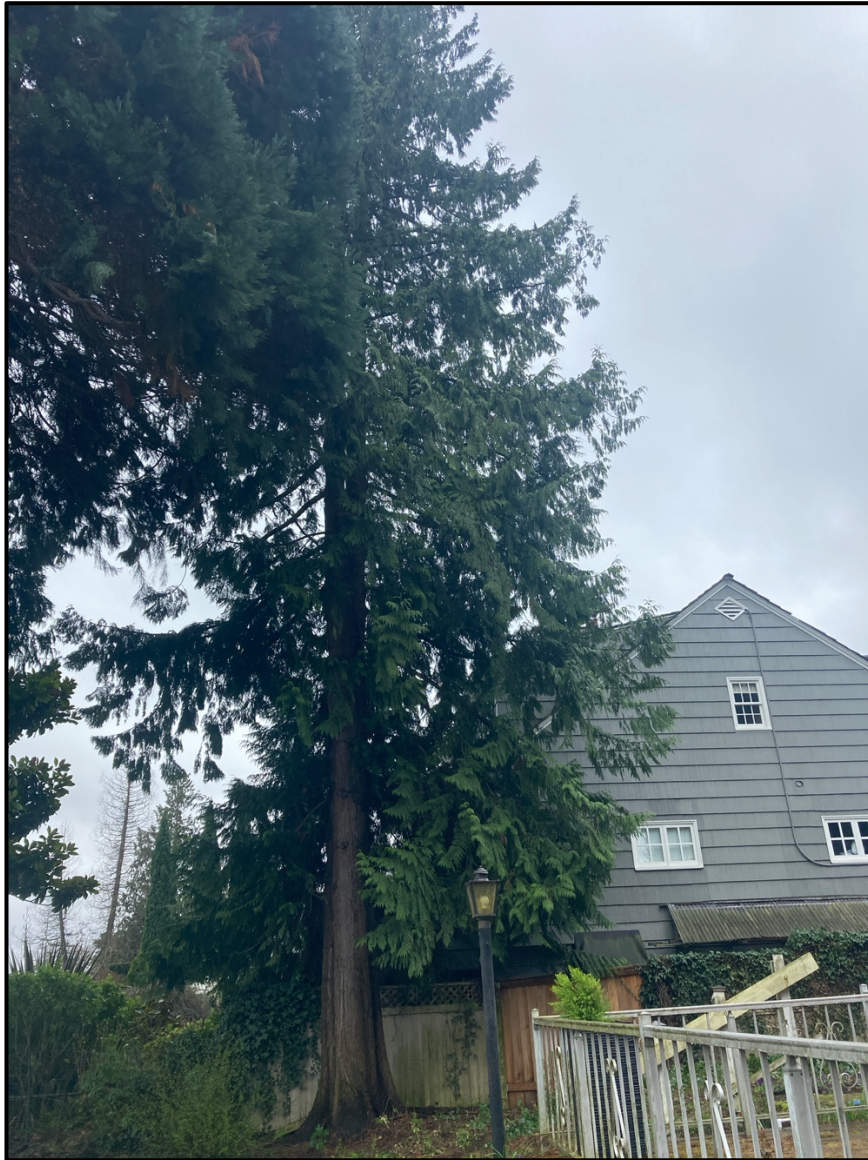
Tree 73 is an exceptional western redcedar located just southeast of the existing house (Photo 2). Tree 74 is an exceptional giant sequoia located west of the existing house. Both trees are to be protected with tree protection fencing located at the Recommended Limits of Disturbance (RLOD). No excavation, grading, materials storage, or machine access is permitted within the tree protection fencing without arborist coordination. The tree protection fencing may be reduced to the Minimum Limits of Disturbance (MLOD) if specific tree protection measures are taken.

The most recent plans show that an addition of an outdoor room which will encroach slightly on the RLOD of trees 73 and 74. The proposed outdoor room addition will sit on pin piles to minimize potential root impacts to trees 73 and 74. Any excavation required for the installation of these piles is to be conducted carefully with a flat-fronted bucket. Any roots encountered must be cut cleanly and immediately backfilled to prevent desiccation. No ground disturbance is planned within the MLOD of either tree. In my opinion, this addition will have a negligible impact to the health and stability of trees 73 and 74.

Photograph 2. Tree 73, an exceptional western redcedar southeast of the existing house.

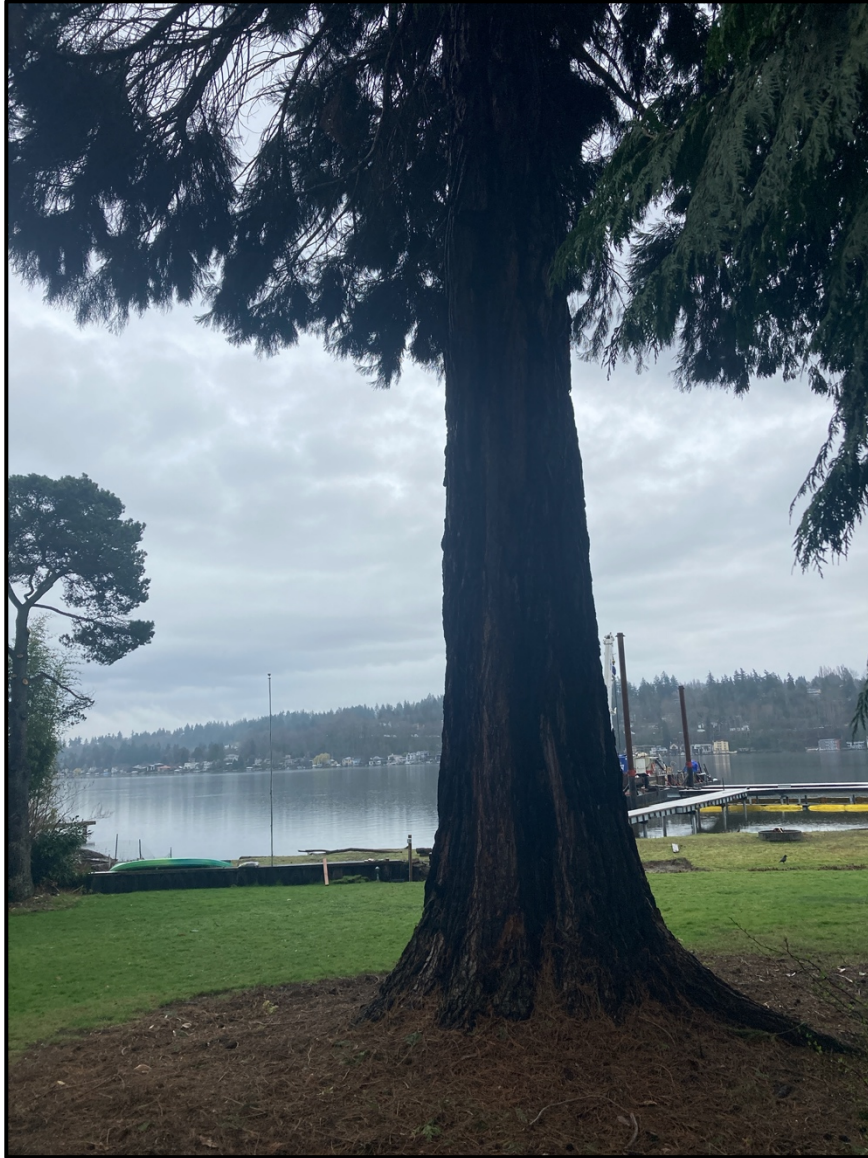
Photograph 3. Tree 74, an exceptional giant sequoia due east of the existing house.

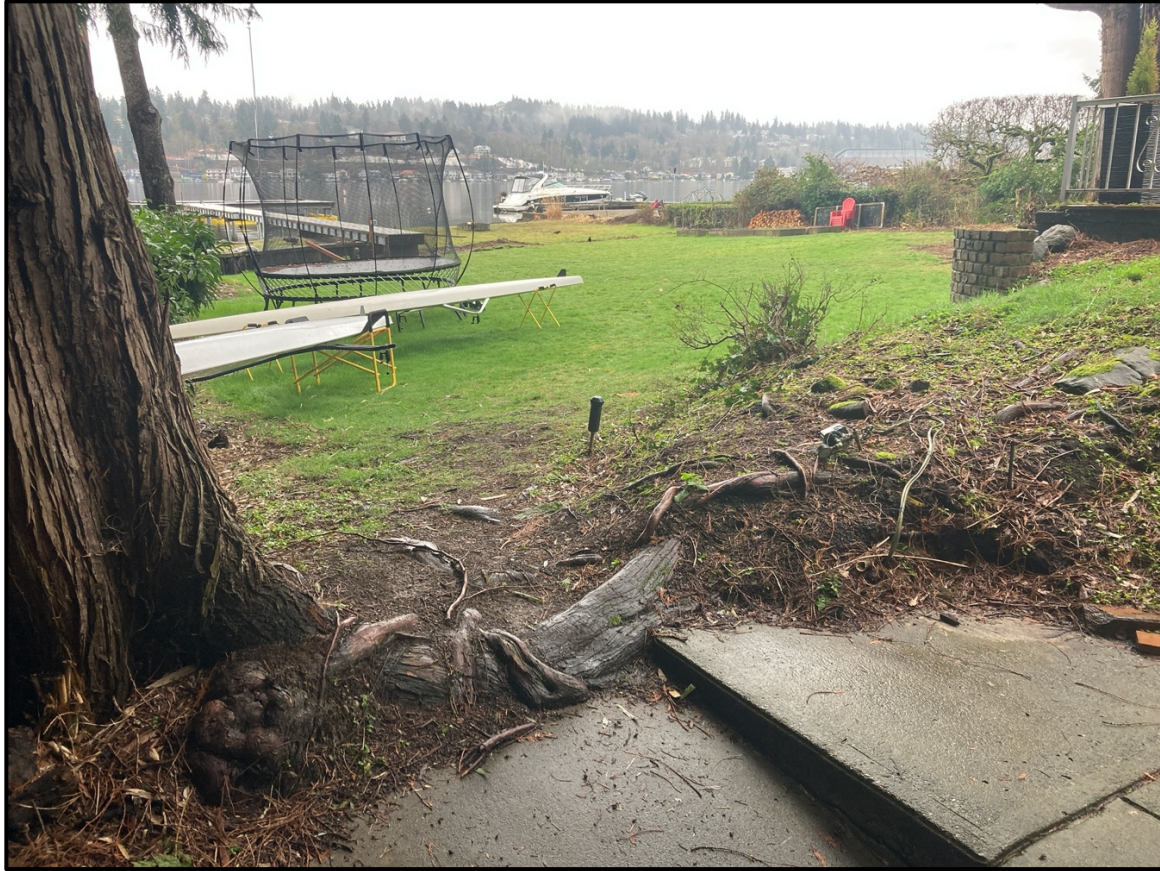
Tree 79 is a western redcedar that has significant conflicts with the existing patio and concrete path and is proposed for removal. (See photograph 4). The stump of this tree should be ground in place and not ripped out to avoid root damage to adjacent trees. Three replacement trees will be required to mitigate this tree, in accordance with the specifications outlined in MMC 19.10.070.

Photograph 4. Tree 79, a 29-inch western redcedar with significant root conflicts with the patio and concrete path. This is the only large tree currently proposed for removal.

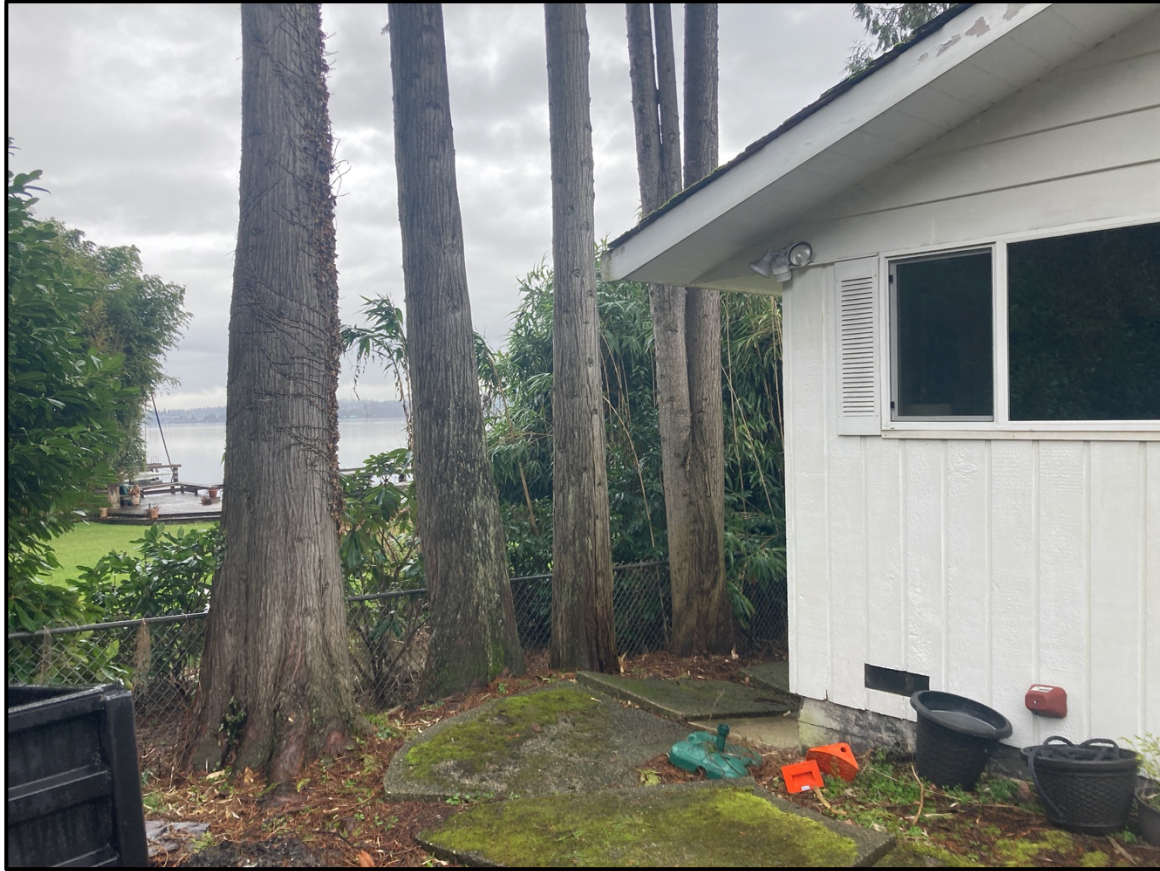
Trees 80-83 are a row of western redcedars north of the house. These trees must be protected at the RLOD of at the edge of the existing hardscapes. Any necessary clearance pruning must be completed by an ISA certified arborist in accordance with the relevant ANSI A300 pruning standards. Pruning should occur prior to the commencement of construction activities. If the concrete path along the north side of the house is to be re-leveled it should be leveled using fill only. No roots should be cut or shaved in this process (see photograph 5).

Photograph 5. Trees 80 through 83, four western redcedars immediately north of the house. These trees must be protected at the edge of the existing hardscapes for the duration of the project. Any leveling of the concrete pavers must be achieved through fill only.
