Memorandum

To: Mathew Wiley
CC: The Miller Hull Partnership LLP c/o April Ng
Site: Wiley Residence Remodel
Address: 6838 96th Ave SE, Mercer Island
Re: Assessment of Impacts to Tree 344 from Soldier Pile Wall Installation in Driveway
Date: January 10, 2024
Project Arborist: Connor McDermott,
ISA Certified Arborist PN- 8704A
ISA Qualified Tree Risk Assessor
Referenced Documents: Arborist Report (Tree Solutions Inc, 05/12/2022)
Grading Plan C200A (LPD Engineering, February 24, 2023)
Foundation Details (PCS Structural Solutions, February 24, 2023)
Garage Shoring and Wall Elevation Details S420 (PCS Structural Solutions, December 8, 2023)

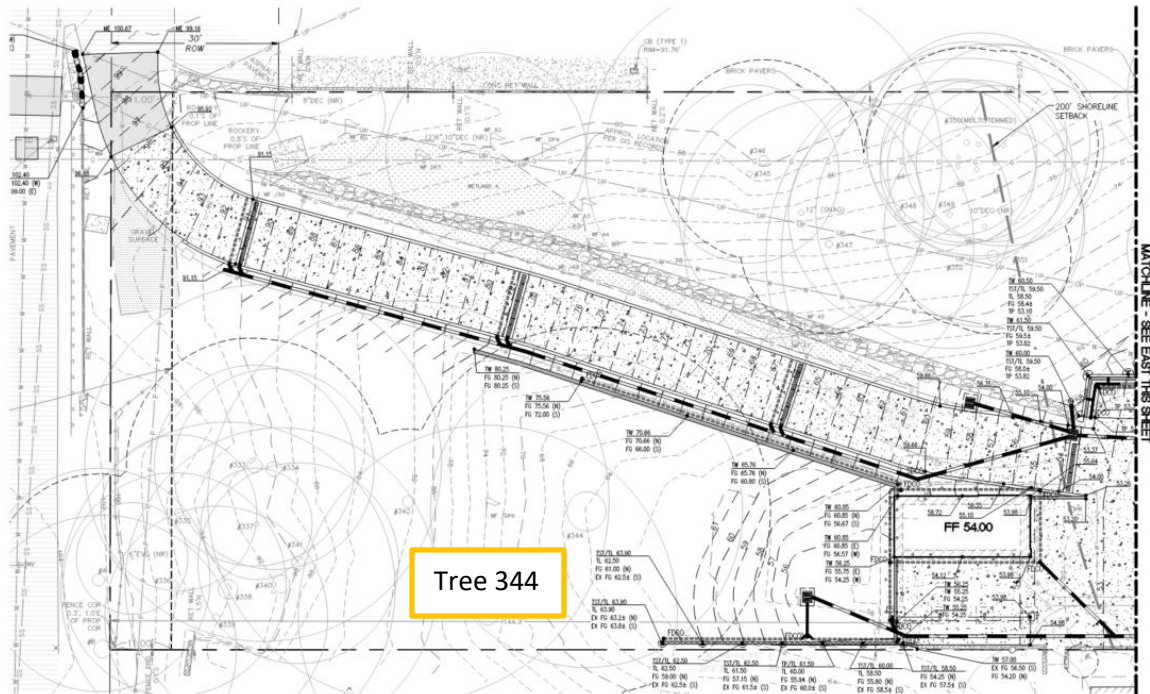
Tree 344 is an exceptional western redcedar that measured 49.7-inch diameter at standard height and had a RLOD of 33 feet. The approved construction plans called for the construction of a concrete retaining wall south of the existing driveway and north of tree 344 (Figure 1). The foundation of the concrete retaining wall had a four foot wide footing that required encroachment into the minimum limits of disturbance (MLOD) of tree 344 and up to 15 feet from the base of the tree (Figure 2).

Figure 1. Snip of the approved grading plan with Tree 344 indicated and the location of the retaining wall shown (Grading Plan C200A, LPD Engineering, 02/24/2023).

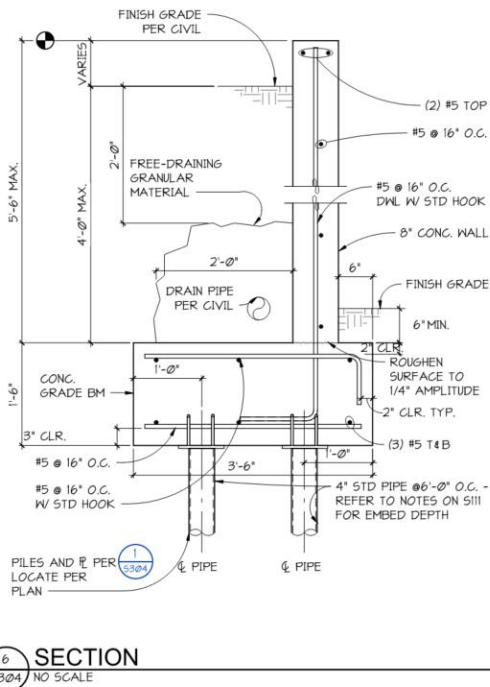
Figure 2. Snip of the concrete footing for the wall. The footing is four feet long and would require encroachment into the MLOD of tree 344 (Foundation Details, PCS Structural Solutions, 02/24/2023)

Due to these impacts, the project team developed an alternative solution to install the retaining wall by utilizing soldier piles. Based on my discussion with the project team, this approach would reduce the encroachment into the RLOD of tree 344 by three or more feet and could be installed from the existing driveway utilizing an auger.

I believe the long term health of tree 344 will not be impacted if excavation within undisturbed soils is limited to the placement of beams for the piles. I recommend the location of the piles are first ground

with a grinding or reciprocating attachment head on the auger for the initial four feet to cleanly cut any roots in the vicinity. No machinery or materials should be stored on top of undisturbed soils within the RLOD of the tree. I recommend the installation of the piles within the RLOD of tree 344 are monitored by the project arborist to guide installation and determine rooting impacts.
