Consulting Arborist Services

Reference: Tree Protection Guidelines and Response to Corrections

Date: June 7, 2023

Site Address: 9167 SE 64th, Mercer Island 98040

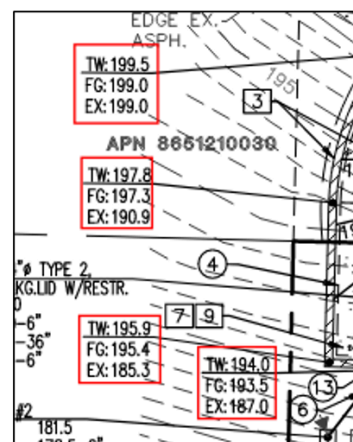
The proposed driveway will be constructed within the LOAD of offsite trees 3557 and 3557.5, two very large cottonwoods. The proposed encroachment is fill over the tree's rootplates from 6 to 7 feet above existing grade. See exhibit right for elevations.

Additionally, excavation for the NW corner of the proposed house will occur within a small portion the LOAD and dripline of these trees.

a tree well and/or retained will will be installed to protect those trees. If removal is required, coordination and agreement with the adjacent property owner is required.

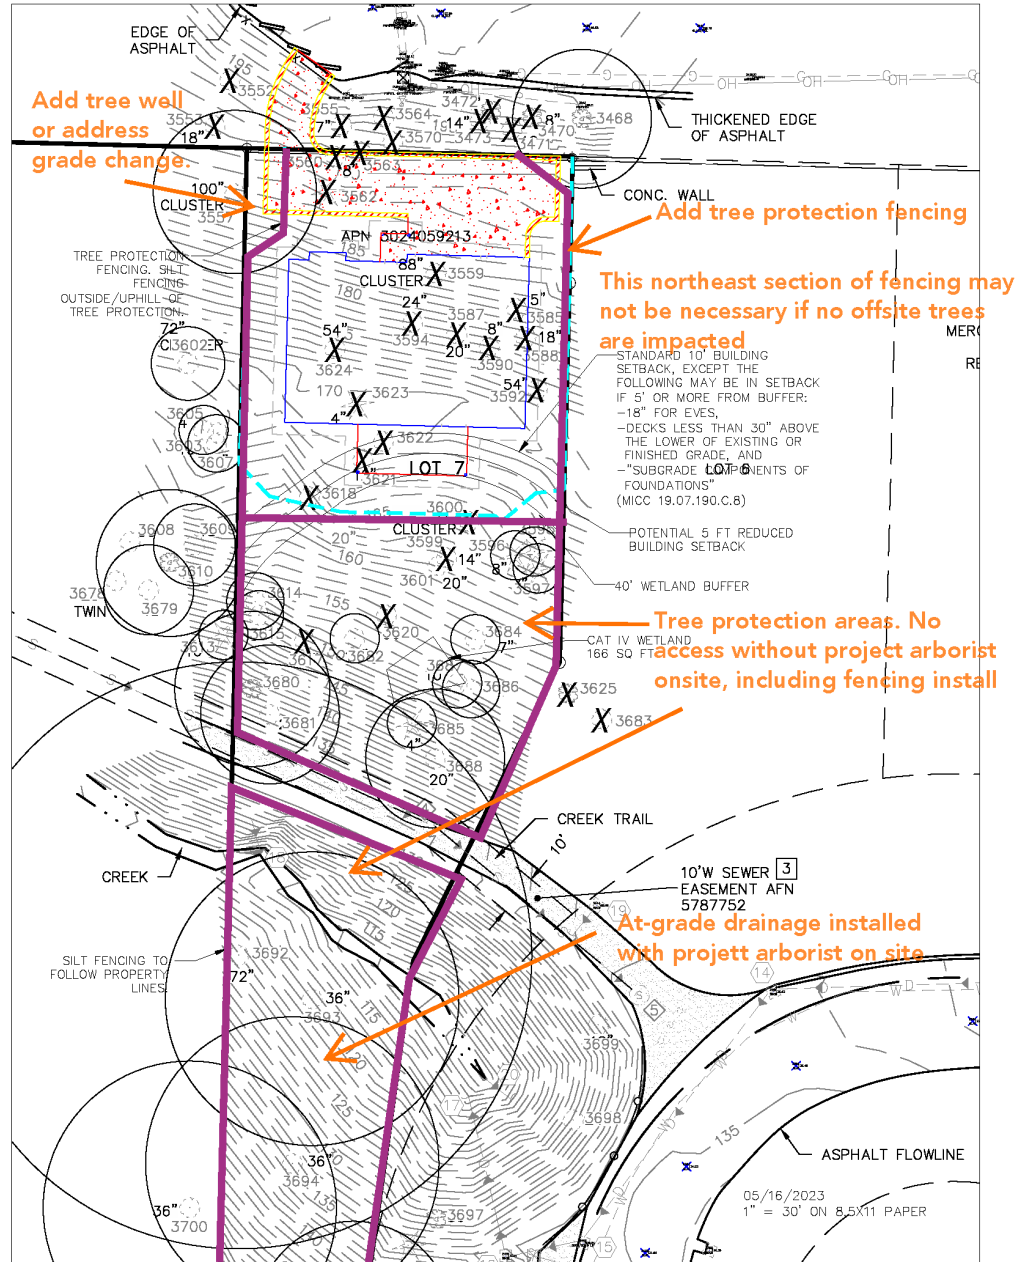
Attachment 4: Annotated Site Illustration – Update Site Plans

Tree protection fencing: A six-foot temporary chain-link fence or approved orange polyurethane equivalent shall be installed outside the driplines of all retained trees, as indicated on the annotated illustration in this report. All site plans shall be updated accordingly. Fencing shall be installed before any site disturbance, demolition or construction, and after tree removal and pruning for clearance is complete. The project arborist shall be onsite during fencing placement that crosses inside any dripline areas of retained trees to monitor and document any impacts. Fencing material, placement and any modifications to tree protection measures shall be approved by the project arborist or a city planner.

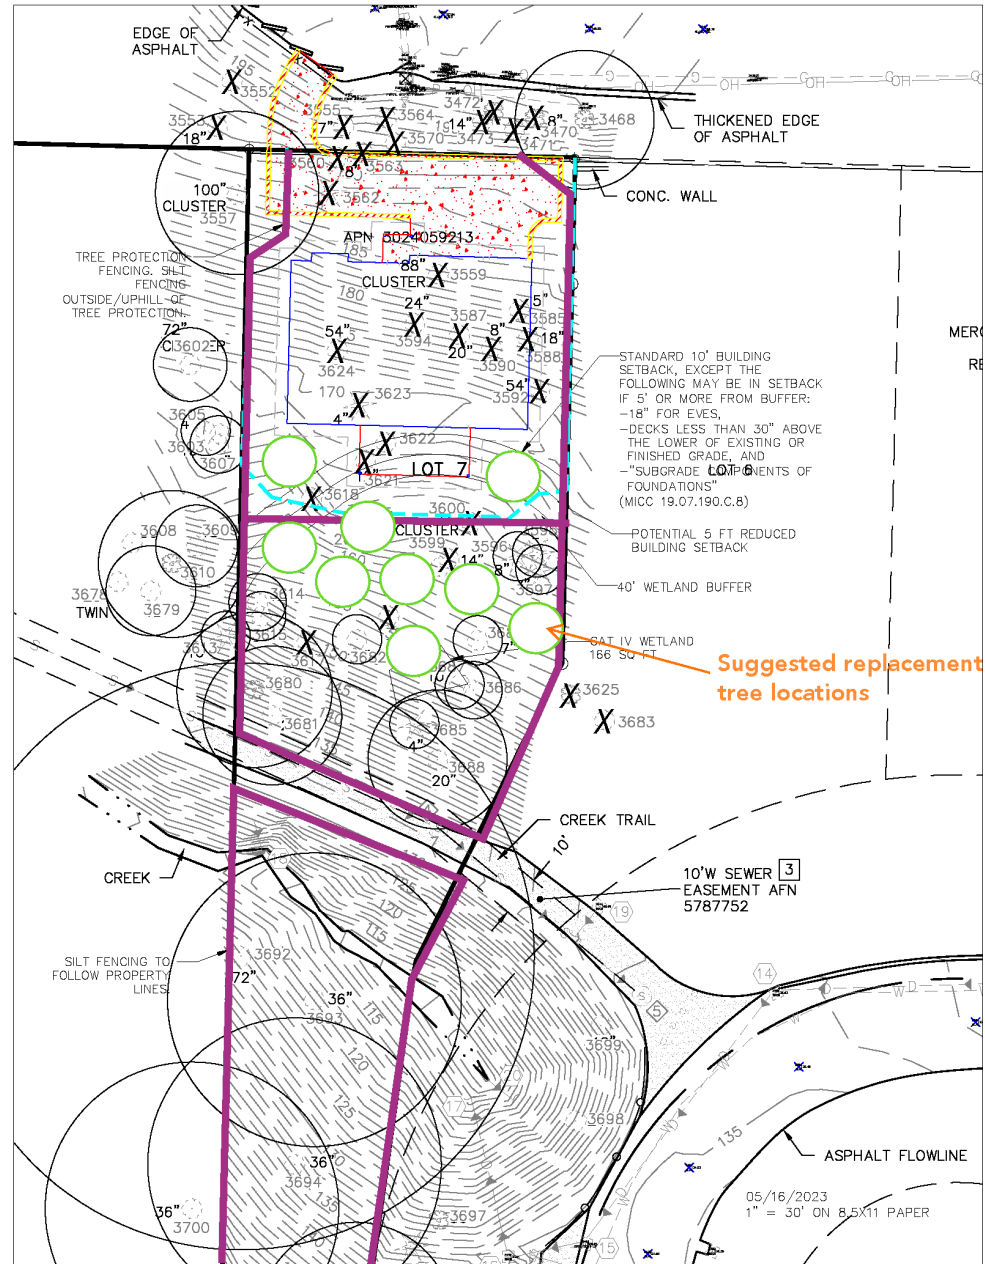
Attachment 5: Recommended Replacement Tree Locations

Nine (9) of 21 required. See pages 6-7.

placement of nine (9) trees on the property, based on space available. All replacement trees can be located south of the new home as space allows with retained trees protected.
