Tree Protection Plan

August 31, 2022

Laurie Yang
8456 SE 40th St
Mercer Island, WA 98040

Jordan Blonski
Certified Arborist PN-8610-A
Qualified Tree Risk Assessor (TRAQ)
Eastside Tree Works
253-358-6143
Jordan@eastsidetreeworks.com

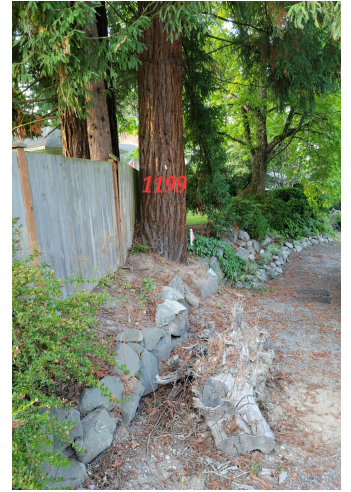
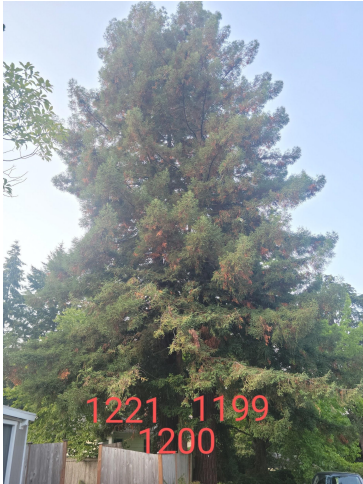
Tree #1199*, Redwood, (*Sequoia sempervirens*) The tree is perched on top of a small stone retaining wall at the northeast corner of the property. The tree has a DBH of 33" at a height of 95' and a crown spread of approximately 20'. There is a small fence that is growing against the trunk at the root flare. This tree is part of a cluster of 3 Redwood trees.

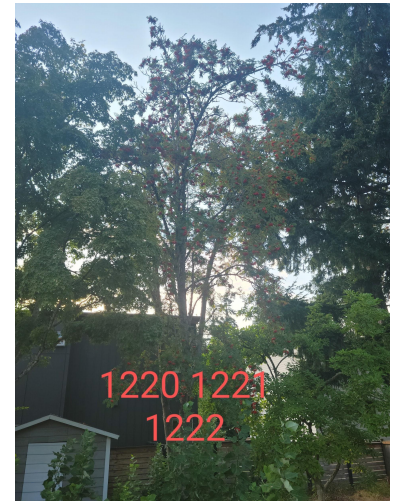
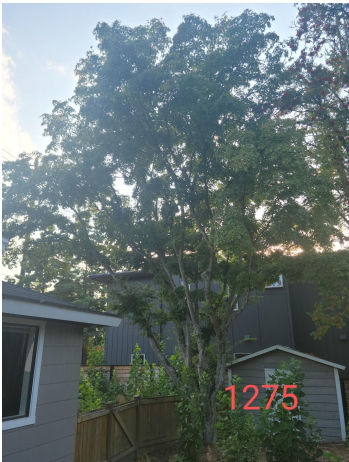
Tree #1201*, Redwood, (*Sequoia sempervirens*) This tree is located at the northeast corner of the property amongst a cluster of 3 Redwood trees. The tree has a DBH of 43" at a height of 100' and a crown spread of approximately 19'. This tree is codominant with included bark. The bifurcation starts at approximately 6'. The tree has not created much reaction wood in reaction to this codominance.

Tree #1220, 1221 and 1222, Mountain ash, (*Sorbus americana*) The tree is located approximately 30' south of the northwestern corner of the property and approximately 12' from the west wall. The tree has a DBH of 10", 9" and 7" at a height of 40' and a crown spread of approximately 16'. Although there is one tag per stem, the stems should be treated as one tree. The three stems all originate at ground level. Excavation of the root flare would be needed to determine if there is included bark. The tree is sparse with some significant tip dieback.

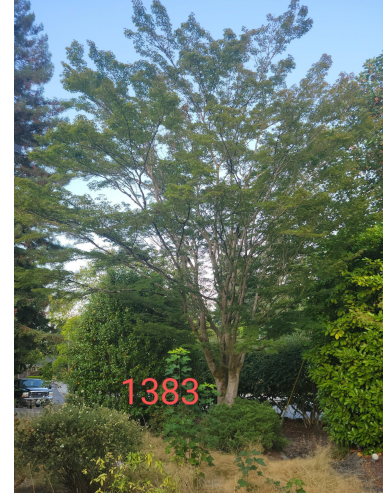
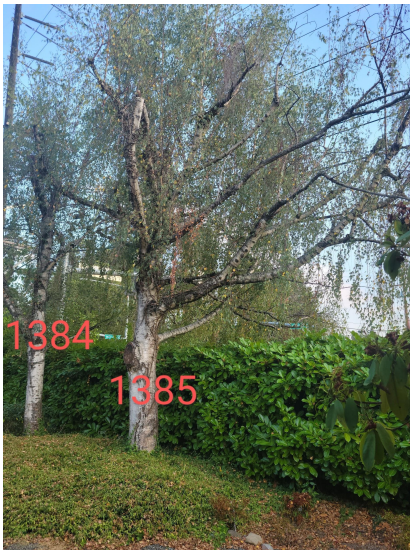
Tree #1275, Japanese maple, (*Acer palmatum*) This tree is located approximately 15' west of the northwest corner of the house. The tree has a DBH of 11" at a height of 30' and a

crown spread of approximately 22'. This tree has 3 stems originating from the ground level, all with included bark. Its canopy does overhang the roof.

Tree #1383, Japanese maple, (*Acer palmatum*) This tree is located approximately 25' east of the southeast corner of the house. The tree has a DBH of 10", 10" and 7" at a height of 20' and a crown spread of approximately 19'. Although the tree has several stems, bark inclusion is minimal and the tree is in very good health.

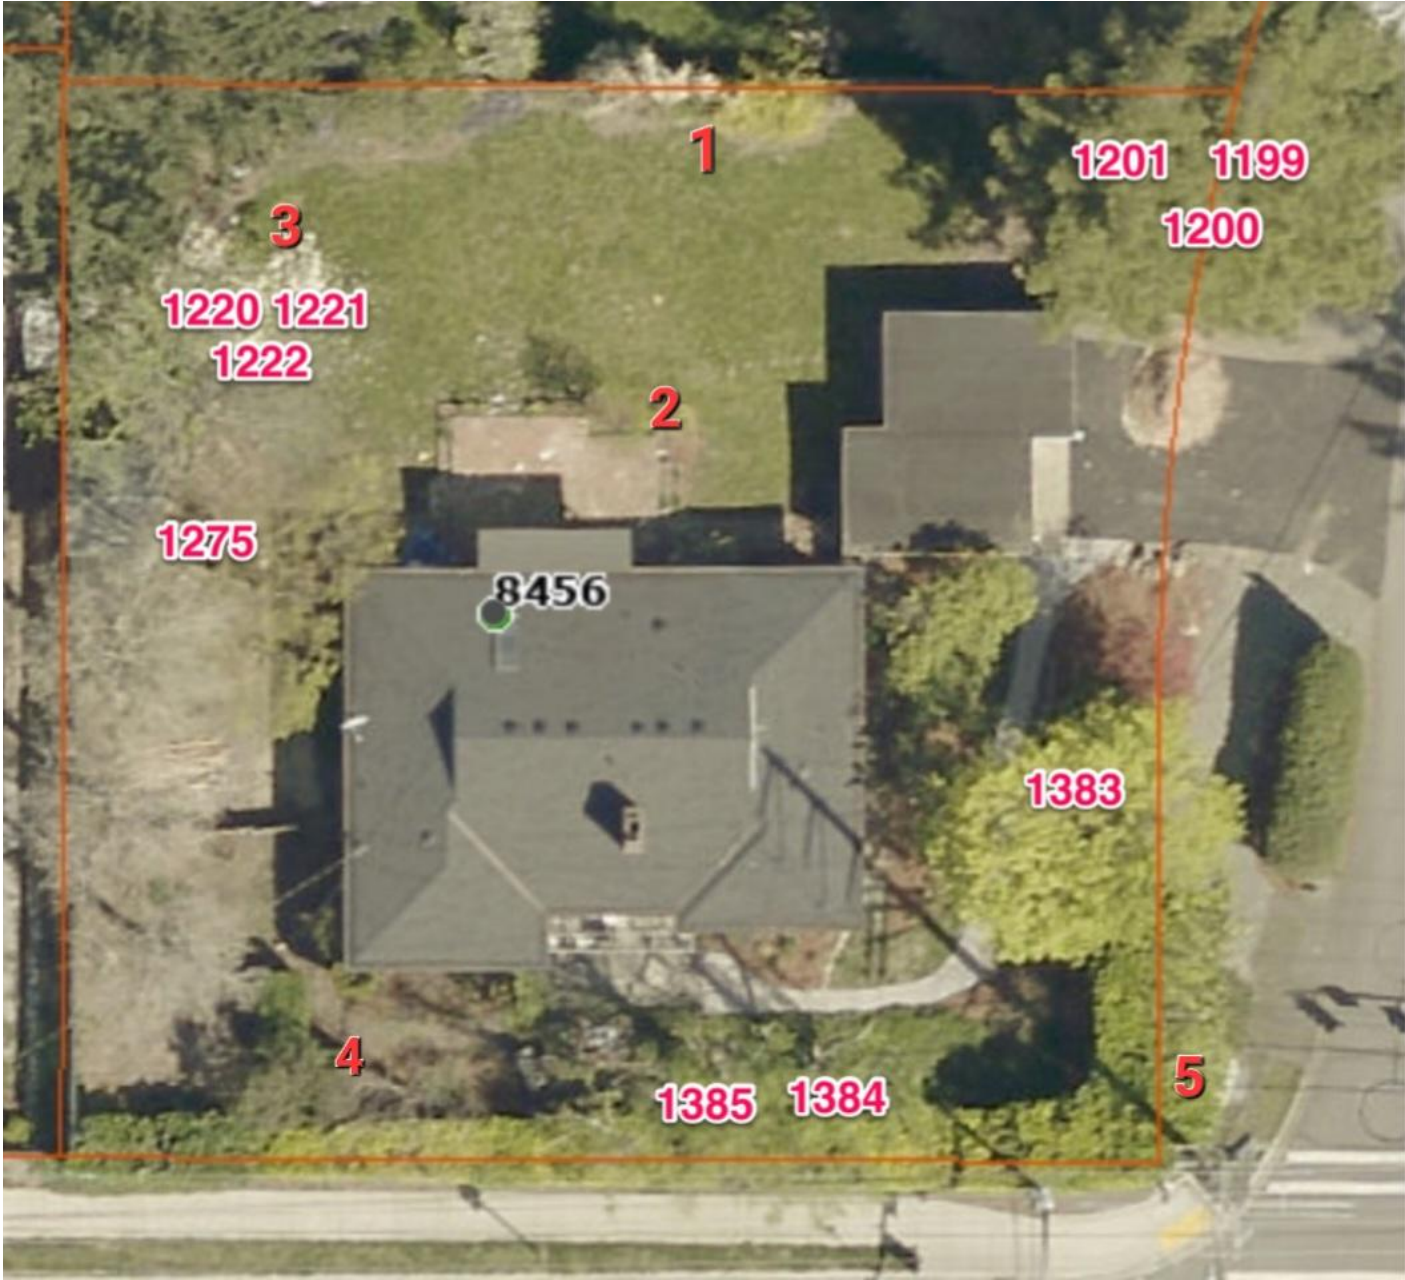
Attachment 2 - Site Map

- Tree #1201* has a TPZ that will likely interfere with construction activities. To the south of the tree, the TPZ will be reduced by 30%. This would reduce the TPZ from 43' to 30'. Any excavation done within the TPZ zones shall be done with hand tools and a consulting arborist on site.
- Tree #1199* has a TPZ that will likely interfere with the construction of the driveway. To the south of the tree, the TPZ will be reduced by 10% to match tree #1201's TPZ. This would reduce the TPZ on the south side of the tree from 33' to 30'. Any excavation done within the TPZ zones shall be done with hand tools and a consulting arborist on site.
