June 9, 2023

Site: 4719 86th Ave SE
Mercer Island, WA 98040
TPN: 7598100421
Area: 11,500 sq ft. = .26 acres

Re: RFI from John Kenney:

May 2, 2023

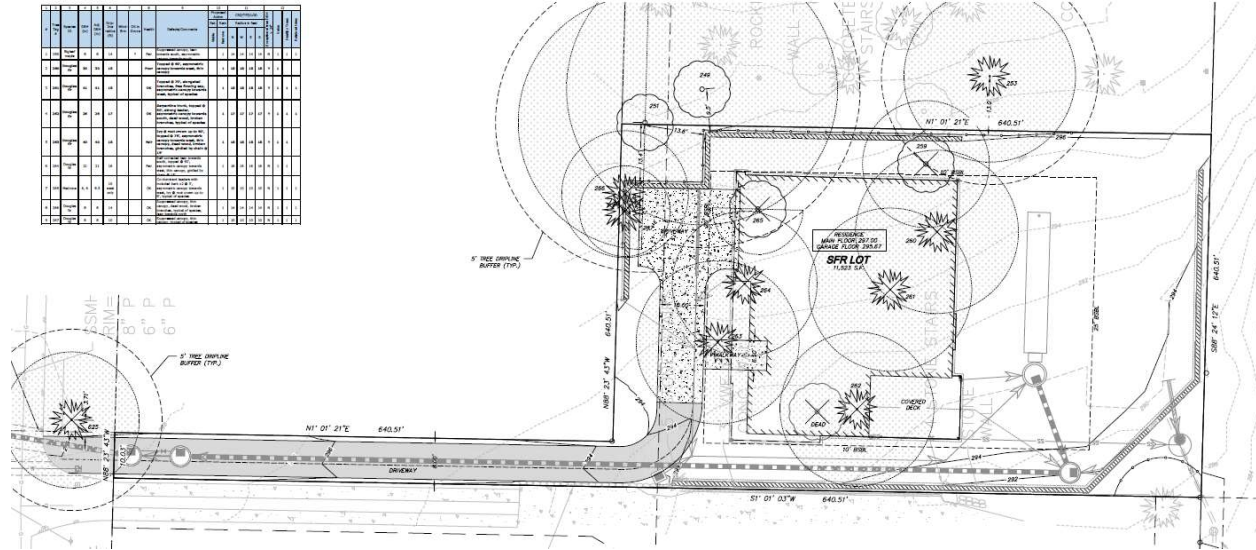
Proposed Site Plan:

*6. I located a tree in the ROW that has previously not been discussed and I am adding that now. I am presuming its removal will require an additional 3 trees for mitigation. The tree has been tagged #625 and is located on the north side of the property adjacent to a 10' wide roadway access. The tree is viable and needs to be removed. I have updated the spreadsheet to include it in the discussion and modified my summary to consider the removal and mitigation.

The subject tree is a white pine, with a lean (self-corrected) to the east. The root ball is shallow (typical of the species) and soil is slightly elevated, likely the consequence of a previous wind throw event. The roots that are preventing the tree from falling are located primarily on the east and south of the tree. Those roots need to be cut in order for the driveway to meet the grade of the street. There are no alternate pathways around this narrow driveway nor are there any construction BMP to span the roots and keep the tree, due to the elevation change to meet grade.

Applicant proposes to mitigate for the loss of the tree by replanting the same species 10' further to the east in the easement.

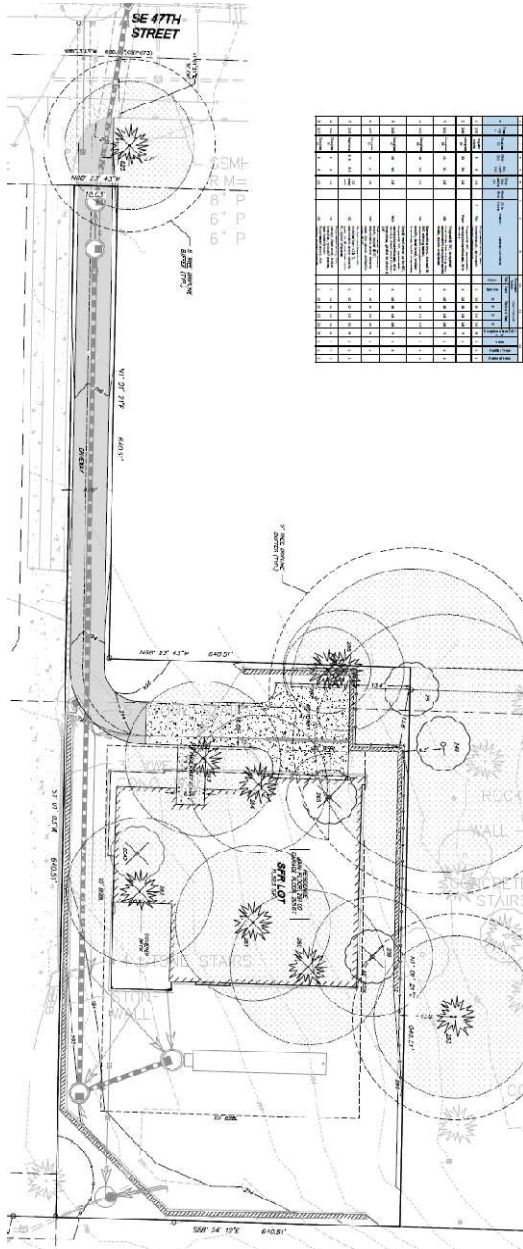
Proposed Site Improvements (for reference only, see Civil Engineering Plans for details):

There are two (2) exceptional trees (#262 and #262) located in the proposed building site. Their dripline + 5' buffer are shown on the Tree Retention Sheet. Permission to remove the two (2) trees is requested because the driveway is the maximum distance the fire Department will allow from the street. To move the house to a different location requires and increase in the driveway access which in turn makes the structure a fire hazard.

Mitigation for exceptional DBH – sized trees is 6: 1 or or 6 X 2= 12 trees. There is one onsite large tree removal as well as one offsite/ROW proposed tree removal. Replacement for those trees is 3:1 or 6 trees. Site mitigation requires 12 + 6 = 18 trees, however, code requiring new trees not be planted within 10 'of each of, utilities or structures allows for only six (6) trees to be replanted.

The additional trees 18-6 = 12 trees will require a fee-in-lieu-of be paid.
