ARBORIST REPORT

December 11, 2021

8455 SE 83rd St Mercer Island, WA 98040

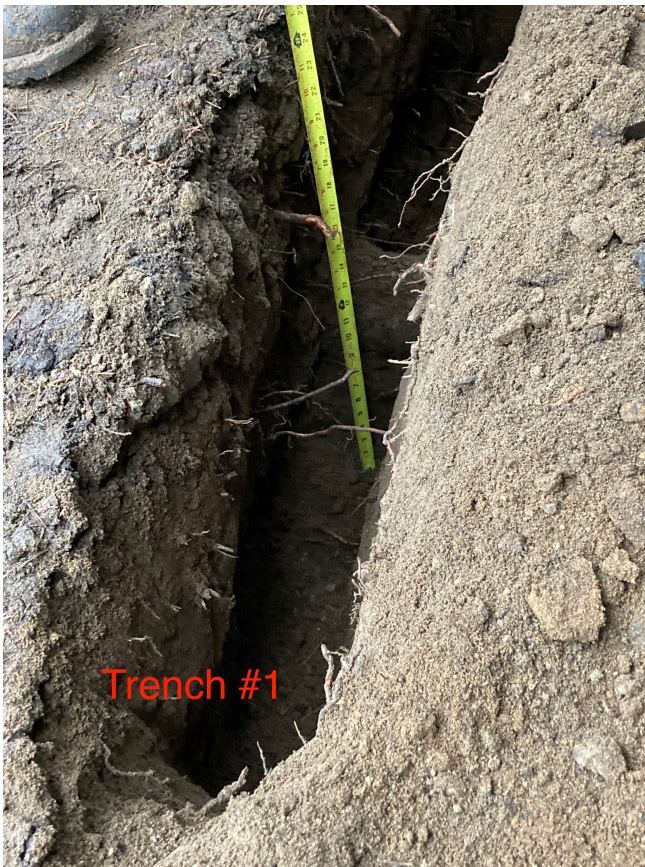
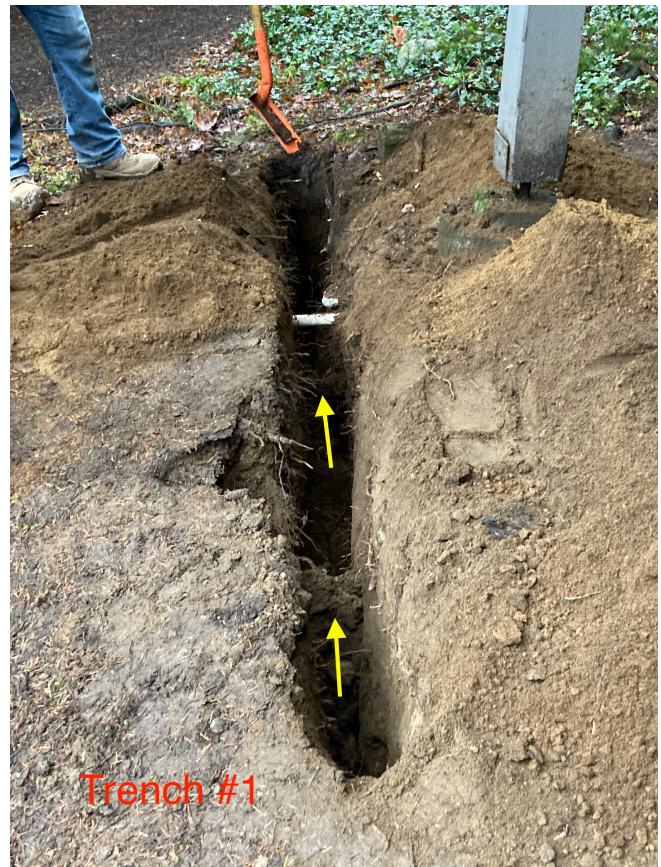
Trench #1 - One 8" diameter root and one 1.5" diameter root were found at approximately 20" deep. The proposed rebuilding of the deck will not directly impact the root system if the corner deck footing remains in the same location. The biggest area of concern, however, is that construction traffic will occur under the drip line of Tree # 351 and encroach into the interior crucial root zone.

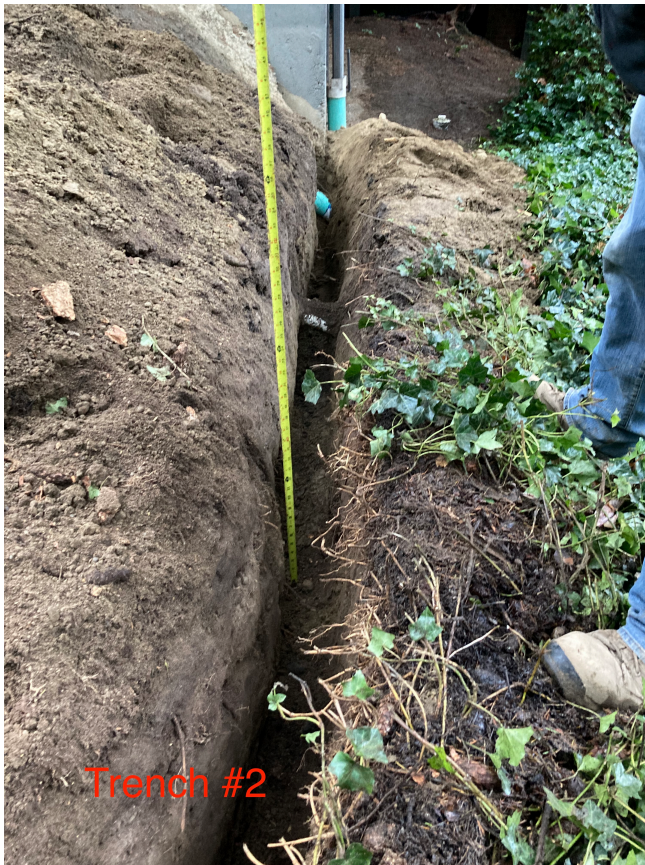
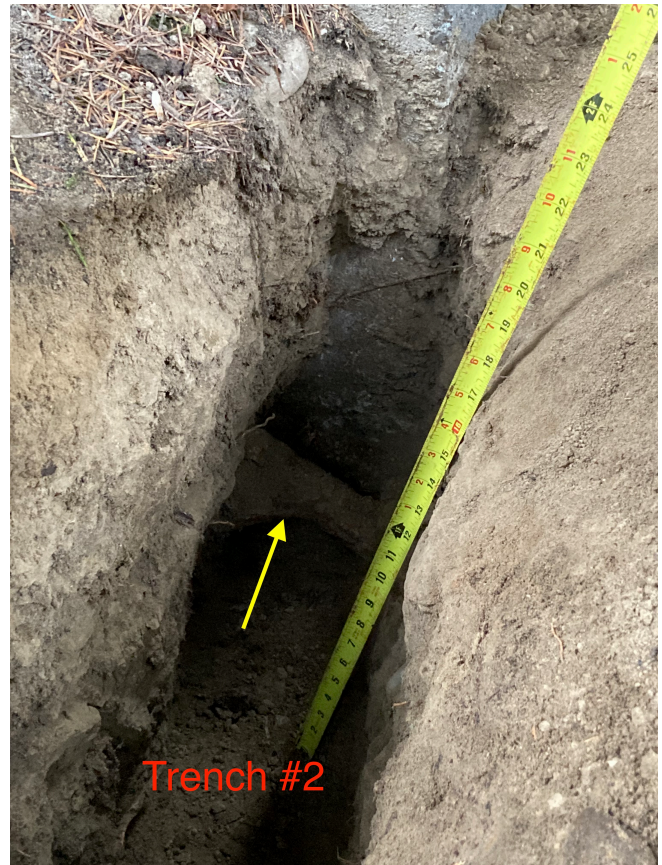
Trench #2 - One 1.5" diameter root was found at approximately 18" deep close to the corner of the residence. While the root system of Tree # 347 will not be directly disturbed the proposed construction to the garage will, however, occur within the drip line and falls well into the interior crucial root zone of Tree # 347.
