Tree Protection Plan

November 15, 2022

8814 MI ProtectionPlan 8814 SE 40th St, Mercer Island, WA 98040 11/15/2022 Page 1 of 20

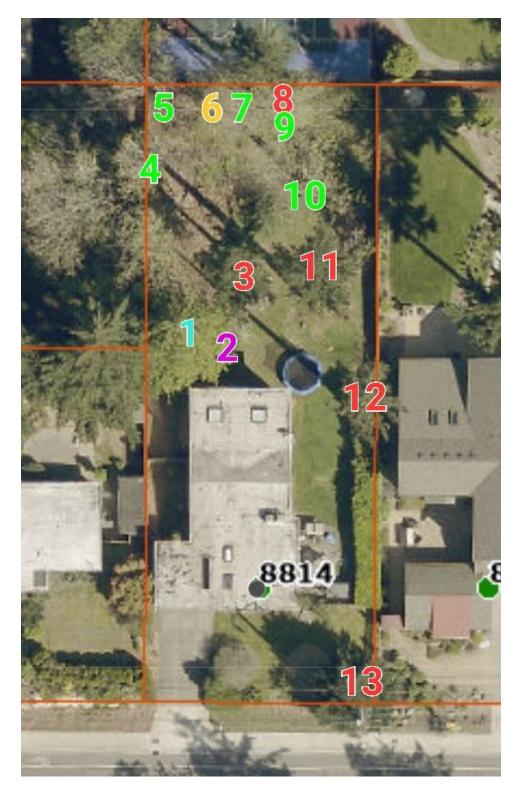
ATTACHMENT 1- ON SITE TREES

Douglas Fir						
Madrona						
<mark>Cedar</mark>						
Big leaf maple						
<mark>Cherry</mark>
